# Full-Scale Fatigue Testing of a Wind Turbine Blade in Flapwise Direction and Examining the Effect of Crack Propagation on the Blade Performance

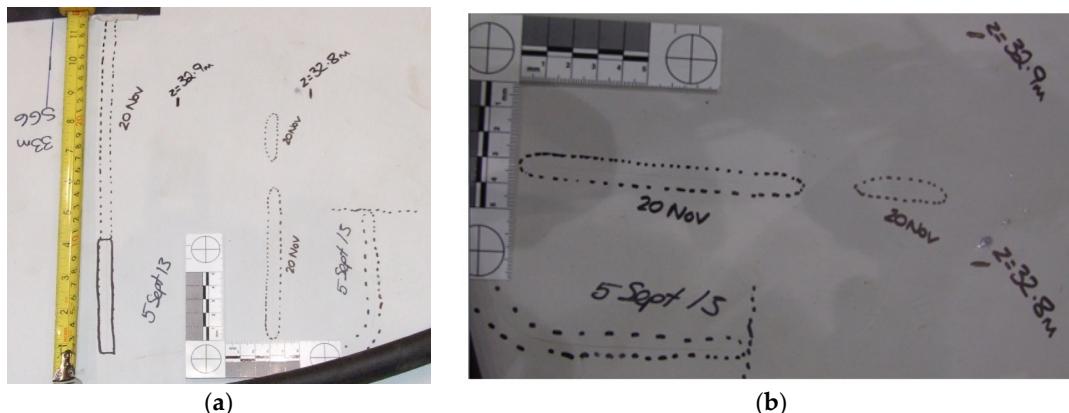
Table 4. Initially, a 2500 kNm bending moment at the root was applied which resulted in 1523  $\mu\epsilon$  at SG2. The strain at this location had increased from 1478  $\mu\epsilon$  before the insertion of crack, showing a 3% increase. A visual inspection was performed after 8063 cycles to check if any existing cracks had propagated or new ones formed. No changes to the existing cracks or to the 200 mm crack at 9 m distance were observed. Later on the visual inspection was repeated after 26,851 cycles. A pre-existing crack at around 32.96 m had extended by 190 mm in the middle of the blade as shown in Figure 13a with the overview image of the two cracks found. Figure 13b shows a close inspection of the new cracks found at about 32.83 m from the blade root which propagated for 110 mm and 40 mm on the middle cross section at this point. The next visual inspection was carried out after 39,934 cycles, where the applied BM value had been increased to 70% of the maximum target BM. The visual inspection showed an existing crack at about 32.96 m propagated 15 mm along the blade longitudinal direction

**Figure 13.** (a) Propagation of existing crack at 32.96 m after 26,851 cyclic loading; (b) Formation of hair line cracks at 32.8 m after 26,851 cyclic loading.

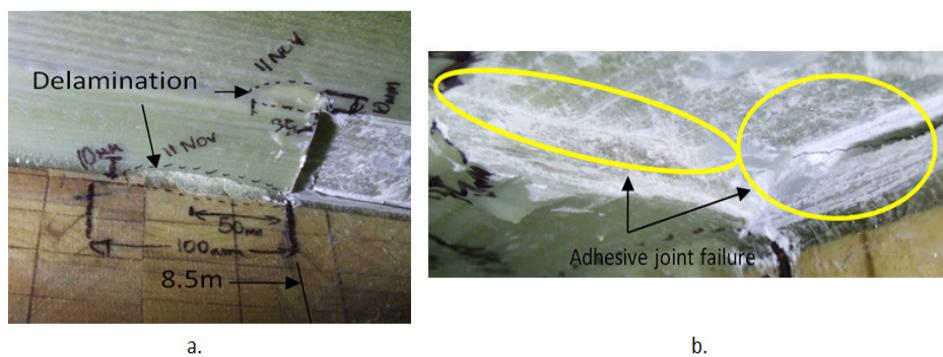
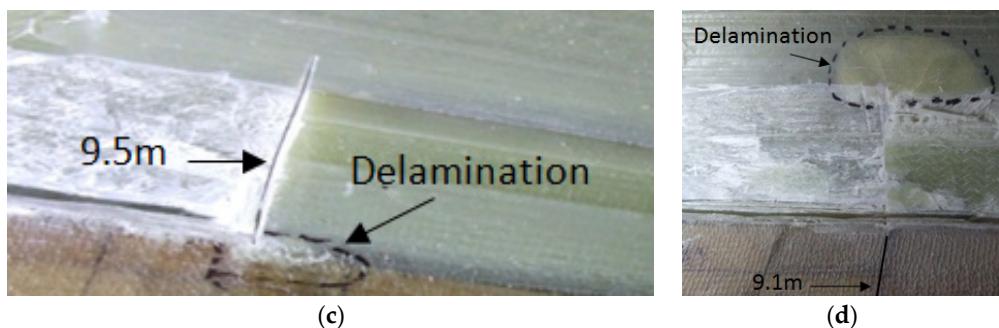
A visual inspection of the blade after 34,776 cycles showed a number of cracks was formed around the 1000 mm extended crack. Inside the web box at 8.5 m from the root, two delaminated areas each at 10 mm in width were detected. The delamination connected to the web had a delamination length of 83 mm and the delamination furthest away from the web had a length of 35 mm as shown in Figure 14a. At 8.5 m, the induced crack through the adhesive joint had propagated from its corner and extended through the plies causing delamination on the web lip, indicating that the crack plane has been deviated from its original path; see Figure 14b. At 9.5 m from the blade root delamination had occurred at the corner of the 1000 mm crack as shown in Figure 14c. Figure 14d shows delamination at 9.1 m at the location of the corner of the 200 mm crack. The fact that the crack bridged across from the unreinforced adhesive to shear web laminate is interesting, and is probably a result of the complex mode II loading that would be induced by a flapwise test in this region. It is also possible that when cutting the crack the blade had travelled into reinforced material as well as through the adhesive, which would make the bridging more likely to occur.

**Figure 14.** Damaged areas around the root: (a) delamination at 8.5 m (b) adhesive joint failure at 8.5 m; (c) delamination inside the web box at 9.5 m and (d) delamination inside the web box at 9.1 m.

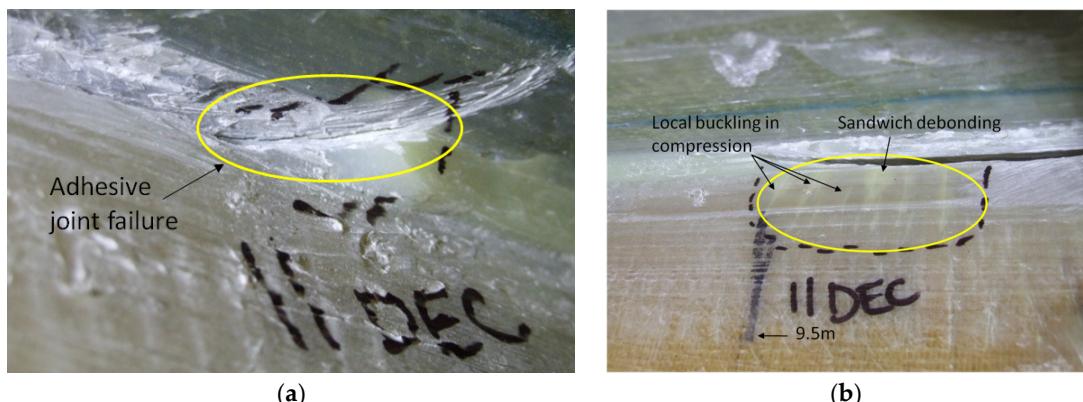
The adhesive joint had debonded outside the web box at 8.5 m as shown in Figure 15a indicating that the crack had propagated all the way through the web. At 9.5 m the blade experienced multiple local buckling under compression, and debonding in the sandwich propagated into the web, as shown in Figure 15b.

**Figure 15.** (a) Adhesive debonding outside the web box at 8.5 m; (b) local buckling under compression and sandwich debonding outside the web box at 9.5 m.

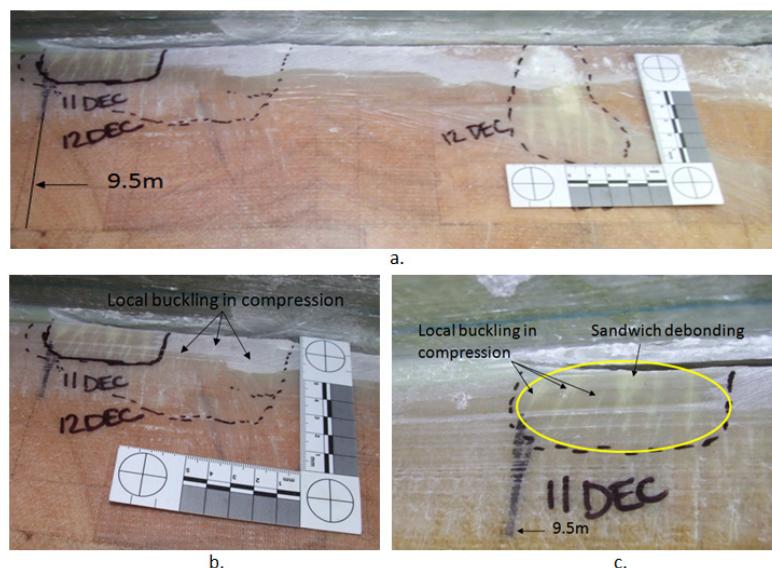
Figure 16a shows outside the web box at 9.5 m with an overview of the damaged areas. The blade experienced multiple local buckling under compression, and sandwich debonding going into the web. Figure 16b is the magnified view of the damaged area at 9.5 m and Figure 16c shows the magnified view of the damaged area at 9.3 m. The crack had also propagated 100 mm in the adhesive joint at 8.5 m.

**Figure 16.** Outside web at 9.5 m (a) overview of local buckling under compression and sandwich debonding (b) magnified view of damage at 9.5 m (c) magnified view of damage at 9.3 m.

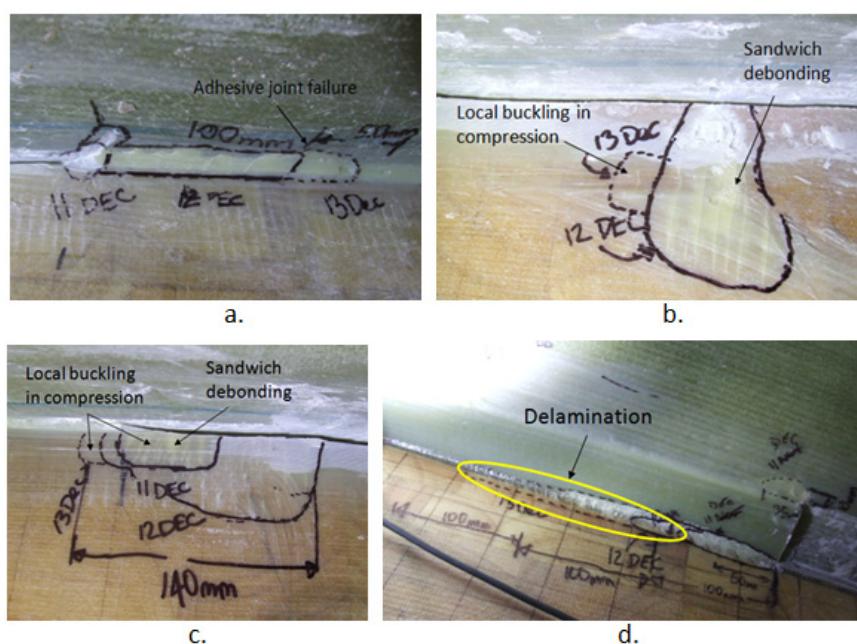
A visual inspection of the blade after 56,762 cycles showed that many of the cracks had extended along the web within the 1000 mm crack area as illustrated in Figure 17. At 9.5 m inside the web some delamination had also begun to occur.

**Figure 17.** Crack propagation within the web; (a) adhesive joint failure outside the web; (b,c) local buckling under compression outside the web; (d) delamination inside the web.
