# Long-Term Atmospheric Corrosion Behavior of Epoxy Prime Coated Aluminum Alloy 7075-T6 in Coastal Environment

**Abstract:** The atmospheric corrosion of epoxy prime coated aluminum alloy 7075-T6 exposed for 7, 12 and 20 years was investigated. The remaining thicknesses of epoxy prime coatings for macroscopically intact coating areas followed a normal distribution and decreased linearly. EIS results demonstrated that the corrosion resistance of the coating decreased with exposure time. After 20 years of exposure, the epoxy coating had lost its protection as cracks existed within the coating and exfoliation corrosion had occurred on the substrate. The substrate was sensitive to exfoliation corrosion through metallographic and TEM analysis. The corrosion products were mainly hydroxides of aluminum. The morphology and chemical compositions of the coating bubbling area and propagation characterizations of exfoliation corrosion were analyzed by SEM, EPMA and EDS. Cracks between the lumps of corrosion products provided the channels for the transmission of corrosion mediums. Furthermore, the mechanical model was proposed to analyze the propagation characterization of exfoliation corrosio

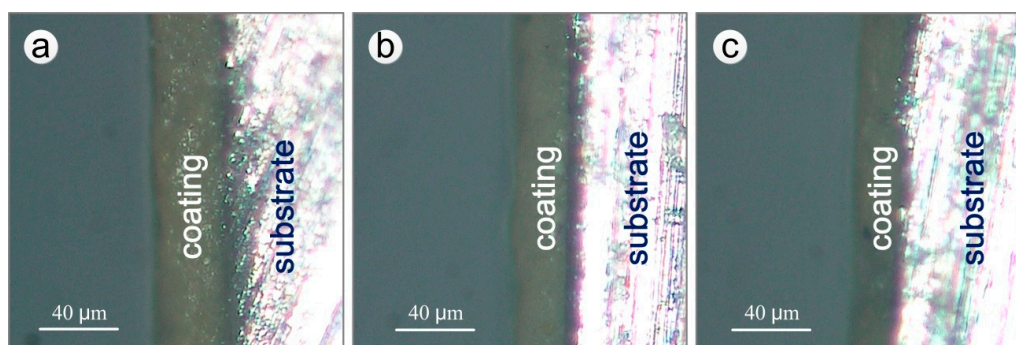
**Figure 3.** Cross-sections of specimens exposed for different years (one side of the upper surface coatings): (a) 7 years; (b) 12 years; (c) 20 years.

From Figure 3, it can be observed that the thicknesses of the epoxy coatings decreased noticeably with exposure time, and the outer surface of the coating was smooth, without visible damage. The remaining thicknesses were described through the Normal, Log-normal, Gumbel, Logistic and Weibull distributions. The corresponding distribution functions are shown below:

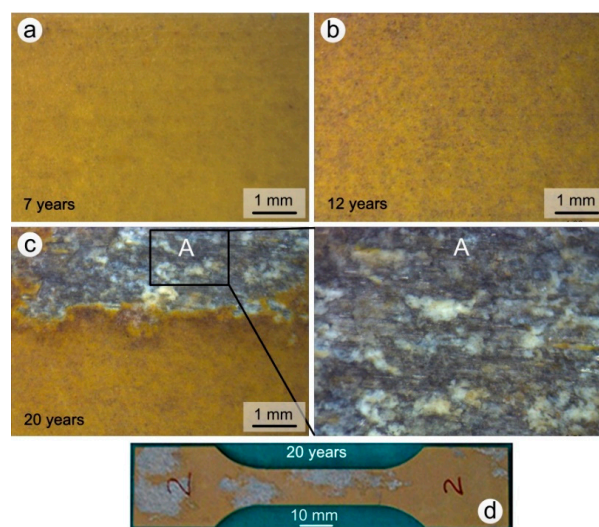
The surface appearance of coated specimens exposed for 7, 12 and 20 years in the Wanning test site are shown in Figure 4. The degree of aging increased with the exposure time and the color of the coating changed, gradually becoming darker. After 7 years a small amount of salts and impurities were deposited on the surface of the coating (Figure 4a); the deposit present on samples that had been exposed for 12 and 20 years also contained impurities such as sand and dust (Figure 4b,c). The concentration of impurities was higher on samples exposed to the atmosphere for 20 years. The surface of the epoxy coating remained macroscopically intact when the exposure times was lower than or equal to 12 year, and no localized corrosion occurred. On the other hand, after 20 years the epoxy coating had partially lost its protection ability, and both the coating and the anodic oxide film had been completely destroyed in the exfoliation corrosion regions (Figure 4d). Meanwhile, the extruded 7075 aluminum alloy substrate displayed layered peeling and the formation of white corrosion products in box A, which are typical of exfoliation corrosion (Figure 4c). The percentage of corrosion regions in corrosion test section of the most severely corroded specimen is up to 70% after 20 years exposure. At the same time, the average percentage of five specimens is about 30%, which is similar to that of specimen 2# (Figure 4d).

**Figure 4.** Surface appearance of coated test specimens exposed to the Wanning test site: (a) 7 years; (b) 12 years; (c) 20 years; (d) 20 years (whole upper surface).

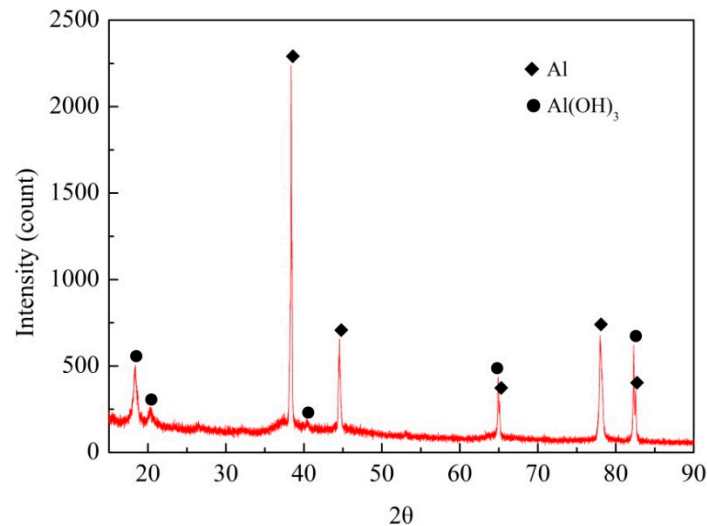
The XRD pattern of the white corrosion products in substrate corrosion area of a specimen exposed for 20 years is shown in Figure 5. The results show that the corrosion products were comprised of  $\text{Al}(\text{OH})_3$ . The volume of this component is larger than that of the parent material, thus forcing the sheets apart. In addition, the more elongated the grains are, the greater the generated wedging force [1,22–24].

Figure 5. XRD spectrum of exfoliation corrosion products.

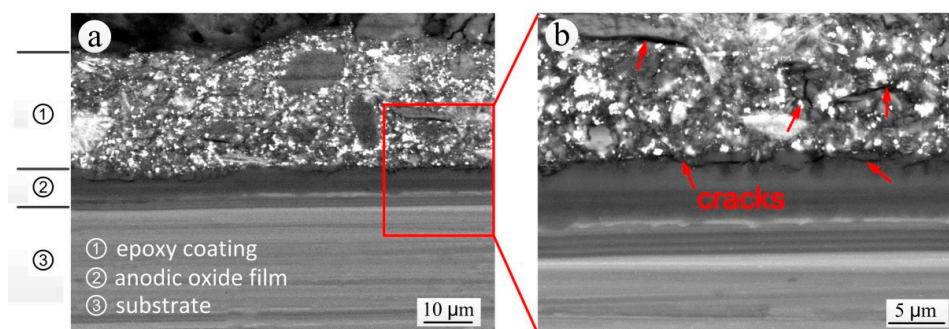
Figure 10 shows the backscattered electron image of the S-L section of the specimen that was exposed for 20 years. Although there was no visible damage along part of the sectional coating thickness, obvious signs of cracking appeared between the local coating and the anodic oxide film and within the coating, leading to a reduced resistance of the coating to the infiltration of water, chlorine ions, sulfate ions and other aggressive mediums, and thus leaving the substrate very vulnerable to corrosion. This was a good explanation for the apparently contrasting observations made on the coating exposed for 20 years of an apparently intact structure but inductive EIS characteristics. The main causes of cracking were:

- (1) Cathodic disbondment: Under the conditions of atmospheric corrosion, the anodic oxide film or aluminum alloy substrate under the coating endures electrochemical corrosion. The oxygen reduction reaction (Equation (9)) occurs on the cathode and the pH in the cathode reign increases significantly. The strong basic environment damages the metal oxide or polymer-coating of the interface, which affects the bonding of the coating to the anodic oxide film, and then causes the cracking [35–37].

- (2) Photoaging of coatings: Small molecules such as ketones, alcohols and acids can be washed away by water during photoaging (ultraviolet irradiation), continuously changing the composition of the coating, which therefore contracts and is subject to a decrease in thickness. This causes and embrittlement of the coating [38]. In addition, the loss of the polymer from the coating will effectively increase the volume concentration of the pigments on the surface of coating. Thus, the surface of coating will become relatively brittle while the inner layer of coating is still relatively elastic, which leads to the superficial and inner cracking of the coating.

- (3) Temperature alterations: The seasonal and daily alternations of atmospheric temperature cause the expansion and contraction of the coating, and the change of coating tension and internal stress, which leads to the decrease of adhesion, cracking and destruction of coating [39].

- (4) Effect of  $\text{SO}_2$  air pollutant: The air pollutant  $\text{SO}_2$  can significantly reduce the adhesion of the coating, resulting in cracking between the coating and anodic oxide film. When  $\text{SO}_2$  and  $\text{H}_2\text{O}$  are simultaneously present, the destruction of the coating is more obvious [40].

**Figure 10.** Backscattered electron image of the S-L section of the specimen exposed for 20 years: (a) SEM morphology; (b) local enlarged SEM morphology.

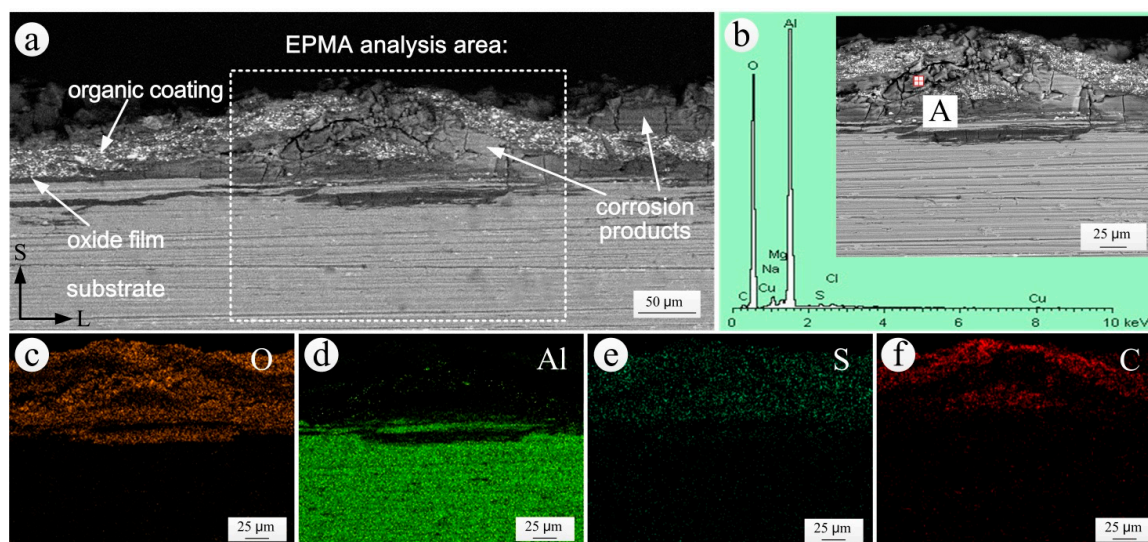
The S-L sectional SEM morphology and EDS spectrum of the corrosion products and the elemental distribution in the coating bubbling area of coated specimen exposed for 20 years are shown in Figure 11. It can be seen that there was an evident bubbling area in the S-L section of the coated specimen exposed for 20 years (Figure 11a). The anodic oxide film under the bubbling area had been destroyed and the aluminum alloy substrate had also been corroded. The EDS results (Figure 11b) and elemental distributions (Figure 11c,d) revealed that the corrosion products in the interior of the bubbling area of Figure 11a were mainly hydroxides of aluminum. The accumulation of corrosion products between the coating and the substrate and the expansion of their own volume led to the bubbling of the local coating. Sulphur was present throughout the entire coating area, as shown in Figure 11e. The only source of S was the air pollutant  $\text{SO}_2$ . The presence of  $\text{SO}_2$  significantly reduced the bonding force between the coating and the substrate, and also reduced the corrosion resistance of the coating [40]. The presence of chlorine in the corrosion products was seen from Figure 11b. The existence of the chlorine ion accelerated the dissolution of the anodic oxide film [41].

**Figure 11.** S-L sectional analysis in the coating bubbling area of coated specimen exposed for 20 years: (a) SEM morphology; (b) EDS spectrum of the corrosion products; (c–f) the elemental distributions of O, Al, S and C obtained by EPMA.

In Figure 11f, the epoxy coating, represented by the presence of carbon, was divided into two parts: an upper part and a lower part. This phenomenon may be due to a certain degree of cracking partaking place between the two layers of the inner coating before the corrosion of the aluminum alloy substrate, as shown in Figure 10. After the corrosion of the substrate occurred, the corrosion products moved along the cracks and inside the coating. The coating was then divided into two parts due to the accumulation and expansion of the corrosion products.

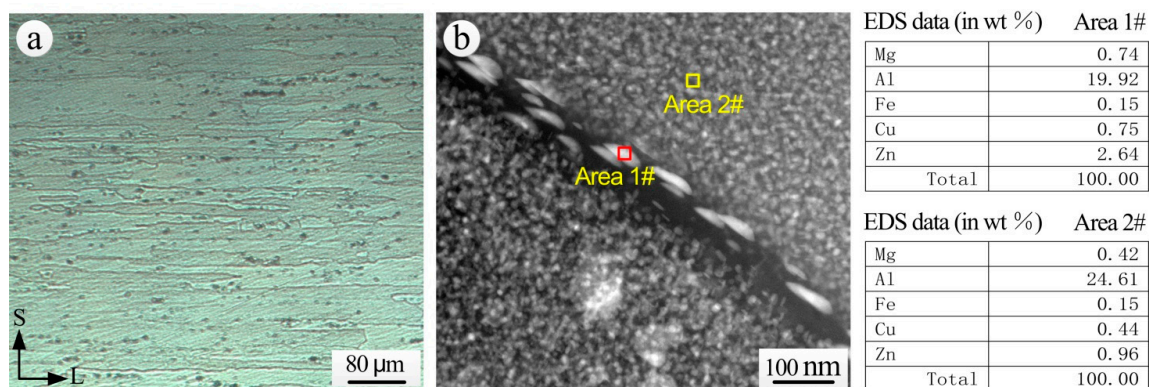
The metallurgical structure of the S-L section and the grain boundary microstructure of 7075-T6 aluminum alloy substrate exposed for 20 years are shown in Figure 12. The grains of extruded 7075-T6 aluminum alloy were flat in the direction of extrusion, and there were a large number of second phase particles (Figure 12a). The second phase particles of 7075 aluminum alloy mainly include  $\eta(\text{MgZn}_2)$ ,  $\text{T}(\text{AlZnMgCu})$ ,  $\text{S}(\text{CuMgAl}_2)$  and  $\beta(\text{Al}_7\text{Cu}_2\text{Fe})$ . The main strengthening phases of

7××× aluminum alloy after T6 aging are the G. P. zone and a small amount of transitional phase  $\eta'$  ( $\text{MgZn}_2$ ). A continuous chain of precipitates is distributed at the grain boundary (Figure 12b). From the comparison of EDS analysis results of the intragranular  $\alpha$  solid solution (Area 2#) and of the precipitates at the grain boundaries (Area 1#), a higher Mg and Zn content is noticed in the grain boundary precipitates, and thus it can be inferred that the grain boundary precipitates consisted mainly of the  $\eta$  phase.

The  $\eta$  phase in the pitting process acts as an anode and will be dissolved preferentially [42]. As the continuous chain of the  $\eta$  phase is distributed at the grain boundary, the anodic  $\eta$  phase at the grain boundary and the precipitate free zone (PFZ) form corrosion interactions and corrosion active channels, resulting in a high susceptibility to intergranular corrosion [43]. Under the action of corrosive mediums, the corrosion propagates along the grain boundaries parallel to the direction of extrusion, and corrosion products accumulate at the grain boundaries. Due to the expansion of corrosion products, wedge forces are generated at the grain boundaries, and eventually the surface of the alloy is exfoliated. Therefore, the 7075-T6 aluminum alloy substrate with 20 years exposure is very sensitive to exfoliation corrosion.

**Figure 12.** 7075-T6 aluminum alloy (a) S-L metallographic section; (b) grain boundary structure and EDS analysis taken by TEM.

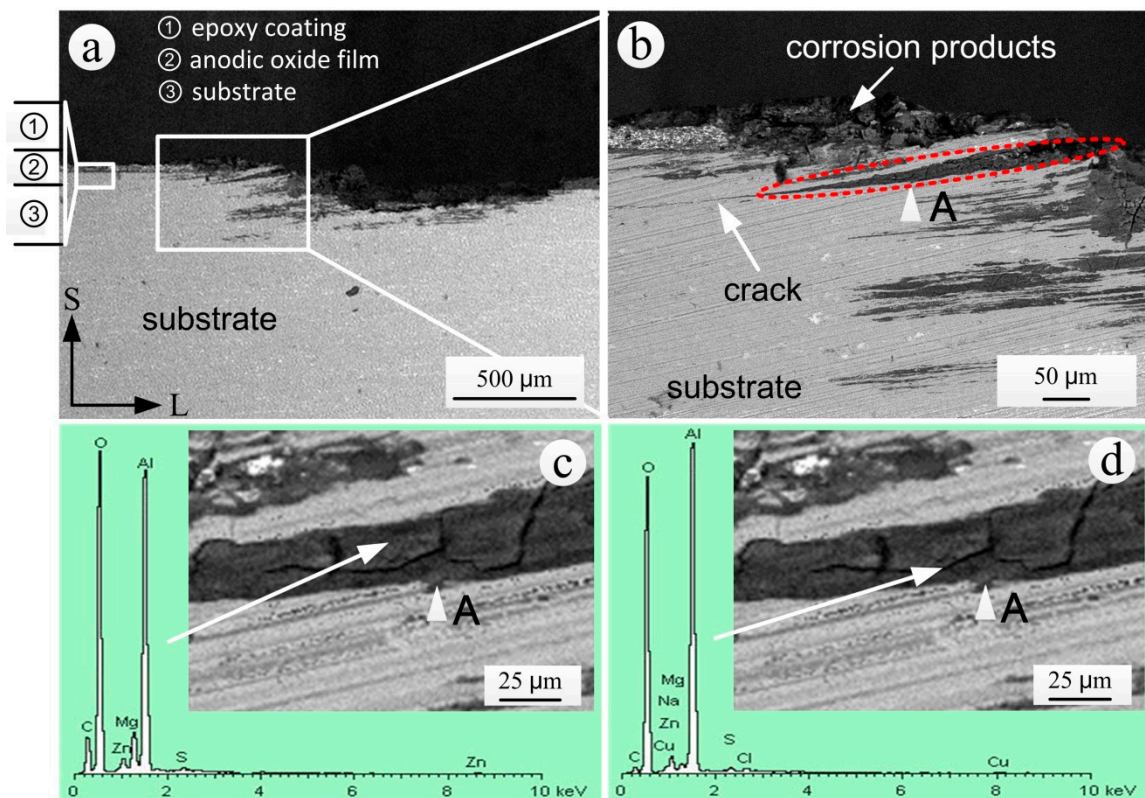
The junction area between the corroded and un-corroded substrate can be used to study the propagation of exfoliation corrosion. Figure 13 shows the S-L sectional SEM morphology and EDS spectrum of corrosion products of the coated specimen that was exposed for 20 years. The substrate and epoxy coating in the left of the exfoliation corrosion area were intact and did not present coating bubbling (Figure 13a). The exfoliation corrosion of the S-L section propagated along the direction of extrusion (L direction). Due to the expansion of intergranular corrosion products, the corrosion products of the A area in Figure 13b showed a wedge shape. Moreover, the structures of the aluminum alloy on the upper side of the corrosion product area noticeably exfoliated outwardly, whereas the exfoliation of structures on the lower side was not obvious. At the same time, there was an obvious crack at the tip of the corrosion products.

Due to the ventilation and daily temperature alternations on the test site, the surface of the specimens underwent dry and wet alternation, which made the products of intergranular corrosion harden (Figure 13c). From the results of EDS analysis in the block area of corrosion product in Figure 13c, it can be found that C and S appeared in the lump area of corrosion products besides the oxygen and the elements contained in the aluminum alloy substrate. Carbon may originate from the organic coating. After local aging and destruction of the organic coating, the polymers entered the corrosion area with the corrosive medium. The existence of S indicated that the air pollutant  $\text{SO}_2$  was indirectly involved in intergranular corrosion through conversion to acid in the moist environment. The annual average of  $\text{NO}_2$  in the Wanning test site was far less than the annual average of  $\text{SO}_2$ ,

as shown in Table 2, correspondingly, N was not found in the corrosion products (Figure 13c,d). Thus, it can be preliminarily inferred that  $\text{NO}_x$  was not involved in the exfoliation corrosion of the aluminum alloy substrate.

The EDS analysis results of the cracking area (Figure 13d) showed the presence of Na and Cl, which were not measured in the lump area (Figure 13c). This result indicated that the cracks in the area of the corrosion products provided the channels for the transmission of corrosion mediums such as NaCl, which created conditions for the further propagation of corrosion.

**Figure 13.** S-L sectional analysis in the junction area between the corroded and un-corroded substrate of the specimen exposed for 20 years: (a) SEM morphology; (b) local enlarged SEM morphology; (c) EDS spectrum in the lump area of the corrosion products; (d) EDS spectrum in the cracking area of the corrosion products.
