# Assessment of the Structural Integrity of the Roman Bridge of Alcántara (Spain) Using TLS and GPR

**Keywords:** TLS; GPR; structural assessment; roman bridge; conservation

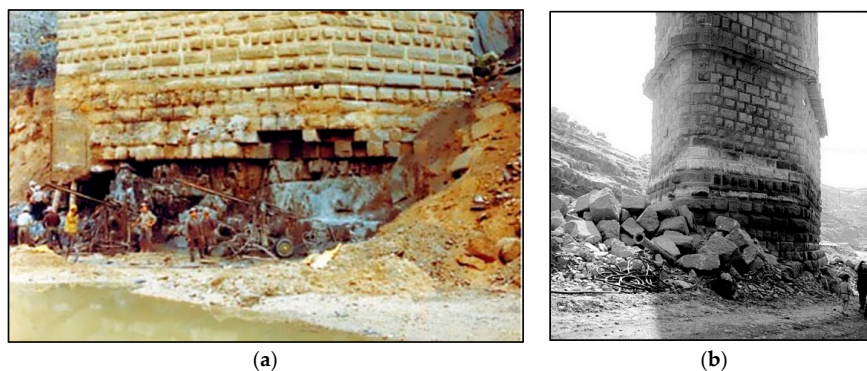
The other element that has done great damage is water flow, which has undermined the left part of pillar number 4 (Figure 4a), which had led to considerable cracking in its upper part, documented by the architect Diego de Ocha in 1804 [17], probably resulting from the river Tajo swelling up prior to 1763, this being the oldest date of the sheets recording water levels [18,19]. Attention was paid to the undermining of the pillar during the repair work of 1857, and was treated with rockfill at the base of the pillar to protect it [10]. However, the problem appeared once again in 1969 when the river ran dry during the construction work of a reservoir upstream. The pillar had lost the rockfill protection and a considerable number of stones, leaving a hollow 4 m high and 2 m deep along the 17 m of the side of the pillar [20] (Figure 4).

**Figure 4.** (a) Repair work on the undermined pillar number 4 left side [20]. (b) Condition of pillar number 3 at the same time [21].

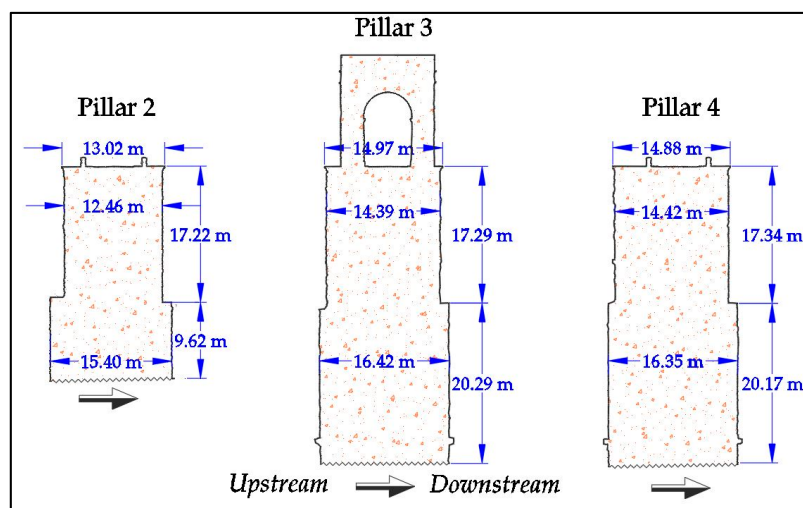
Figure 9. Transversal sections of pillars 2, 3 and 4.

In the case of the pillars, this difference in measurements through history is also seen. The central pillar, or pillar number 3, the most important in terms of its dimensions due to the role it plays in the formal composition of the bridge, was assigned a value by Fernando Rodríguez in 1797 [11,12,15,18,19] that was 2.30 m lower than the measurements taken for the present study by Angel Marras [38].

In the latest measurements taken in 2017, no collapse was detected in the bridge's pillars. The only variations observed on the vertical plane were those corresponding to recesses and protrusions of the

blocks as a result of drawing the characteristic dressed stone blocks of the bridge in representation of the standard sections (Figure 9).

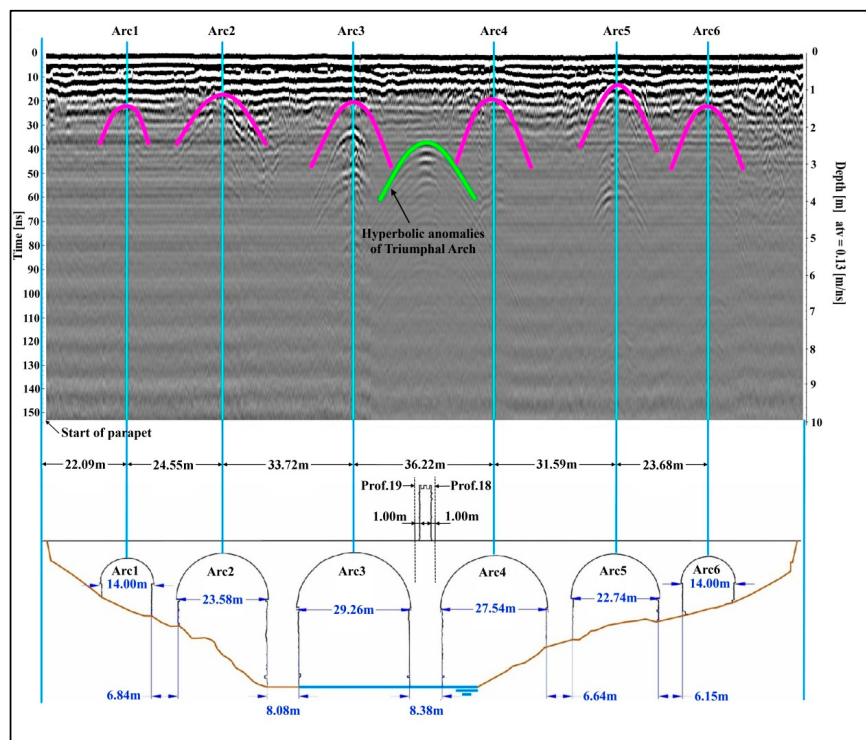
Longitudinally, Figure 10 shows the composition of the elevation of the bridge and the composed radargram (Prof 8–Prof 12) of transect L1 with the 200 MHz antenna, which covers practically the entire length of the bridge in the W–E direction ( $\approx 190$  m). Hyperbolic reflections are quite clearly observed, corresponding longitudinally with the location of the arches of the bridge. In depth, different layers more or less horizontal can be appreciated up to 20 ns (1 m, with  $v = 0.13$  m/ns) approximately. Over these layers, the beginning of the different hyperbolic anomalies can be seen, which may correspond to the presence of granite stone making up the filler, as the arches of the bridge are at depths of over 3.5 m.

The hyperbolic anomaly detected in the central part at 40 ns is quite interesting because it does not correspond to any of the arches of the bridge. The anomaly is produced by the Triumphal Arch that is on the bridge. The radiograms Prof 8 to 12 were collected with a 200 MHz not shielded antenna. In some specific structures, these reflections can be seen with this antenna, as shown in Figure 10.

**Figure 10.** Radargrams Prof 8 to Prof 12 superimposed on the longitudinal elevation of the bridge from the TLS survey.

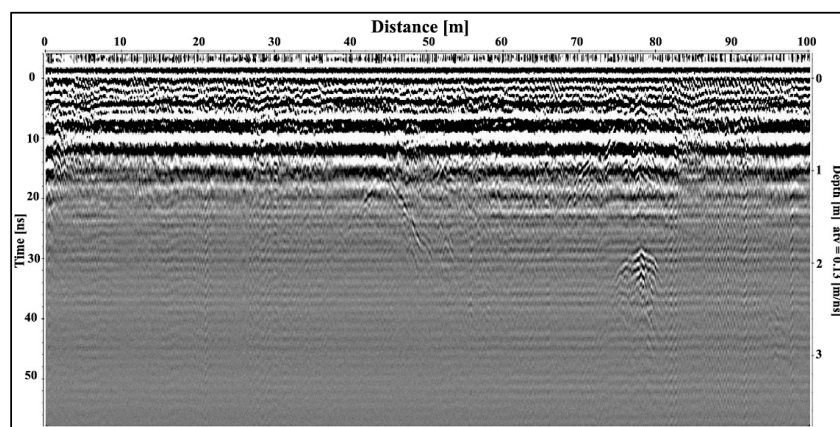
This is seen in more detail in radargrams Prof 16 and Prof 17 collected in the first 100 m with the 500 MHz antenna (Figures 11 and 12) and the equipment configured for maximum depths of 3.5 and 1.5 m respectively. In Prof 16, we can confirm the hypothesis of the anomaly produced by the Triumphal Arch, because when collecting the radargram with a shielded antenna, the anomaly does not appear after 90 m.

**Figure 11.** Radargram Prof 16 on transect L1, length 100.3 m and maximum depth 3.5 m, obtained by the 500 MHz antenna.

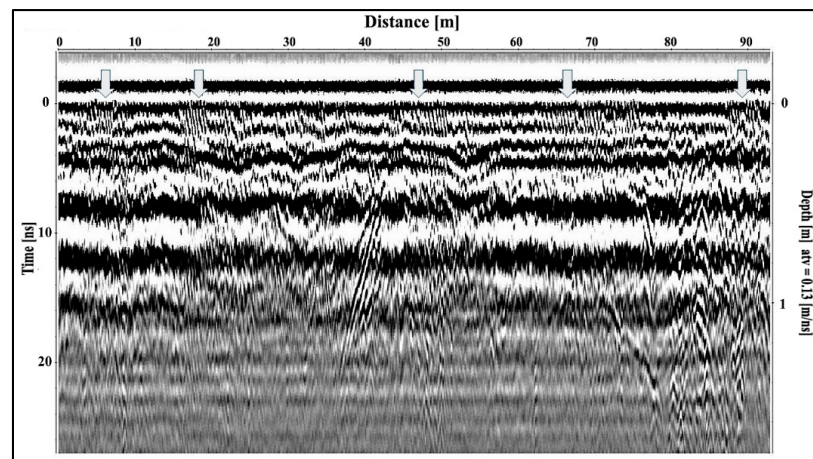
Figure 12 shows in greater detail the different strata of the bridge's filler. The first 20–25 cm would correspond to granite paving blocks, each of which is between approximately 5 and 10 cm thick. At greater depth, horizontal reflections are seen that configure an area up to a depth of 1 m made up of strata of greater thickness (around 20 cm) which may correspond to the different layers of the compacted ground filler.

**Figure 12.** Radargram Prof 17 on the transect L1, length 92.9 m and maximum depth 1.5 m, obtained by the 500 MHz antenna.

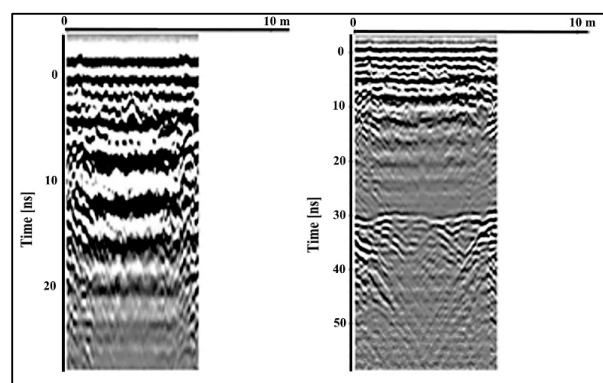
Regarding the transversal plane, Figure 13 shows the radargrams Prof 18 and Prof 19 (500 MHz antenna). In both, the reflections can be clearly appreciated on the lateral walls of the bridge, as well as the different layers of paving and compacted ground. Radargram Prof 19 also reveals a clear horizontal reflection at around 30 ns of depth ( $\approx 2$  m), which would correspond to the stonework. Nevertheless, in Figure 12, longitudinal, the hyperbolic anomalies appeared higher up in the keystones of arches 2, 3, 4 and 5.

One hypothesis to explain the reduction of the height of the anomaly between the longitudinal and the transversal data is that the filler is horizontal up to a depth of approximately 2 m. This strengthens the area of the kidneys of the arches, which is weaker in the arches. If the thickness of the arch is deducted in the middle of those arches, the resulting thicknesses are less than 2 m (Figure 8).

**Figure 13.** Radargrams Prof 18—left—and Prof 19—right—collected by the 500 MHz antenna on transect T1.

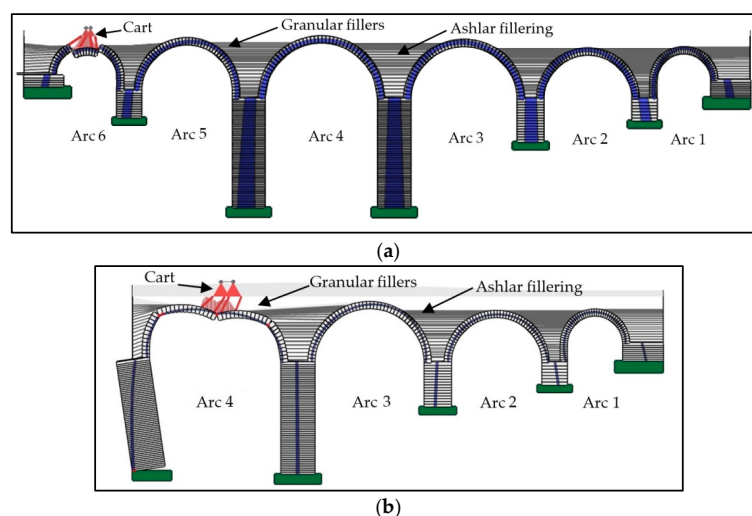
Figure 15 shows an example of failure by slipping and by mechanism.

**Figure 15.** (a) Failure by slipping at position S0.1. (b) Failure by mechanism.

Of the conditions the bridge has been in, the one that led to the lowest safety levels was the demolition of arch number 5, which lasted from 1809 until 1857. Moreover, in the event of the exhaustion mechanism (Figure 15b) on the left side of the base of pillar number 4 in that condition, the stonework would open up. Taking into account that it is in this area that the loss of stonework took place before being repaired in 1857 and 1969 (Figure 4a), it can be confirmed that the origin of this loss was the opening of the joints in the stonework due to the imbalance of the thrust of arch number 4 following the demolition of arch number 5. This fissuring facilitated the entrance of water and the loss of the stones. Figure 4b shows the lower stones of pillar number 3 subjected to the same repairs. They only show signs of wear, since in that case the loads descend the pillar through the centre without causing tractions in its face (blue line in Figure 15b).
