# Fatigue Failure in Engineered Components and How It Can Be Eliminated: Case Studies on the Influence of Bifilms

**Citation:** Campbell, J.; Tiryakioğlu, M. Fatigue Failure in Engineered Components and How It Can Be Eliminated: Case Studies on the Influence of Bifilms. *Metals* **2022**, *12*, 1320. <https://doi.org/10.3390/met12081320>

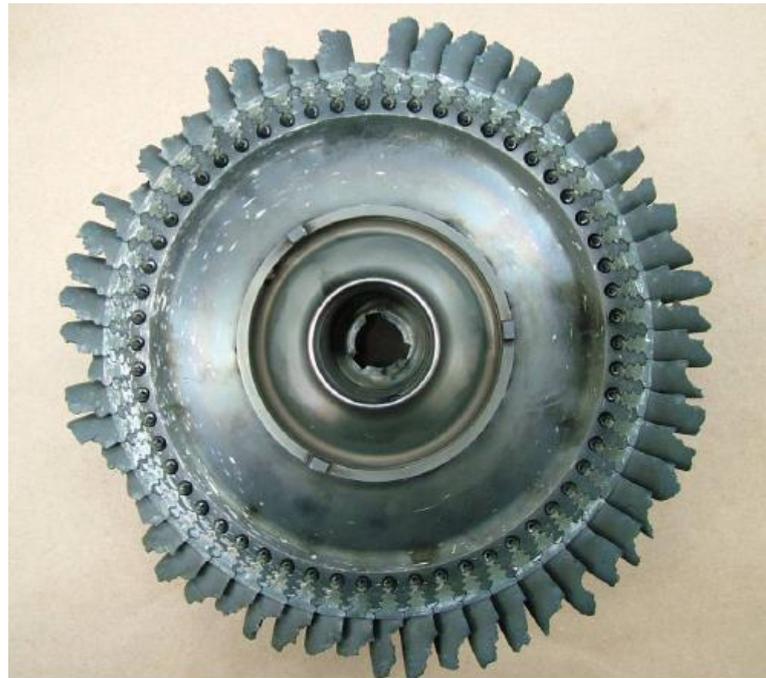
Our first example is the catastrophic failure of a turbine blade which led, in turn, to the failure of many of the other blades of the turbine (Figure 5), causing a Cessna aircraft to crash with the loss of lives [39].

**Figure 5.** The extensive damage to the turbine by the catastrophic fatigue failure of one blade during a flight [39].

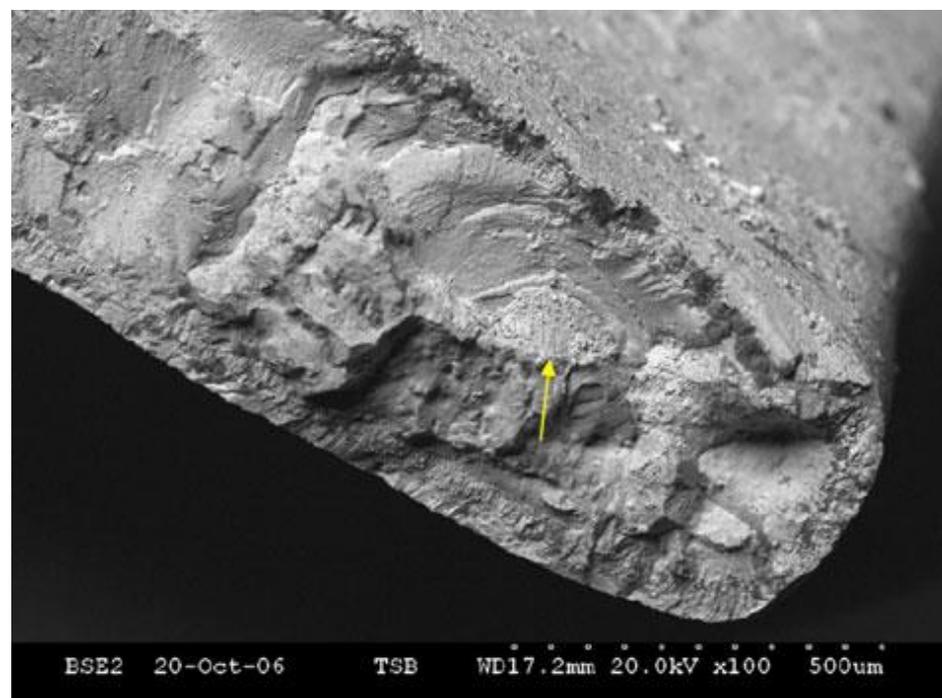
The fracture surface of the cast Ni alloy turbine blade which failed due to fatigue is shown in Figure 6. The fracture surface is somewhat rugged, tending to follow the grains of this polycrystalline casting. However, only a very few grains on the fracture surface showed striations. For much of the fracture surface the form of some of the ‘grains’ is curious, perhaps best described as quasi-cleavage (a name to conceal our ignorance of the fast-cracking mechanism, which is definitely not cleavage, but probably the opening of a bifilm). Other quasi-cleavage grains tended to resemble conchoidal fractures, which is a failure mode to be expected in a brittle glass, not a ductile metal. It is suggested that these features are bifilms, ballooning out like the sails of a square-rigged ship in the powerful flow of metal during casting. The main fracture seems, therefore, to be the result of bifilms. A generous quantity of bifilms is predictable in many early gravity-poured turbine blade castings. Those relatively few grains which revealed striations show the action of a fatigue failure mode for those regions of the metal where bifilms happened to be absent.

The identification of the conchoidal areas as due to bifilms, confirming bifilms to be the major failure mechanism, is corroborated below.

**Figure 6.** Failed turbine blade. Many grains had the appearance of conchoidal fracture surfaces; difficult to explain unless from the billowing shapes of bifilms. Very few areas of striations could be found on the fracture surface, suggesting a limited amount of fatigue in this so-called fatigue failure [39].

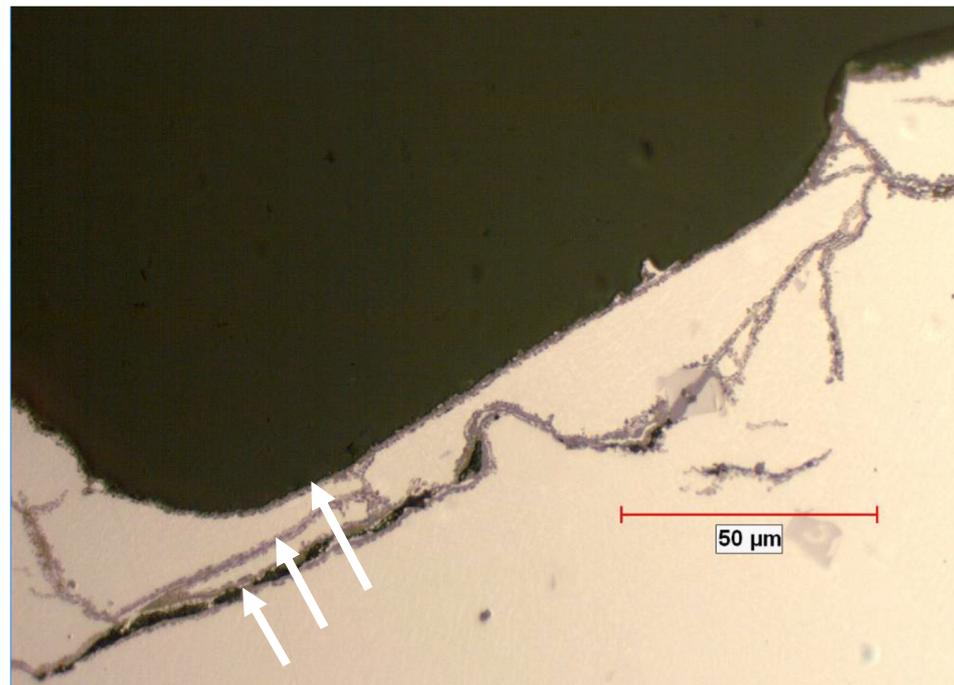
Figure 7 shows a section through the fracture surface. It reveals an array of oxide double films, i.e., bifilms, on a large grain (revealed by etching). Interestingly, they have a feature which is a defining characteristic of bifilms: there are three which are parallel, probably following a crystal plane (as illustrated schematically in Figure 3). The growth of grains and dendrites organizes the bifilms in this way, so it is to be expected that multiple bifilms can sometimes be parallel in a single grain. This is not the case for a crack grown by stress, in which the first crack effectively relieves the stress in its immediate surroundings, inhibiting the growth of additional parallel cracks.

**Figure 7.** A section through the fracture surface, the main fracture displaying the remaining half of the double oxide film which formed the main pre-crack. Two additional oxidised film-like features, one of which is clearly a double film, form a close group of three parallel cracks (arrowed) [39].

The bifilms identified in the metallographic sections clearly occupy between 50 and 90% of the width of the blade. This leaves relatively little of the area to be fatigued, confirming the paucity of ‘real’ fatigue evidence on the fracture surface.

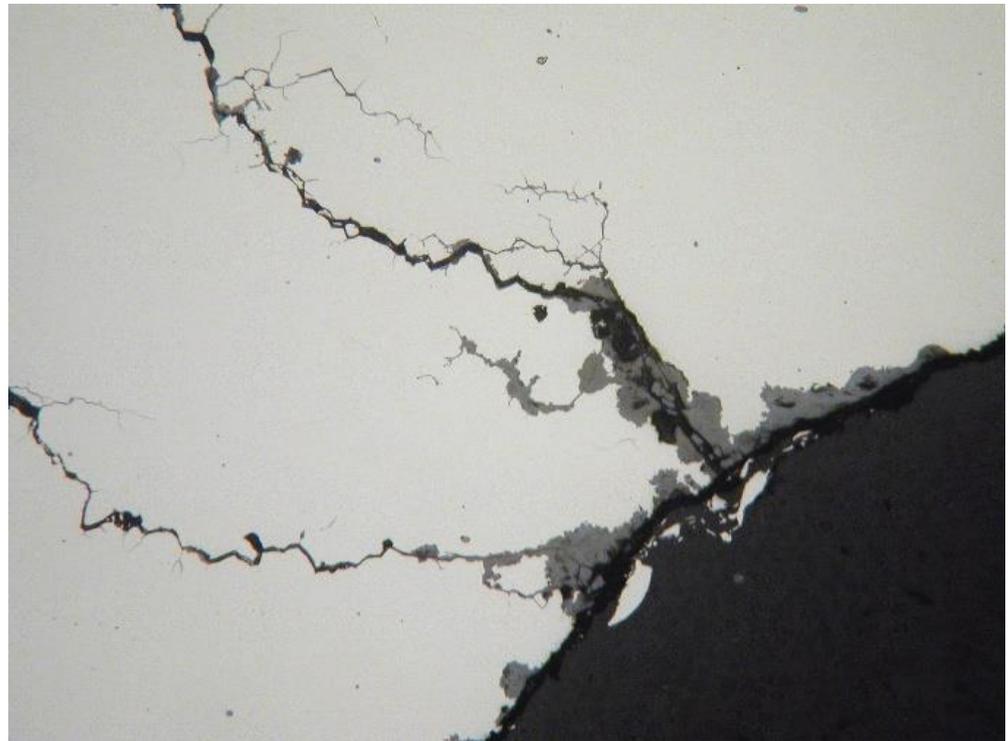
exterior interfaces of the bifilms provide electrochemical couples to speed corrosion. The first outcome of these processes will be the creation of an etch pit (Figure 8). It is reasonable to conclude, therefore, that the existence of an etch pit is the witness to the pre-existence of a bifilm at that location. Furthermore, of course, the bifilm will be expected to be vastly more extensive than the etch pit.

**Figure 8.** A detail of a large hemispherical etch pit, initiated by the two pre-existing bifilm cracks (rather than the pit initiating the cracks), in a steel blade of a steam turbine Reprinted with permission from ref. [51]. Copyright 2022 Elsevier.

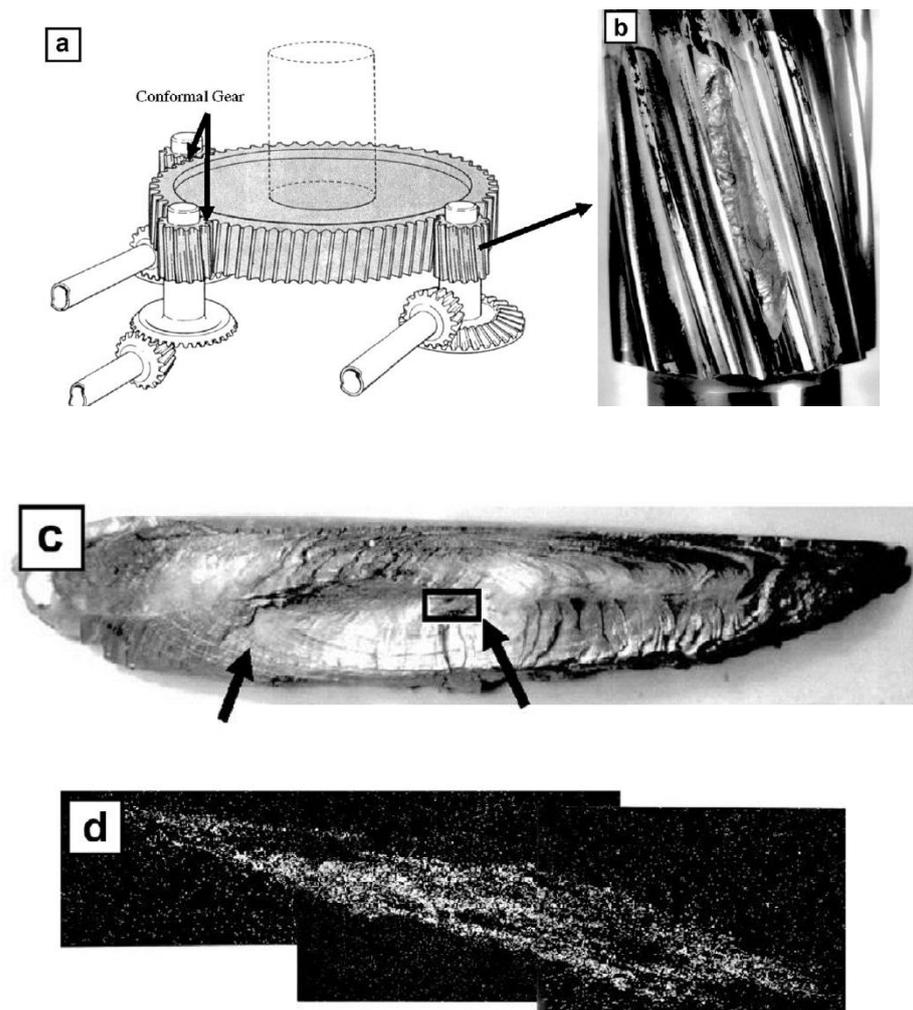
Moving on to another example of a fatigue failure in a helicopter, details of a steel conformal gear is presented in Figure 9 [52]. The conformal gear in the mechanism is shown in Figure 9a, and the failed gear is presented in Figure 9b. The analysis of the fracture surface showed that fatigue initiated from a subsurface defect in the boxed area shown with an arrow in Figure 9c. X-ray map of the area showed the presence of oxygen (Figure 9d) and aluminium at that spot, leaving no doubt that an alumina ( $\text{Al}_2\text{O}_3$ ) bifilm caused the in-service failure.

**Figure 9.** The details of an in-service failure of a steel helicopter conformal gear: (a) the gear assembly, (b) the gear that failed due to fatigue, (c) analysis of the fracture surface, showing the fatigue crack initiation site (boxed) and striations, and (d) X-ray map showing the presence of oxygen at the crack initiation site Reprinted with permission from ref. [52]. Copyright 2022 Elsevier.

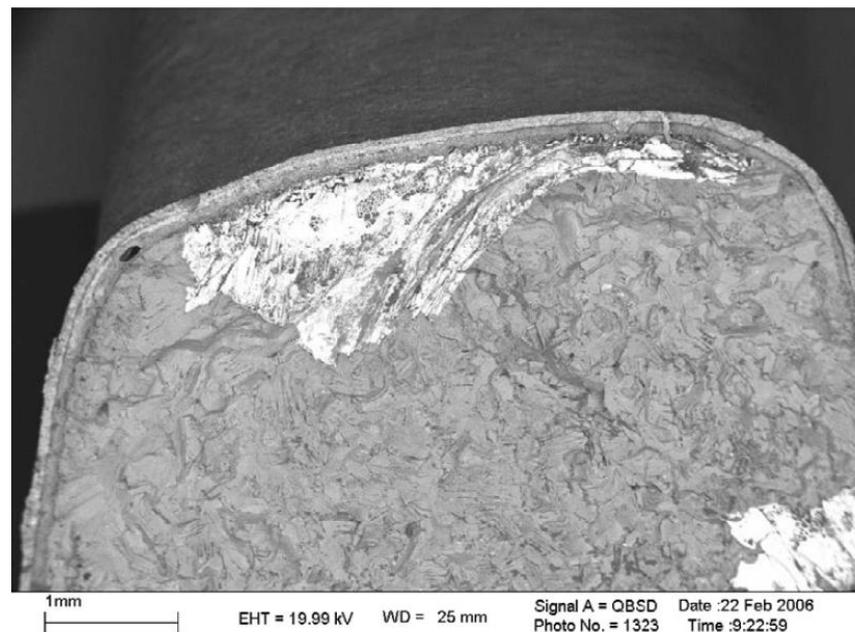
Magnesium castings used in helicopters as gearbox housings seem to have suffered from fatigue failure due to entrained surface films. These are generally large castings, generally moulded in sand and cast in air. The traditional filling system designs are now known to be poor, so that oxide film entrapment to form bifilm cracks is likely. Davies et al. [52] analysed the fatigue crack initiators in helicopter magnesium gearbox casings, and reported that more than 70% of the failures can be attributed to bifilms (and pores). An example of a cast WE43 magnesium alloy gearbox housing that failed in-service due to fatigue is presented in Figure 10, which shows a large oxide film occupying a large area of several square millimeters that served as the main fatigue initiator (although a second bifilm crack can be seen, which also contributed to fracture).

**Figure 10.** An oxide film exposed on the fracture surface of a WE43 magnesium alloy casting Reprinted with permission from ref. [52]. Copyright 2022 Elsevier.

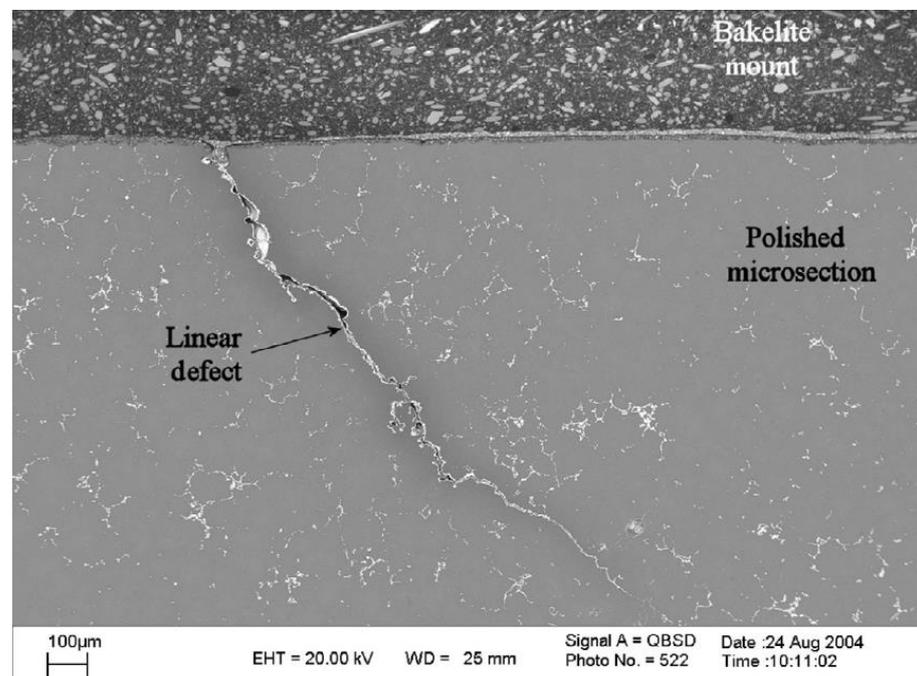
In a later analysis of helicopter housings, Belben [53] showed that almost all fatigue initiators of the housing that failed in-service are attributed to entrained surface oxides. Such an oxide was found near the cracked web of a cast WE43A magnesium alloy casting in Figure 11.

**Figure 11.** A bifilm crack over 1 mm long found adjacent to the cracked web on a cast Mg alloy housing Reprinted with permission from ref. [53]. Copyright 2022 Elsevier.

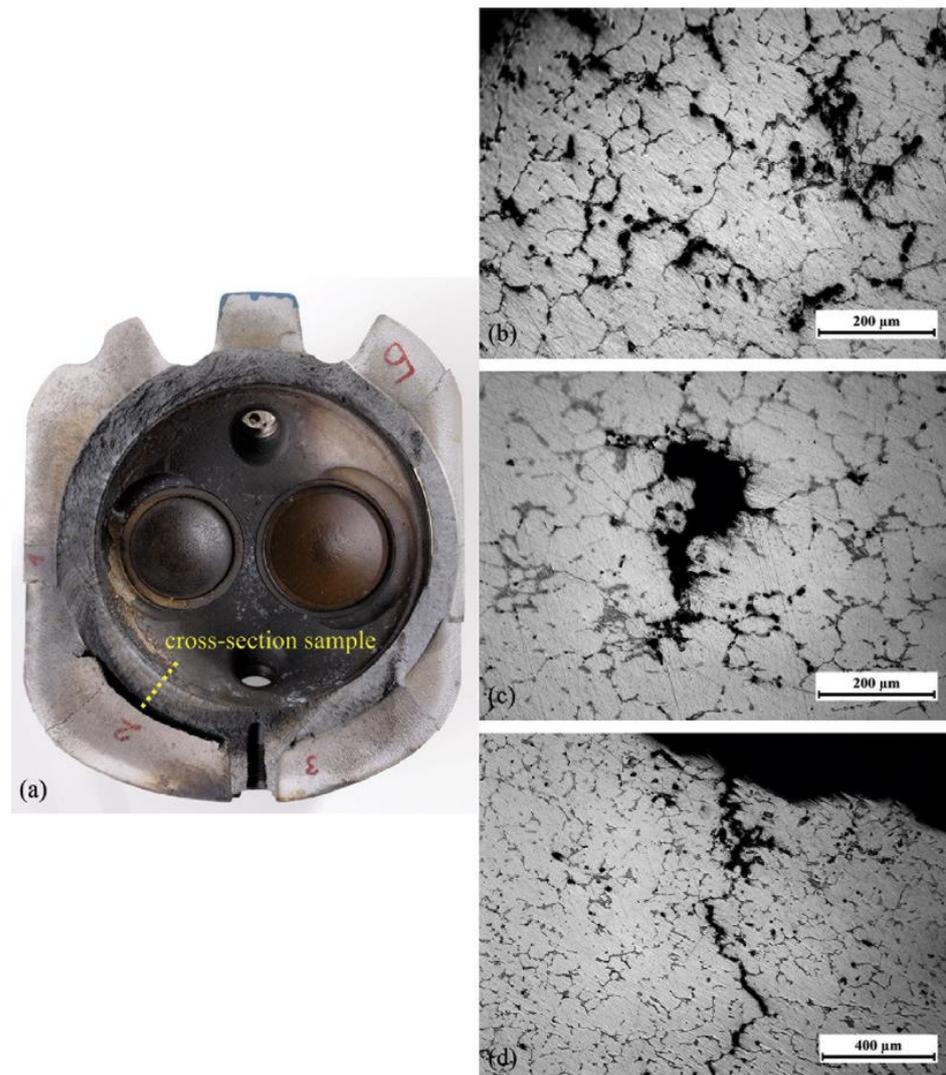
separation of cylinder heads in service and, therefore, loss of power during flight. Such failure was reported [54] in two cases of piston engine failure in an Utva-75 aircraft that occurred within a period of four months of each other. In both cases, in-service failure of their cast aluminium alloy cylinder heads, and consequent loss of power during flight, was attributed to fatigue. Failure analysis of the regions adjacent to the region of the fatigue fracture surface is presented in Figure 12. Metallographic analysis near the fracture surface [54,55] showed a high density of bifilms. Such damage given to liquid metal during melt preparation and casting results in significant weakening of the metal that subsequently results in premature, (potentially) catastrophic, failure due to fatigue.

**Figure 12.** The failure analysis of the cylinder head that failed in service: (a) the failed cylinder head, (b–d) bifilms that were found in the area adjacent to the failed region Reprinted with permission from ref. [54]. Copyright 2022 Elsevier.

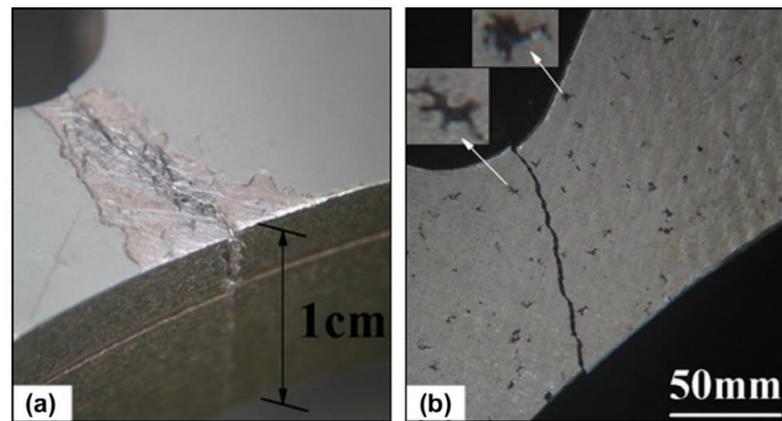
Li et al. [56] reported the in-service failure of an airplane frame component casting of an Al–Cu–Mn–Ti alloy. Two failed castings are shown in Figure 13. Note that pores are visible in Figure 13b. As discussed previously, pores are only the visible part of the damage given to liquid metal, and, therefore, actual entrainment damage is larger (as is evident in Figure 14). Moreover, electron microscopy of the pores on the fracture surface showed extensive oxide films, as shown in Figure 14. It is only realistic to expect that bifilms extend

**Figure 13.** Two failed airplane frame castings (a,b) of an Al-Cu-Mn-Ti alloy. Pores are visible in (b) Reprinted with permission from ref. [56]. Copyright 2022 Elsevier.

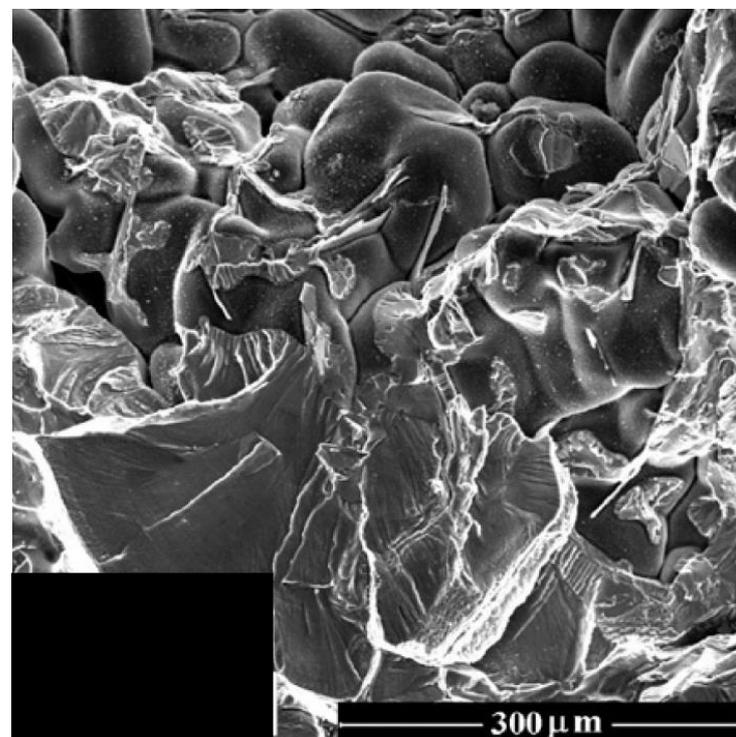
**Figure 14.** A pore found on the fracture surface of one of the castings in Figure 13, showing the presence of oxide films on the surface of the pores. The films are the remaining half of the bifilm, or bubble, and appear to have been sucked into the inter-dendritic regions, probably as a result of shrinkage during freezing Reprinted with permission from ref. [56]. Copyright 2022 Elsevier.

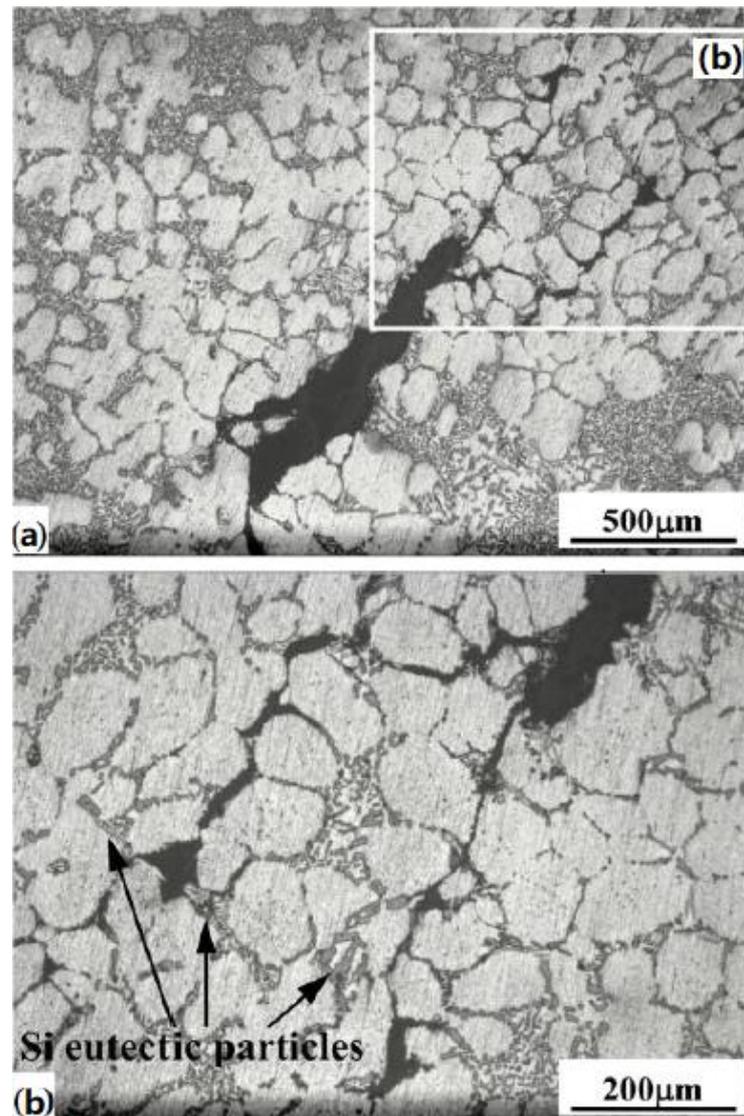
into the matrix and remain as unopened at the end of solidification. However, in a tensile stress state, they open right away, concentrating the tensile load into the remaining area of the frame, leading to the almost immediate formation of a propagating fatigue crack. This is shown in the results of Li and Hu [57], who investigated why an Al-7%Si-Mg alloy casting for an airplane frame failed in vibration tests. They found a large number of pores, as well as bifilms associated with the pores, that extended into the aluminium matrix, as shown in Figure 15. These features, also referred to as fissures, demonstrate the extensive damage given to the liquid metal prior to solidification. We can also see that a densification process, such as hot isostatic pressing, would close this pore but would not heal the damage, at least not completely, as was observed in A206 castings [8,9].

**Figure 15.** Bifilm (part of which is opened as a pore, while other parts remain closed as cracks) extending into the aluminium matrix found near the failed region of an Al-7%Si-Mg airframe casting. (a) the overall defect, (b) the magnified version of the square in (a) showing the unopened bifilms associated with the pore. Reprinted with permission from ref. [57]. Copyright 2022 Elsevier.
