# Failure Analysis of Two HP-Nb Heat-Resistant Tubes after 46,000 h Exposure to Reformer Service Conditions

**Abstract:** This study presents a failure analysis in two reformer tubes used for hydrogen production in a petrochemical industry. These tubes (Tube A and Tube B) were made by the centrifugal casting of HP-Nb alloy in such a way that one contained titanium as a micro-element, and the other was free from titanium in its chemical composition. Although the two tubes were subjected to similar creep conditions, Tube A failed after only 46,000 h of operation against the design life of 100,000 h. SEM images showed initiation and growth of creep pores next to chromium carbide particles, as well as the formation of microcracks in Cr<sub>23</sub>C<sub>6</sub> carbides. Pore initiation occurs as a result of grain boundary sliding and is strongly dependent on structural morphology. The tube containing titanium (Tube B) showed higher thermal stability and higher creep resistance than the tube without titanium (Tube A), which was due to the formation of finer and more discrete carbide particles. The final fracture of the tube without titanium (Tube A) occurred due to the coalescence of

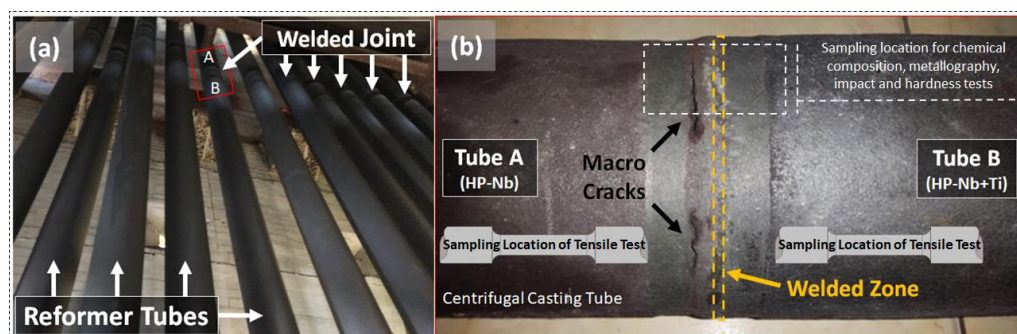
Figure 1a shows the location of these tube sections (Tube A and Tube B) in the reformer furnace. Although both tubes were under similar temperature and stress conditions, Tube A showed premature cracking and failure (Figure 1b). According to visual inspection, latitudinal cracks were observed at a distance of 6 mm from the welded joint in Tube A while no macroscopic cracks were observed in Tube B. The premature failure of the HP-Nb reformer tube without Ti (Tube A) after 46,000 h of service at the approximate temperature of 1000 °C as compared to Tube B (with 0.12% Ti) was studied. The observed damages included latitudinal cracks adjacent to the welding area, resulting in the need to replace the tubes after 46,000 h of service which is significantly lower than the expected life of the tubes.

**Figure 1.** (a) Centrifugal cast tubes in the reformer furnace and (b) latitudinal cracks formed perpendicular to the stress direction on Tube A.

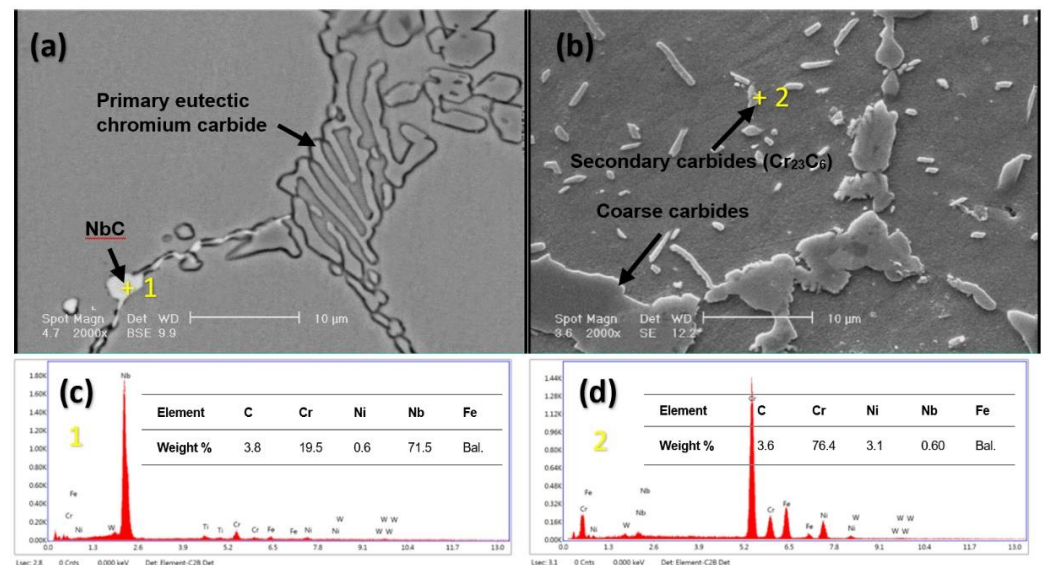
The failed tube (tube A) showed several microstructural features. As can be seen in Figure 2a, the as-casted microstructure before exposure to service conditions consists of a primary carbide network (mostly including chromium and niobium carbides) in the interdendritic grain boundaries. Due to the low solubility of niobium in the austenite matrix, the niobium carbides precipitated at the grain boundaries or cell boundaries. This resulted in higher activation energy for slip and formation of creep pores, which can be supplied through stress or temperature [20]. Exposure of the tubes to high temperatures results in the conversion of the primary eutectic carbides to coarse Cr<sub>32</sub>C<sub>6</sub> particles and the coalescence and precipitation of dispersed Cr<sub>23</sub>C<sub>6</sub> carbides in the matrix (Figure 2b).

**Figure 2.** SEM images of Tube A (a) as-cased, and (b) after exposure to reformer service conditions for 46,000 h, (c,d) point elemental analysis of present phases using EDS system.

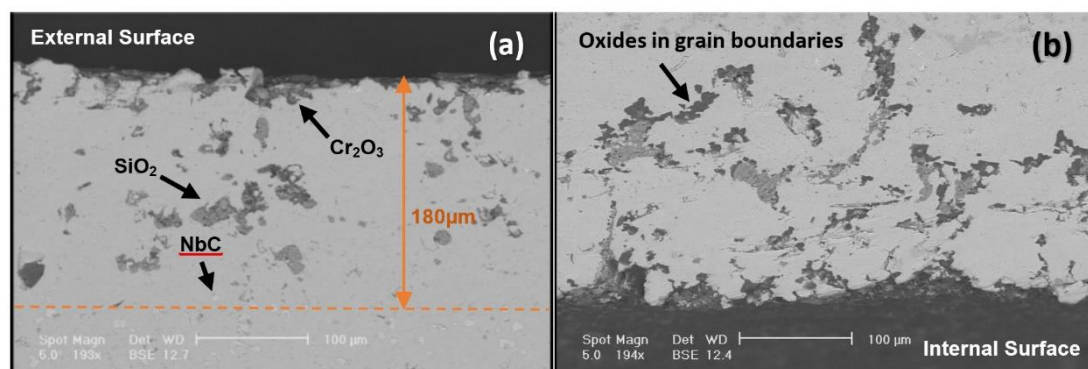
Near the outer shell of Tube A, a thin chromium-rich oxide layer and then a band of silicon oxides with an approximate thickness of 180 micrometres were observed (Figure 3a). In this region, despite the presence of niobium carbides as fine, dispersed particles (white precipitates), no chromium-rich precipitates were observed. The presence of the  $\text{Cr}_2\text{O}_3$  layer has resulted in the depletion of chromium from adjacent areas in this layer, creating a region with no chromium-rich precipitates. Similarly, on the internal surface of the tube, oxide particles were observed at the boundary of austenite grains with an approximate thickness of 200 micrometres after the oxide layer (Figure 3b). These precipitates resulted in extreme brittleness of the tube and can be the initiation point for creep cracks. Carburation of the internal surface can automatically decrease the alloy's ductility at high temperatures. During this process, the formation of grain boundaries as microcrack sources results in decreased ductility. Furthermore, a decrease in chromium content in the matrix can result in the loss of oxide films on the internal surface of the tube, thus resulting in decreased corrosion resistance [21]. Although carburation and oxidation processes are known as the failure processes for reformer tubes, no sources for creep pores or cracks were observed next to the external or internal surface of the failed Tube A. In other words, the main reason for failure in Tube A is not the carburation of the internal surface or oxidation of the external surface of the tube.

**Figure 3.** BSE micrograph of Tube A from (a) oxides and chrome-depleted zones near the external surface and (b) oxides and chrome-depleted zones near the internal surface of the tube.

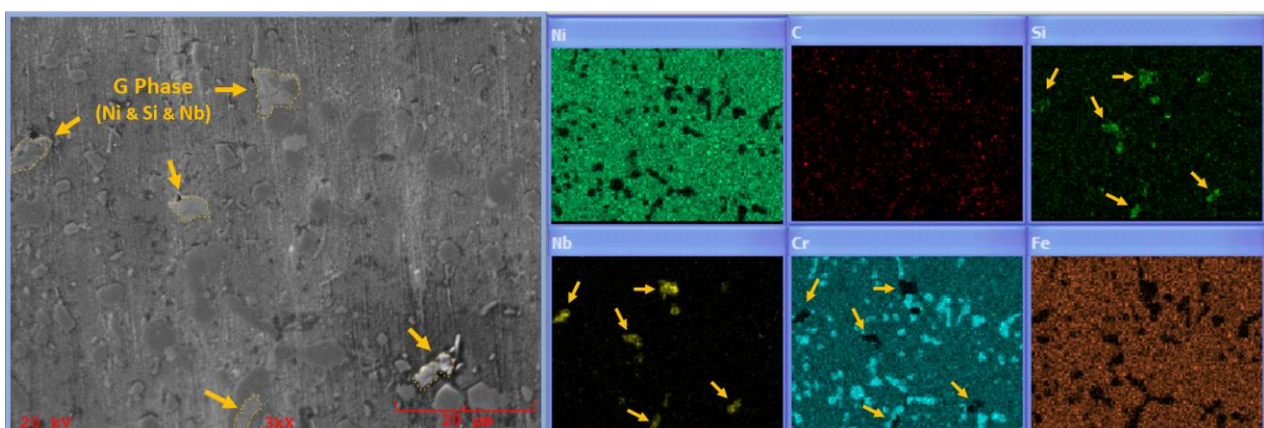
Our investigation showed that there is no evidence of the G phase in tubes containing titanium (Tube B). A low titanium concentration can result in the formation of niobium–titanium carbide complexes. Since titanium is insoluble in the G phase, it can increase the stability at higher temperatures and delay the transformation of (NbTi)C to the G phase. Therefore, the volume fraction of the G phase is lower in HP steel modified with Ti [22,24]. According to the X-Ray Mapping images presented in Figure 4, there are nickel, silicon, and niobium-rich areas identified in Tube A which is due to the presence of the G phase in tubes without titanium. These areas, indicated with arrows, have low chromium content, which, due to the lower strength and ductility of this phase compared to niobium carbides, are suitable areas for the initiation of creep pores. The volume expansion as a result of niobium carbide to G phase transformation can result in stress and therefore the formation of creep pores [12]. On the other hand, the transformation of niobium carbide into the G phase removes the hard phase (NbC) that can prevent the movement of dislocations and thus this phase transformation reduces the creep resistance [17].

**Figure 4.** X-Ray Mapping images of tube A showing the distribution of various elements in SEM images.

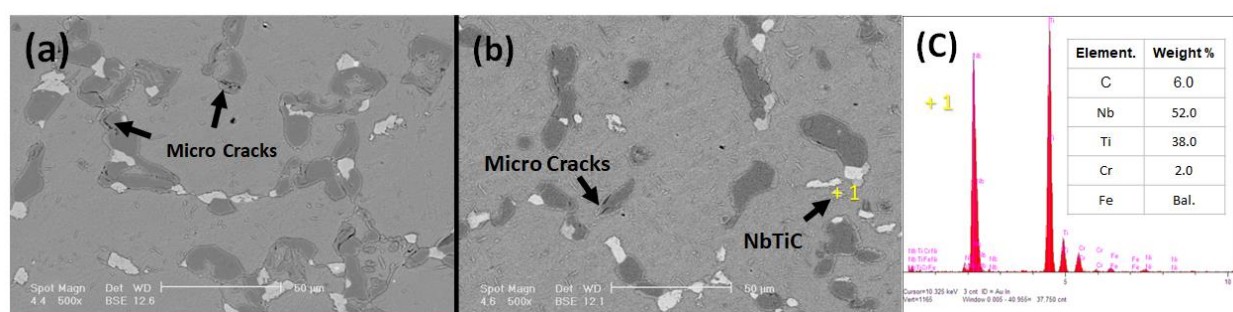
According to Figure 5, the coalescence of the carbide network in the titanium-free sample is higher compared to the sample containing titanium. Furthermore, the tube

containing titanium as an alloying element (Tube B) has a finer structure. Therefore, based on the effects of microstructural morphology on the initiation, growth, and coalescence of creep pores, it is expected for the Tube B to have higher ductility and creep resistance compared to the Tube A. This improvement in creep behaviour can be due to the presence of Ti carbonitrides and their effect on secondary carbide precipitates during ageing. The reason for the lack of failure in Tube B, despite tolerating similar service conditions to Tube A, is the positive effects of titanium on the creep behaviour of the alloy.

**Figure 5.** SEM images of tube microstructures after ageing: (a) Tube A without titanium and (b) Tube B containing 0.12 wt. % of titanium (c) point elemental analysis of NbTiC phase using EDS system.

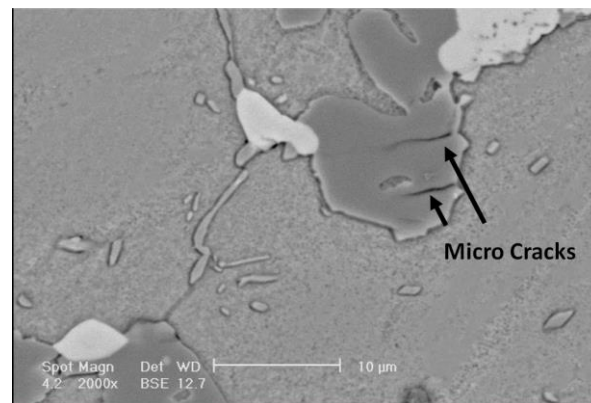
According to the SEM images obtained from the microstructure of failed tube (Tube A) close to the main crack, the creep pores have initiated on grain boundaries perpendicular to the direction of the applied stress and their number and size has increased over time. The continuous initiation of creep pores in this case is dependent on the strain and is generally facilitated by the cracks formed on the Cr<sub>23</sub>C<sub>6</sub> carbide particles. As shown in Figure 7a,b, intergranular fracture occurred along the continuous carbides, and creep voids grew more on coarser carbides, especially in the triple grain boundary regions. According to spot analysis (Figure 7c) and the weight ratio of carbon and chromium, the stoichiometry of these carbides is mainly Cr<sub>23</sub>C<sub>6</sub>.

**Figure 6.** SEM images of microstructure of failed tube (Tube A). Micro cracks formed within chromium carbide particles are indicated with the arrows.

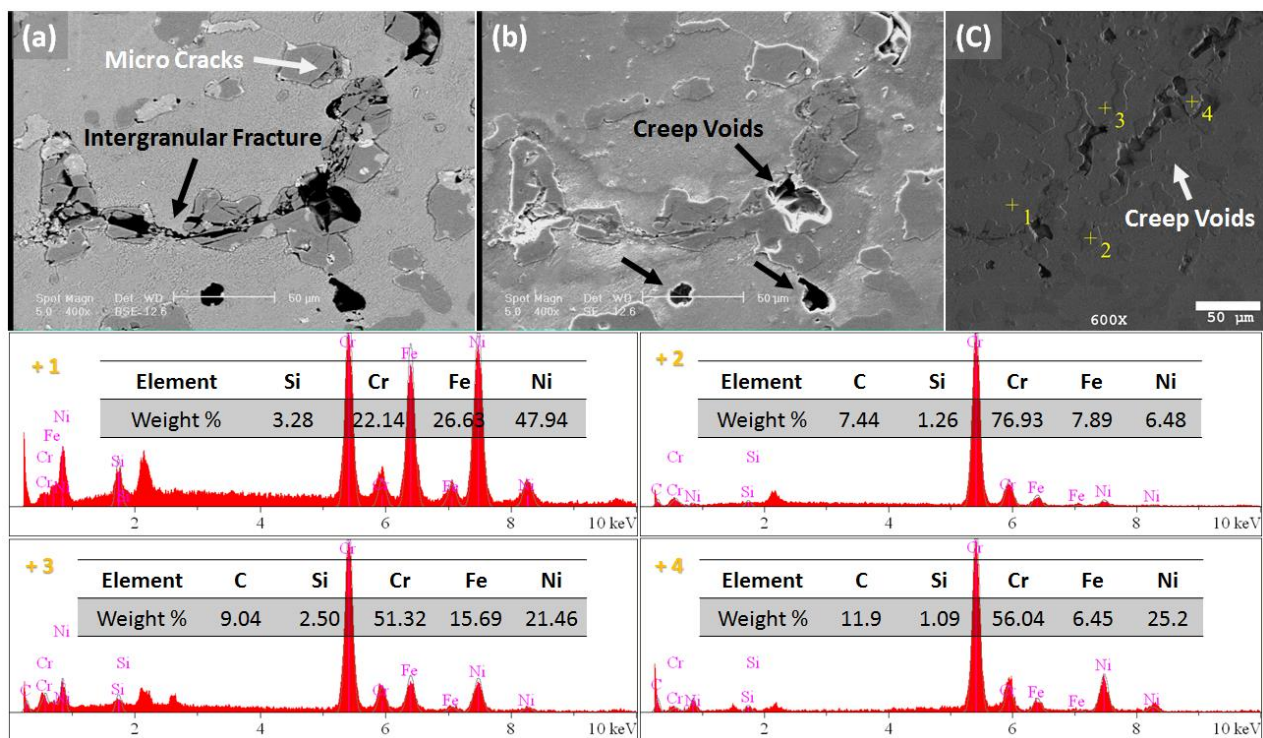
**Figure 7.** (a,b) SEM images of Microstructure degradation of Tube A, (c) point analysis of phases in the degraded area using SEM equipped with an EDS. The growth of creep voids and propagation of microcracks at grain boundaries and chromium carbides are shown.

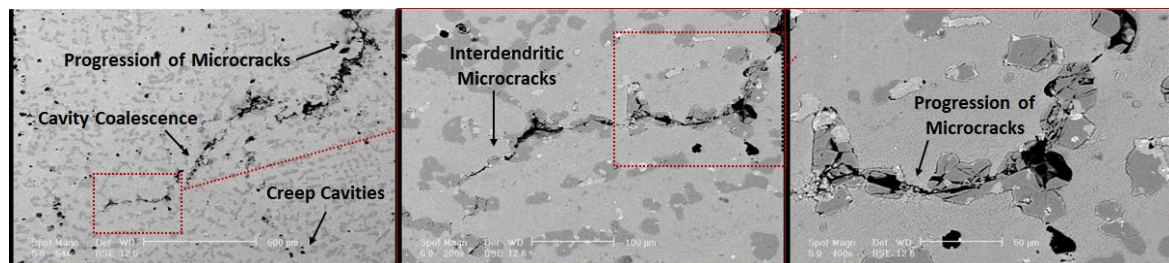
The decrease in the life cycle of reformer tubes is determined under the influence of creep damage which is indicated by progressive changes in the microstructure. The transfer of carbides, initiation of microcracks, and formation of creep pores often occur in the final stage of the creep damage and immediately before the failure. The growth of these creep pores mostly occurs perpendicular to the direction of the applied stress, and their growth rate is controlled by localized creep strain. The final fracture occurs due to pile-up of the pores, formation of grain boundary cracks, and an increase in the number and size of cracks. According to Figure 9, creep cavities are mostly observed in the triple or wedge-shaped areas and on chromium carbide particles. Coarsened chromium carbide particles merge under the influence of reformer temperature, and create suitable areas for initiation of creep pores. The pile-up of grain boundary cracks also occurs along the length of chromium carbide particles, indicating merged carbide particles as preferred crack initiation zones.

**Figure 9.** SEM images showing the pile-up of creep pores along the length of grain boundaries or inside grain boundary carbide particles and coalescence for the formation of cracks in the failed tube.

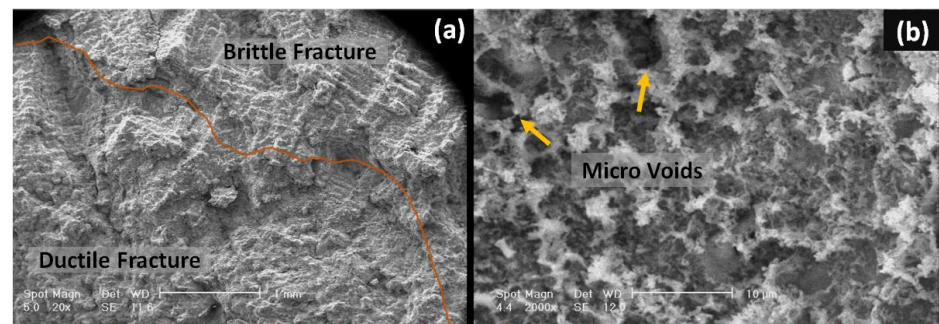
Based on the results of fractography studies, the fracture morphology of the failed tube (Tube A) is jagged, which indicates unsuitable mechanical properties. The furrow and ridges distributed on the fracture surface are seen in Figure 10a. The porosity has resulted in non-uniformity of distribution in tensile/compression stress. The imaginary line indicates the boundary between ductile and brittle fracture zones. As can be seen in Figure 10b, the fracture is ductile using the void coalescence mechanism in the areas with merged carbide particles (arrows). These microvoids are a suitable location for the coalescence of cracks due to the increase in local stress.

**Figure 10.** SEM images of fracture surface morphology of the failed tube, (a) final ductile and brittle fracture surfaces and (b) ductile fracture surface.

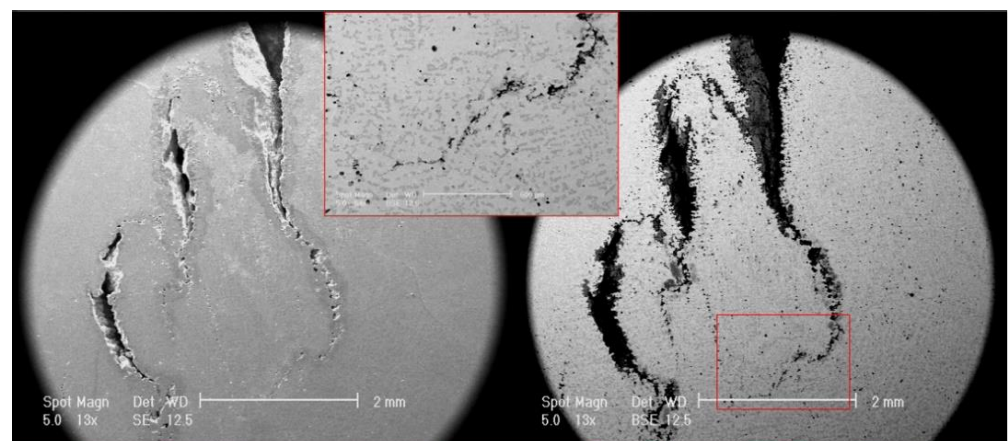
As a result of cyclic mechanical and thermal loadings caused by unexpected shut-downs, the thermal-mechanical fatigue process leads to microstructural damages such as carbide cracks and creep pores. According to Figure 12, the macrocracks are formed as a result of the coalescence of microcracks formed on the surface of chromium carbide particles as well as creep pores. The growth rate of these cracks is proportional to the applied strain and these cracks are grown perpendicular to the direction of applied stress. The creep behaviour of studied tubes in the current study is highly dependent on the difference in microstructural properties as a result of the addition of titanium to HP-Nb alloy.

**Figure 12.** SEM images of cracked regions; directional creep pores are seen along the length of main cracks. The singular creep pores have a uniform distribution in the matrix.
