Confirming Debonding of Non-Metallic Inclusions as an Important Factor in Damage Initiation in Bearing Steel

In this work, we investigated a failed tapered roller bearing that operated in a wind turbine. The bearing was removed from the gearbox following the formation of an axial crack. All specimens were extracted from the inner ring. The specimens are made of AISI 52100 martensitic steel and have a chemical composition as shown in Table 1. The resulting microstructure consists of tempered martensite, spheroidal carbides homogeneously distributed in the martensitic matrix, and transition carbides [42]. Transition carbides are precipitates formed during tempering treatment from supersaturated martensite; they include η and ϵ carbides [46]. To examine the presence of non-metallic inclusions (NMIs) and any associated damage in the bearing, 4 samples were cut from the zone of interest along circumferential and axial planes in the loaded zone (Figure 1). Samples were prepared for metallographic observation using a Struers (Struers, Ballerup, Denmark) type 50A15 cut-off wheel on a Discotom-5 cutting machine. Cutting was performed at a low speed and with underwater cooling to prevent an

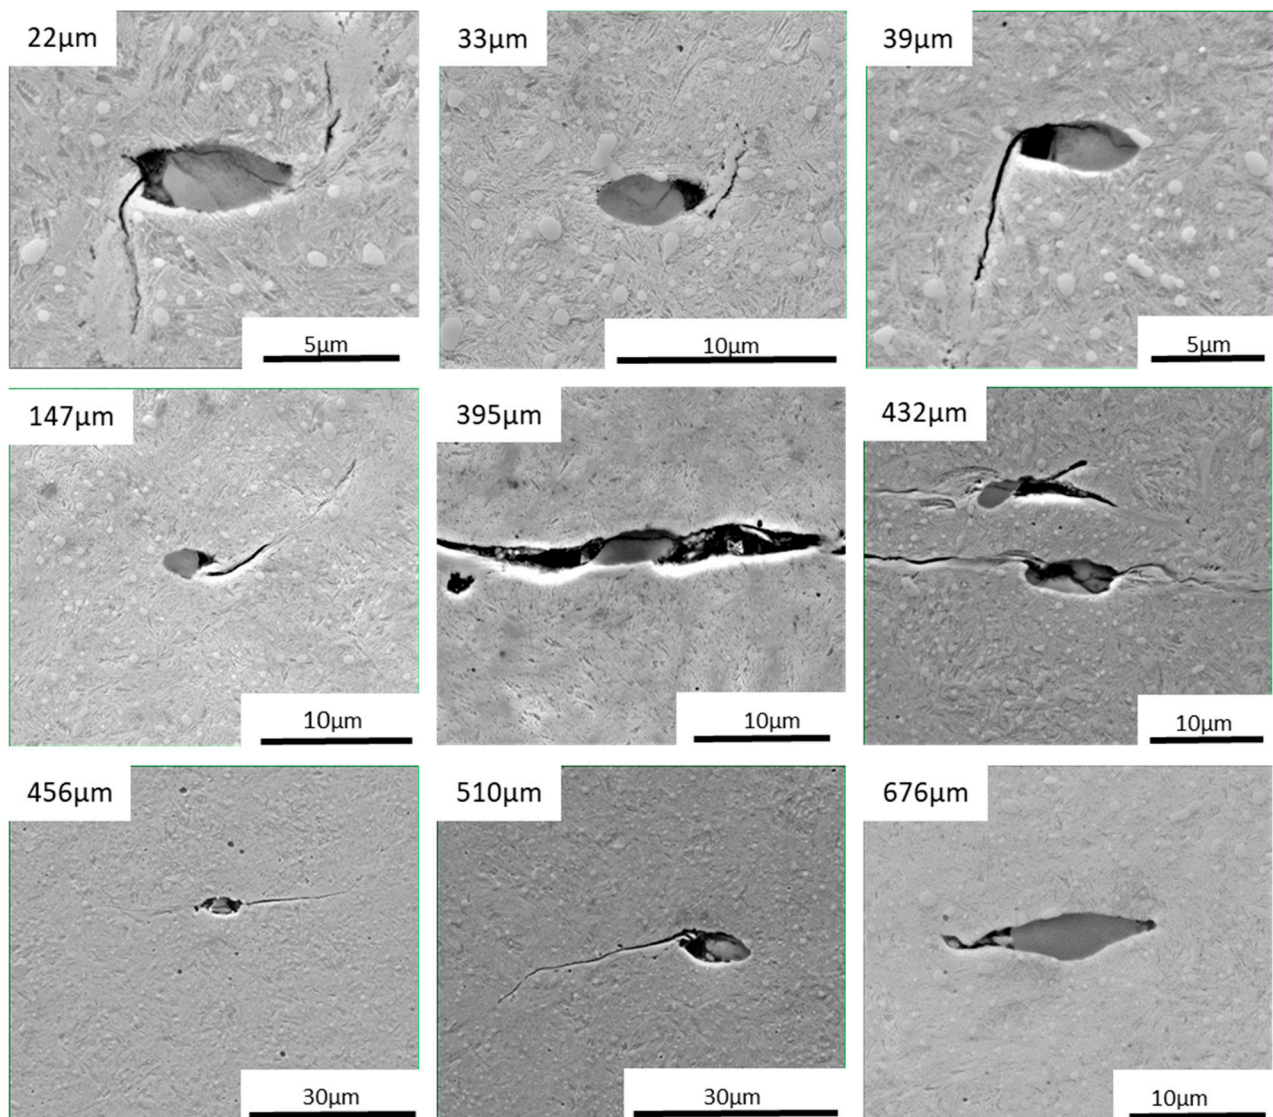
Considering debonding as an important factor, all inclusions in the loaded zone were analyzed, and it was found that most of the inclusions (85%) in the loaded zone were detached from the steel matrix. The investigation of the inclusions in the non-loaded zone suggests that the load is not responsible for the debonding. This is most likely due to the different thermal expansion coefficients and/or strain incompatibilities being enhanced during the deformation processing. Moreover, the different thermal expansion coefficients of inclusions with the bulk material can result in the development of tensile and compressive residual stresses parallel to the normal inclusion–matrix interface. In addition, strain incompatibilities during the formation processing of the steel can result in the formation of cavities at the inclusion interface [42]. Given such a high number, it is suggested that size, shape, and chemical composition do not influence debonding of the inclusions.

Figure 6. SEM-SE images of damage around inclusions in the loaded zone. The top-left number represents the distance from the raceway surface. The damage started on the side of the inclusion that was debonded from the bulk material. This is applicable for the wide range of distances (from 22 to 676 μm) from the raceway surface, suggesting that debonding plays a role in the entire loaded zone.

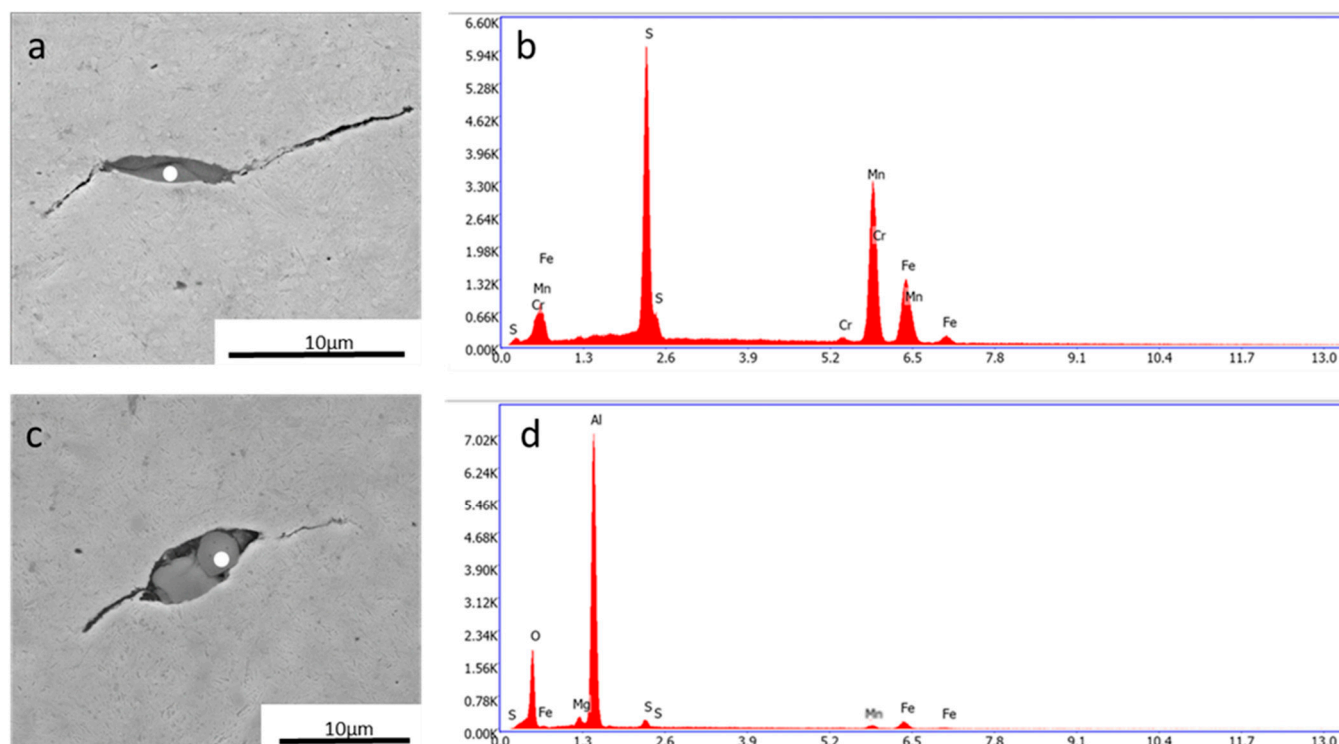
non-metallic inclusions captured by SEM, with white dots representing the locations of the EDS analysis. The corresponding EDS spectra of (a) and (c) are represented in (b) and (d), respectively. The different chemical composition of inclusions can also be observed in SEM figures; MnS is light grey without a different contrast, while two ‘particles’ (MnS + Al₂O₃) have different contrast, visible in (c). The percentage of the inclusions that caused a WEA is similar for both types: 34% for pure MnS and 37% for the MnS + Al₂O₃ type. Thus, our observations do not indicate a markable influence of the chemical composition of the inclusion on damage initiation.

Figure 7. Types of inclusions present in this study. (a) SEM–SE figure of MnS inclusion; the white dot is where the spectra were taken. (b) EDS spectrum of the dot in (a). (c) MnS + Al₂O₃ inclusion type; this is also visible in the SEM figure, where contrast is present within different non-metallic compounds. (d) EDS spectrum of the white dot presented in (c).
