Article

Study of Relation between Shot Peening Parameters and Fatigue Fracture Surface Character of an AW 7075 Aluminium Alloy

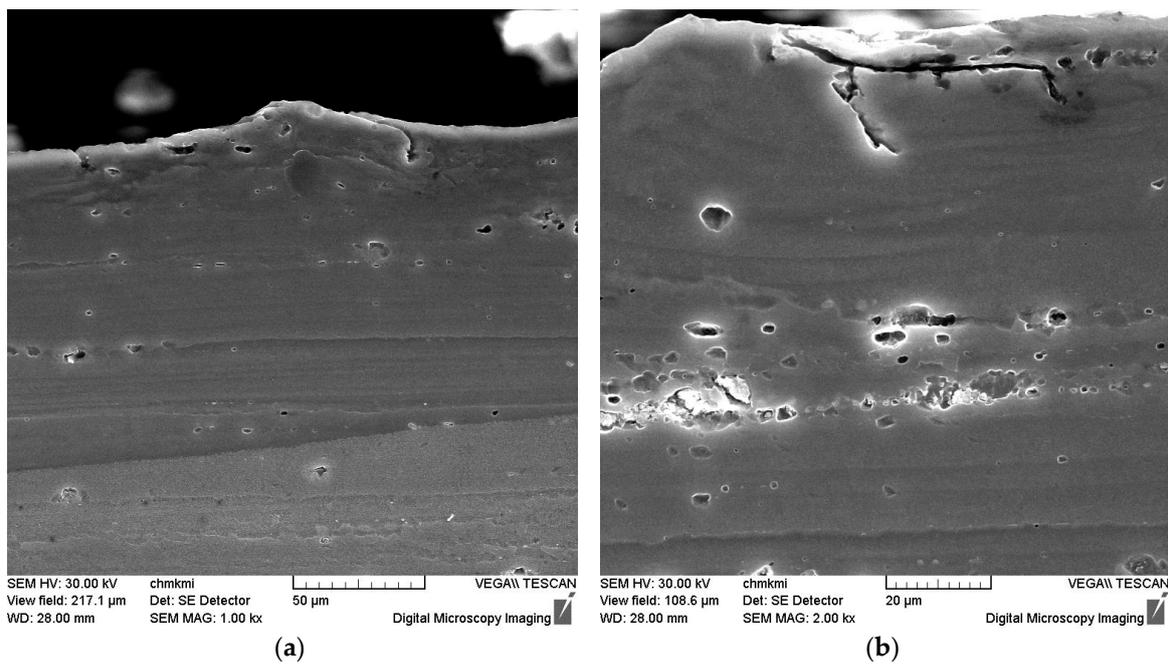
Figure 7. Surface layer of the 6.9 A/100% specimen with deep strengthened layer after shot peening with surface micro cracks (a); in detail (b); SEM.

All the higher peening intensities and coverages had a strong negative effect on the fatigue life (Figure 3), which can be explained by the creation of micro cracks in the surface layer and peeling-off material from the specimen's surface (Figures 7–9). Further impact of the peening media, after

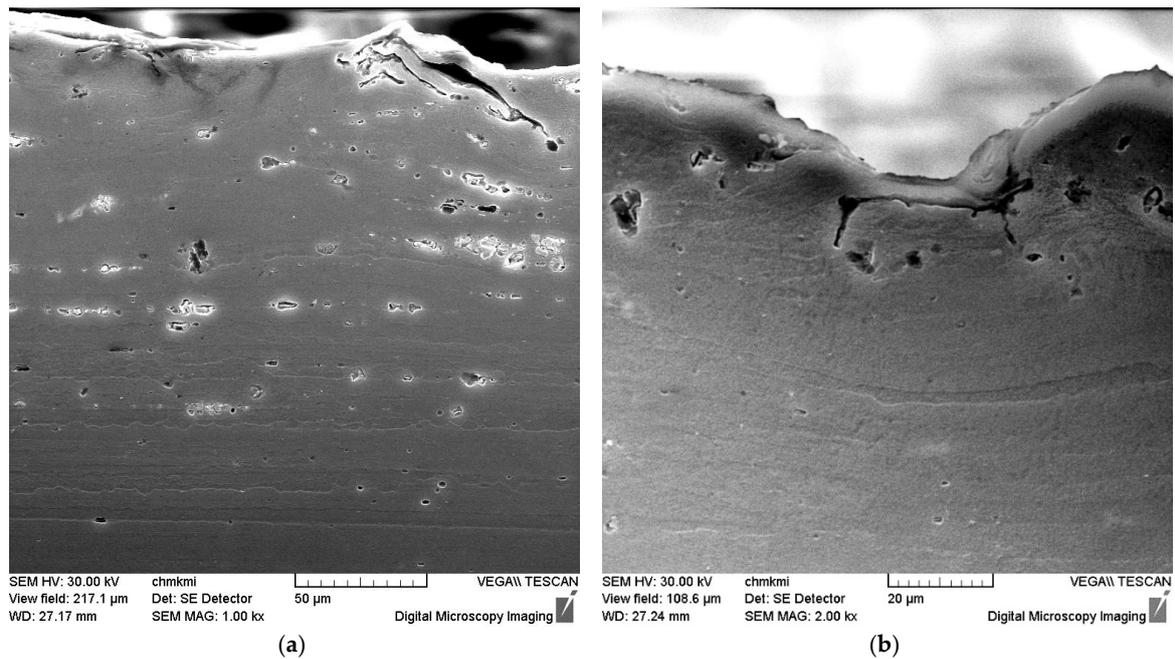
Figure 8. Surface layer of the 14.4 A/100% specimen with deep strengthened layer after shot peening with surface micro cracks (a); in detail (b); SEM.

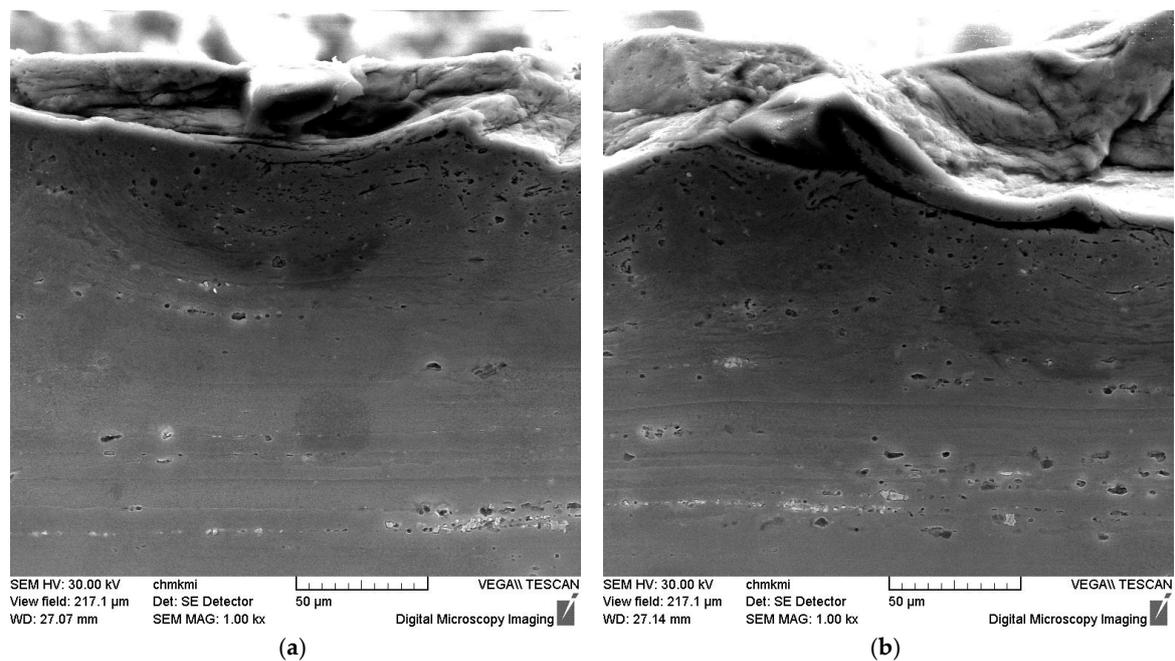
Figure 9. Surface layer of the 14.9 A/650% specimen with deep strengthened layer after shot peening with surface micro cracks and small layers peeling off (a); in detail (b); SEM.

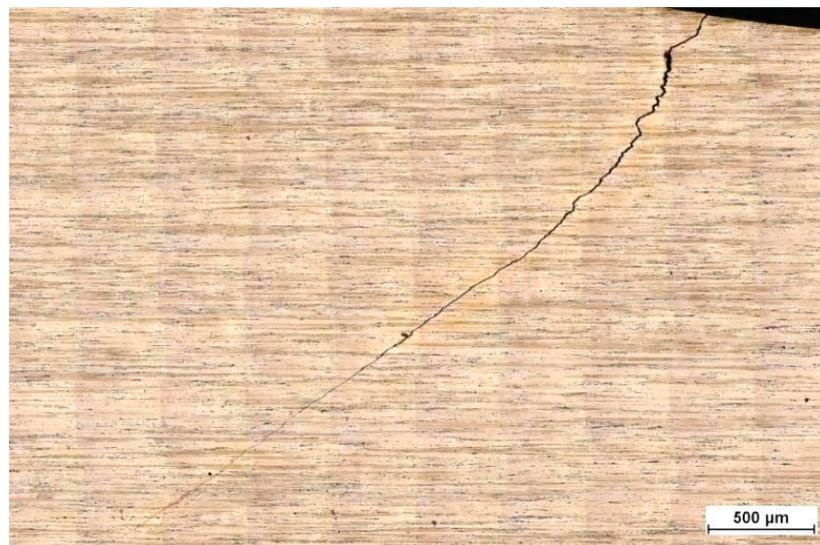
on a longitudinal cut of the NP fatigue specimen with an initiated fatigue crack, propagated to approximately half of the cross section (Figure 10).

Figure 10. Character of the fatigue crack initiation and propagation in NP fatigue test specimen ($\sigma_a = 176$ MPa, $N_f = 6.8 \times 10^7$ cycles), longitudinal cut. Reproduced with permission from Trško, L.; Guagliano, M.; Bokůvka, O.; Nový, F.; Jambor, M.; Florková, Z. *J. Mater. Eng. Perform.* Published by Springer Nature, 2017 [5].

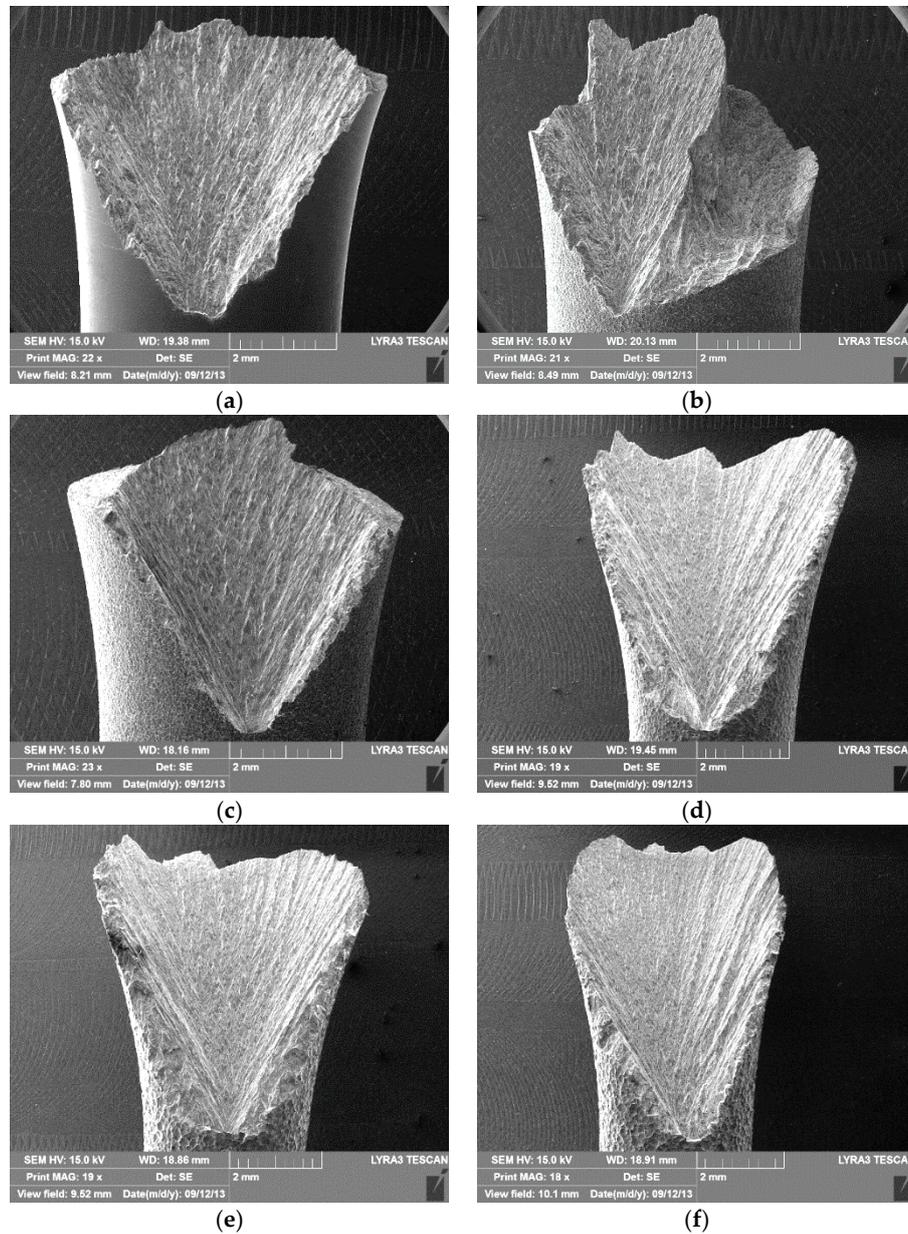
After the comparison of the close-up views of all types of the fatigue specimens, which were all tested at the stress amplitude level of $\sigma_a = 185$ MPa (Figure 11), it is obvious that the fatigue crack propagation character is common to all of those specimens and the angle of propagation is approximately the same. The difference in the ratio between the surface fractured by the fatigue damage and the final rupture is caused by different times after which the length of the crack shifted the ultrasonic system out of resonance frequency.

Figure 11. Macro views of fatigue fractures of specimens loaded at stress level $\sigma_a = 185$ MPa, SEM. (a) NP, $\sigma_a = 185$ MPa, $N_f = 2.6 \times 10^7$ cycles; (b) 8.3 N/100%, $\sigma_a = 185$ MPa, $N_f = 1.0 \times 10^8$ cycles; (c) 9.6 N/650%, $\sigma_a = 185$ MPa, $N_f = 1.6 \times 10^8$ cycles; (d) 6.9 A/100%, $\sigma_a = 185$ MPa, $N_f = 2.4 \times 10^7$ cycles; (e) 14.4 A/100%, $\sigma_a = 185$ MPa, $N_f = 4.9 \times 10^6$ cycles; (f) 14.9 A/650%, $\sigma_a = 185$ MPa, $N_f = 7.3 \times 10^6$ cycles.

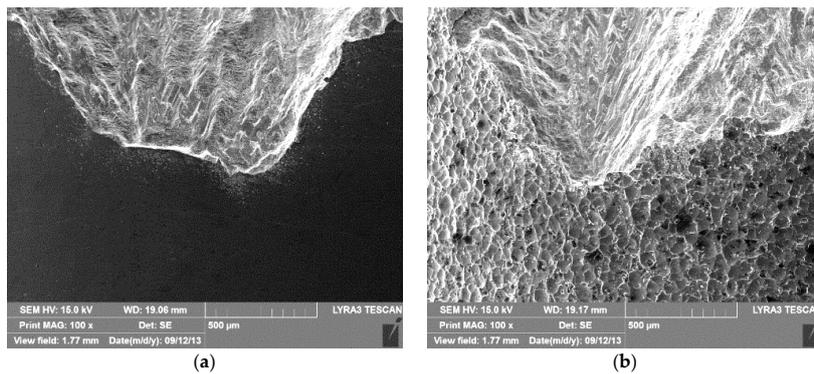
When comparing the crack initiation sites on the NP and 8.3 N/100% shot peened specimens, despite the change of the surface character these have the same appearance and no difference in crack propagation in the strengthened surface layer can be observed as well (Figure 12).

Figure 12. Fatigue crack initiation sites of fatigue test specimens: (a) NP , $\sigma_a = 185$ MPa, $N_f = 2.6 \times 10^7$ cycles; (b) 8.3N/100%, $\sigma_a = 185$ MPa, $N_f = 1.0 \times 10^8$ cycles, SEM.

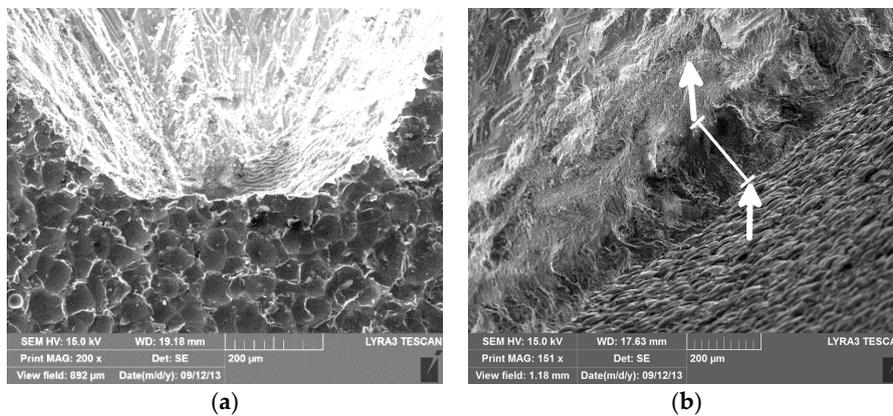
On the fracture surface of a specimen treated with 9.6 N intensity and coverage of 650%, the fracture of the surface layer had a different appearance than the rest of the fracture surface. In addition, the orientation of the crack propagation in that surface layer was different, and it seems to be perpendicular to the original surface of the specimen (Figure 13).

Figure 13. Fatigue crack initiation site of 9.6 N/650% shot peened specimen (a); and different character of fatigue crack propagation in the strengthened surface layer—the crack path with respect to the specimen's surface is marked with arrows (b); $\sigma_a = 185$ MPa, $N_f = 1.6 \times 10^8$ cycles, SEM. Reproduced with permission from Trško, L.; Guagliano, M.; Bokůvka, O.; Nový, F.; Jambor, M.; Florková, Z. *J. Mater. Eng. Perform.* Published by Springer Nature, 2017 [5].

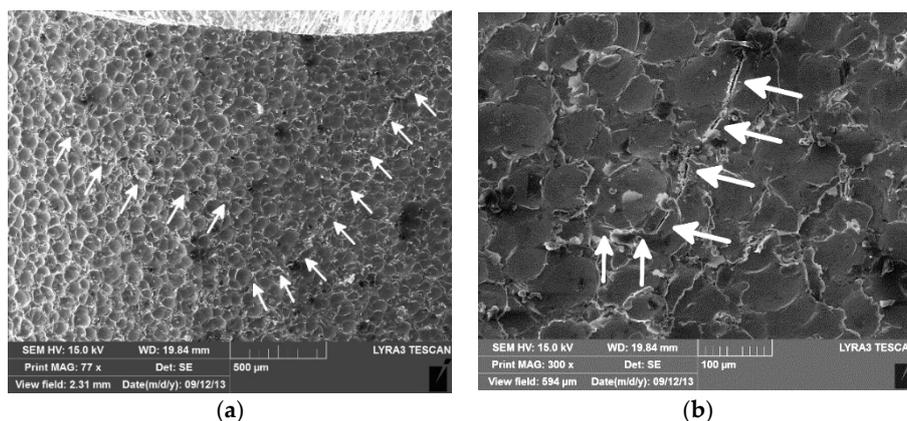
After careful observation of the area close to the fatigue crack initiation site, two more, very narrow fatigue cracks initiated below the dominant one were found. Those cracks copy exactly the shape of the dominant crack, which means that the horizontally initiated crack is perpendicular to a vector of the applied force and then the crack propagation deviates towards the specimens' longitudinal axis (Figure 14a, marked with white arrows). After taking a closer look at the detail of the initiated crack (Figure 14b), it can be seen that the crack has no preferential orientation in relation to the surface dimples (shot peened surface morphology) and the crack propagates through the bottom of the dimples and also through the raised edges of the dimples.

Figure 14. Multiple initiated fatigue cracks (a); and in detail (b); specimen treated with 9.6 N/650% parameters, $\sigma_a = 185$ MPa, $N_f = 2.5 \times 10^7$ cycles, SEM. Reproduced with permission from Trško, L.; Guagliano, M.; Bokůvka, O.; Nový, F.; Jambor, M.; Florková, Z. *J. Mater. Eng. Perform.* Published by Springer Nature, 2017 [5].

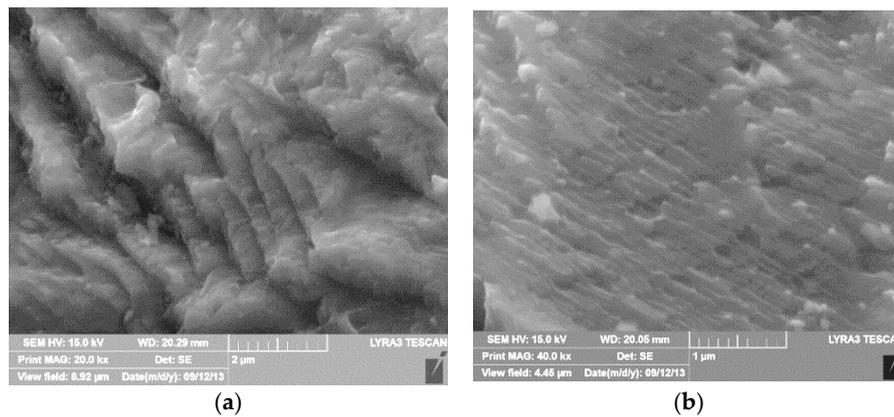
Fatigue fracture of a specimen treated with the 6.9 A intensity with the coverage of 100% reveals more details of the fatigue crack initiation (Figure 15). In Figure 15a, the fatigue fracture character of the area close to the fatigue crack initiation can be seen; the strong influence of the deformation texture on the short cracks' propagation is obvious. Short fatigue cracks during their propagation had extremely small increments (approximately $0.1 \mu\text{m}$), which is best documented in Figure 15b. Around the fatigue crack initiation site of this specimen, a net of secondary cracks surrounding the

Figure 15. Fatigue crack propagation character near the fatigue crack initiation site (a); and extremely small propagation increments of fatigue crack (b); specimen treated with 6.9 A/100% parameters, $\sigma_a = 185$ MPa, $N_f = 2.4 \times 10^7$ cycles, SEM.

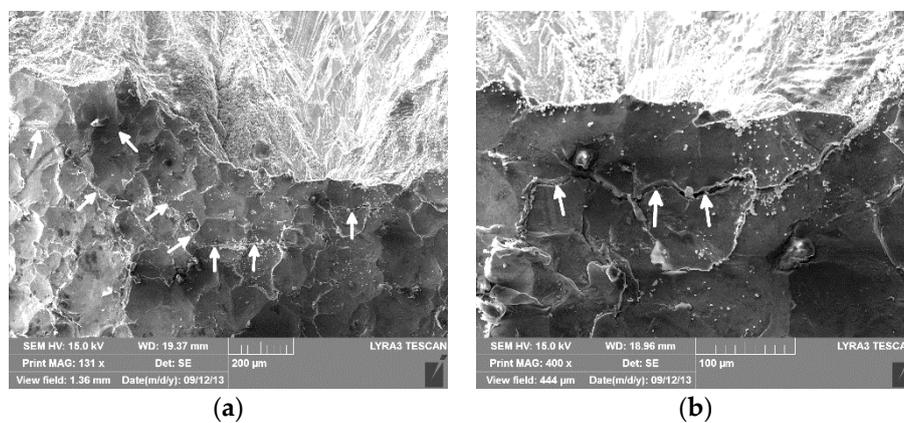
area of the main crack initiation site can be observed (Figure 16). Those cracks were present only under the initiation site and, according to Figure 17, all of them were created by forking of the main crack. The fracture appearance of the treated surface layer was also slightly different than the inner part of the fatigue fracture surface, as can be seen in Figure 17.

Figure 16. Net of secondary cracks surrounding the area under the fatigue crack initiation site (a); in detail (b); specimen treated with 6.9 A/100% parameters, $\sigma_a = 185$ MPa, $N_f = 2.4 \times 10^7$ cycles, SEM.

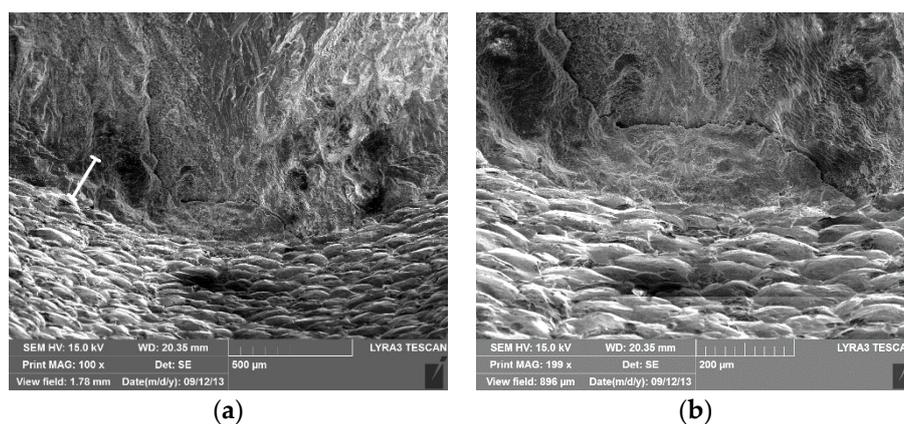
Figure 17. Different appearance of the strengthened surface layer on the fracture surface (a); and forking of the main crack in the area of fatigue crack initiation (b); specimen treated with 6.9 A/100% parameters, $\sigma_a = 185$ MPa, $N_f = 2.4 \times 10^7$ cycles, SEM.

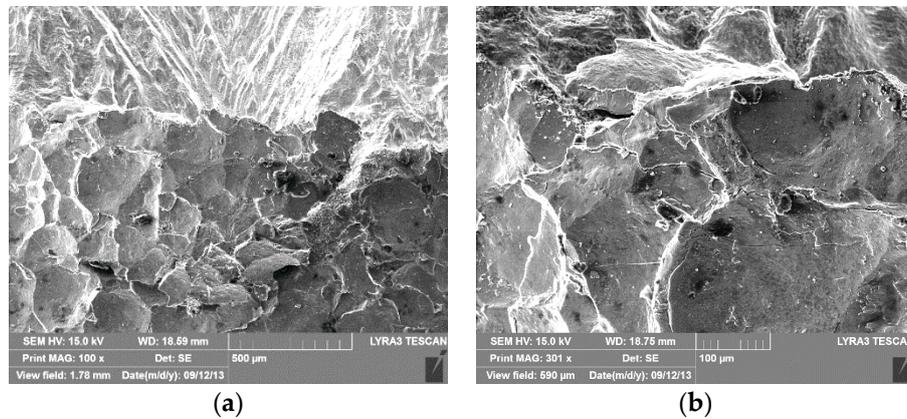
Observation of the fracture surface of the specimen peened with the 14.4 A intensity with coverage of 100% reveals that the net of the secondary cracks under the initiation site is even more prominent (Figure 18). The fracture of the surface layer has also a different character and it is much deeper than in

Figure 18. Net of secondary cracks under the fatigue crack initiation site (a); in detail (b); specimen treated with 14.4 A/100% parameters, $\sigma_a = 185$ MPa, $N_f = 4.9 \times 10^6$ cycles, SEM.

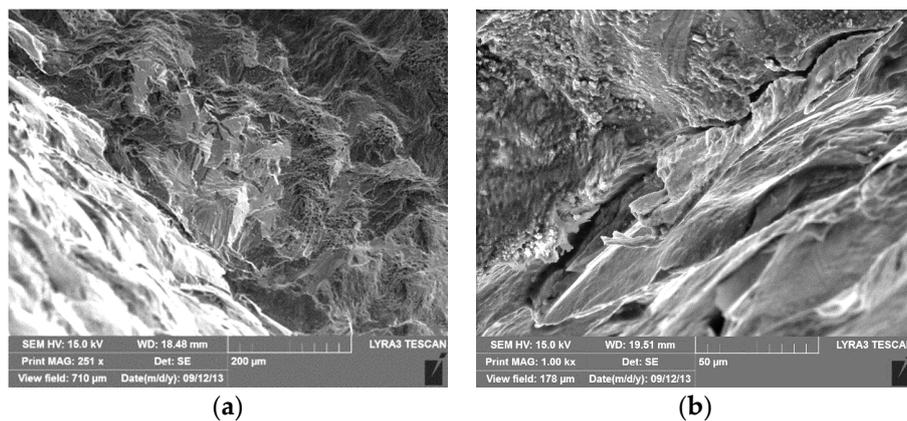
previous treatments (Figure 19a). In addition, in a small number of places it was observed that whole material layers on the surface started to peel off from the specimen due to the applied cyclic loading (Figure 19b).

Figure 19. Different character of crack propagation in the strengthened surface layer (a); and peeling-off surface layer (b); specimen treated with 14.4 A/100% parameters, $\sigma_a = 185$ MPa, $N_f = 4.9 \times 10^6$ cycles, SEM.

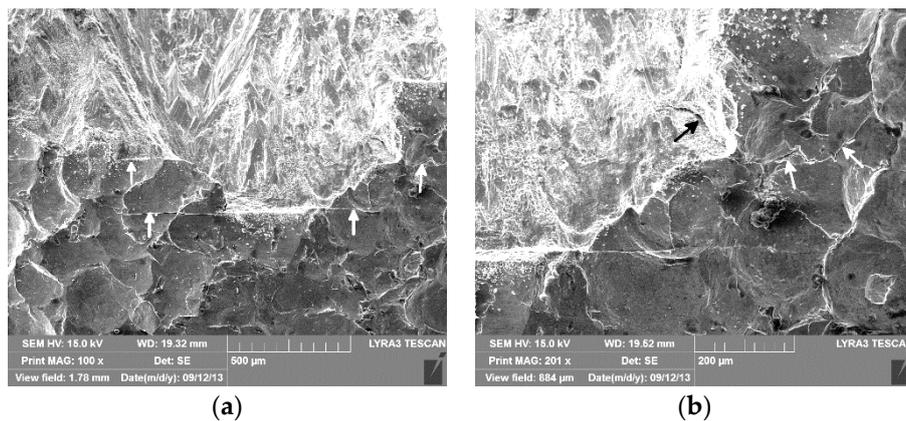
The fracture surface of a specimen after the most severe shot peening treatment with the intensity of 14.9 A and coverage of 650% also shows a net of secondary cracks under the area of initiation (Figure 20). Again, a deep surface layer had a different fracture character than the rest of the fracture surface (Figure 21a), but the thickness of this layer, of a different appearance, seems not to be as uniform as in previous cases. Whole layers of material peeled off from the surface of the specimen, as can be seen in Figure 21b.

Figure 20. Net of secondary cracks under the fatigue crack initiation site (a); in detail (b); specimen treated with 14.9 A/650% parameters, $\sigma_a = 185$ MPa, $N_f = 7.3 \times 10^6$ cycles, SEM.

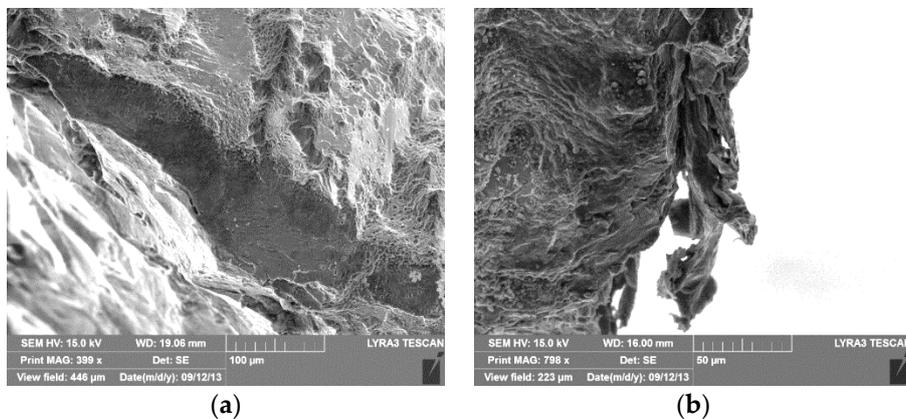
Figure 21. Different character of crack propagation in the strengthened surface layer (a); and peeling-off surface layer (b); specimen treated with 14.9 A/650% parameters, $\sigma_a = 185$ MPa, $N_f = 7.3 \times 10^6$ cycles, SEM. Reproduced with permission from Trško, L.; Guagliano, M.; Bokůvka, O.; Nový, F.; Jambor, M.; Florková, Z. *J. Mater. Eng. Perform.* Published by Springer Nature, 2017 [5].

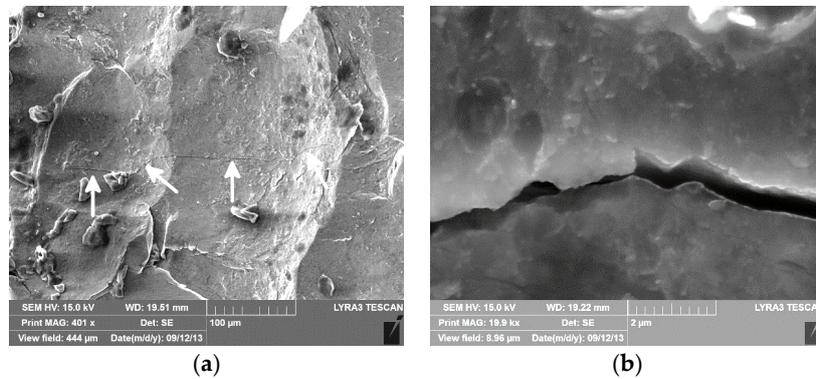
The secondary initiated fatigue crack (Figure 22a) was extremely narrow and had a width of barely 1 μm (Figure 22b). Again, the net of secondary cracks, copying the boundary between the affected surface layer and the core of the material, evolved and resulted in the separation of the treated surface layer from the specimen due to the cyclic loading (Figure 23).

Figure 22. Multiple initiated fatigue cracks (a); and in detail (b); specimen treated with 14.9 A/650% parameters, $\sigma_a = 185$ MPa, $N_f = 7.3 \times 10^6$ cycles, SEM.

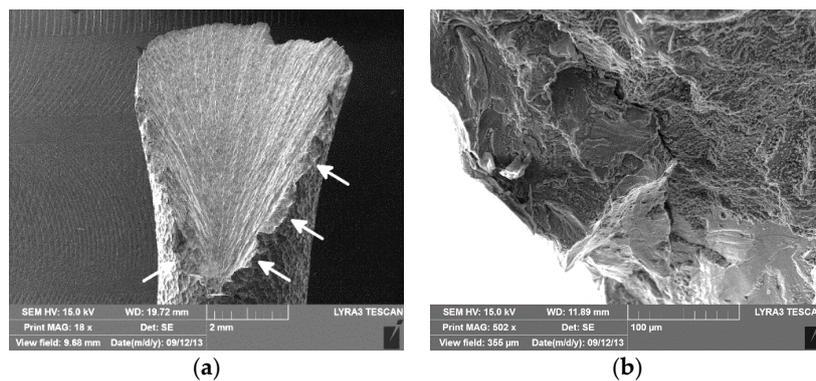
Figure 23. Peeling-off surface layer on the macro view (a); and in detail (b); specimen treated with 14.9 A/650% parameters, $\sigma_a = 185$ MPa, $N_f = 7.3 \times 10^6$ cycles, SEM.

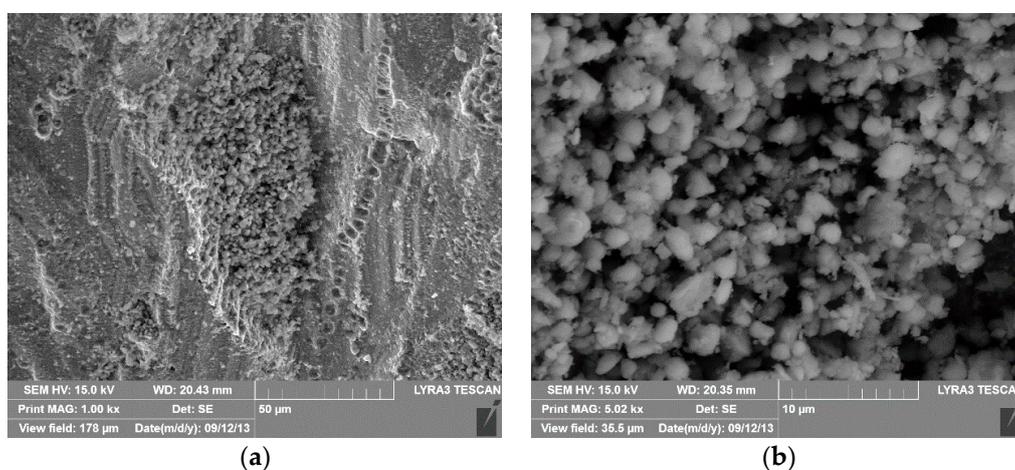
Figure 24. Surface layer damaged by fretting (a); and detail of the oxide created on the damaged surface (b); specimen treated with 6.9 A/100% parameters, $\sigma_a = 185$ MPa, $N_f = 2.4 \times 10^7$ cycles, SEM.
