# Article Effects of Grain Boundary Microconstituents on Heat-Affected Zone Cracks in a Mar-M004 Weldment

**Abstract:** Repair-welding of a cast Mar-M004 superalloy by gas tungsten arc welding was performed. Liquation cracks of the heat-affected zone (HAZ) in a Mar-M004 weldment were closely related to the presence of low-melting constituents along the solidified boundaries in the weld. The metal carbides (MC),  $M_3B_2$  and  $M_5B_3$  borides,  $Ni_7(Hf,Zr)_2$  intermetallic compounds, and  $\gamma$ - $\gamma$ 'colonies were found at the interdendritic boundaries. Fine boride precipitates mixed with intermetallic compounds in lamellar form were more likely to liquate during repair-welding. The melting of borides and intermetallic compounds in 1180 °C/4 h treated samples confirmed the poor weldability of the Mar-M004 superalloy due to enhanced liquation cracking. In addition to boride formation, fractographs of liquation cracks revealed strong segregation of B element in carbides and intermetallics, which might further lower the solidus temperature of the repair weld.

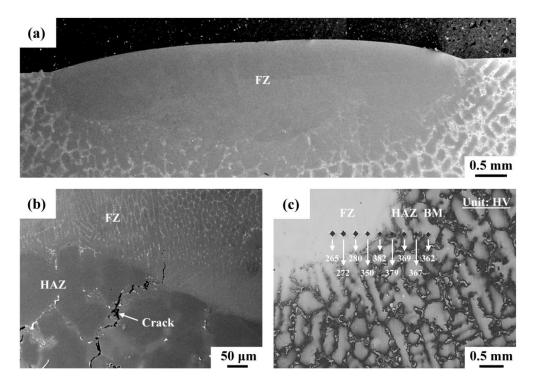
Figure 2 shows the cross-sectional view of a repair weld with IN625 as the filler metal. The FZ revealed that the microstructure was finer and more uniform than that of the cast BM with white solidified products at the boundaries (Figure 2a). The liquation cracks were more likely to propagate along the white phase in the HAZ of a Mar-M004 weldment as illustrated in Figure 2b. The hardness distribution from the FZ to the cast BM of the weld is displayed in Figure 2c. The hardness of the FZ, in which was deposited IN625 filler, was about HV 265. The cast Mar-M004 BM had a hardness of about HV 365. The HAZ near the fusion boundary had a slightly higher hardness than did the other zones. It was deduced that the welding heat caused the dissolution of coarse  $\gamma'$  precipitates during the heating cycle and enhanced the formation of fine  $\gamma'$  in the subsequent cooling cycle, resulting in the increased hardness therein.

**Figure 2.** (**a**) Cross-sectional view of the repair weld; (**b**) liquation crack in the heat-affected zone (HAZ) of the weldment; (**c**) microhardness indentations from the fusion zone (FZ) across the weld interface to the base metal (BM).

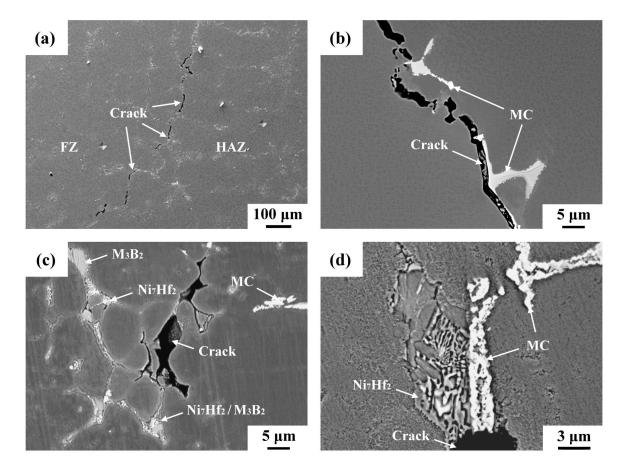
Mar-M004 welds were subjected to a standard metallographic procedure to reveal internal defects. Figure 6 shows SEM micrographs of microcracks in the HAZ next to the FZ of the repair weld. Obviously, microcracks propagated along interdendritic region of the HAZ (Figure 6a). The induced microcracks were clearly in association with the inherently metallurgical factors of the cast Mar-M004 superalloy. As reported in previous works [16,23,25,26], constitutional liquation of MC carbides,  $M_3B_2$  borides,  $M_2SC$  sulfocarbides,  $\gamma'$  particles, and  $\gamma$ - $\gamma'$  eutectic accounts for the HAZ liquation cracking of IN738 superalloy welds. The cracks were found to be more likely to propagate along the interfaces between the MC carbides and the matrix (Figure 6b) owing to the substantial amounts of MC carbides in the cast Mar-M004 superalloy. The imposed shrinkage stress on the liquated phases promoted the occurrence of HAZ cracking of the Mar-M004 weld. Liquation cracking was also found to initiate and propagate along the boundaries between the  $\gamma$ - $\gamma'$  colonies (Figure 6c), wherein some minor phases in between might dominate the cracking. Inspection at higher magnifications showed that complex

microconstituents in lamellar forms also played an important role on the HAZ liquation cracking as shown in Figure 6d.

**Figure 6.** (**a**) The occurrence of liquated cracks in the HAZ of the Mar-M004 weld; (**b**) crack growth along the interface between the MC carbide and matrix; (**c**) lamellar white phases and carbides ahead of liquated crack; and (**d**) complex microconstituents ahead of liquation crack.

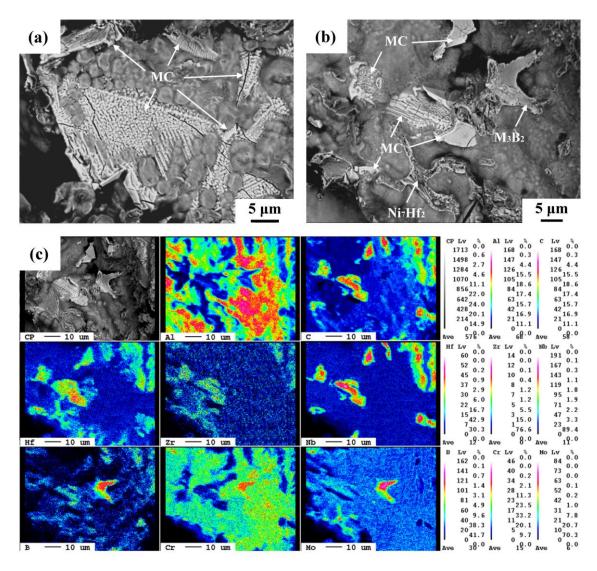
After immersion in liquid nitrogen for a short time, the existing microcracks in the HAZ of the Mar-M004 weld were opened by applying a bending force. The fracture appearance of those microcracks was inspected by SEM in the BSE image, and EPMA maps were used to determine the chemical compositions of the coverings as shown in Figure 7. The fracture surface revealed the typical feature of hot cracking of a weld, i.e., solidified liquid droplets and eutectic constituents on the fracture surface (Figure 7a). The coverings on the fracture surface had different morphologies, including blocky, lamellar, and arrayed fine precipitates (Figure 7a,b). A few fine cracks were found to propagate through those solidification products, indicating the ease of cracking or brittleness of the solidification products. The high brightness of the eutectic constituents also implied the aggregation of high atomic weight elements. The EPMA maps (Figure 7c) indicated that the smooth fracture surface was enriched in Al but lean in other alloy elements. The cobble-like features enriched in Al were could be the separation between the  $\gamma$ - $\gamma'$  colonies. Additionally, the distributions of C and B were used to sort the types of microconstituents. The C map was used to identify the formation of isolated carbides or  $\gamma/MC$ eutectics. The results clearly showed the strong partitioning of Nb and Hf to the MC carbides in blocky or lamellar shapes. The B map indicated that the low-melting constituents on the fracture surface consisted of high B, Cr, and Mo concentrations, implying the formation of Cr-Mo borides. Moreover, a high tendency of B to segregate to those zones of carbides and intermetallics was noticed. It was also

seen that the co-segregation of Hf and Zr (strong carbide formers) did not need to be accompanied by C segregation to form MC carbides simultaneously. Without the participation of C, the co-segregation of Hf and Zr shown in the EPMA maps would facilitate the formation of Ni-(Hf,Zr) lamellar intermetallic compounds instead of MC carbides.

**Figure 7.** (**a**,**b**) SEM fractographs of liquated cracks and (**c**) the associated elemental mappings determined by EPMA.

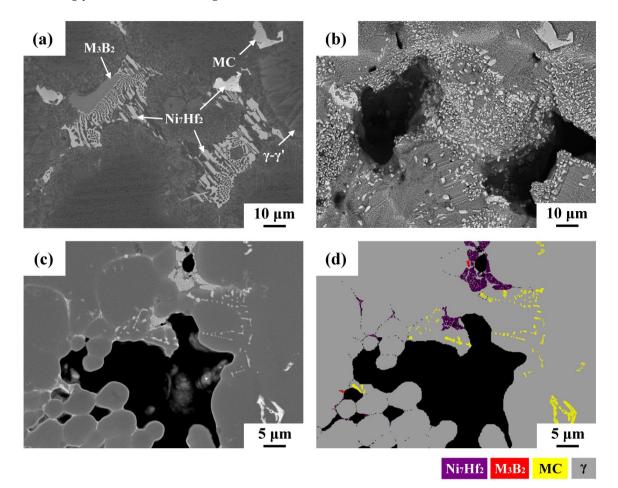
In prior work [33], premature melting of final solidification products, such as  $\gamma - \gamma'$  colonies, MC carbides, Cr-Mo borides, and Ni-Hf intermetallic compounds at the dendrite boundaries, accounted for the HAZ cracking of a Mar-M004 weldment. Pre-weld heat treatments were performed to eliminate those harmful microstructures and thereby improve the weldability of the cast superalloys [16,27,31,34]. In this work, pre-weld heat treatment was carried out at  $1180 \text{ }^{\circ}\text{C}/4$  h in hard vacuum followed by Ar-assisted cooling to room temperature. After metallographic preparations, the initial microstructures of the sample were inspected by SEM in BSE images, with special attention paid to the grain boundary microconstituents. After solution treatment, the same sample was examined again to reveal the variation in microstructures at the same site. Figure 8 illustrates the evolution of microstructures before/after pre-weld heat treatment. In Figure 8a, MC carbides, borides, and lamellar intermetallics were present in the sample before pre-weld treatment. After solution treatment at 1180  $^{\circ}C/4$  h in high vacuum, the borides and lamellar intermetallics ahead of  $\gamma$ - $\gamma'$  colonies liquated unexpectedly. This event caused the formation of micro-pores in the sample (Figure 8b). The MC carbides still resisted melting during this solution treatment. After the damaged sample was polished, the surface morphologies of the solution-treated sample were investigated in BSE images and subjected to EBSD analysis; the results are shown in Figure 8c,d. The figures revealed that those regions ahead of  $\gamma \gamma'$ colonies liquated preferentially (Figure 8c). The EBSD map (Figure 8d) showed that liquation cracking was strongly related to the melting of borides and lamellar intermetallics.

**Figure 8.** (a) BSE image of the cast microstructure; (b) the microstructural change of the (a) sample after solution-treatment at 1180 °C for 4 h; (c) BSE image of the liquated sample after metallographic preparation; and (d) EBSD map of the (c) sample.

- (5) To achieve a crack-free weld, a proper pre-weld heat treatment for such a cast superalloy should be customized on the first priority if refurbishment of the turbine is required.
