# Microbiologically Influenced Corrosion of a Pipeline in a Petrochemical Plant

**Abstract:** This paper investigates a severe microbiologically influenced failure in the elbows of a buried amine pipeline in a petrochemical plant. Pipelines can experience different corrosion mechanisms, including microbiologically influenced corrosion (MIC). MIC, a form of biodeterioration initiated by microorganisms, can have a devastating impact on the reliability and lifetime of buried installations. This paper provides a systematic investigation of a severe MIC-related failure in a buried amine pipeline and includes a detailed microstructural analysis, corrosion products/biofilm analyses, and monitoring of the presence of causative microorganisms. Conclusions were drawn based on experimental data, obtained from visual observations, optical/electron microscopy, and Energy-dispersive X-ray spectroscopy (EDS)/X-Ray Diffraction (XRD) analyses. Additionally, monitoring the presence of causative microorganisms, especially sulfate-reducing bacteria which play the main role in corrosion, was performed. The results confirmed that the failure, in this case, is attributable to sulfate-reducing bacteria (

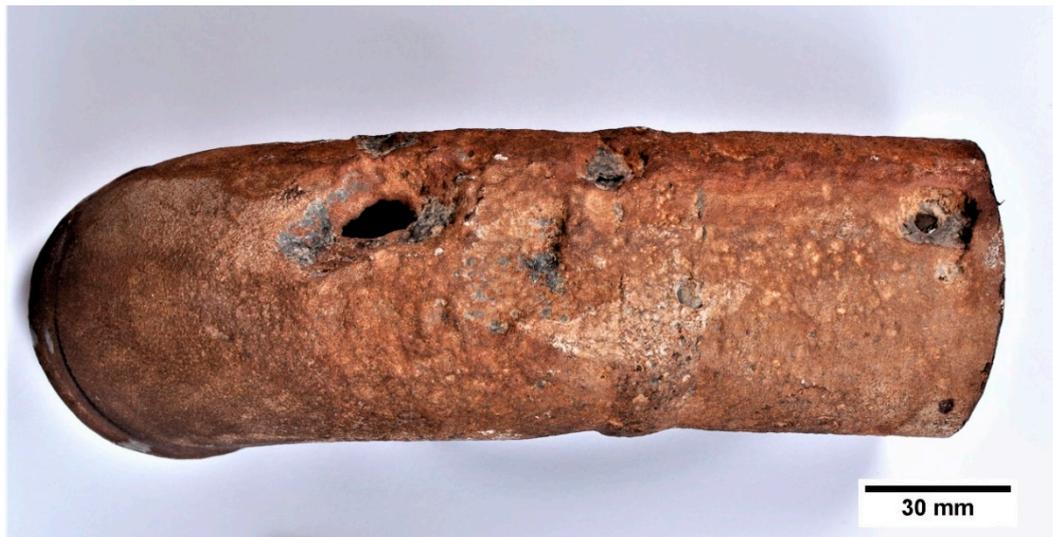
Figure 2 shows a typical failed elbow, taken out of the service. Both the inner and outer surfaces were covered with red/yellow–brown and, in some spots, black rust layers. The elbows were heavily damaged at the outer surface. Large pits and perforations were seen on the surface. Pits on the exterior of the failed elbows were at different stages, with some at the early stages, while a few have turned into big holes during service. While the outside part of the elbows had undergone severe localized corrosion, the inside part hardly showed any pitting, see Figure 3, indicating that the pitting had started from the outer surface. There were hardly any signs of surface irregularities (e.g., erosion or surface deformation) other than severe surface pitting.

**Figure 2.** An example of the failed elbows.

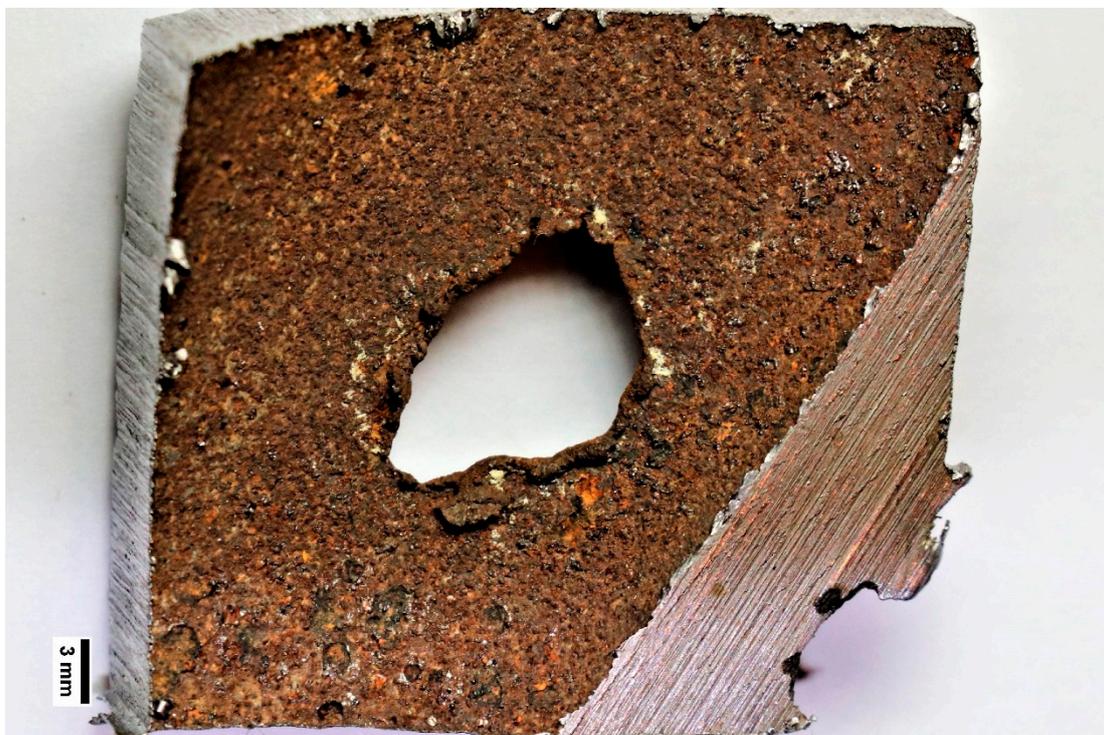
**Figure 3.** An inner surface of the failed elbows.

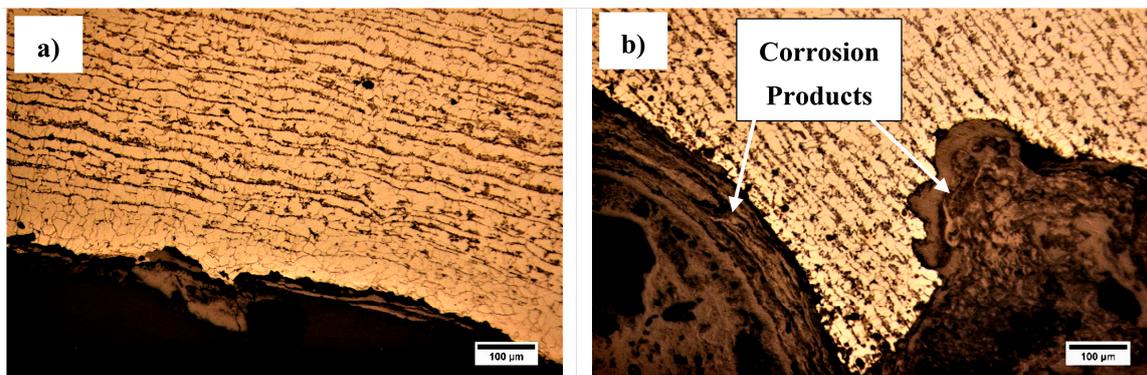
Figure 4a shows the microstructure of the failed elbow at the inner surface. The observed elongated ferritic–pearlitic microstructure is an indication that the alloy was in the as-rolled state. As mentioned before, there was no indication of pitting at the inner surface. Figure 4b shows the microstructure of a cross-section at the outer surface. Severe perforation and deep pits were observed at the outer surface. Furthermore, pits were covered with corrosion products, while in some cases, corrosion products had a layered structure.

**Figure 4.** The optical microscopy (OM) microstructures of the (a) inner surface and (b) the outer surface.

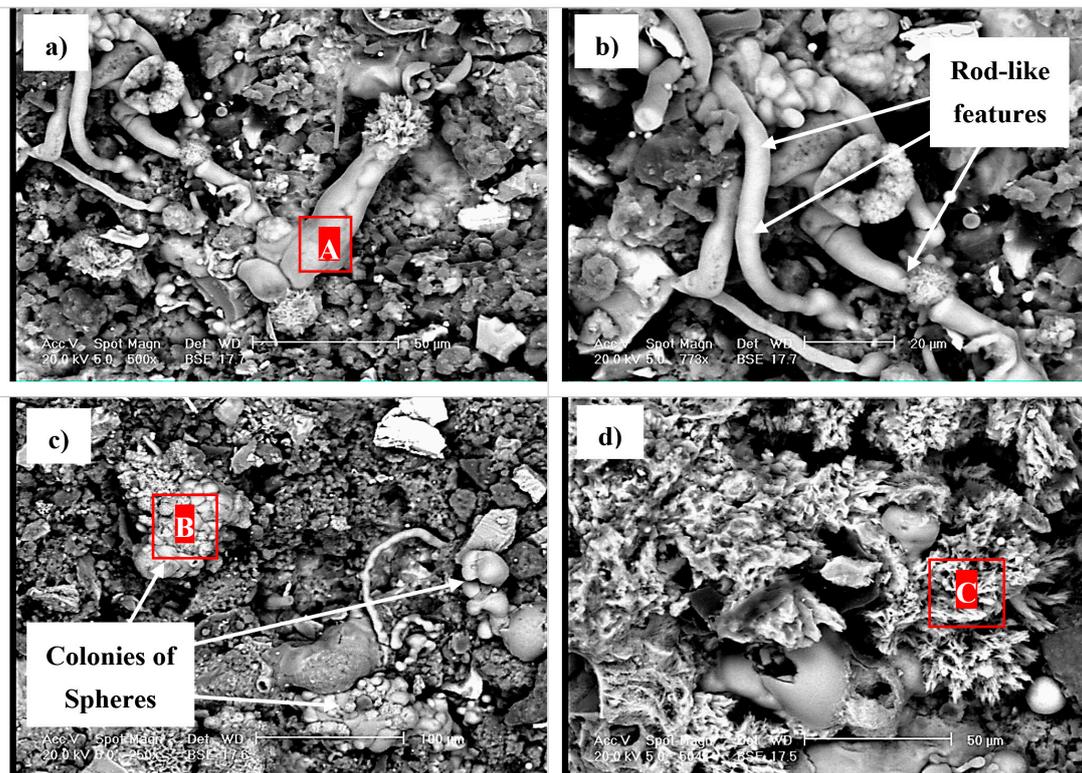
Figure 5 shows the typical features found inside pits at the outer surface. This figure clearly shows that the surface was covered with a biofilm. Biofilms, consisting of complex communities/colonies of microorganisms and EPS, can dissolve oxygen and create gradients of pH, resulting in localized forms of corrosion, such as crevice corrosion and pitting [10]. Three noticeable features were seen in the biofilm:

- (i) Rod-shaped products, with approximate length of 50  $\mu\text{m}$ ;
- (ii) Colonies of spheres, with their size ranging from 10 to 100  $\mu\text{m}$ ;
- (iii) Flower-like surface features, all shown in Figure 5.

Rod-like features were, statistically, more frequently seen than the other two morphologies. The distributions of all the mentioned morphologies were rather homogeneous, i.e., all features were seen in each and every pit.

**Figure 5.** Scanning Electron Microscope (SEM) photomicrographs showing biofilms (or surface deposit) and features inside biofilms, i.e., (a) and (b) rod-like features, (c) colonies of spheres, and (d) flower-like features.

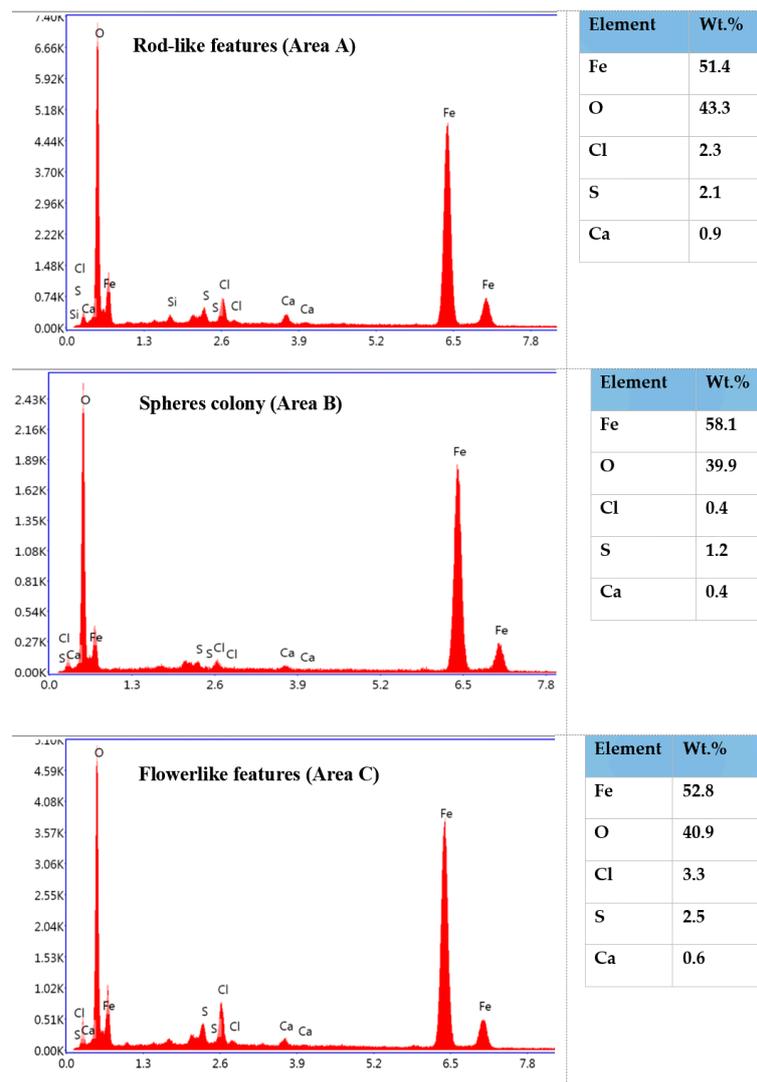
Figure 6 shows the results of EDS analyses of rod-like, spherical, and flowerlike corrosion products. In terms of the chemistry, there was no meaningful difference between these features, inferring that the difference between these features is only morphological. The presence of sulfur in all the EDS spectra is an indication that the observed features are SRB, which is an anaerobic bacterium. SRB is known to be the primary factor of MIC. Organic compounds attracted to the surface of steel make it an ideal environment for the colonization of microorganisms [2]. Amongst different microorganisms, SRB is known to have excellent adaptability to extreme conditions. Biochemical energy for the growth of SRB is obtained by reducing sulfate ( $\text{SO}_4^{-2}$ ) to sulfide ( $\text{S}^{-2}$ ) in the presence of natural organic compounds. At the same time, with the absorption of atomic hydrogen (H) on the surface of iron, it will gradually disappear [16]. Overall, the major detrimental metabolic activities of SRB are mostly related to its ability to:

**Figure 6.** Energy dispersive X-ray spectroscopy (EDS) analyses of areas shown in Figure 5, related to rod-like, spherical, and flower-like features ( $x$ -axis: Energy (KeV),  $y$ -axis: a.u.).

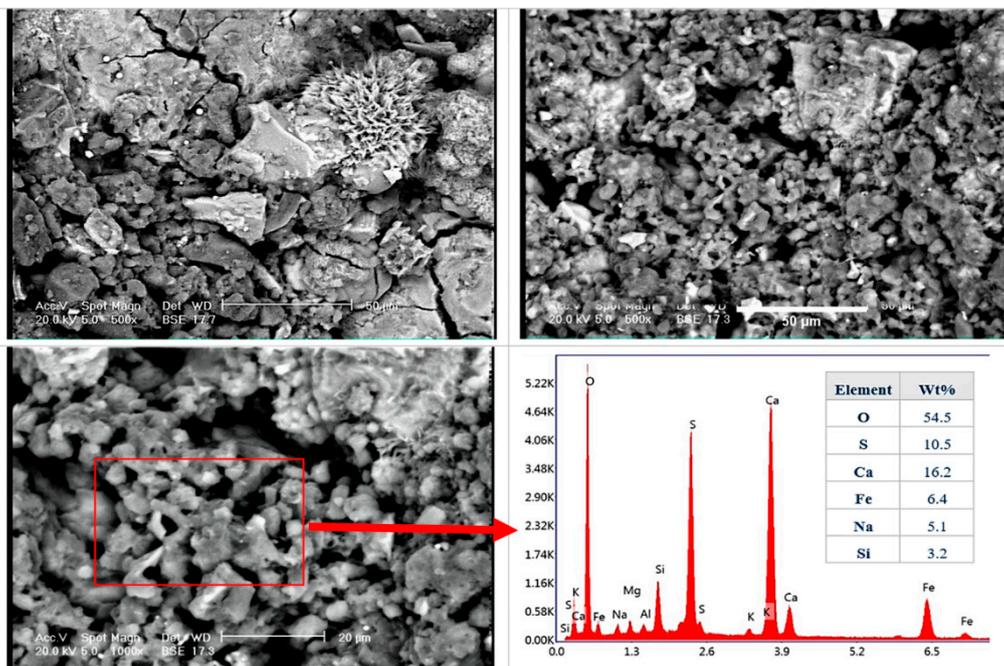
Figure 7 represents a closer look at the biofilm in the outer surface in which microorganisms are distributed. Biofilm is a self-produced firmly-attached EPS surface layer. In fact, the stability of microorganisms is dependent on the biofilm, given that the biofilm provides structural support for microorganisms and, to a great extent, protects them from environmental, physical, and chemical stresses. Biofilms could host a variety of different microorganisms including fungi, bacteria, eukaryotes, and archaea, with each having a different metabolic ability [2]. The SRB, in particular, has a vigorous metabolism, producing a certain amount of EPS (in fact, often there are also other microorganisms present that are mainly responsible for EPS production), which rapidly adhere to the surface of the metal and build a biofilm [14,18]. The biofilm, in this case, has a porous nature, making the ion/nutrition exchange much easier. EPS are composed of charged polymers and can significantly contribute to the accumulation of different chemical species inside EPS. In the case where organic acids are produced by microbial species, mineral dissolution rates are expected to increase [19,20]. The results of EDS analysis show that elements oxygen, sulfur, calcium, chloride, and iron were present in the biofilm. Figure 8 shows typical XRD patterns of corrosion products, taken from the surface of the pipe. The results confirmed the formation of a significant amount of oxide-hydroxide (FeOOH), iron oxide, and iron sulfide. The latter is a typical corrosion product when SRB is the controlling microorganism.

Figure 7. Examples of SEM images of biofilms together with EDS analysis.

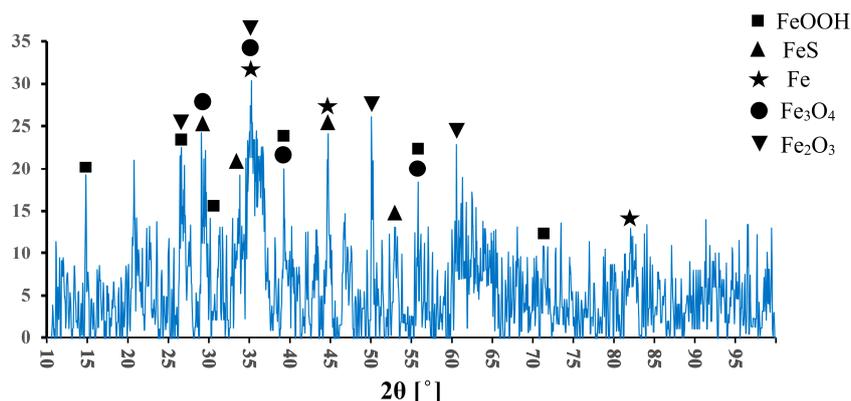
Figure 8. An X-ray diffraction analysis of the surface of the pipe.

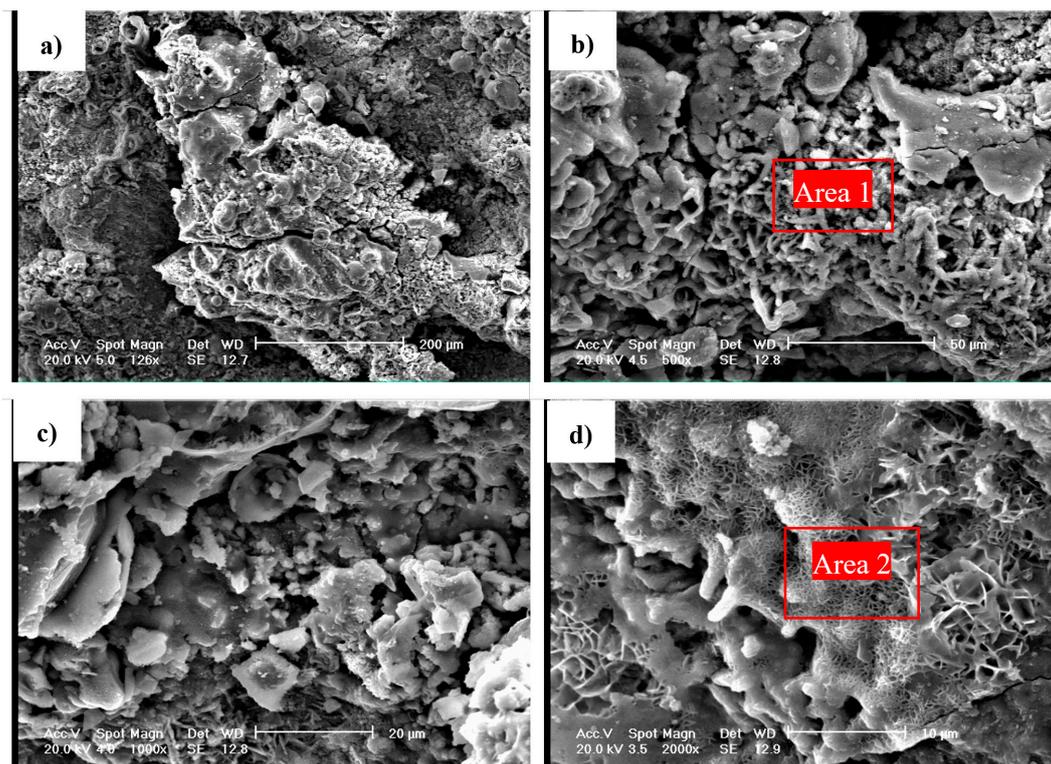
Figure 9 shows SEM images of corrosion products at the inner surface. As mentioned earlier, there was hardly any sign of localized corrosion. The inner surface in some areas was covered with a porous scale-like layer intermingled with some globular  $\alpha$ -FeOOH particles, see Figure 9a,b. Other observed morphologies of corrosion products were plate-like micaceous crystalline features, see Figure 9c, and honeycomb-like structures, see Figure 9d, with both being typical morphologies of  $\gamma$ -FeOOH. Therefore, overall, the inner surface was covered with different iron oxide-hydroxides and possibly other oxide products. Figure 10 shows the EDS analysis of the areas shown in Figure 9. There was no sign of sulfur and chloride, unlike what was seen at the outer surface. It appears that the failure has started from the outer pipe surface, and corrosion products at the inner surface were caused by the liquid inside the pipeline.

**Figure 9.** Different morphologies of the corrosion products at the inner surface: (a) and (b) scale-like layer intermingled with some globular  $\alpha$ -FeOOH particles, (c) plate-like micaceous crystalline features, and (d) honeycomb-like structures.

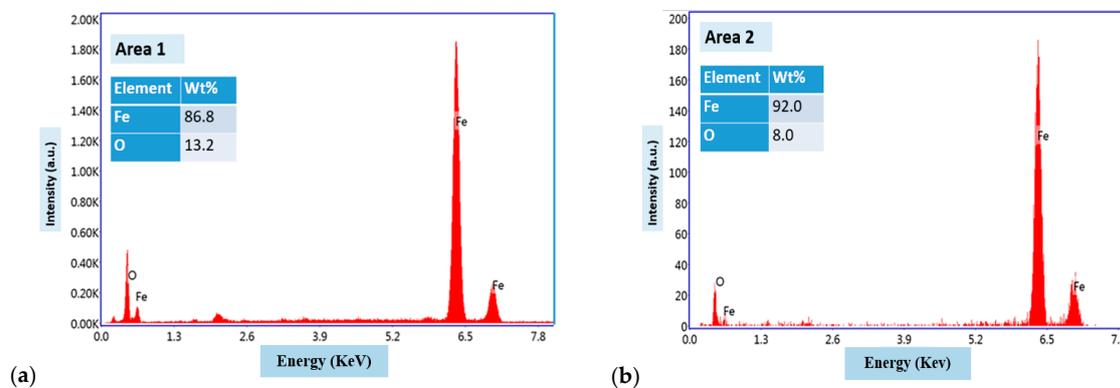
**Figure 10.** EDS analyses of (a) area 1 and (b) area 2, shown in Figure 9.

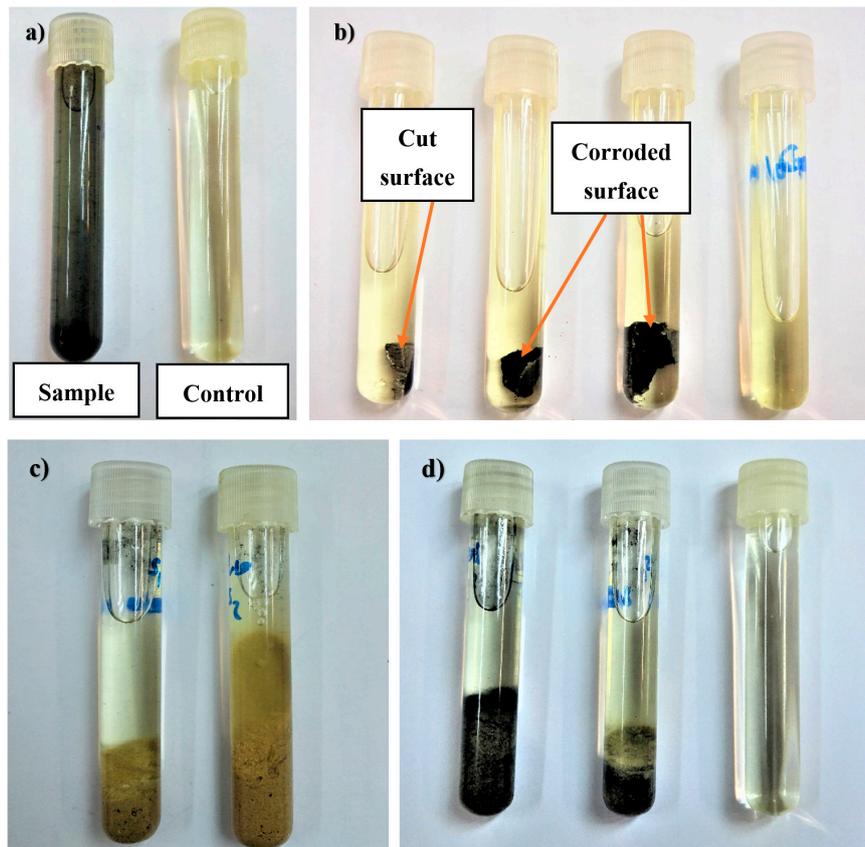
Surface scratches from the corroded elbows and samples of soil from the corrosion area were inoculated in SRB-specific media and incubated in anaerobic conditions for 20 days. As shown in Figure 11, the black precipitation is created due to SRB growth and  $H_2S$  and FeS production in the media. It is noticeable that the SRB-induced black precipitation was only created on the corroded surface of the failed elbow, and there was no sign of black precipitation on the cut surface, see Figure 11b. The formation of SRB cells was confirmed by SEM images, see Figure 12, and EDS spectra, see Figure 13. SRB is resistant to environmental stresses such as pH and temperature variations, chloride concentration, and high values of pressure. They form biofilms and create massive corrosion products by deteriorative mechanisms [21,22].

**Figure 11.** SRB growth monitoring in specific media after 20 days. Control: The specific medium without inoculation. (a) Surface scratch from corrosion tube, (b) the corrosion tube cuts (c) the soil samples of corrosion area after five days, and (d) after 20 days.

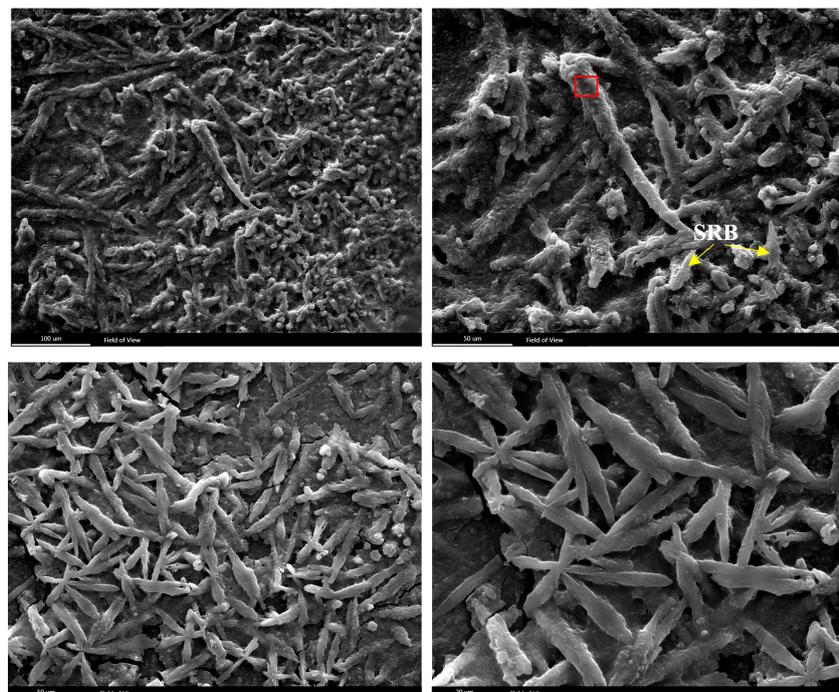
**Figure 12.** SEM images of SRB growth in specific media inoculated by the surface scratches of the corroded sample (all pictures are from similar features with different magnifications).

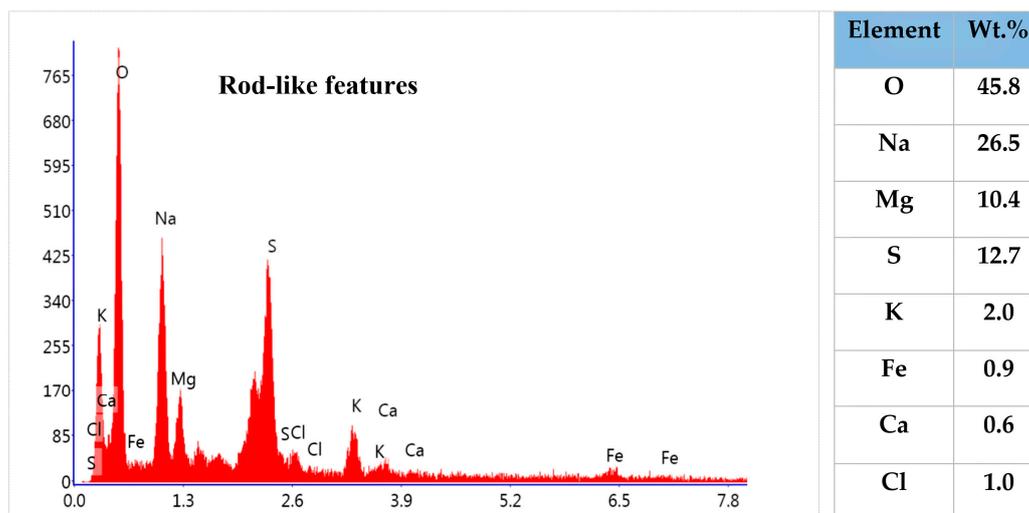
**Figure 13.** An EDS analysis of area shown in Figure 12 (*x*-axis: Energy (KeV), *y*-axis: a.u.).

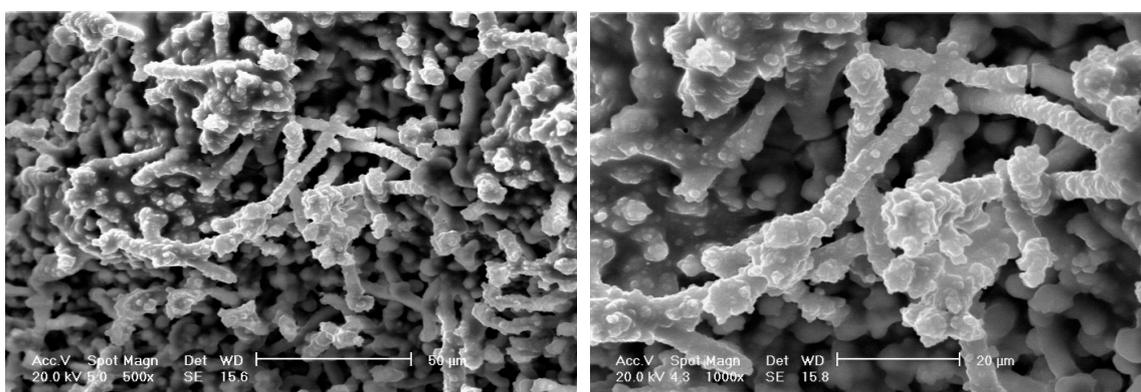
The corroded tube was also cultivated in the media. The results revealed that due to reactivation and reproduction of SRB, the amount of corrosion products increased. The corrosive effects of SRB are shown in Figure 14. The redox potentials of as-received soil before inoculation in an SRB-specific medium and that after inoculation were 19 and  $-315$  mV, respectively. The decrease in the redox potential can be attributed to the enhanced activity of SRB, which is in accordance with the presented results of Figures 11–13 [23,24].

**Figure 14.** Corrosion products development after reactivation of SRB due to inoculation of the corroded tube cuts in the SRB-specific media (Images are from similar features with different magnifications).
