Case Study

Natatorium Building Enclosure Deterioration Due to Moisture Migration

Lawrence Graham, Mark Scott and Aleka Pappas *

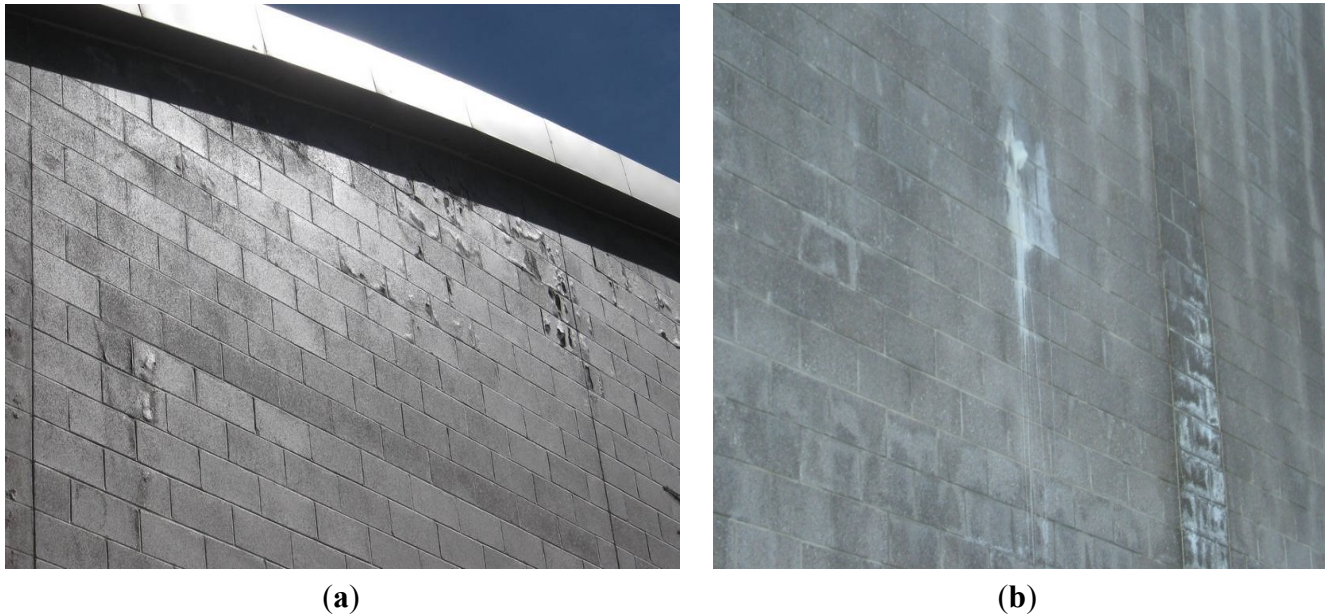
To begin the investigation, the investigators performed a review of construction documents along with a visible inspection of the building that included architectural and mechanical systems. Spalling, efflorescence, and blistering of the masonry was observed throughout the façade (Figure 2a), with the most severely deteriorated masonry at the southwest corner below the soffit. Ice was found forming on the façade in some locations (Figure 2b). When the soffit was examined, a pool chemical odor was detected at the soffit vents, indicating that interior air was exfiltrating out through the grilles. This revealed that pool room was likely positively pressurized relative to the exterior at this location. There was no visual evidence of distress on the interior side of the exterior walls.

From these initial inspections, the investigators concluded that the deterioration at the exterior CMU walls was a result of moisture laden air from the interior being forced into the wall assembly by a positive pressurization of the natatorium. Based on the locations of most of the CMU deterioration, a breach in the air barrier at the intersection of the wall and roof was the likely path for the moist interior

air to travel into the wall. Further, the wall assembly was not able to properly dry to the outside due to a coating that had been applied to the exterior face of the CMU. The moisture trapped in the wall froze at night and thawed out during the day, causing freeze-thaw deterioration. The large daily temperature swings of the dry mountain climate amplified this effect.

Figure 2. (a) Blistering and spalling at south façade; (b) Ice formations.

1. Repairing the natatorium air/vapor barrier at the wall-to-roof interface and where trusses penetrate exterior and interior walls;
2. Re-balancing the mechanical system to provide a negative pressurization in the space;
3. Replacing deteriorated CMU units;
4. Removing the exterior coating on the face of the CMU;
5. Replacing the metal roof, insulation and air/vapor barrier at the natatorium as soon as possible.

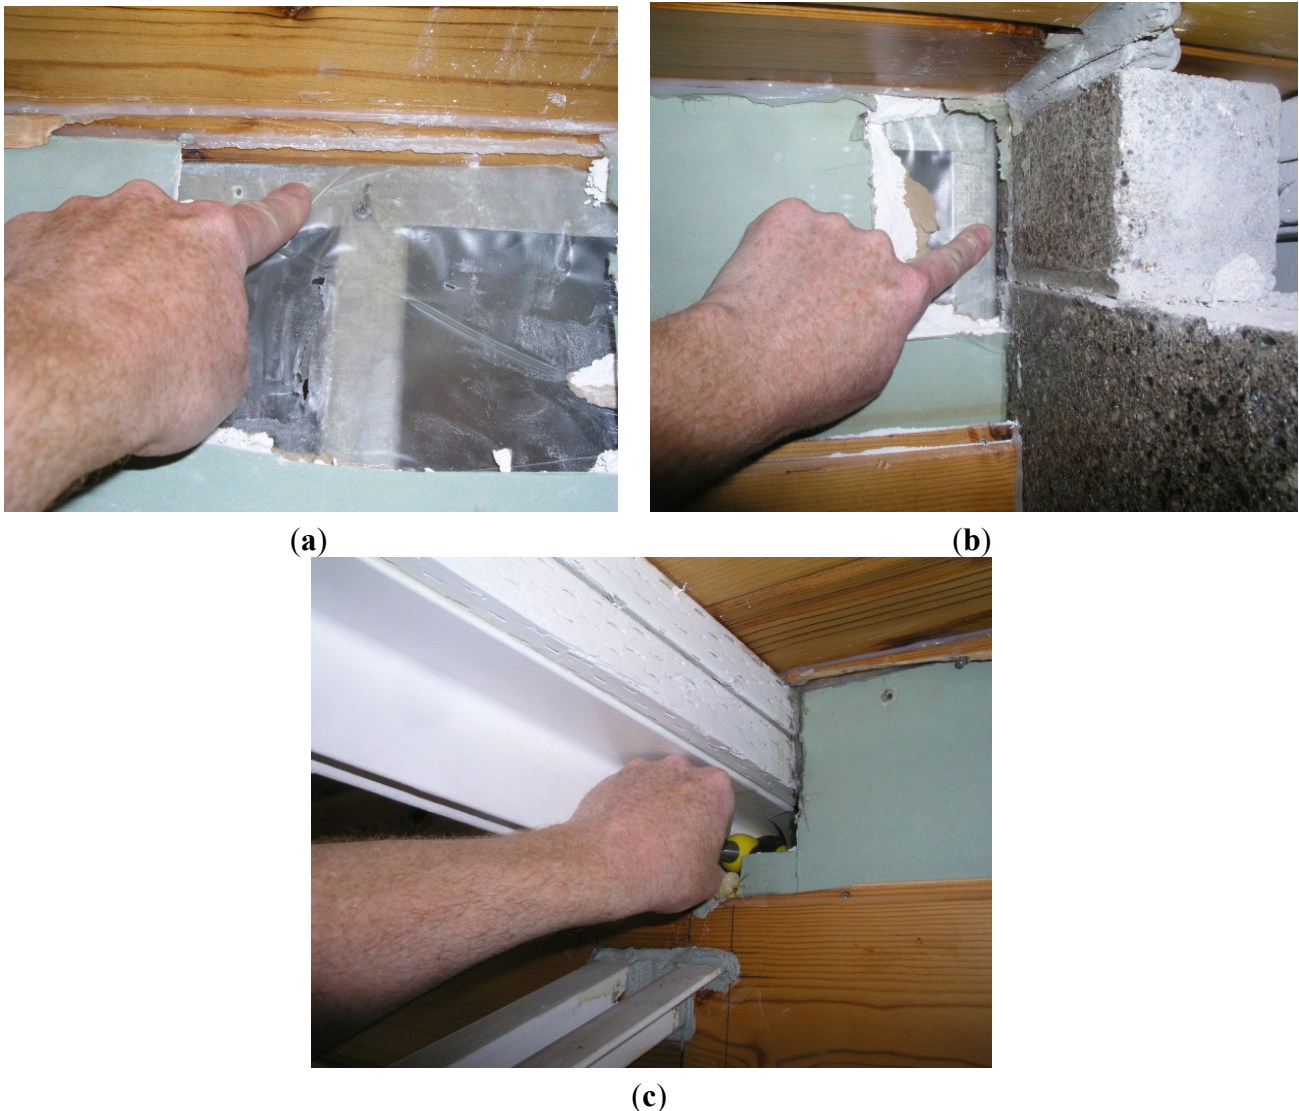
The investigators made three investigative openings at the interior face of the exterior wall where it meets the roof deck. The openings were primarily meant to determine how the air barrier was terminated at the roof, and to determine as-built conditions in order to develop repair details to improve the continuity of the air/vapor barrier. In opening the walls, the investigators found a number of concerns: (1) the air/vapor barrier at the top of the wall was not sealed to the roof air/vapor barrier or the decking (Figure 3a); (2) the air/vapor barrier at the wall sheathing to CMU pier interface was not sealed at penetrations of the roof trusses (Figure 3b); (3) there were significant gaps in the air/vapor barrier where the roof truss top chords penetrate the CMU piers and exterior wall (Figure 3c); (4) there was no air/ vapor barrier in some areas adjacent to windows; and (5) there was no air/vapor barrier at interior walls separating the natatorium from mechanical spaces.

Figure 3. (a) Air/vapor barrier at wall to roof interface; (b) Air/vapor barrier at concrete masonry unit (CMU) pier; (c) Gap in wall at truss penetration.

These breaches in the air/vapor barrier correlated with the observed distress on the exterior CMU walls, and supported the theory that this was the path of moisture laden air penetrating the building envelope. Proper termination of the wall air/vapor barrier to the roof deck, along with sealing the open gaps at the truss penetrations, should significantly reduce the amount of interior air that can enter the exterior wall construction. Termination of the wall air/vapor barrier to the roof air/vapor barrier, although the preferred remedy, was cost-prohibitive.

The investigators provided construction documents for the repairs to the air/vapor barrier to seal gaps at truss penetrations with spray polyurethane foam, and to terminate the air/vapor barrier at the roof using a sealant and termination tape. Because of the low slope of the roof, recommendations included replacing the existing metal panel roof at the natatorium with a thermoplastic single-ply 80 mil PVC membrane system fully adhered to a gypsum cover board. The insulation and sheathing on top of the wood deck were also replaced, with a sheet waterproofing membrane installed on the sheathing board.

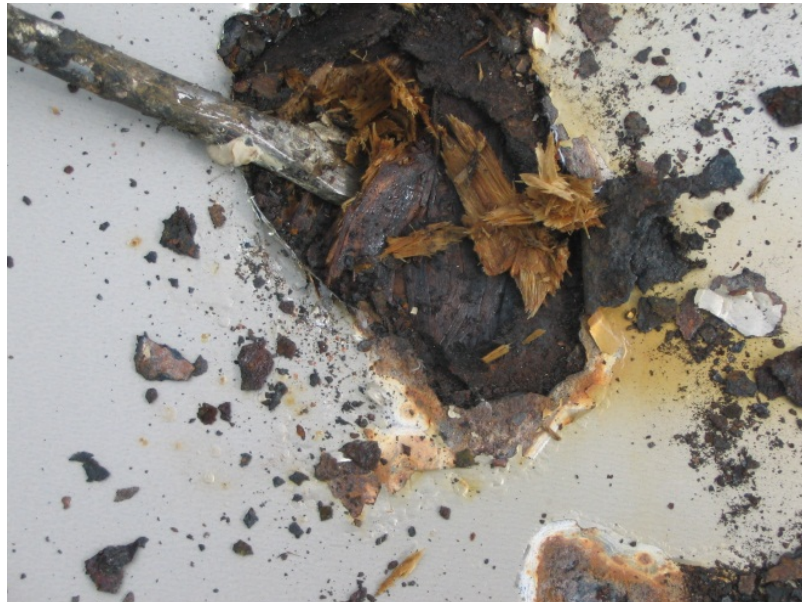
About a year after the initial investigations (the schedule was dictated by the owner's financing availability), the investigators performed inspections of the natatorium metal panel roof that revealed components saturated with moisture and significant deterioration (Figure 4). The original roof consisted of, from outside to inside: architectural metal panel roofing system on an oriented strand board (OSB) surface board, composite insulation, self-adhered membrane (air/vapor barrier) on

Figure 4. Deterioration of oriented strand board (OSB) at roof.

As with the deterioration of the façade, these issues were initially suspected to be in part the result of a moisture drive from the interior of the building into the exterior enclosure. However, the investigators found that the moisture in the roof was primarily a result of water leaking in from the outside. The inspection of the roof over the natatorium revealed that corrosion of the metal panels was occurring throughout the entire roof area, with the highest concentration of corrosion occurring at the area of lowest slope: flat to one-half inch slope per foot. The metal panel roofing was an architectural metal panel system, which is designed to shed water. This type of system is not watertight, and to function properly should be installed with a minimum slope of three inches per foot. The curved roof system had been installed flat at the top, allowing significant amounts of moisture from rain and snowmelt to enter into the system. The structural integrity of the roof wood decking had not yet been compromised, but was likely to be if repairs were not made.
