Durability of ETICS with Rendering in Norway—Experimental and Field Investigations

Tore Kvande ^{1,*}, Noralf Bakken ², Einar Bergheim ² and Jan Vincent Thue ¹

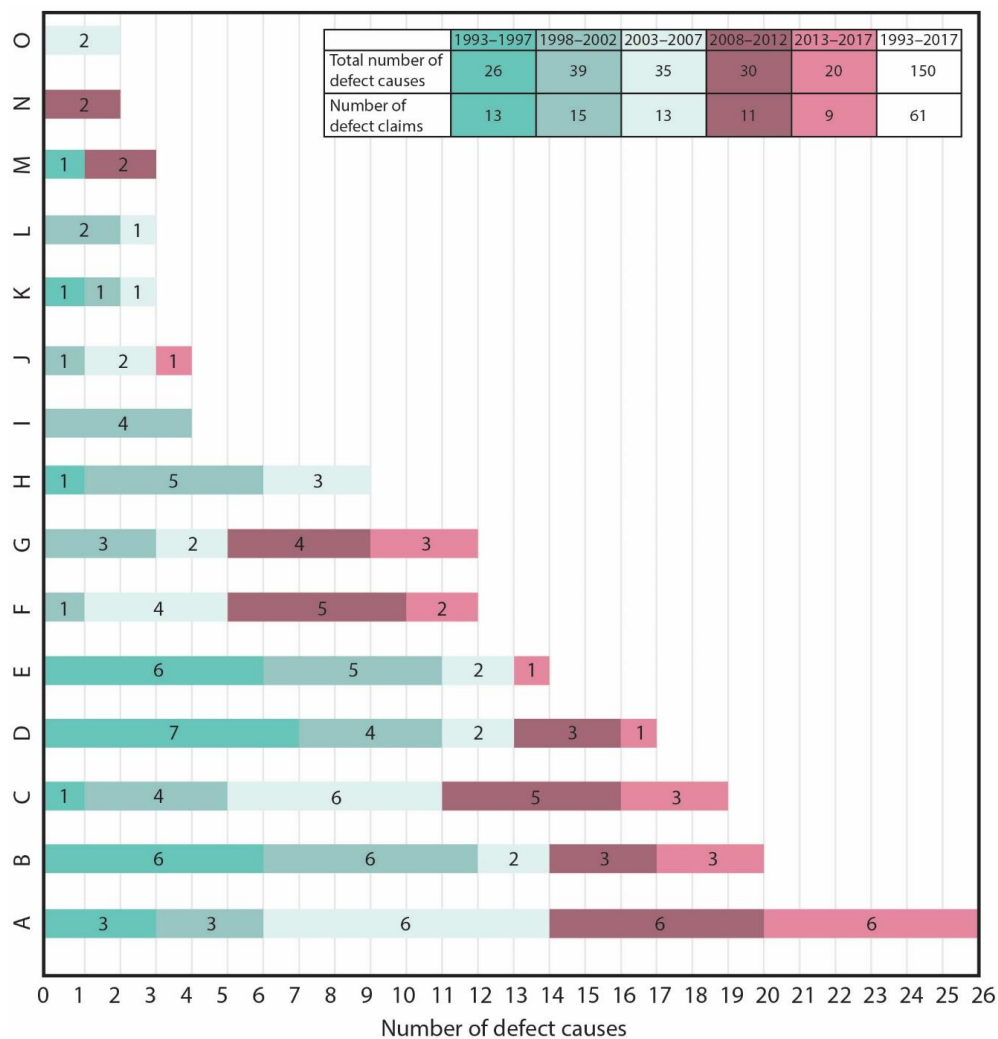
Each of the reports included in the SINTEF Building Defect Archive relates to one defect object (building). The majority of defect cases have been complex, with several causes of defect. Therefore, with regard to ETICS, 150 causes of defect were registered for all 61 defect reports (defect objects). Deficient solutions and/or poor execution were demonstrated by the fact that several conditions failed at the same time. The most prevalent causes of defect for ETICS are ranked in Figure 6. The ranking is based on the total number of defect registrations in the period 1993–2017, but the Figure also gives an indication of the trends by listing the number of defect registrations in five-year periods, e.g., 1993–1997, 1998–2002, 2003–2007, 2008–2012, and 2013–2017, respectively. The causes of defect are grouped together as they appear in the individual defect reports. A short description of the most prevalent causes of defect (A to O) is given in the following:

Figure 6. Ranking of the most frequent building-defect causes for ETICS in SINTEF Building Defect Archive (period 1993–2017). See description of defect causes A–O in the text.

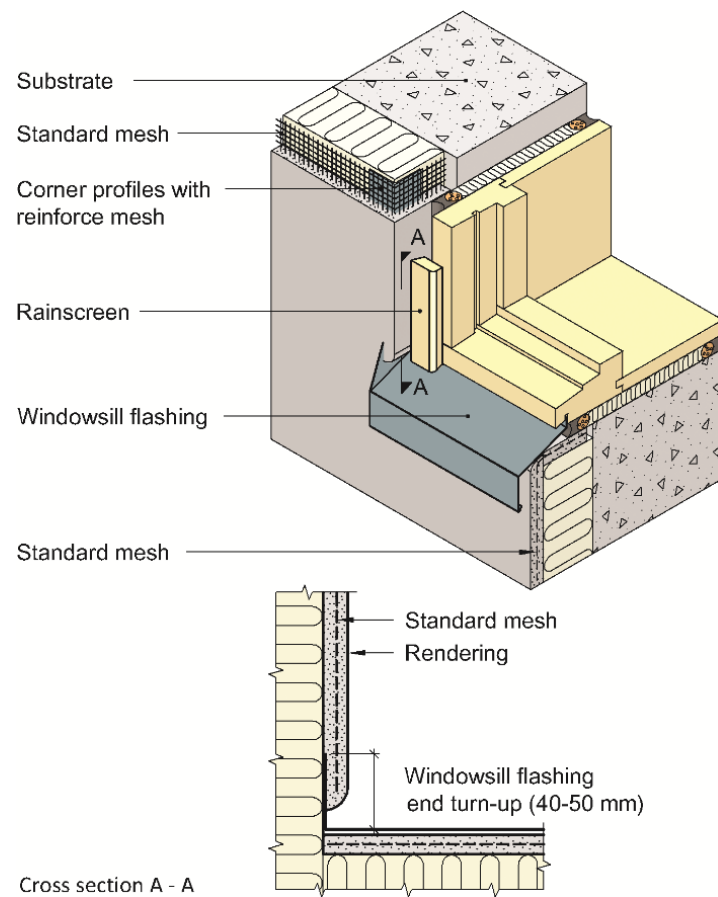
Defective forming and/or execution of cornice, horizontal, parapet, and windowsill flashings are repeated items. Similarly, deficient execution of end flaps against flashings frequently occurs. In addition, deficient roof gutters and drainpipes can impose heavy local loads. Frequently, flashings against precipitation are not adapted to the façade system but are confronted on an individual basis, as seen in the fortunate window solution in Figure 7. Selected references on the causes of defect include Lisø et al. [21].

Figure 7. Recommended installation of window in a brick or concrete wall with ETICS. The flashing variant is adapted to the render system in question and is most applicable for render mortars based on organic binding agents (plastic).

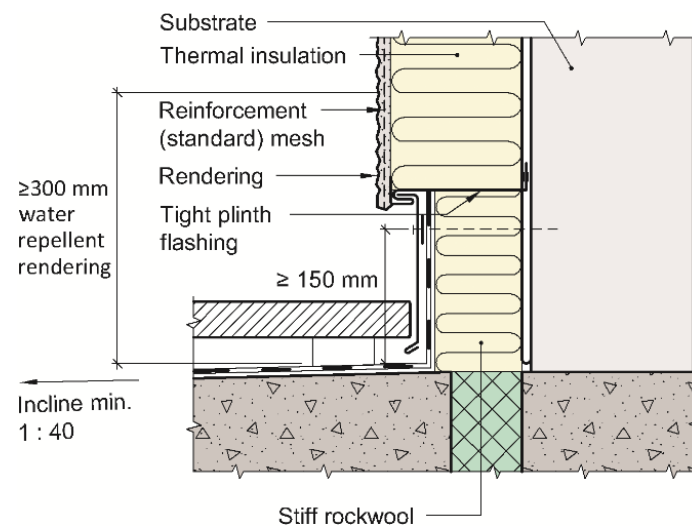
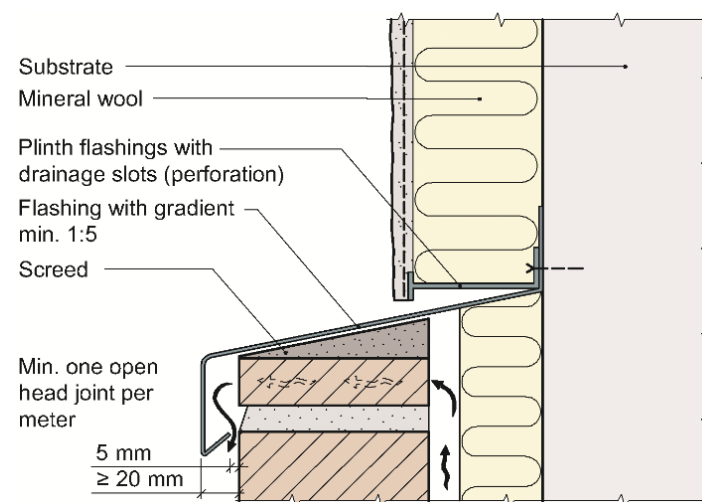
Insufficient transitions to balconies and other façade materials often lead to moisture problems in the structure. Examples of fortunate transition solutions are provided in Figures 8 and 9. Selected references on the causes of defect include Kvande et al. [28].

Figure 8. Example of a moisture-resistant wall finishing against a balcony.

Figure 9. Example of a moisture resistant transition between a façade system with ETICS and a brick veneer wall.

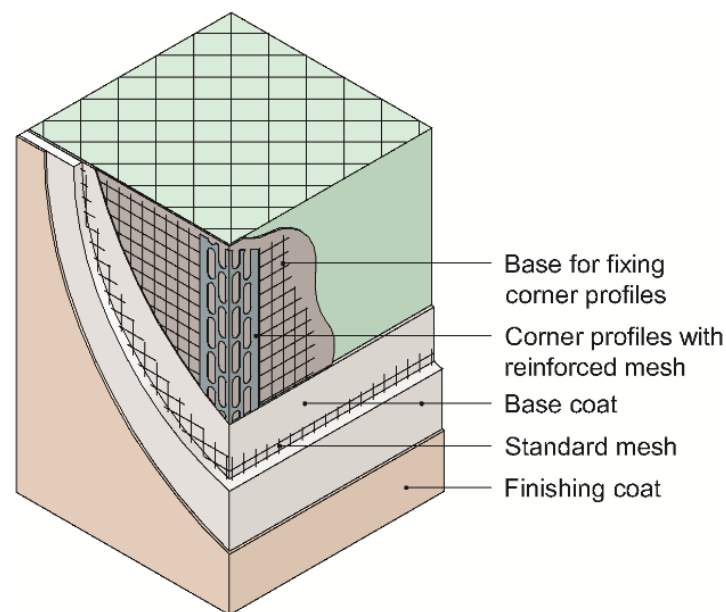
- The most vulnerable points for a façade system are the edges/corners. It is imperative to use corner profiles and plinth flashings that work well with the render and give reduced risk of cracking. Figure 10 shows an example of recommended corner reinforcement which was developed based on the laboratory testing and field experiences.

- Omission of plinth flashing always leads to severe water exposure at the edge of the render and consecutive frost damage. Similarly, unsatisfactory design of the drip edge of the plinth flashing prevents water from flowing away from the building in a proper manner.

- The transition to the plinth flashing at the base of the façade system can be challenging because the reinforcement mesh tends to be drawn too far up during erection of the mesh. The mesh ought to overlap the flashing to prevent cracking.

Figure 10. Example showing how effective corner reinforcement can be achieved.
