Pathology and Rehabilitation of Vinyl and Linoleum Floorings in Health Infrastructures: Statistical Survey

Abstract: A statistical survey on the pathology and rehabilitation of linoleum and vinyl floorings is presented. It is based on the visual inspection of 101 vinyl and linoleum floorings, in six health infrastructures in Lisbon, Portugal, which enabled the validation of the classification/nomenclature previously proposed, as well as the corresponding correlation matrices. It was also possible to identify the most common types of anomalies, their probable causes, the most adequate in situ diagnosis methods, and the most useful repair techniques. Anomalies, diagnosis methods, and repair techniques files were also validated. The obtained data enabled anomalies to be related to their causes, in situ diagnosis methods, and respective repair techniques e.g., a high number of scratches/wear were detected associated with dragging of equipment. The conclusions drawn intend to raise awareness among the industry actors and minimize the development of anomalies and their causes at the design and application stages. Furthermore, the main sensitive issues of the cladding system during its s

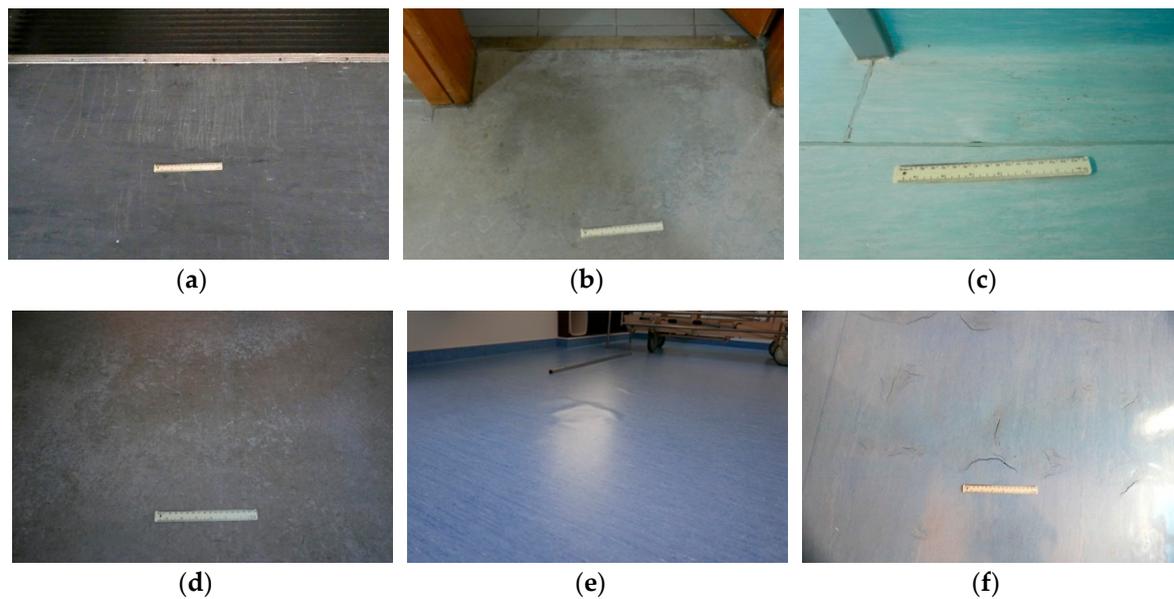
As for location of anomalies, in some situations, a specific type of anomaly is predominant. It is the case of anomaly “A-A1 scratches/wear”, which is often seen in poorly executed transition areas or at the entrance of the rooms (Figure 4a,b). It is also the case of anomaly “A-A3 brightness changes”, which often occurs immediately below the alcohol-based disinfectant dispensers (Figure 4c).

Figure 4. Anomalies: (a) A-A1 scratches; (b) A-A1 wear; (c) A-A3 brightness changes; (d) A-A3 brightness changes on a linoleum flooring due to an inadequate maintenance; (e) A-B2 peeling, requiring the use of repair technique R-B2 partial replacement; (f) A-B3 depression/settlement, requiring the use of repair technique R-B1 total replacement.

(77% and 94%), “R-A3 stripping” (19% and 53%), “R-B1 total replacement of the flooring” (19% and 24%), and “R-B2 partial replacement of the flooring” (27% and 29%, respectively). Although the inspected rooms were in health facilities, and the cleaning requirements were extremely high, the results on the replacement techniques were acceptable, since most A-A2 and A-A3 anomalies were stains, discoloration, and brightness changes with some aesthetic value, but not accumulated dirt. As for stripping (R-A3), in linoleum floorings, it was less associated with stains than with brightness changes. It was noticed that floorings were cleaned and waxed regularly, but stripping was only partial and not in the required timings, often resulting in alternated areas with different wax thicknesses, as seen in Figure 4d.

Anomaly A-B3 may occur both in small and large areas, influencing the choice of repair techniques R-B1 (36%) or R-B2 (80%). Figure 4f illustrates a corridor, where the constant passage of trolleys and a possible poor levelling layer caused depressions, which later evolved to cracks.
