Earthquake Environmental Effects and Building Properties Controlling Damage Caused by the 6 February 2023 Earthquakes in East Anatolia

Keywords: 2023 Turkey earthquakes; coseismic surface ruptures; liquefaction; landslides; damage; structural failure

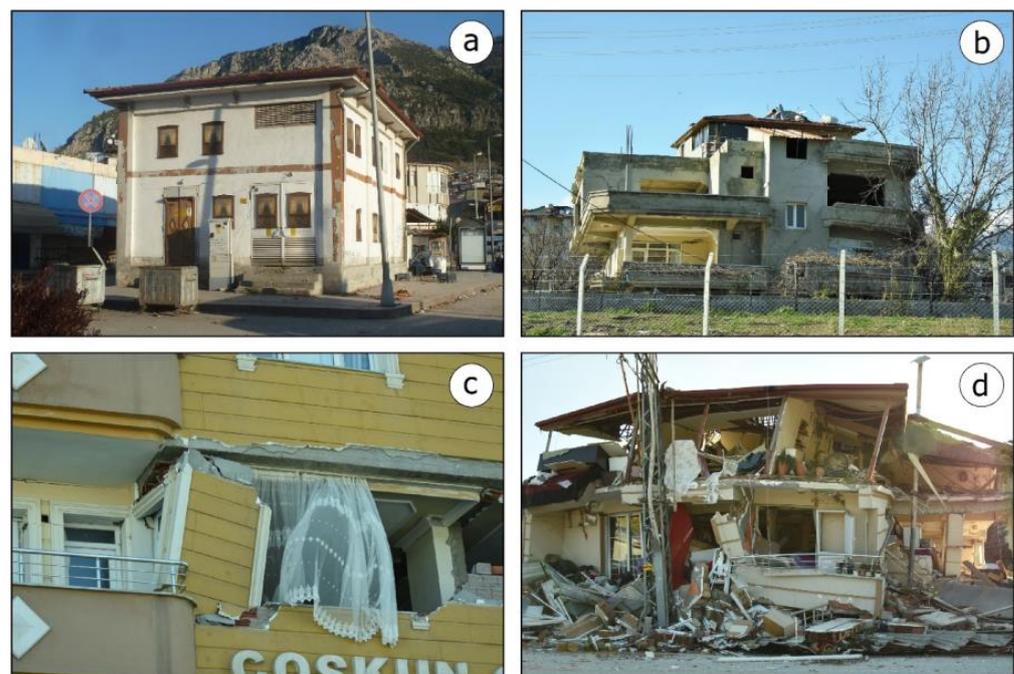
Figure 6. (a) Sparse capillary cracks on the façade. (b) Large and penetrating cracks. (c) Collapse of secondary structural elements. (d) Partial yet irreversible collapse of a house.

- Capillary and/or medium-sized cracks (damage grade 1 in EMS-98), which in most cases do not raise cause for concern (Figure 6a).
- Large-sized or even penetrating cracks (damage grades 2 and 3), which require further investigation (Figure 6b).
- Partial and/or total collapse of constructions' entire sections, which are, however, related to secondary structural elements such as cantilevers, infill walls, canopies, etc. (damage grade 4; Figure 6c).
- Damage to the structures' load-bearing system, with partial (irreversible) and/or total collapse of the structure (damage grade 5; Figure 6d).

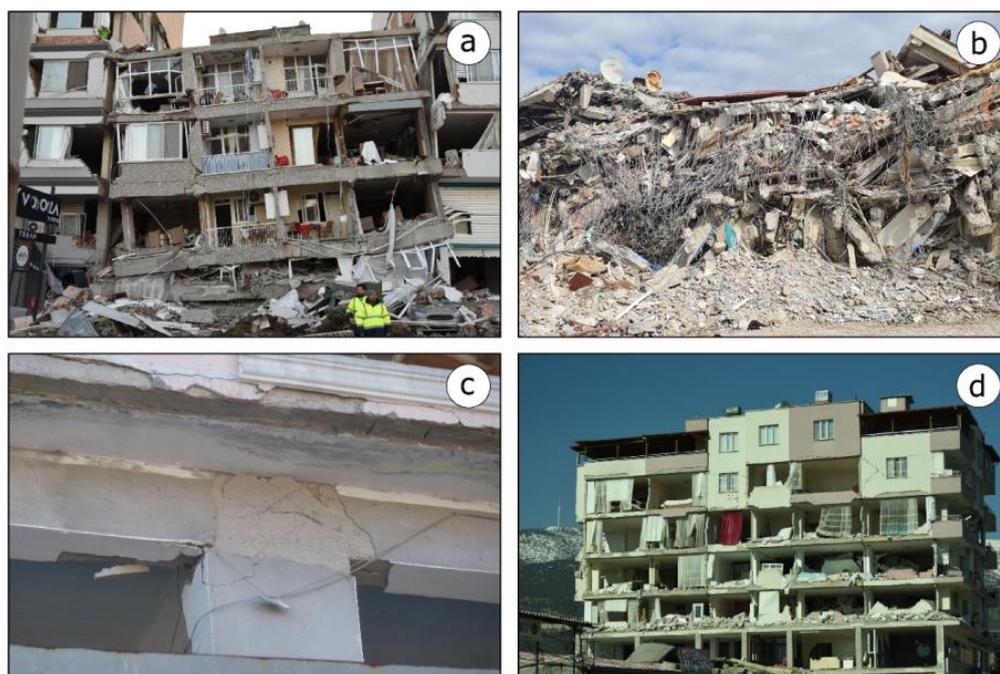
The seismic performance of single buildings in the epicentral area was in general more unfavorable compared to the cases where similar buildings were located next to each other, forming a building complex. Due to the vertical motion in the epicentral areas, these building complexes worked in favor of their structural performance, which is something that might not have been the case outside the epicentral area, where the horizontal motion prevailed. Interesting examples of these two extreme cases include the rhythmic destruction, a phenomenon detected by Carydis et al. [42,43] in the areas affected by the February-March 1981 Athens (Central Greece) earthquake sequence and the 1 October 1995 Dinar (Turkey) earthquake, and the lethal domino-type progressive collapse [44–46]. The first is observed in rows of either similar or identical buildings constructed within a small distance, on the same soil conditions and characterized with a great variation in the observed damage, from an almost intact structure up to partial or total collapse. The second effect occurs when the structural elements are loaded beyond their ultimate capacity and fail with the initial local failure spreading from element to element, eventually resulting in the collapse of either the whole structure or a disproportionately large part of it [44–46] (Figure 7a).

Figure 7. (a) Domino-type progressive collapse of an RC building in Iskenderun city (Hatay province). (b) Total collapse of an RC building in Türkoğlu town (Kahramanmaraş province). The uncovered reinforcement bars were remarkably clean, revealing the poor quality and amount of the used cement. (c) The beam or slab-column joints in an RC building in Antakya city (Hataly province) were also proved to be inadequately detailed and reinforced, resulting in structural insufficiency. (d) Parts of a structure with conversion of balconies to rooms were heavily loaded and damaged.

After observing earthquake collapse and demolition debris (sand, gravel and rebar) in several sites of the disaster field, it was apparent that smooth, practically frictionless and round riverbed material was used in the concrete mix. Furthermore, it was obvious that the concrete was of poor quality with an inadequate amount of cement, since the observed steel

reinforcement bars that had been uncovered were remarkably clean, without any cement paste detected on their surface (Figure 7b), with the same concept also being observed for the aggregates.

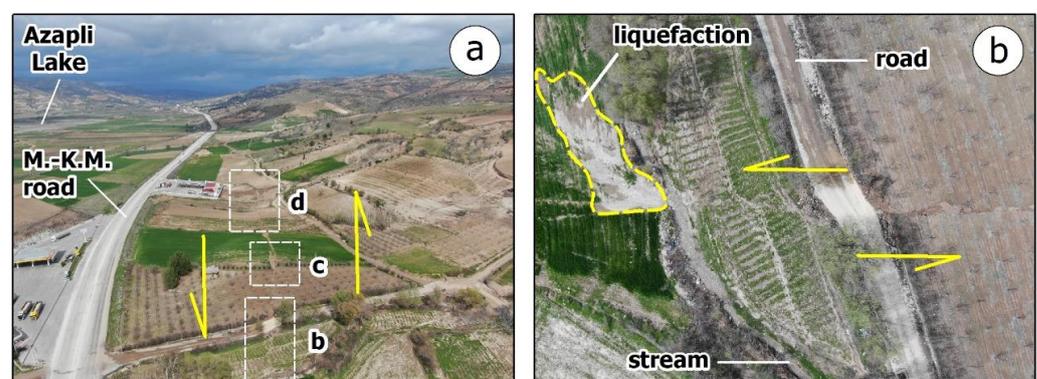
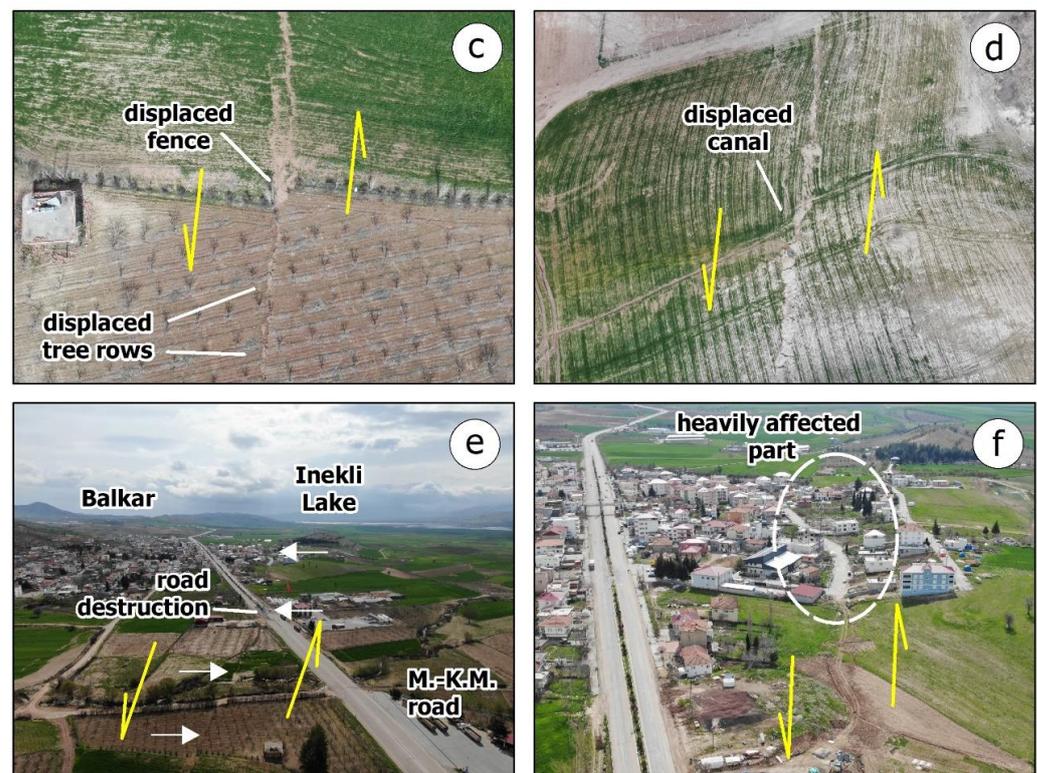
The Balkar area is the northernmost location at which we have observed coseismic surface ruptures along the main strand of the EAFZ. The NE-SW striking Pazarcik segment has been formed in this area along with a pull-apart basin, on the eastern margin of which Balkar town was founded. Within this basin, Lake Azapli is located north of Balkar. From our field survey, we detected NE-SW striking coseismic surface ruptures with a total length of 2 km. The maximum left-lateral offset observed in the area was of the order of 6 m, an offset equal to the one measured by Karabacak et al. [49]. The post-seismic surface ruptures deformed fields north of the city, causing offset of rural roads, perimeter fences, rows of olive trees and other crops (Figure 8a–d). However, their most destructive effect was observed on the main road network and the building stock of the city. The section of the Malatya–Kahramanmaraş road located north of the town was ruptured and displaced (Figure 8e), causing traffic difficulties until repair. Regarding the building stock, there was heavy structural damage to many buildings in the western part of Balkar (Figure 8f) due to the offset along the surface rupture. Almost all the buildings in the western part of the city that suffered severe structural damage, including partial collapse, were reinforced concrete buildings with infill walls.

Figure 8. (a) Drone view from S to N of the area north of Balkar, where coseismic surface ruptures were detected. The area is located in the eastern margin of a pull-apart basin, where Balkar was founded. Azapli Lake is located in the western part of the basin. The coseismic surface ruptures caused displacement of rural roads and streams (b), fences and tree rows (c) and irrigation canals (d); destruction of the Malatya–Kahramanmaraş road (M.-K.M. road) (e); and heavy building damage in the western part of Balkar including collapse (f). The yellow arrows show the left lateral strike-slip direction, while the white arrows in (e) point to the position of the surface ruptures.

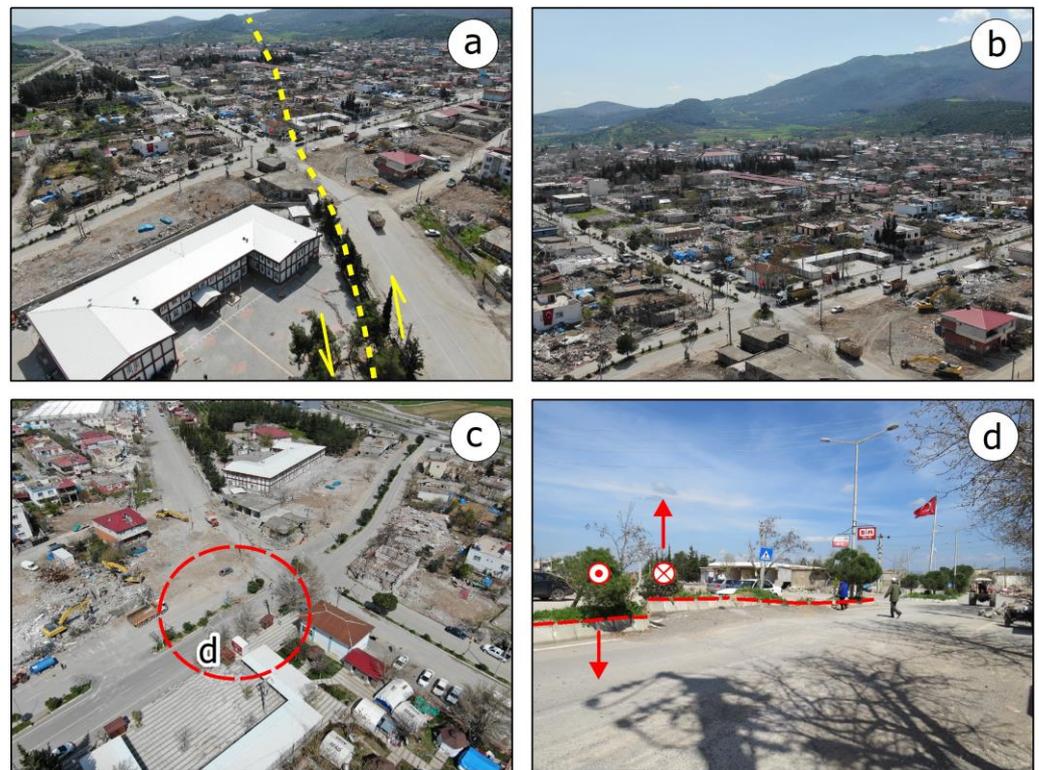
The coseismic ruptures crossed the residential area of Şekeroba town in a NE-SW direction (Figure 9a) and caused the total or partial collapse of buildings founded along or close to them (Figure 9b). Pop-up ridges were also identified along the coseismic ruptures such as the one formed at the intersection of Akcakoyunlu and Beiediye roads (Figure 9c), resulting in the destruction of the roadway (Figure 9d) and collapses of buildings constructed near this structure or along the rupture. This rupture was detected again southwest of Şekeroba towards the Yeşilyurt settlement.

Figure 9. (a) Drone view from N to S presenting the central and southern part of Sekeroba town. Coseismic surface ruptures (yellow dotted line) were observed within the residential area, resulting in many collapses (b) due to the lateral offset and the formation of associated structures. The yellow arrows in (a) show the left lateral strike-slip direction. At a crossroads of Sekeroba (c), a large bulge was detected (red frame in (c)) corresponding to the formation of a pop-up ridge (d) within the principal deformation zone. In (d), the upward arrow corresponds to uplift, and the downward arrow to subsidence. Buildings adjacent to this bulge sustained heavy to very heavy damage including partial and total collapse, while other structures including roads and adjacent pavements were heavily deformed.

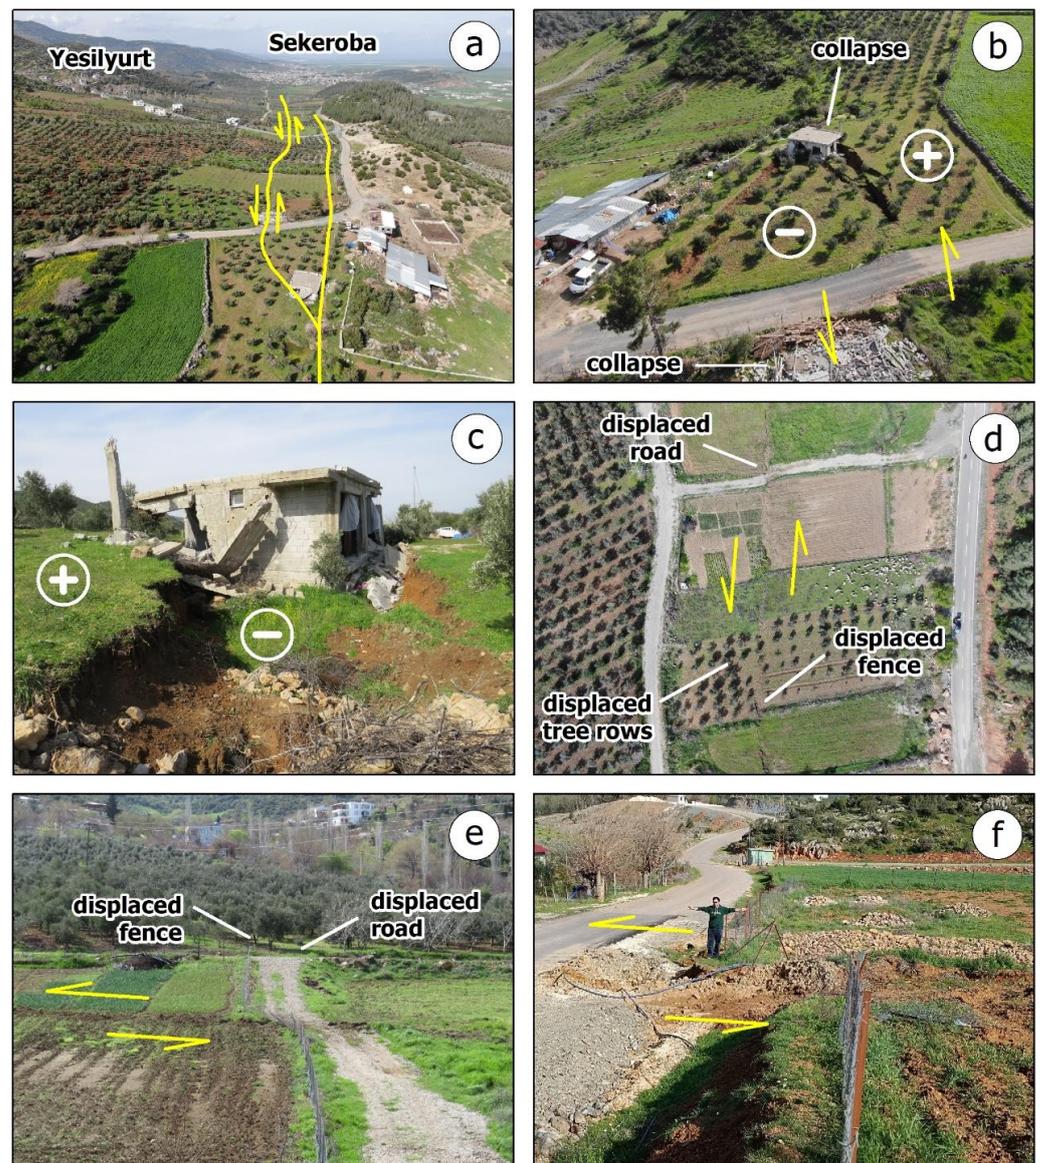
In the Yeşilyurt area, an elongated valley has been formed in a NE-SW direction within which a system of two surface ruptures was observed in parallel arrangement (Figure 9a). The westernmost was observed towards the middle of the valley while the easternmost was detected towards its eastern margin, both with an average NE-SW strike (Figure 10a). These ruptures intersect southwest of Yeşilyurt Köyü road, causing the total destruction of two RC houses that happened to be founded at the intersection point (Figure 10b,c), as well as the collapse of warehouse houses and other farm structures along or close to the ruptures.

This section of the parallel surface ruptures is approximately 2.5 km long. They have caused left-lateral offset of all surface morphological features of the area such as stream beds and other human-made features such as fences, rows of olive trees and vineyards, rural roads, etc. (Figure 10d–f). The left-lateral offset was 2.80 m based on field measurements. Along these ruptures, secondary EEEs were triggered and comprised liquefaction including ejection of liquefied material from the generated ruptures and covering of adjacent fields, as well as landslides along steep slopes that could be characterized with high susceptibility even before the occurrence of the early February 2023 earthquakes.

Figure 10. (a) Coseismic surface ruptures within an elongated valley southwest of Sekeroba. (b) Buildings along the coseismic surface ruptures suffered collapse. (c) The collapse house at the intersection point suffered not only with the left-lateral offset but also with vertical displacement along the ruptures. The left-lateral offset was clearly detected in several sites along the ruptures with impact on cultivated fields and tree rows (d), rural roads and fences (d–f). The symbol (+) corresponds to uplift, while the symbol (–) corresponds to subsidence. The yellow arrows show the left lateral strike-slip direction.

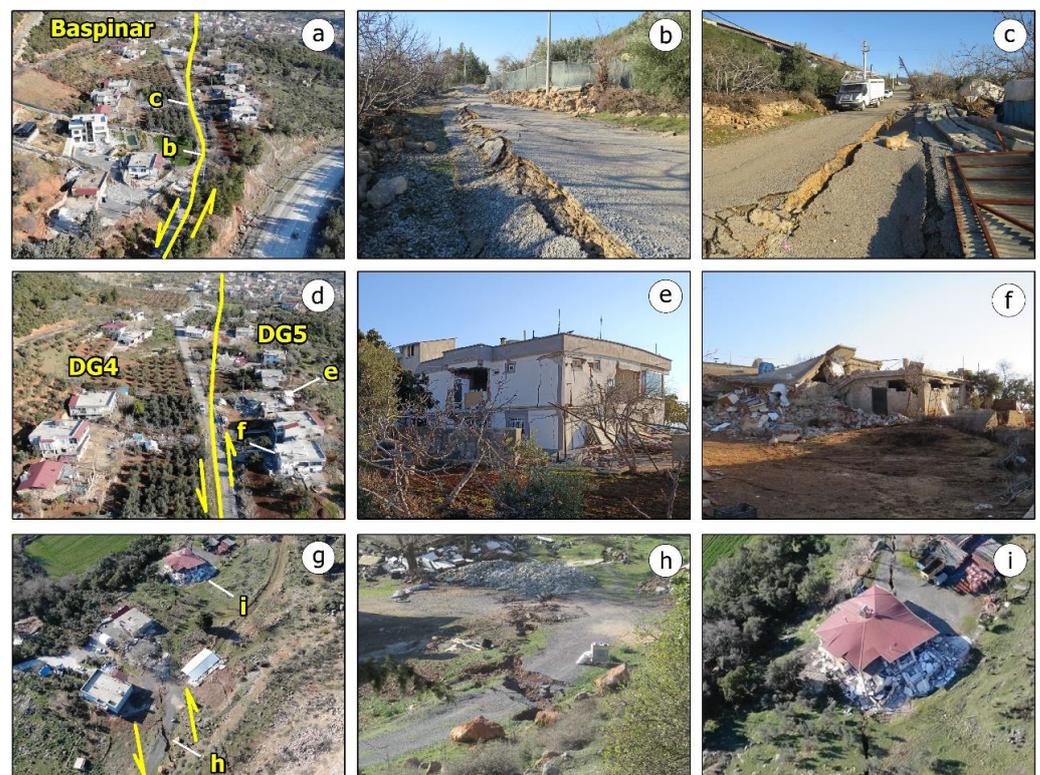
In the Başpınar area (Figure 11), ground deformation and offset ranging from 2.0 to 3.2 m along the observed coseismic surface ruptures (Figure 11a–c) resulted in heavy and very heavy structural damage to buildings (Figure 11d–f). Those houses that were founded either a few or tens of meters from the rupture suffered structural damage that was milder than the previous ones and did not collapse (Figure 11g–i). The observed left-lateral offset resulted also in cracking and destruction of road sections, displacement of perimeter walls of houses and field fences as well as deformation of fields. At other sites located along or close to the coseismic ruptures, rockfalls and slides occurred along slopes, which were either already highly susceptible to a landslide triggering even before the generated earthquakes or were mobilized due to the deformation observed along the rupture.

Figure 11. (a–c) Views of the coseismic surface ruptures (yellow lines) in Başpınar area located at the western suburbs of Nurdağı. (d–f) RC buildings with infill walls founded close to the surface ruptures sustained damage grade 4 (DG4) and 5 (DG5) in terms of the EMS-98, respectively. RC buildings located along the ruptures totally collapsed (g–i). The yellow arrows show the left lateral strike-slip direction.

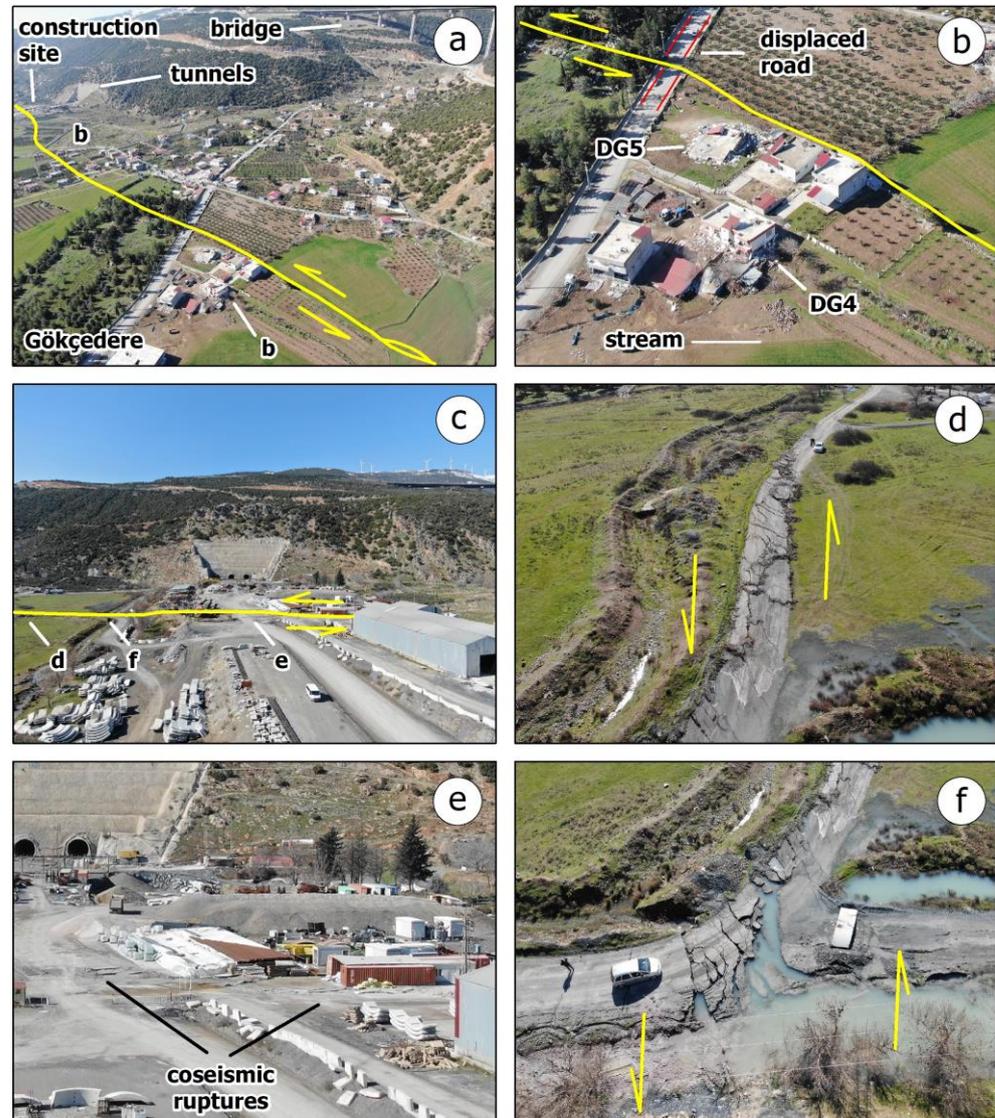
In Gökçedere settlement, the NE-SW striking coseismic surface ruptures caused ground deformation and offset affecting all elements of the natural and built environment comprising fields, streams, buildings and roads (Figure 12a). Several buildings suffered damage of grade 4 and 5 in terms of the EMS-98 scale corresponding to heavy and very heavy structural damage, respectively (Figure 12b). Urban streets and dirt roads were displaced (Figure 12b). At various sites along the fault lines, structures typical for strike-slip faults were identified. Such a structure was revealed with a bulge on the road immediately south of a road construction site located north of the settlement of Gökçedere (Figure 12c). This bulge corresponds to a pop-up ridge that deformed the road leading to the slopes of a construction site (Figure 12d), resulting in traffic interruption until damage restoration. No collapse was recorded at the construction site as the ruptures were observed under container-type warehouses with road construction material and equipment

(Figure 12e). The only issue created was disturbed stacks of construction material. No failures were reported in the adjacent tunnels [50]. Secondary EEEs were observed at the same site, such as liquefaction along the stream banks arranged parallel to the construction site and subsequent inundation of an adjacent field (Figure 12f).

Figure 12. (a) Coseismic surface ruptures (yellow lines) in the area of Gökçedere settlement. The ruptures caused ground deformation resulting in (b) partial or total collapse of buildings (DG4: damage grade 4, DG5: damage grade 5 based on EMS-98) and offset of urban streets in the area. The yellow arrows show the left lateral strike-slip direction. (c) The ruptures crossed a road construction site. (d) A road leading to the site suffered bulge and cracking attributed to a pop-up ridge. (e) No damage was observed to structures and warehouses of the road construction site as well as to the adjacent tunnels. (f) Liquefaction was also triggered close to the coseismic ruptures.

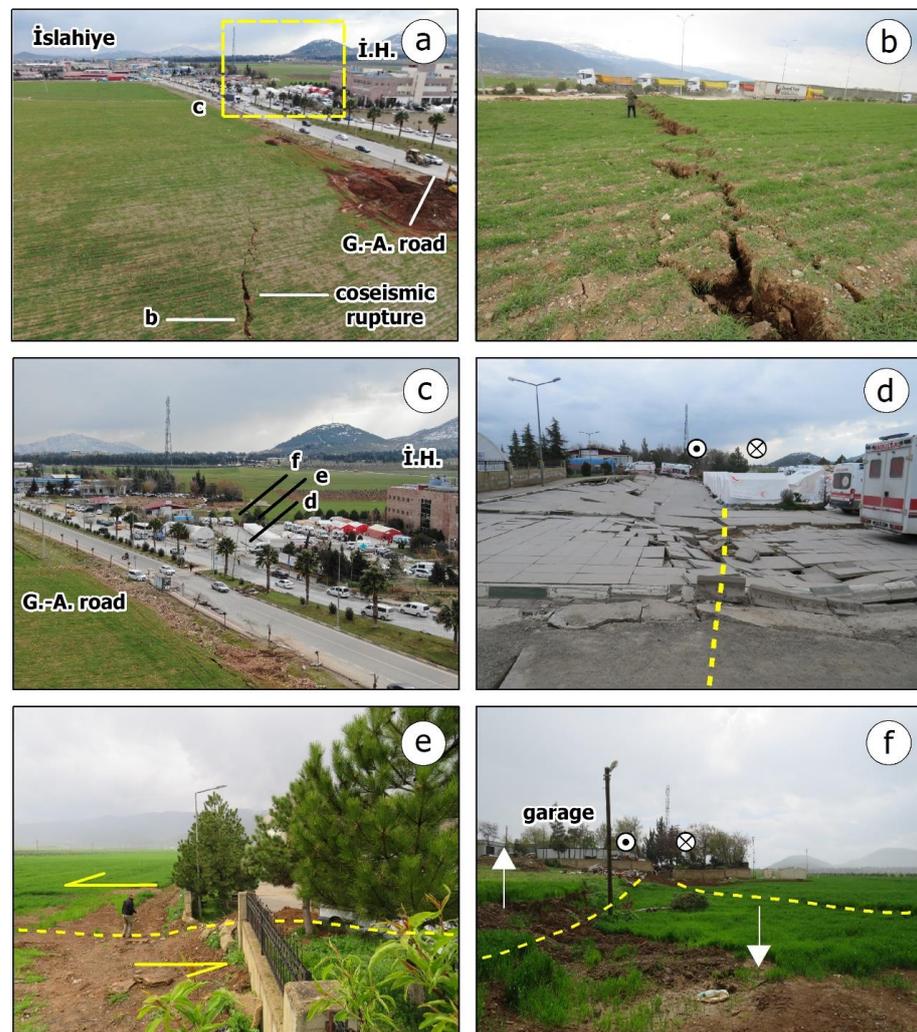
In the İslahiye area, we identified the southward continuation of the coseismic surface ruptures that occurred in Nurdağı area. This NNE-SNW striking occurrence is 6 km long. Its northern N-S striking part develops within agricultural land. It extends from the area east of Türkbahçe, at a distance of 1 km east of the settlement, to the İslahiye hospital area in the south (Figure 13a–c). The primary effect in this section has deformed fields, ruptured parts of the road network north and east of the hospital, destroyed the hospital's ambulance parking yard (Figure 13d) and displaced the hospital's perimeter wall to the

south of the health facilities (Figure 13e), as well as the perimeter wall of a neighboring workshop. Based on the field observations, the left-lateral offset was 1.90 m.

Figure 13. (a,b) Coseismic surface ruptures in İslahiye hospital (İ.H.) area located at the northern end of İslahiye town. They affected fields and caused damage to part of the Gaziantep–Antakya (G.-A.) road. (c) The hospital located at a small distance west of the observed ruptures remained unaffected and operational during the aftershock period. (d) The surface ruptures (yellow dotted lines) have also affected the ambulance parking yard at the hospital entrance and (e) displaced the concrete perimeter wall south of the hospital. (f) A small-scale pull-apart basin was observed just outside the southern perimeter wall of the hospital. The upward white arrow corresponds to uplift, and the downward white arrow to subsidence. The yellow arrows show the left lateral strike-slip direction.

A subsided part corresponding to a small-scale pull-apart basin within the main deformation zone has been formed between the perimeter wall of the hospital and the adjacent workshop to the south (Figure 13f). Further south, this rupture has NNE-SW strike, and ruptures rural land without affecting structures passing west of İslahiye town and the Değirmencik settlement located south of the town. The only infrastructure that was found to be affected by the offset are parts of the road network in the area, and more specifically the Gaziantep–Antakya main road (G.-A. road in Figure 13a), which was displaced and cracked, resulting in destruction of the road surface without traffic disruption.

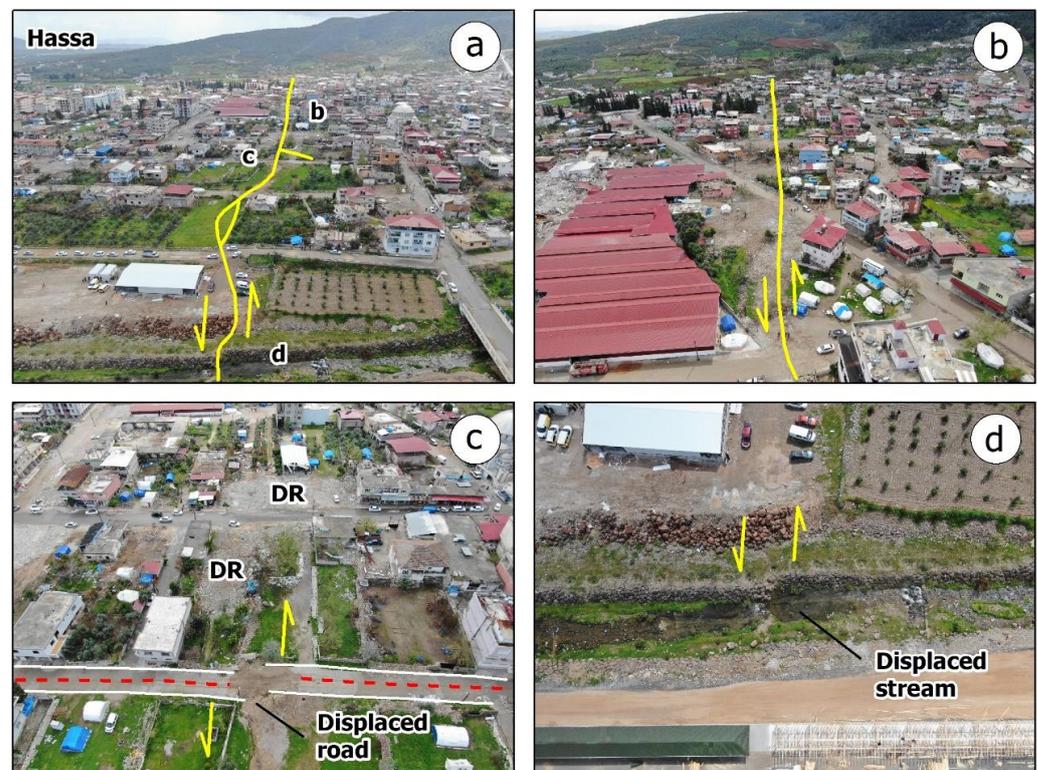
Another typical case of impact from surface ruptures formed within a residential area is the damage observed within Hassa town located in the southern part of the earthquake-affected area. This rupture was detected in the western part of the city (Figure 14a). It has a NNE-SSW strike and is about 850 m long. Houses founded on the rupture were completely destroyed with most of them suffering total collapse (Figure 14b,c). Sections of the city's road network with which the rupture intersected were cracked with traffic being temporarily disrupted. Perimeter walls of houses and fences were also destroyed by the offset. The rupture displaced a stream bed crossing Hassa town in an E-W direction (Figure 14d). Based on field observations and UAS imagery, the left-lateral offset was of the order of 3 m.

Figure 14. (a) Drone view of the southwestern part of Hassa town presenting the coseismic surface ruptures (yellow lines) formed within the built-up area. Several empty spaces along the rupture (b) correspond either to collapse due to the earthquake or to subsequent demolition and debris removal (DR in (c)), revealing heavy and very heavy building damage along and close to the ruptures. They also caused displacement of a road (c) white lines correspond to the road edges and the red line corresponds to a red brick line in the middle of the road). The coseismic surface ruptures caused the displacement of the main E-W trending stream (d) that divides the town in two. The yellow arrows show the left lateral strike-slip direction.

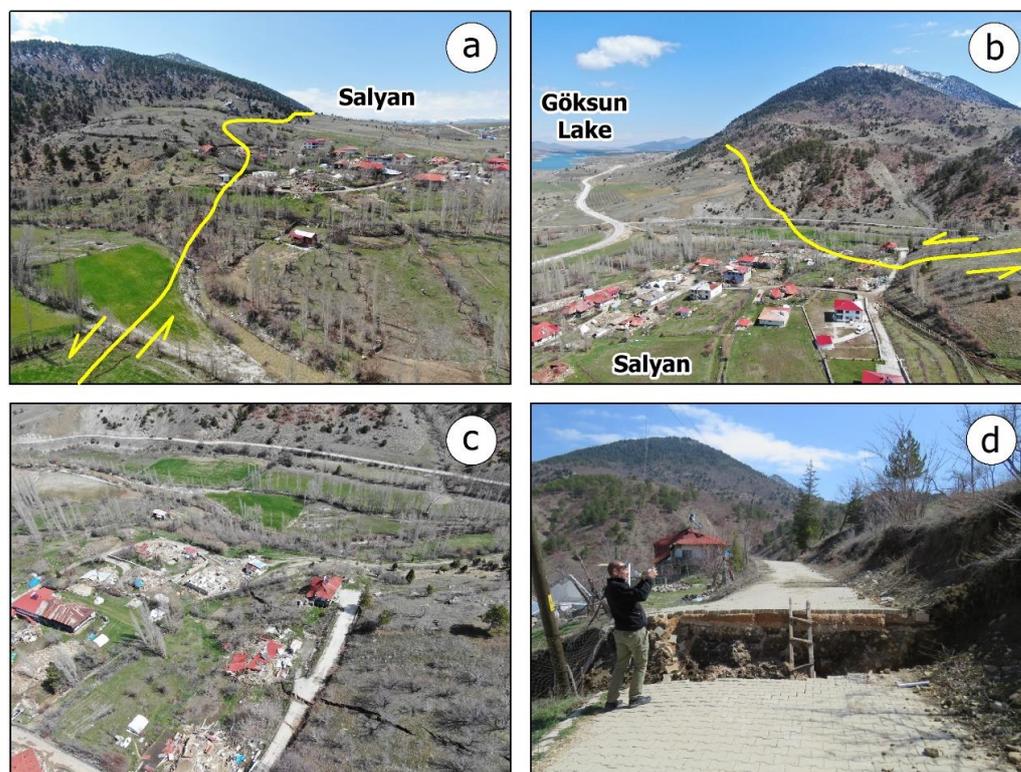
developed along the Çardak segment were initially detected in Saylan village (Figure 15a,b) between Kaleköy village and Gücüksu town. This rupture had a NE-SW strike, a length of 12 km and presented a left-lateral offset of about 2 m. The deformation and the offset in this part of the Çardak segment caused severe structural damage at its intersection with buildings, which razed to the ground (Figure 15c). The left-lateral offset in the built-up area of the village was accompanied with a vertical offset of about 1 m (Figure 15d).

Figure 15. (a–d) Views of the coseismic surface ruptures (yellow lines) in the Saylan area located along the Çardak segment of the northern strand of the EAFZ. (a) View of the coseismic surface ruptures from NW to SE and (b) from SE to NW. (c) Buildings founded along the ruptures suffered total collapse due to the left-lateral offset accompanied with a vertical offset (d). The yellow arrows show the left lateral strike-slip direction.

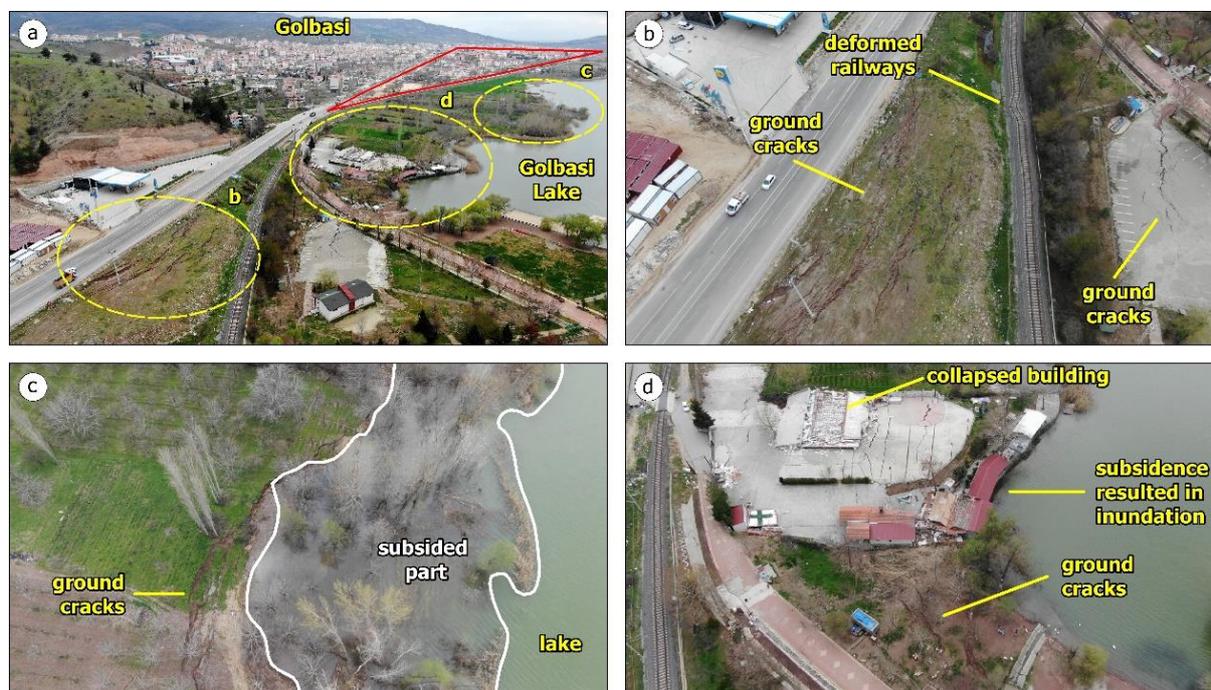
subsidence, while others were totally collapsed (Figure 16d). Entertainment facilities such as a playground constructed near the lakefront were also destroyed by ground cracks attributed to lateral spreading.

Figure 16. (a) Drone view of the eastern part of the Gölbaşı Lake from NE to SW presenting areas affected by lateral spreading along the lakeshore. The red frame includes the part of the city that sustained damage due to the lateral spreading in this lakeside environment. (b) Ground cracks resulted in deformation of fields and railways passing through the area. (c) A part of the lakeshore suffered subsidence and the subsequent inundation resulted also in impact on vegetation. (d) Ground cracks triggered by lateral spreading and subsidence along the lakeshore resulted in heavy damage to buildings and facilities and subsequent inundation.

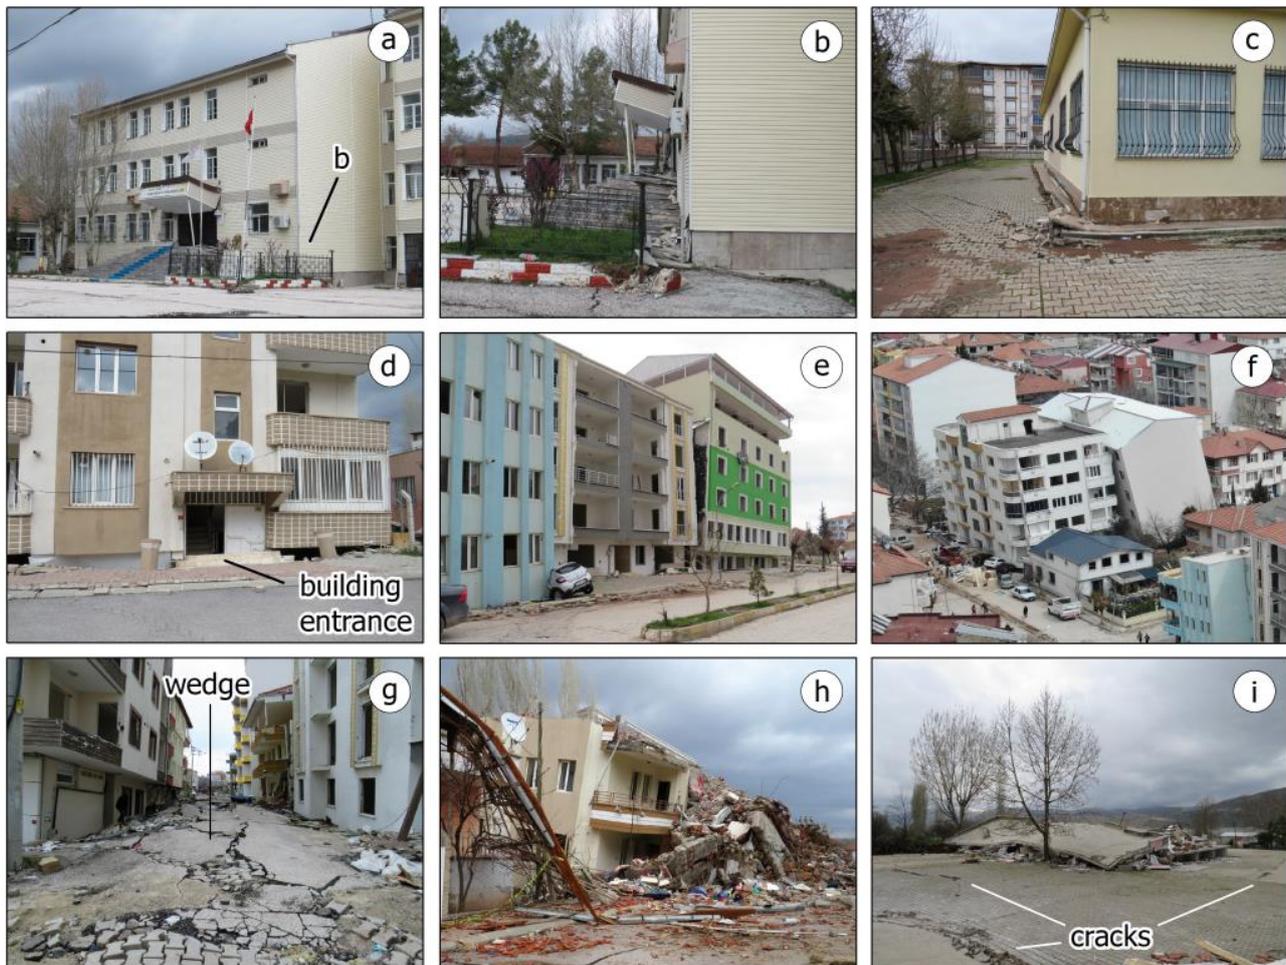
- Uniform vertical displacement with many buildings suffering sinking without noticeable tilt of the structure and no damage to its upper part (Figure 17a–d);
- Non-uniform vertical displacement comprising tilting without suffering any other structural or non-structural damage to the upper part of the structure (Figure 17e);
- Tilting of buildings and damage attributed to pounding of adjacent structures (Figure 17f);
- Lateral displacement of buildings over liquefied soil directly beneath its foundation accompanied with the formation of a passive resistance wedge in the surrounding soil (Figure 17g);
- Outspread multi-layer collapse (Figure 17h);
- Pancake-type collapse (Figure 17i).

Figure 17. Views of damage to RC buildings attributed to liquefaction and lateral spreading within the residential area of Gölbaşı town. (a–d) Buildings suffering sinking without tilting. (e) Tilting of buildings without damage to the upper part of the structure. (f) Tilting of buildings and damage attributed to pounding of adjacent structures. (g) Lateral displacement of buildings on either side of the road accompanied with formation of a passive resistance wedge in the surrounding soil. (h) Outspread multi-layer collapse and (i) pancake-type collapse.

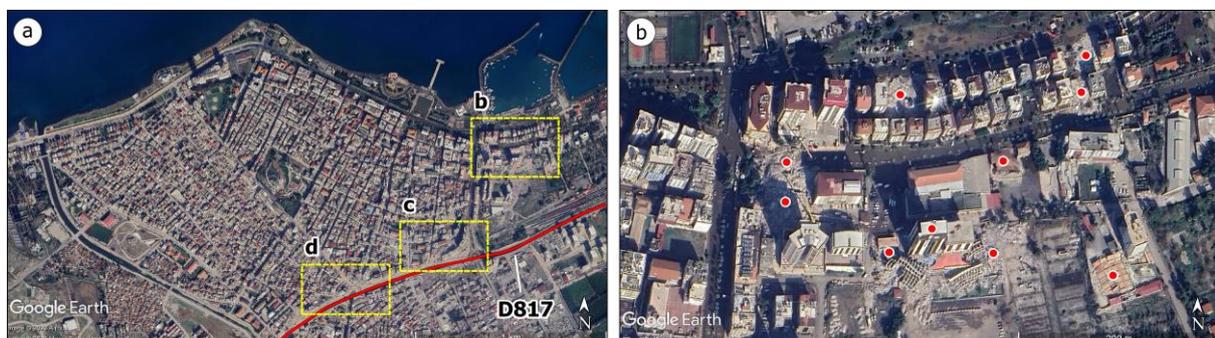
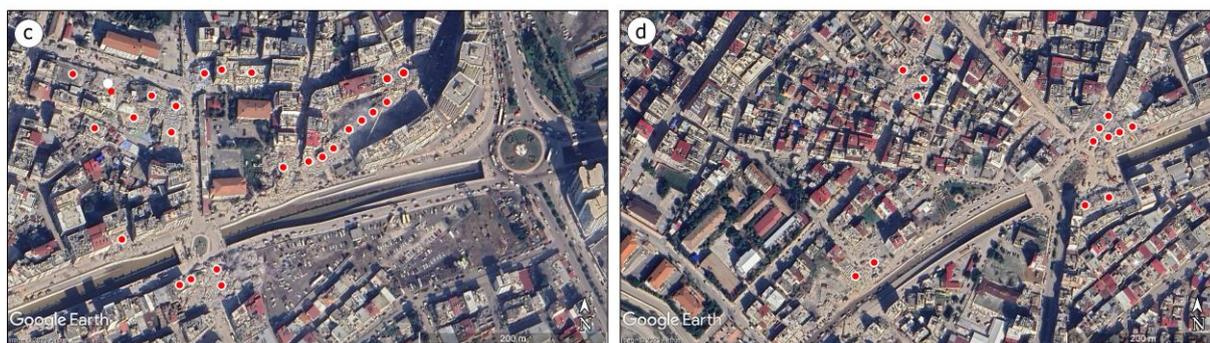
The structures founded in the coastal zone proved to be particularly vulnerable to strong ground motion and the surface deformation related to liquefaction phenomena. In particular, they were affected by liquefaction-related settlement due to loss of the foundation bearing capacity without suffering other structural damage. As for the buildings most affected by the earthquake and that sustained very heavy structural damage including collapse, the majority is located in the Çay district, in particular, in the first row of buildings south of Ataturk Avenue and in the rows of buildings immediately north of state road D817 and the city railway line (Figure 18a). This zone comprises the old city beach and many areas of artificial deposits created for the purpose of constructing new buildings on the new created land. It is significant to note that the area is referred to by many locals as a swamp. The type of collapses observed mostly in this zone are pancake-type and outspread multi-layer collapse (Figure 18b–d), typical of liquefaction-induced building damage.

Figure 18. The most affected area of Iskenderun city is the Çay district (a) extending from the coastline to the D817 state road. Heavy and very heavy damage corresponding to partial and total collapses (red dots) of RC buildings, respectively, was detected within three segments of this district (yellow dotted boxes in b–d).

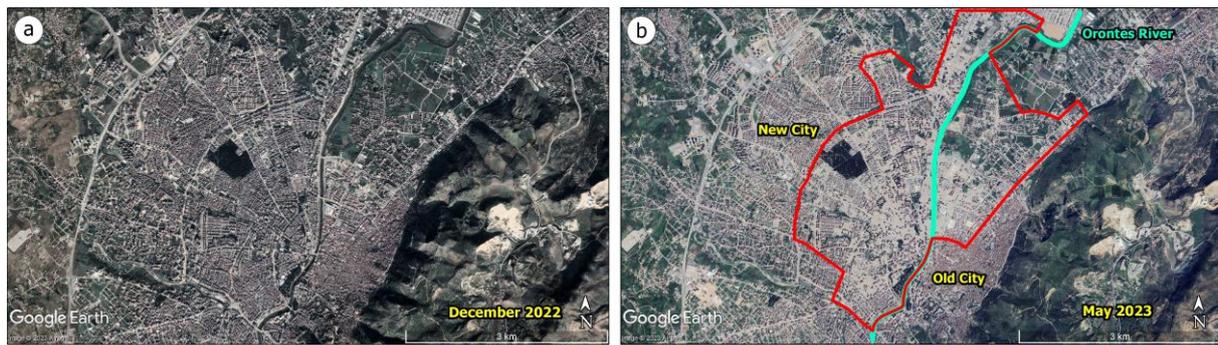
As mentioned above, this area heavily affected by the early February 2023 earthquakes is built up by Holocene alluvial deposits [56]. Based on previous research and reports dealing with the seismic hazard and site effect in Antakya city, it is concluded that the Quaternary units in Antakya can cause variation at the ground motion amplification [59]. Despite the fact that liquefaction in this area has not been presented in the research of Taftoglou et al. [32], the arrangement of collapses along the western bank of the Orontes River and the distribution of liquefaction phenomena in an area close to the city with similar geological and geomorphological conditions (near the meanders of the Orontes River at the southern boundary of the old Amik Lake) makes the occurrence of liquefaction phenomena under the most affected part of Antakya city a certainty.

Figure 19. Antakya city (a) before (December 2022) and (b) after (May 2023) the early February 2023 earthquakes. The empty spaces in the built-up area of Antakya were created after the removal of collapse and demolition debris. They reveal that the most affected area of Antakya city with very heavy structural damage in buildings (red polygon) comprises a part of the new city west of the Orontes River with maximum width of about 2 km and a part of the old city east of the river with maximum width of about 1.5 km.

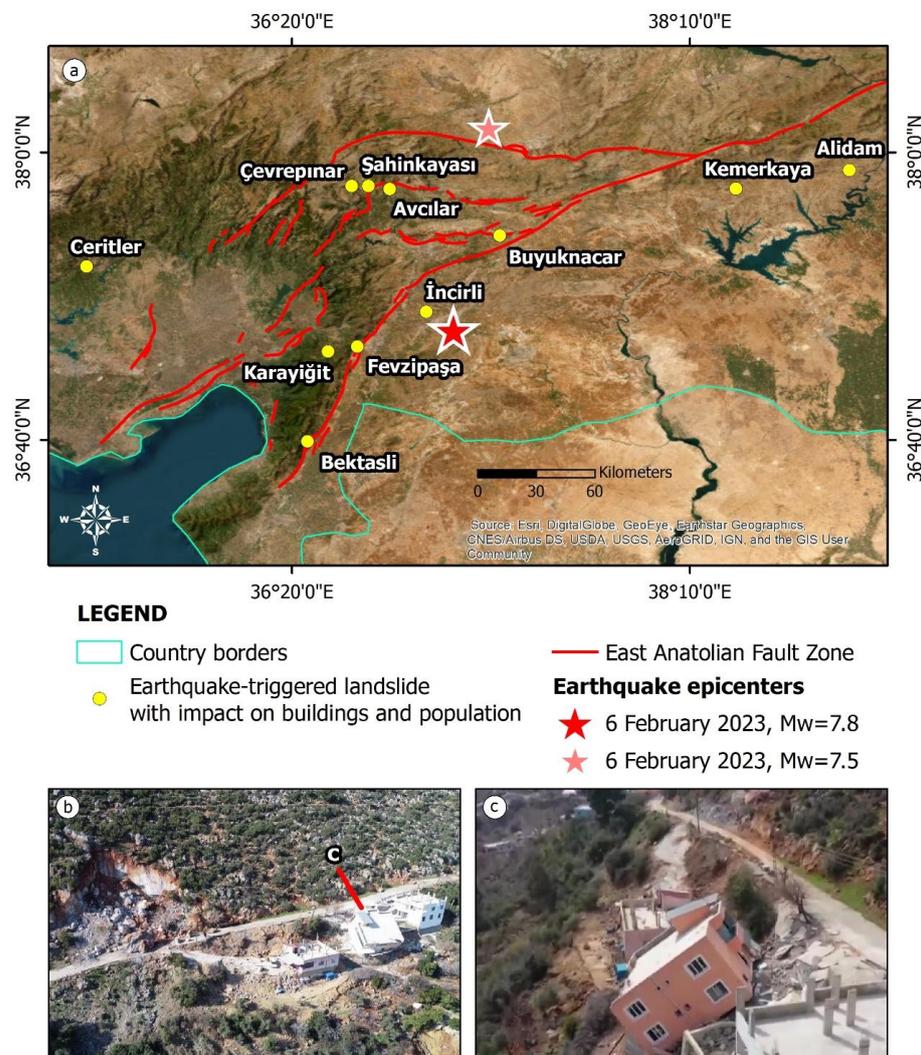
Cases of settlements that suffered landslide impact on their built environment and residents were recorded in the majority of the 11 provinces of southeastern Turkey. Typical examples were detected in provinces presented in Figure 22.

Figure 22. (a) Location map of landslides with impact on buildings and population (fatalities and injuries). (b,c) Characteristic view of landslide impact on residential buildings in Bektasli village (Kirikhan district, Hatay province).
