# Insights into the Oroville Dam 2017 Spillway Incident

**Abstract:** In February 2017, a failure occurring in Oroville Dam’s main spillway risked causing severe damages downstream. A unique aspect of this incident was the fact that it happened during a flood scenario well within its design and operational procedures, prompting research into its causes and determining methods to prevent similar events from reoccurring. In this study, a hydroclimatic analysis of Oroville Dam’s catchment is conducted, along with a review of related design and operational manuals. The data available allows for the comparison of older flood-frequency analyses to new alternative methods proposed in this paper and relevant literature. Based on summary characteristics of the 2017 floods, possible causes of the incident are outlined, in order to understand which factors contributed more significantly. It turns out that the event was most likely the result of a structural problem in the dam’s main spillway and detrimental geological conditions, but analysis of surface level data also reveals operational issues that were not present during previous larger floods, promoting a discussion about flood control d

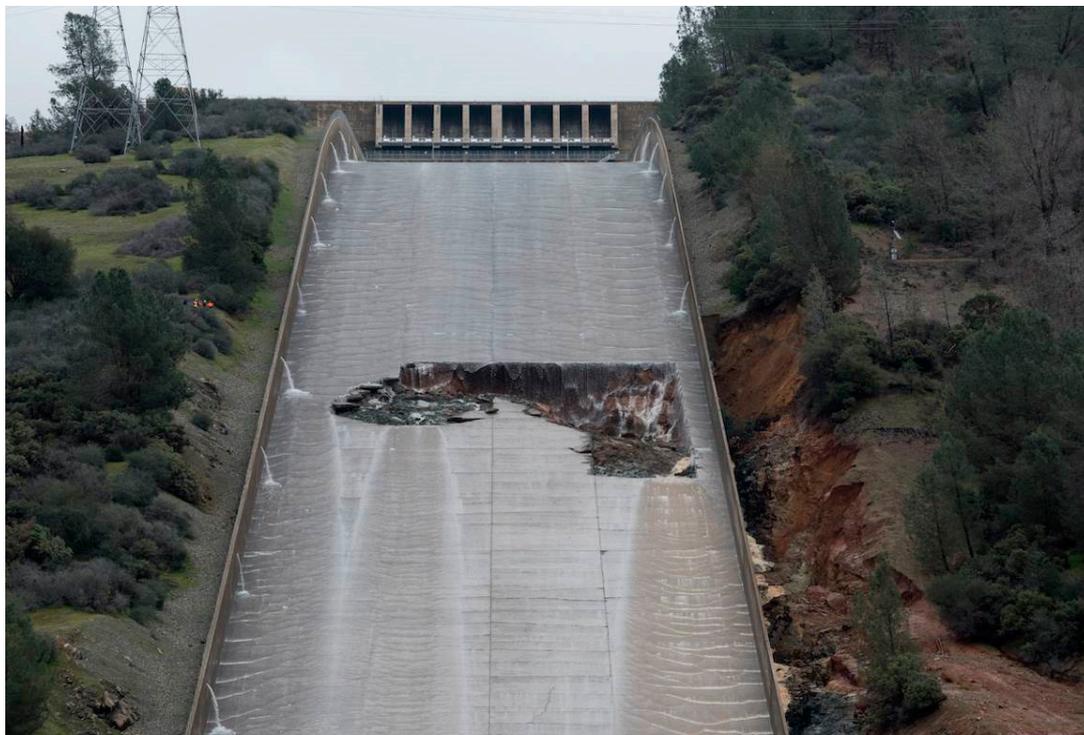
**Figure 2.** 7 February 2017. Front view of the initial main spillway chute damage [38].

At this point, the main spillway is already severely damaged, and any discharges at that point would rapidly amplify this erosion and move entire parts of the concrete chute and walls downstream. However, Lake Oroville's surface elevation is already past the flood control minimum, and inflows from the February rain storm are imminent. After brief consultation with various dam safety agencies, the operators decided to release test flows into the main spillway and monitor the damage. These small flows ranged hourly from around 300 m<sup>3</sup>/s to 900 m<sup>3</sup>/s over the course of February 8. On the very next day, February 9, the hole in the main spillway had increased in size.

A worrying aspect of the spillway damage is that it was moving uphill. This is a typical sign of a failure known as headcutting (or undercutting), which is what happens when water flowing across a hard surface falls onto a softer surface below.

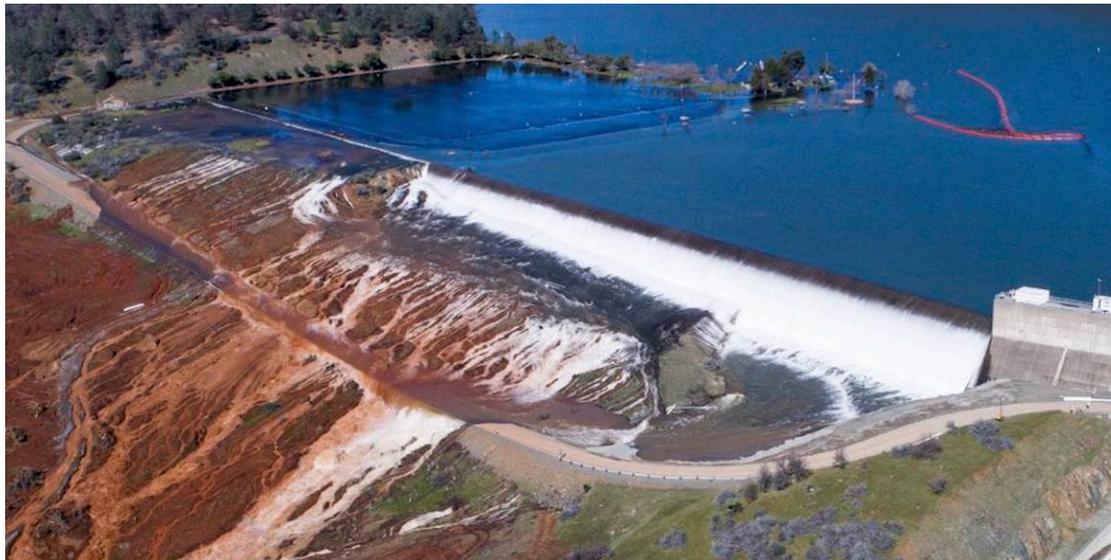
A noticeable fact is that there is a parking lot just next to the emergency spillway, which is at a lower elevation, and thus is flooded by design whenever water pours over the weir. Furthermore, an access road located just below the structure was also subsequently flooded and quickly destroyed, as seen in Figure 3.

**Figure 3.** 11 February 2017. Image of the flooded parking lot and access road located next to the emergency spillway [39].

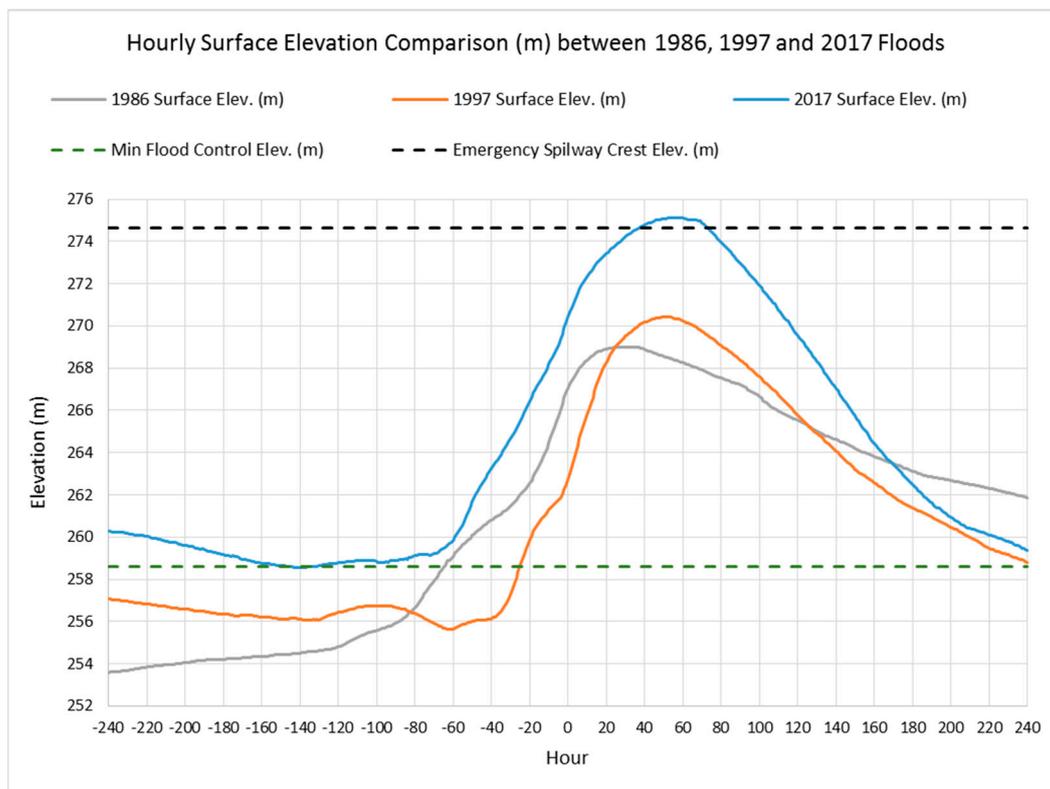
Naturally, no two flood events are the same and they all impact Oroville Dam in subtly different ways, but this comparison contains clues on what went wrong during the 2017 spillway incident. Notably, while the 2017 peak inflow is the lowest of the three major flood events, its surface elevations are the highest. This is due to two factors. First, as is clear from the graph, shortly prior to peak inflow, the surface elevation during the 2017 event was higher than in previous floods. Already, this has a negative impact on flood management. While this elevation is below the minimum limit specified by the flood control manual [22], the 2017 flood is actually harder to manage than previous events. This is partly why, despite not being a record flood, this event came close to causing severe damages to Oroville Dam's key structures once the main spillway failed.

**Figure 4.** Comparison of Oroville reservoir hourly surface elevations 10 days before and after the peak inflow of the 1986, 1997 and 2017 flood events.

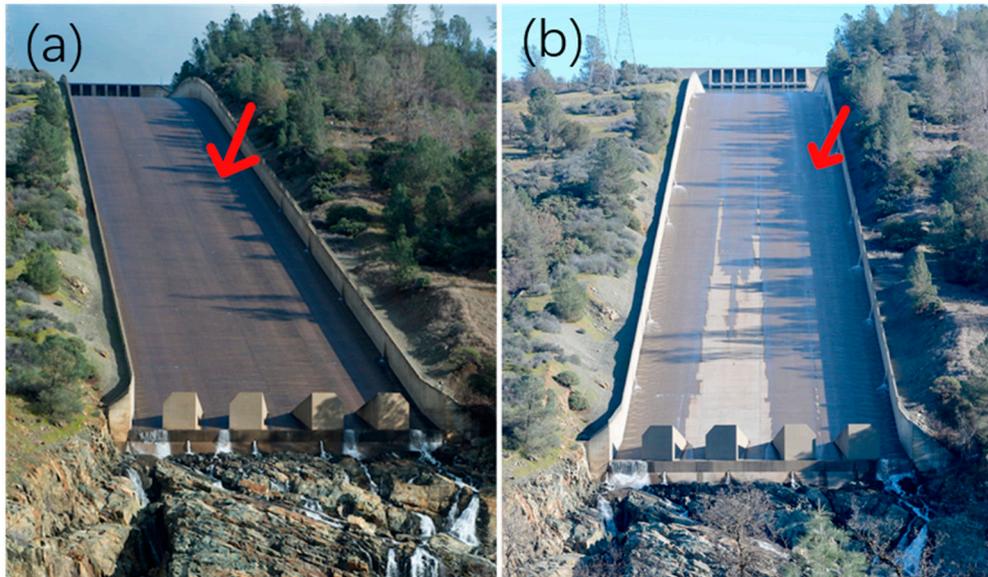
**Figure 5.** Views of the Oroville Dam main spillway chute. (a) taken on 11 January 2017, and (b) taken on 27 January 2017. A red arrow points to the location of the initial chute failure [38,51].

While these pictures were only taken within 16 days of each other, there are significant differences in the spillway chute. A center section of the chute's concrete floor appears dry on the right-hand picture, despite flows passing over the rest of the structure. This indicates possible irregularities among the floor slabs. Furthermore, the fact that this dry patch is not visible in the photo taken earlier, could possibly mean that a possible slab uplift occurred near the red arrow's location, diverting small water flows around it instead of over it.

Furthermore, by looking at the drain system more closely, two clues are revealed: First, water is coming out of the drains under pressure, which is not according to design specifications, and secondly, discharge from these drains significantly increased in a short time, once flows from the January flood filled up the Oroville Dam reservoir. This is a telltale sign of a buildup of excess water occurring beneath the spillway, which could apply significant forces to the concrete slabs from below and cause them to uplift [40]. Additionally, the January 27 photograph shows the drains on the opposite wall operating under pressure as well.

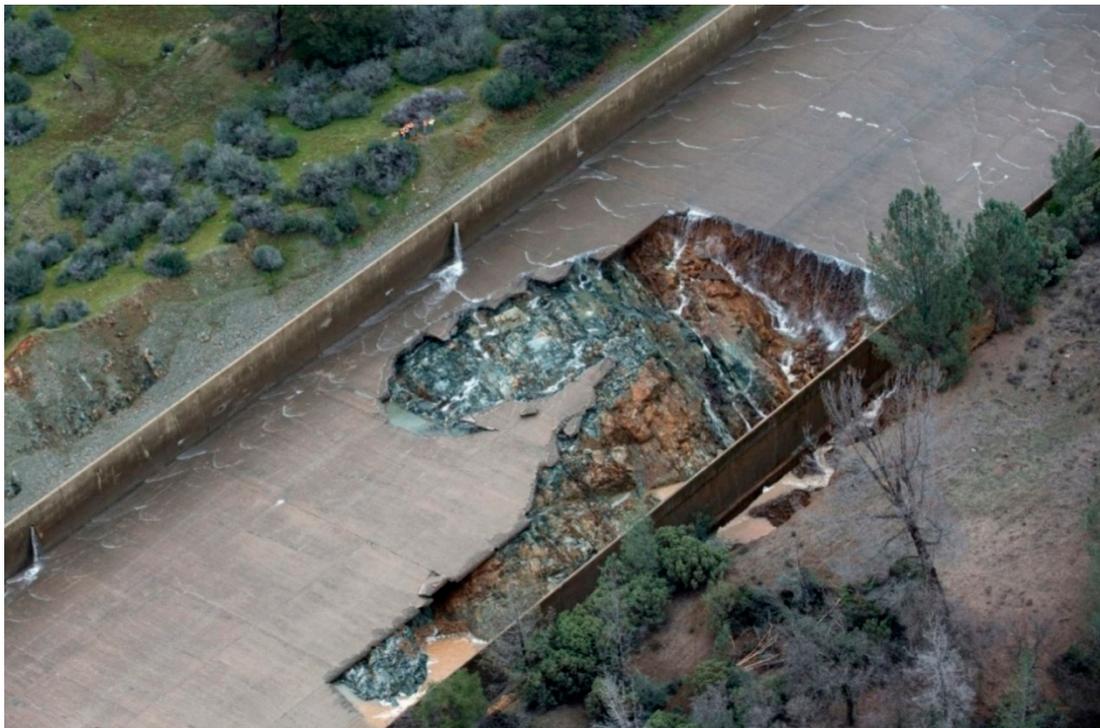
Based on Figure 7, it appears that the foundation rock is indeed composed of the metavolcanic materials mentioned previously. However, this particular section of bedrock appears highly fractured and heterogeneous. There is a significant variance of color in the formations, indicating different degrees of weathering. Furthermore, due to the orientation of the seams, the rock is expected to erode away in large chunks, not in sheets. It is also possible that water was able to seep through cracks in the weaker, more weathered sections of rock and undermine the chute from below.

**Figure 7.** 7 February 2017. Side view of the initial spillway chute failure [38].
