Bio-Environment-Induced Degradation and Failure of Internal Fixation Implants

Abstract: Internal fixations provide fast healing but their failure remains problematic to patients. Here, we report an experimental study in failure of three typical cases of metals: a bent intramedullary stainless steel nail, a broken exterior pure Ti plate, and a broken intramedullary stainless steel nail. Characterization of the bent nail indicates that those metals are vulnerable to corrosion with the evidence of increased surface roughness and embrittlement. Depredated surface of the Ti plate resulted debris particles in the surrounding tissue of $15.2 \pm 6.5 \mu\text{m}$ in size. Nanoparticles were observed in transmission electron microscope. The electron diffraction pattern of the debris indicates a combination of nanocrystalline and amorphous phases. The failure mode of the broken nail made of stainless steel was found to be fatigue initiated from the surface. This study clearly shows the biological-attack induced surface degradation resulting in debris and fatigue. Future design and selection of implant materials should consider such factors for improvement.

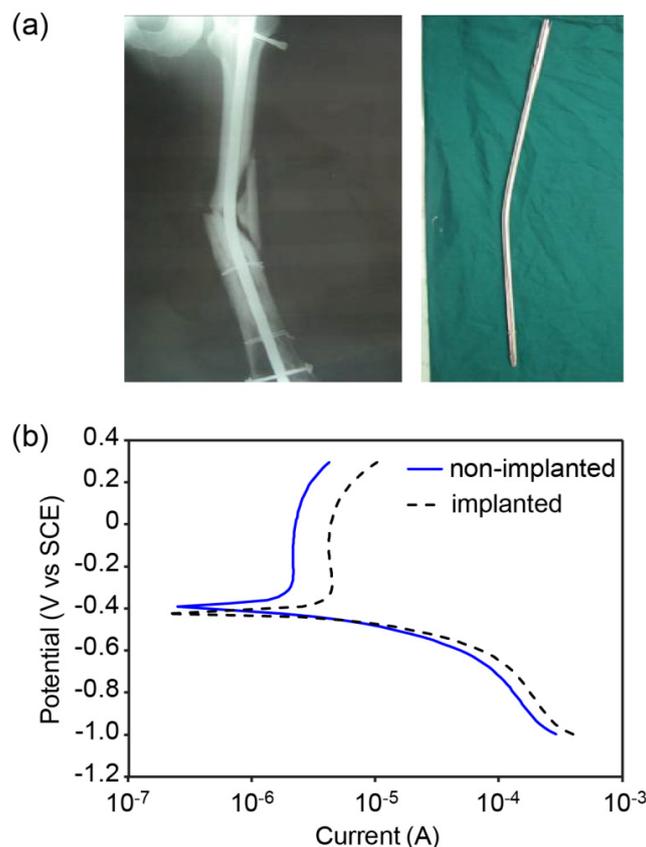
Implants are sometimes damaged due to further accident. A bent long intramedullary nail of stainless steel 316L was collected during the revision surgery, which was performed four months after the initial surgery. The X-ray film shows a complicated fracture where the bone appears to be crushed into the intramedullary nail (Figure 1a). The potentiodynamic study reveals the corrosive behavior of the specimen. In Figure 1b, the passive region for the implanted material occurs at a much higher current than that for the non-implanted material. This implies an increased chance for corrosion on the implanted material if the two materials were placed in the same environment. The trend of the curve is typical for stainless steels.

Figure 1. (a) The X-ray film and the extracted bent long intramedullary nail; (b) the potentiodynamic polarization scans of a non-implanted nail and the implanted nail.

There are several possible reasons. First, the bio-environment corrodes the metal surface. Second, the surface becomes rougher due to degradation. To verify this, we conducted surface roughness and hardness measurements to see if any degradation or hardening of the surface due to implanting.

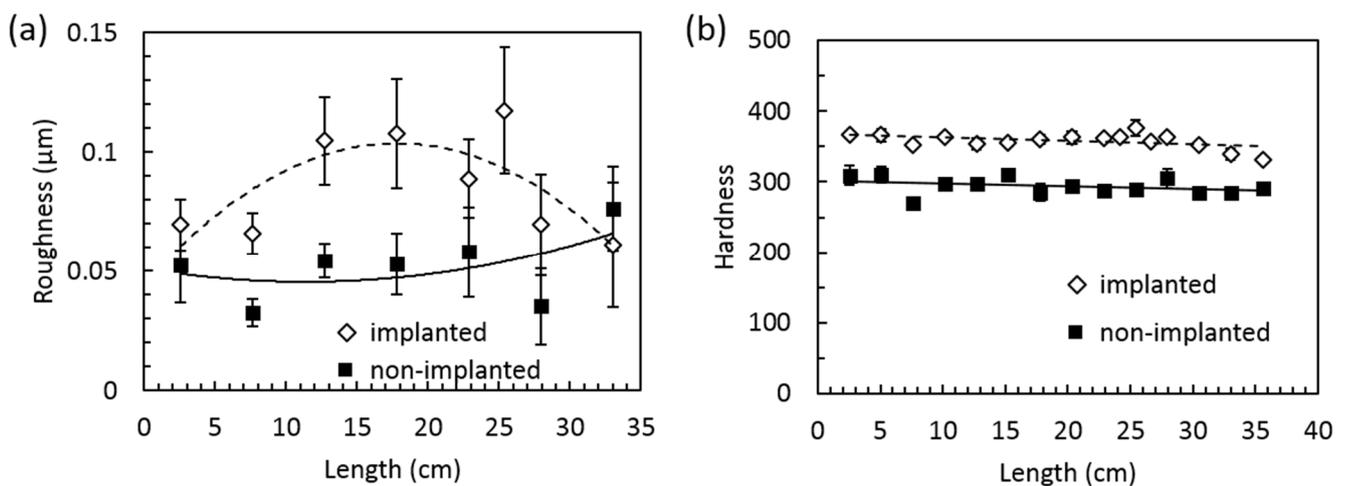
Figure 2 shows the results. Figure 2a is the roughness data comparing the implanted and otherwise. It is clear that the implantation makes the surface significantly rougher, meaning the detachment of the surface material. Correspondingly, the surface is hardened as well. This is the evidence of chemical reactions between the implant and physiological environment resulting in corrosion that leads to the increase of the surface roughness. The fact that the increased hardness might be due to the formation of oxide that is usually harder than metal itself, this is in line with the roughened surface. The increased surface roughness is a collective result of corrosion *in vivo*, the movement between the inner surface of the bone and the implant, and the mechanical collision during its surgical extraction.

Figure 2. (a) The surface roughness of a non-implanted nail and the long implanted nail; (b) the HV microhardness.

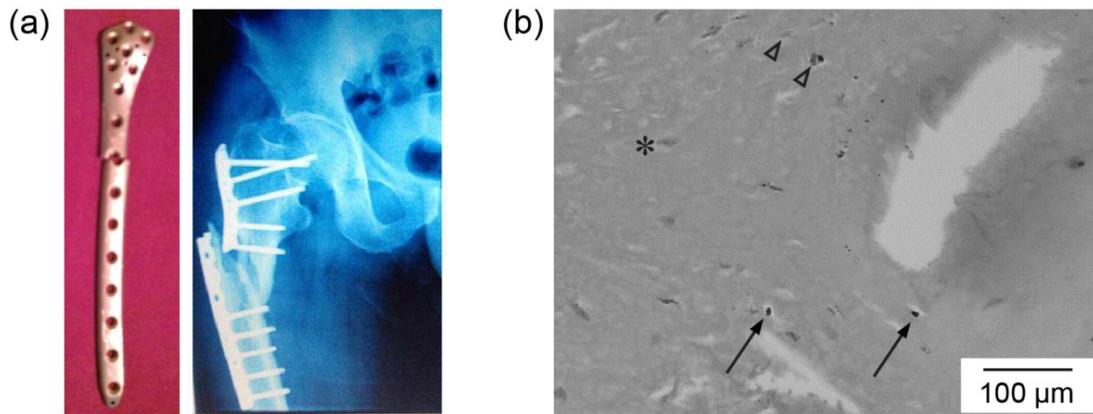
The biological environment-induced surface roughening is expected to lead to further degradation. Here is a case of such a scenario. Locking and unlocking screws are commonly used on an exterior plate. The Ti femoral plate broke on the position where a screw hole was (Figure 3a). The X-ray film of the patient shows a locking screw was originally installed. The residual stress from the screw increased the chance of failing of the plate. The tissue from another screw hole with a locking screw was obtained during the revision surgery. Debris of irregular shapes and varied sizes were observed in the tissue (Figure 3b). Some particles were only encapsulated by the surrounding tissue (marked by arrows) and others caused the presence of the inflammatory cells around them (marked by triangles), indicating the different fate of particles that might also be related to their encapsulation time. Fibroblasts play an important role in bone healing that were also seen (pointed by an asterisk). The images clearly show that debris particles generated from the minimal motion between the locking screw and the screw hole were later encapsulated by the tissue.

Figure 3. (a) The Ti exterior plate and the X-ray film of the patient; (b) the cross-section of the tissue collected from a hole of a locking screw (not on the broken site). Arrows point at the debris particles after encapsulation. Triangles point at the particles with surrounding inflammatory cells. Fibroblast is marked by an asterisk.

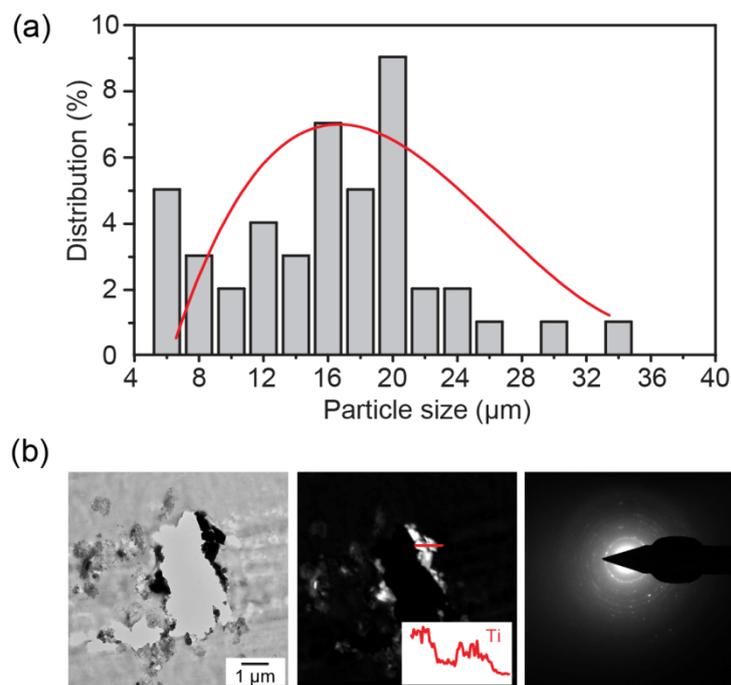
The size distribution and elemental information of the debris are shown in Figure 4. Micro-sized particles were counted based on the optical images. The Ti particle size is $15.2 \pm 6.5 \mu\text{m}$ and the mode value is $20 \mu\text{m}$, as shown in Figure 4a. The TEM image in Figure 4b confirms the existence of nano-sized debris particles that were undetectable by an optical microscope. The microtome cutting left a non-intact cross-section due to the fact that the razor was unable to cut through the metallic wear debris. The bright field and dark field TEM images are shown. The inset EDX pattern of Ti corresponds to the indicated line in the dark field image that confirms the particles were composed of Ti. The electron diffraction pattern on the right indicates a combination of nanocrystalline and amorphous phases in the debris.

Figure 4. (a) Size distribution histogram of Ti debris particles with a polynomial fit; (b) the elemental confirmation of Ti particles embedded in tissue using TEM.

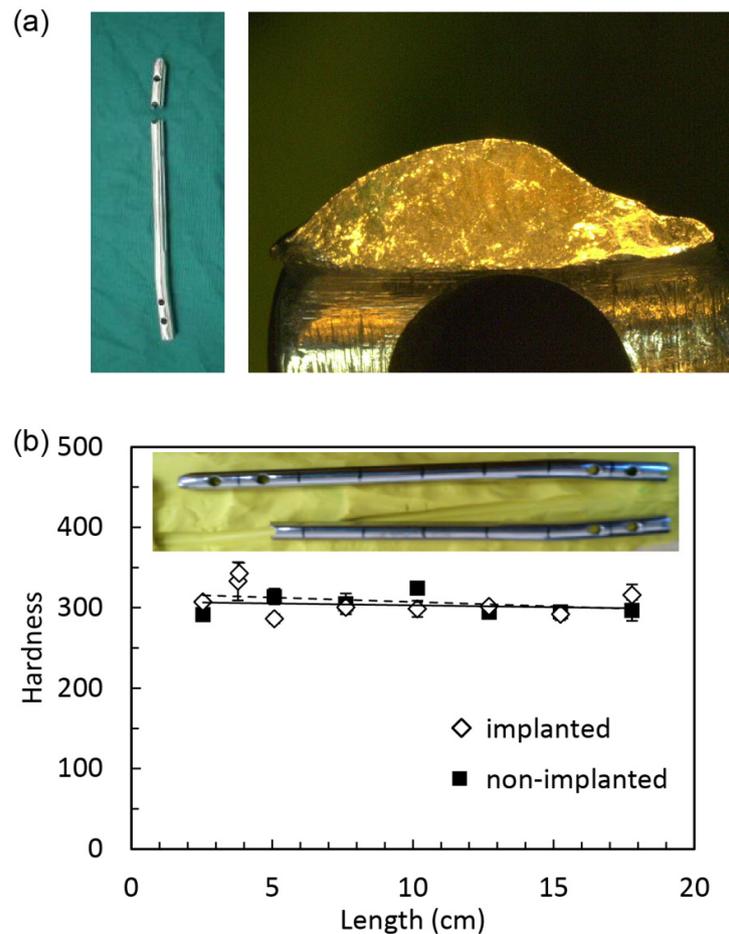
Surface degradation provides enormous opportunity of origin for fatigue failure. An example was found in a short femoral intramedullary nail that displays brittle fracture due to fatigue, as seen in Figure 5a. The well-developed cracks were initiated at the surface. The fatigue occurred over a large number of cycles with stress at the fracture site well over the fatigue limit. Furthermore, the embrittlement was found on the surface close to the breaking point. As seen in Figure 5b, the hardness change was evidenced by the mechanical hardness tests. The implanted material was shown to be more brittle, which creates a condition for crack propagation rather than the stress distributing through ductile deformation. The hardness data show that the surface of the implanted sample was harder around the fracture point.

Figure 5. (a) The fractography of the broken short intramedullary nail of stainless steel; (b) the HV hardness shows that the surface of the implanted sample was harder around the fractured point.
