Bridge Inspection with an Off-the-Shelf 360° Camera Drone

Andreas Humpe

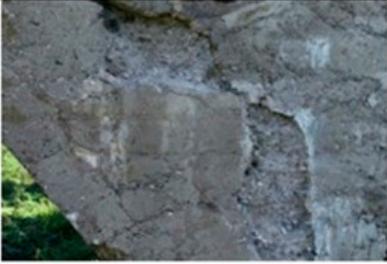
The concrete spalling can be well observed by both cameras. The image shows concrete spalling at the Abutment of the first bridge.
Concrete cracking

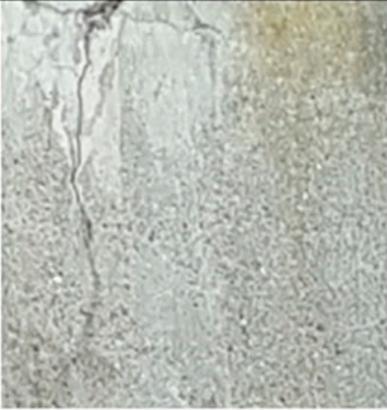
The image shows a concrete crack at the Abutment of the second bridge. This damage was detected by both cameras
Efflorescence

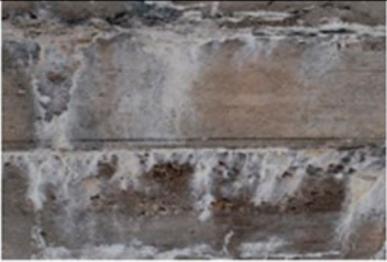
At the first bridge we found efflorescence and discoloration at the arch ceiling. The damage could be observed by both cameras. However, the HD camera underneath the drone cannot take images of the ceiling close to the crown of the arch.
Corrosion

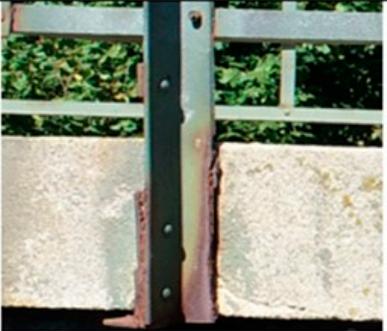
We found corrosion at the railing of both bridges. The corrosion could also be observed by both cameras.
Waterproofing failure

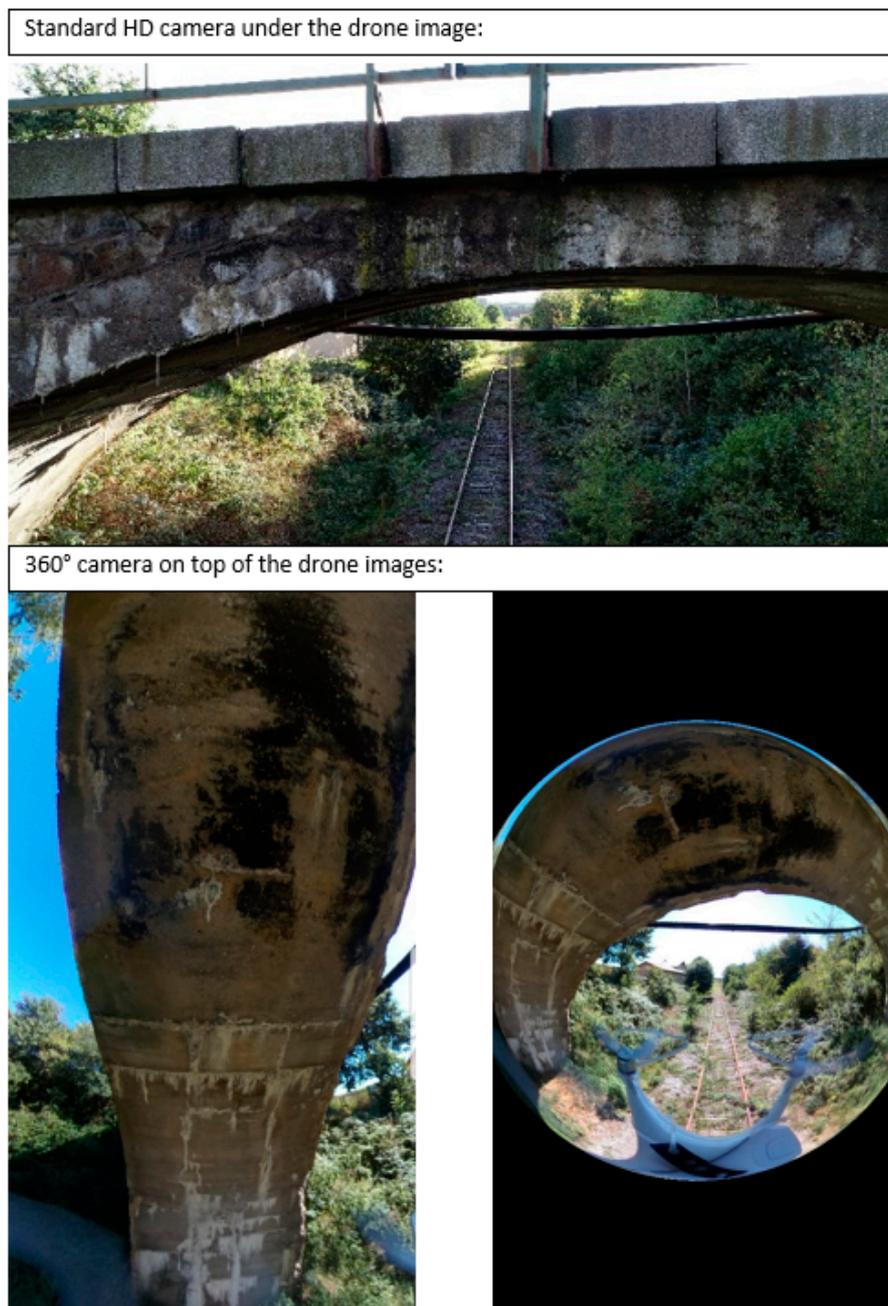
Figure 12. Comparison of the HD and 360° camera images of the arch bridge ceiling.

Fortunately, even a closer look at the bridge ceiling does not reveal any major cracks. However, some concrete spalling and waterproofing failure is visible and should be monitored in the future. The author concludes that the 360° camera on top of the drone is much better suited to taking images of the bridge ceiling compared to the standard HD camera underneath the drone.
