Wind-Induced Vibration Monitoring of High-Mast Illumination Poles Using Wireless Smart Sensors

Abstract: This paper describes the use of wireless smart sensors for examining the underlying mechanism for the wind-induced vibration of high-mast illumination pole (HMIP) structures. HMIPs are tall, slender structures with low inherent damping. Video recordings of multiple HMIPs showed considerable vibrations of these HMIPs under wind loading in the state of Kansas. The HMIPs experienced cyclic large-amplitude displacements at the top, which can produce high-stress demand and lead to fatigue cracking at the bottom of the pole. In this study, the natural frequencies of the HMIP were assessed using pluck tests and finite element modeling, and the recorded vibration frequencies were obtained through computer vision-based video analysis. Meanwhile, a 30.48 m tall HMIP with three LED luminaires made of galvanized steel located in Wakeeney, Kansas, was selected for long-term vibration monitoring using wireless smart sensors to investigate the underlying mechanism for the excessive wind-induced vibrations. Data analysis with the long-term monitoring data indicates that while vortex-induced vi

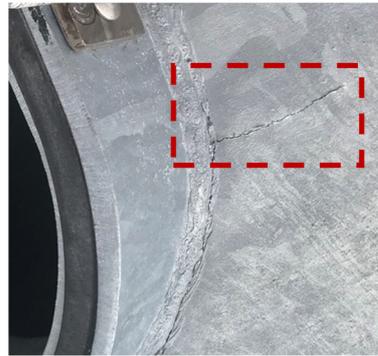
The Kansas Department of Transportation (KDOT) discovered premature cracks near the handhole of several newly installed HMIPs in western Kansas [16], as shown in Figure 1. In addition, KDOT recorded several videos of the HMIPs experiencing large cyclic displacements at the top of the HMIP due to wind loading. Hence, a preliminary study was conducted on the recorded videos to investigate the nature of the excessive vibrations. The videos were analyzed using the Kanade–Lucas–Tomasi (KLT) feature tracking approach to extract the maximum displacement and vibration frequencies of the structure. First, the region of interest around the light assembly was selected to track the displacement at the top of the HMIP, where the maximum displacement occurs, as shown in Figure 2a. The sampling frequency of the recorded video was 29.97 Hz, which was used to track the displacement time history using the KLT feature point tracker [17] for the detected feature points in Figure 2b. Subsequently, the tracked displacement was utilized to estimate the natural frequency of the HMIP. Results indicated that the average peak-to-peak displacement was approximately 0.60 m, as shown in Figure 3a. In addition, the power spectral density (PSD) of the tracked displacement showed that a mode with a natural frequency of 0.61 Hz dominated the vibration, as illustrated in Figure 3b. The preliminary conclusion will be compared with the pluck test results, FE modeling, and wind-induced vibration data. Following the observation of significant vibrations and the preliminary video-based

Figure 1. A premature crack (shown in the red box) near the handhole of an HMIP in West Kansas (Credit: KDOT).

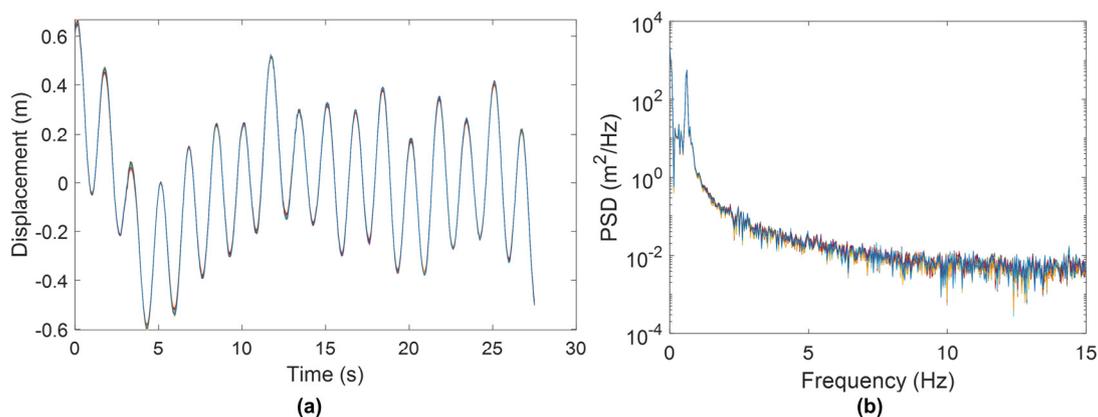
Figure 3. (a) Displacement time histories of feature points from the top of the HMIP extracted from the video. (b) Power spectral density (PSD) of the tracked displacements showing a dominant frequency of 0.61 Hz.

The video analysis indicated that the vibration is dominated by a 0.61 Hz frequency and a maximum displacement of 0.30 m, which was confirmed to be the first-mode frequency through the pluck tests and FE analysis. Furthermore, the long-term field monitoring revealed that the HMIP experienced two types of wind-induced vibrations: buffeting and vortex shedding. Vibrations caused by buffeting are excited by the turbulence component of wind load, resulting in vibration over a wide range of angles. The study found that the vibration magnitude when buffeting occurred in the crosswind direction was higher compared to buffeting-induced vibrations that occurred in other directions. Additionally, the vibration response from buffeting was governed by the first mode. On the other hand, vortex shedding excites the structure only in the crosswind direction at critical wind speeds. The critical velocities for VIV range between 4.47 and 7.60 m/s for the second-mode lock-in. However, VIV occurred less frequently and exhibited lower magnitudes than buffeting.

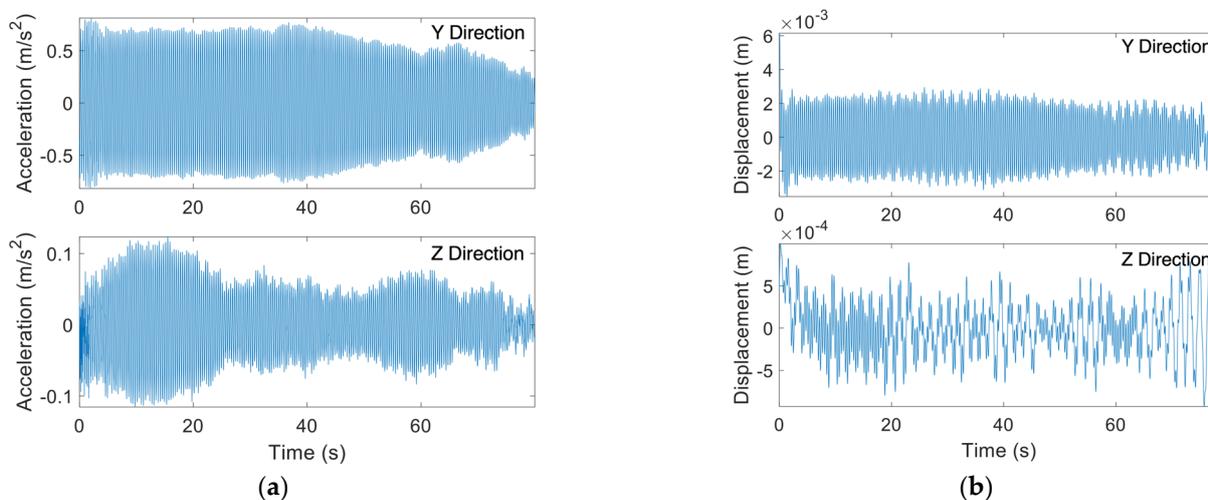
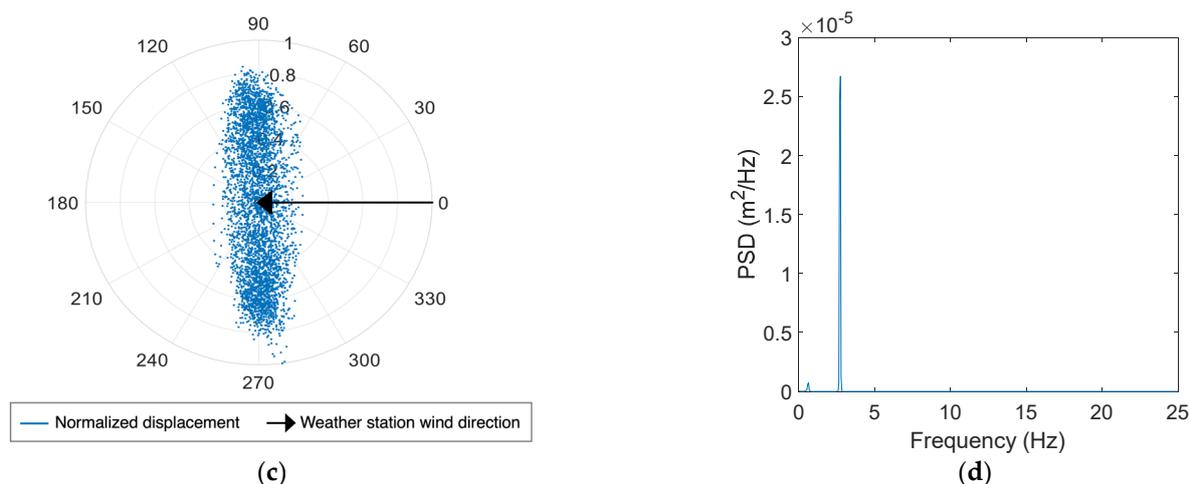
Figure 13a illustrates acceleration time histories for the HMIP under VIV as recorded by the sensor installed at an elevation of 17.37 m. The corresponding displacement for the same wind event is shown in Figure 13b. The nearest weather station [26] reported a wind speed of 4.47 m/s, with the wind blowing from the east. Unfortunately, the sensor connected to the anemometer was not triggered when the dataset was collected. However, the anemometer readings from other wind events were consistent with the weather station. Therefore, the data analysis in this section is based on the wind information provided by the weather station. The displacement in the Y-axis shown in Figure 13b indicates that the HMIP was engaged in VIV during the wind event. The wind was blowing from the eastern direction, aligning with the Z-axis of the Xnode. It can be seen that the Z-axis displacement was negligible compared to the Y-axis. The normalized wind rose for the data in Figure 13c shows that the HMIP vibrated in the north–south direction while the wind direction was from the east, resulting in a crosswind vibration. The total PSD obtained by summing the PSDs of the Y-axis and Z-axis is illustrated in Figure 13d. The PSD curve demonstrates a second-mode lock-in, where the second mode dominates the vibration. Given that the wind speed reported by the weather station was 4.47 m/s, falling within the critical wind velocity range, the HMIP experienced VIV in the crosswind direction and was dominated by the second mode. Although VIV was reported to occur more frequently than buffeting in HMIPs and other tall, slender structures [1,3,10,26], during the monitoring period, VIV was observed to have lower amplitudes and happen less often than buffeting.

Figure 13. (a) Collected acceleration time histories for VIV; (b) Displacement time histories obtained from the collected acceleration data for VIV; (c) wind rose for VIV showing crosswind vibration; (d) PSD of the total displacement responses showing lock-in during VIV.

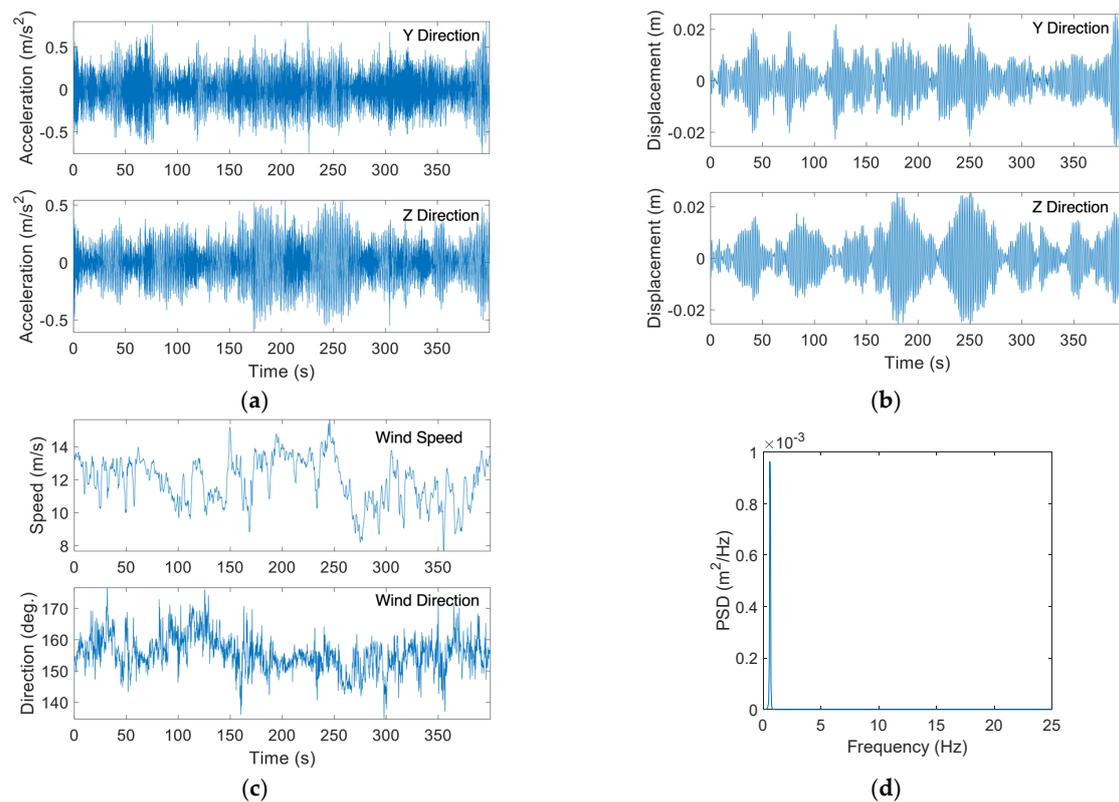
Figure 14a,b shows typical acceleration and displacement time histories due to buffeting from the monitoring campaign. The wind speed and direction for the same dataset are demonstrated in Figure 14c. It can be noted that wind speed fluctuated between a maximum of 15.65 m/s and a minimum of 7.82 m/s, while the wind direction was consistent and around 155 degrees. The wind turbulence intensity, which is defined as the standard deviation of the wind speed (u') over the mean wind speed (U) [27], is high and around 12%. The displacement amplitude in Figure 14b fluctuates with the wind speed, where the maximum displacement the pole experienced during the wind event was 0.0254 m. The PSD curve corresponding to the displacement data in Figure 14d shows that the first mode dominated the vibration of the HMIP. Overall, vibrations due to buffeting exhibited amplitude fluctuation depending on the wind speed variation and were dominated by the first mode.

Figure 14. (a) Collected acceleration time histories for along-wind buffeting-induced vibration; (b) Displacement time histories obtained from the collected acceleration data for along-wind buffeting; (c) Collected wind speed and wind direction during along-wind buffeting excitation; (d) PSD of the total displacement responses due to buffeting.

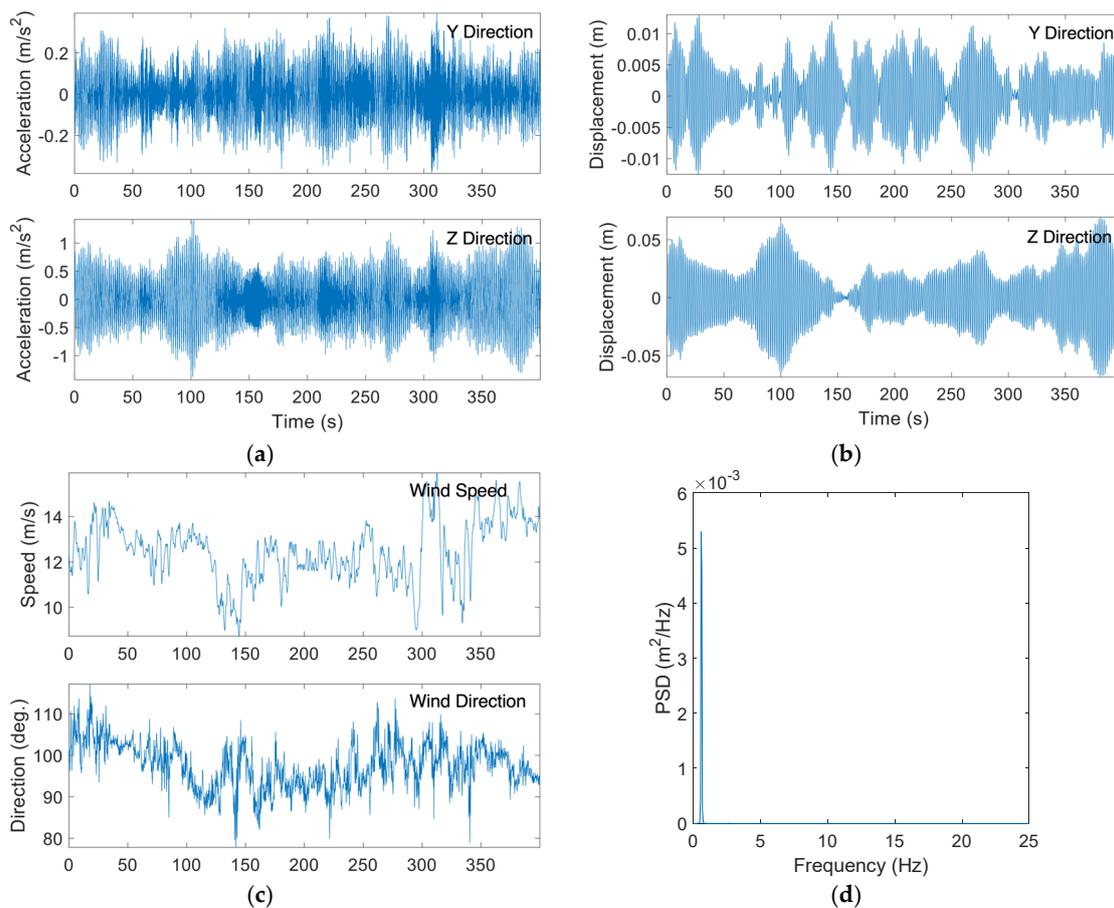
The acceleration and displacement time history in Figure Figure 17a and 17b, respectively, are for the same dataset shown in Figure 15c with the crosswind vibration. The displacement exhibited a fluctuating behavior that varies as the wind speed changes. Figure 17c shows that the wind speed fluctuated between 8.94 and 15.65 m/s while the wind direction remained constant at approximately 100 degrees. The wind turbulence intensity is high, around 11%. Upon examining the PSD derived from the displacement data, it was observed that the HMIP's vibration was predominantly governed by the first mode, as illustrated in Figure 17d.

Crosswind vibration with a single frequency dominating the vibration can be attributed to VIV, buffeting, or galloping. Regarding VIV due to wind crossing the main pole body, the critical velocity due to vortex shedding and first-mode lock-in ranges between 0.98 and 1.65 m/s, which is 10 times less than the one experienced by the HMIP; therefore, VIV associated with the main pole structure was excluded as the source of this excessive vibration in the crosswind direction. In addition, VIV can also be caused by the light assembly on the top of the HMIP. Junge [28] performed a series of computational fluid dynamic (CFD) analyses for the light assembly under various wind velocities and angles. The study indicated that VIV could occur close to the first mode under a specific wind speed and angle. However, the data we collected indicate the HMIP experienced crosswind vibration under various wind directions, including north, north-northwest, west-southwest, and south, indicating that the light assembly did not contribute to the first mode lock-in. The 11% turbulence intensity suggests that the vibration could not be due to galloping, which is caused by quasi-steady forces. Additionally, no ice or snow was present to create an asymmetric shape of the HMIP when the data were collected. Consequently, galloping was excluded as a potential reason for this excessive vibration. Thus, it was concluded that buffeting is the primary cause of this crosswind vibration. This type of buffeting-induced vibration exhibited a higher vibration magnitude than others triggered by buffeting. For instance, the displacement amplitudes for the crosswind buffeting in Figure 17b are almost twice the magnitude of those in Figure 14b, which were associated with crosswind buffeting.

Figure 17. (a) Collected acceleration time histories for crosswind buffeting-induced vibration; (b) Displacement time histories obtained from the collected acceleration data for crosswind buffeting; (c) Collected wind speed and wind direction for crosswind buffeting; (d) PSD of the total displacement responses due to crosswind buffeting.

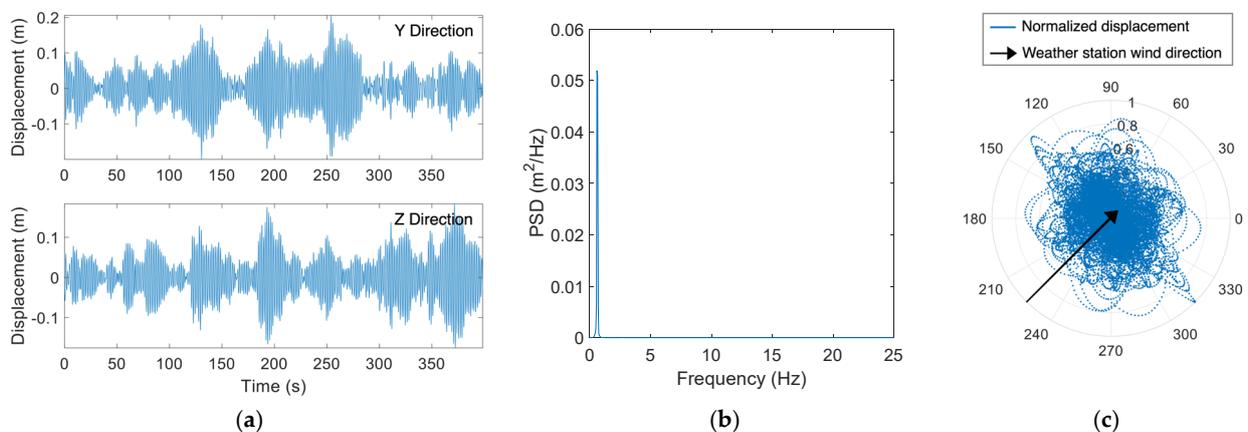
The displacement time history derived from the accelerometer located at the height of 29.10 m during the storm is shown in Figure 19a. The displacement data exhibited fluctuation and reached large amplitudes. The maximum displacement the HMIP experienced was about 0.24 m, which is the closest displacement magnitude to the 0.30 m captured in the video from KDOT. Such large displacement can induce high stress and potentially cause fatigue cracking near the base of the HMIP over time [28]. Figure 19c shows the wind direction compared to the normalized magnitude and direction of the HMIP displacement. According to the weather station, the wind blew from the southwest (SW) direction. Therefore, the wind rose plot indicates that the vibration primarily occurred in the crosswind direction. Additionally, Figure 19c shows the HMIP moving in different directions, but it is mainly dominated by crosswind vibration. To further evaluate the contribution from each mode, an 8th-order bandpass elliptic filter was applied to the measured acceleration. Subsequently, the filtered acceleration data were converted into displacement to assess the modal contributions to the HMIP vibration during the storm. Figure 20 represents the displacement magnitude and direction associated with the first three modes and the wind direction. The results indicate that the first mode contributed the most, with a displacement magnitude of 0.24 m. In contrast, the effects of the second and third modes are significantly lower than that of the first mode. Hence, the excessive wind vibration experienced during the Derecho storm exhibited crosswind buffeting characteristics due to its fluctuating displacement, large vibration amplitude, and first-mode dominance in the HMIP vibration.

Figure 19. (a) Displacement time histories captured during the Derecho storm; (b) the total PSD; (c) normalized wind rose for total displacement during the Derecho storm.

The maximum recorded displacement was 0.24 m, measured at the top of the HMIP, which occurred during the Derecho storm. This value is the closest to the 0.3 m displacement extracted from the video during the preliminary investigation. Additionally, the first mode dominates the vibration from both the video recording and the Derecho storm. Therefore, the data analysis indicated that the excessive wind vibration experienced by the HMIP is attributed to crosswind buffeting. Such excessive vibrations can generate high-stress demand at the bottom of the structure, initiating and propagating fatigue cracks such as fatigue cracking around the handhole and potentially resulting in the failure of the structure if left unaddressed. The findings from this study suggest that future research for vibration mitigation should focus on increasing the damping level of HMIPs by implementing structural dampers instead of aerodynamic dampers since aerodynamic dampers change the aerodynamic properties of the system to disrupt the formation of vortices. However, the study indicates that VIV is not the main cause of excessive vibrations. As a result, using aerodynamic dampers will not help reduce unwanted vibrations.
