Figure S1. SEM images of MPLs (micro-porous layers) surface with different FEP (fluorinated ethylene propylene) content (indicated percentages are by weight)

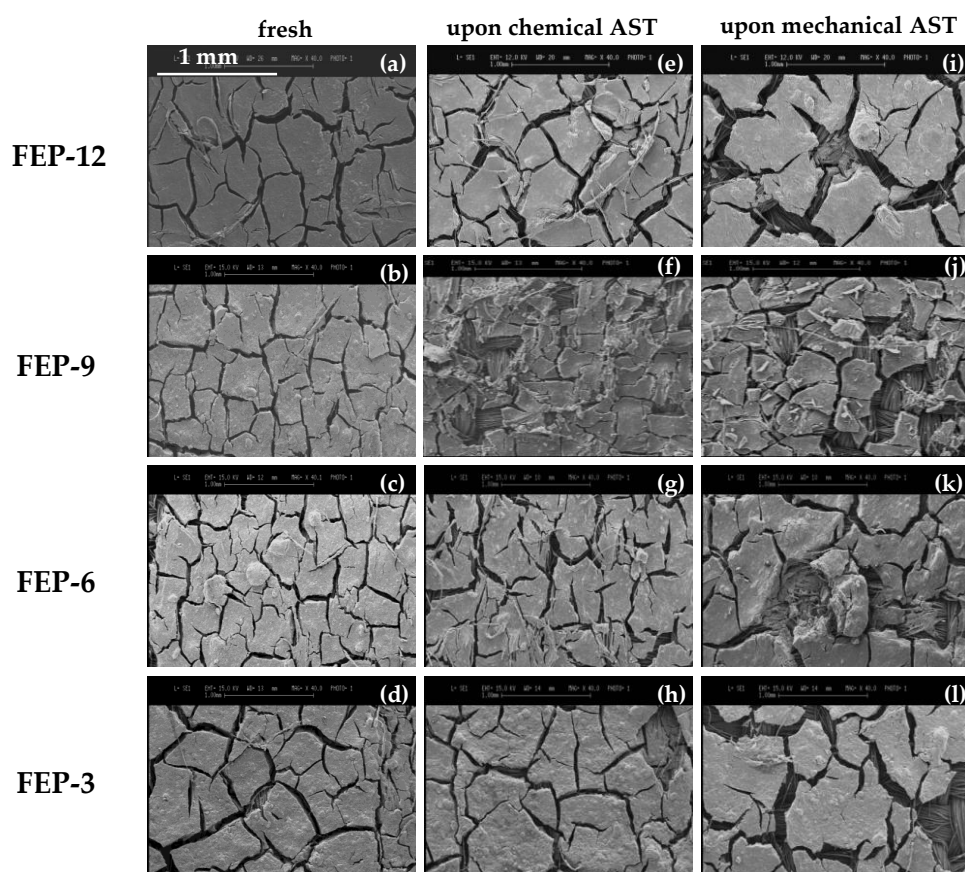
Figure S2. Fresh (a, b, c, d), 1000 h chemically aged (e, f, g, h) and 1000 h mechanically aged (i, j, k, l) MPLs containing 12, 9, 6 and 3 % wt of FEP.

All MPLs show very similar surfaces; slightly larger cracks can be tentatively identified on FEP-3 (d) and this might be a reason of its lower performance at any operating condition. Mechanically aged samples exhibit more damaged surfaces with more evident and wider cracks than chemically treated ones. This might reduce capillary pressure across the MPLs making water removal more difficult and worsening mass transport properties. Indeed mechanically aged samples showed worse performance than corresponding chemical ones. FEP-12 seems to be the MPL which better resists stress tests and this may cause the observed higher durability.
