Analysis and Disposal of Typical Breakdown Failure for Resin Impregnated Paper Bushing in the Valve Side of HVDC Converter Transformer

Hao Tang ^{1,2,*}, Guangning Wu ¹, Ming Chen ³, Jiang Deng ¹ and Xining Li ²

Keywords: valve side bushing; resin impregnated paper; HVDC converter transformer; bushing breakdown failure; field repair

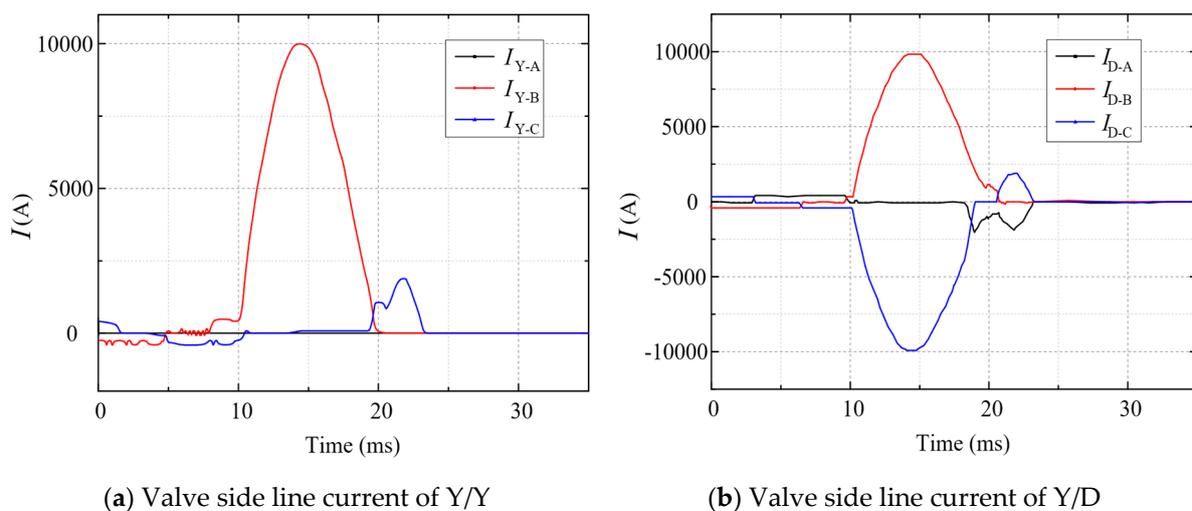
At the time of the RIP valve side bushing failure, valve side line current of Y/Y converter transformer (I_{Y-A} , I_{Y-B} , I_{Y-C}) and those of Y/D converter transformer (I_{D-A} , I_{D-B} , I_{D-C}) are shown in Figure 2a,b. The peak value of fault current which is defined as I_F , and it is equal to I_{Y-B} , I_{D-B} , I_{D-C} . These fault current are all 10 kA, shown in Figure 2a. I_{Y-A} , I_{Y-C} , I_{D-A} are close to 0 A. Meanwhile, as shown in Figure 3, the current in the pole line (I_{DP}) is also 0 A, while the current in the neutral line (I_{DNC}) is equal to 10 kA. The whole duration time of fault current is about 10 ms, in the meantime, Y rectifier bridge V6 and D rectifier bridge V5 and V6 turn on.

Figure 2. Fault current waves in all valve side of converter transformers.

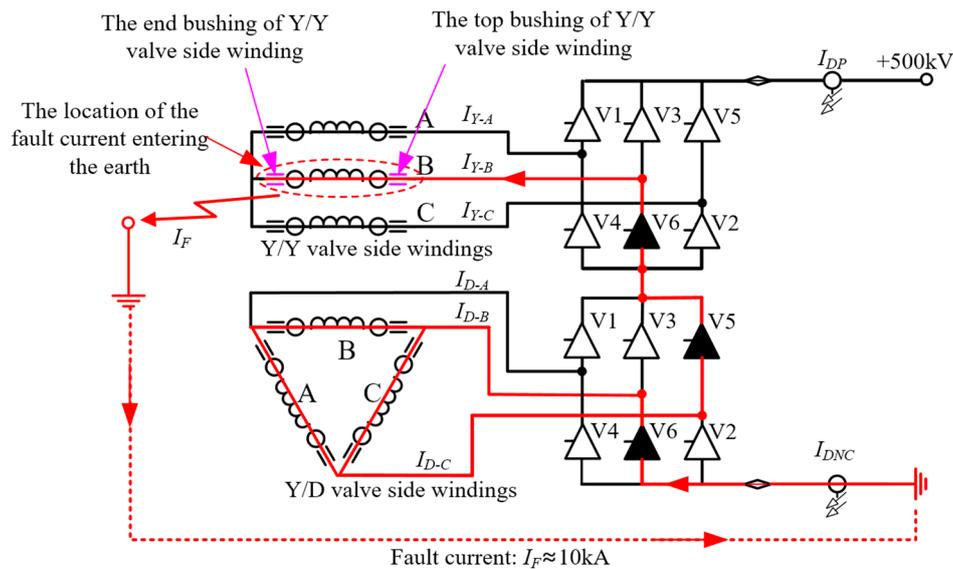
Figure 3. Fault current loop in converter station at the time of bushing failure.

Based on the characteristics of these currents, the flow loop of the fault current in the converter station can be obtained, shown in Figure 3. The location of the fault current entering the earth can be concluded at the end valve side of Y/Y-B converter transformer. This shows that the end valve side bushing of Y/Y-B converter transformer has been broken down.

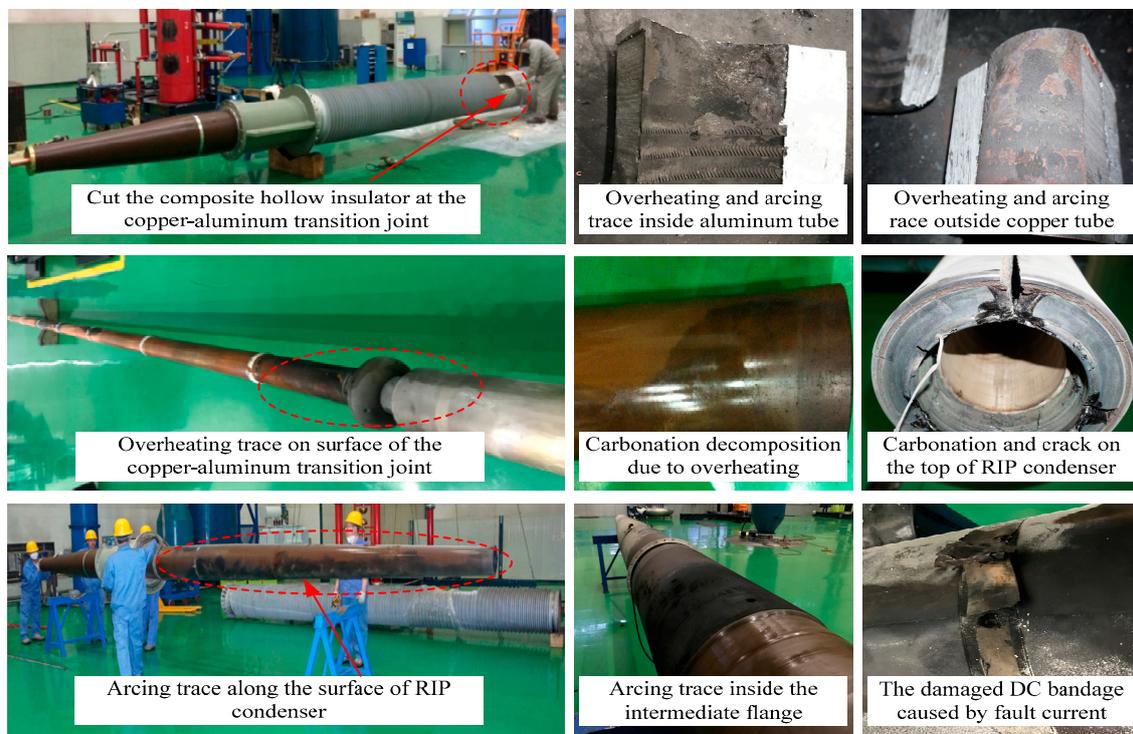
The arcing and overheating traces of the disassemble inspection on the failed bushing is shown in Figure 4. When the composite hollow insulator is cut down, obvious overheating trace is found on the contact surface of the copper–aluminum conductive tube transition joint. Inside the joint, partial contact surface of both copper conductive tube and aluminum conductive tube has been melt, and the spring contact between two tubes is totally damaged. Due to overheating, cracking and carbonization of the top RIP condenser close to the transition joint has occurred. Some carbonized decomposition particles are attached to the top-part surface of RIP condenser.

Figure 4. Arcing and overheating trace detected on the RIP condenser and conductive tube.

It was clear that the solid insulator material (resin impregnated paper) around area of the copper–aluminum transition joint has been carbonized due to the overheating of high abnormal contact resistance at the copper–aluminum conductive tube transition joint. These carbonation decomposition particles are attached to the surface of RIP condenser which can lead to a reduction in the flashover voltage. Influence of partial overheating of abnormal copper–aluminum transition joint inside bushing on abnormal temperature distribution is analyzed in Section 4.

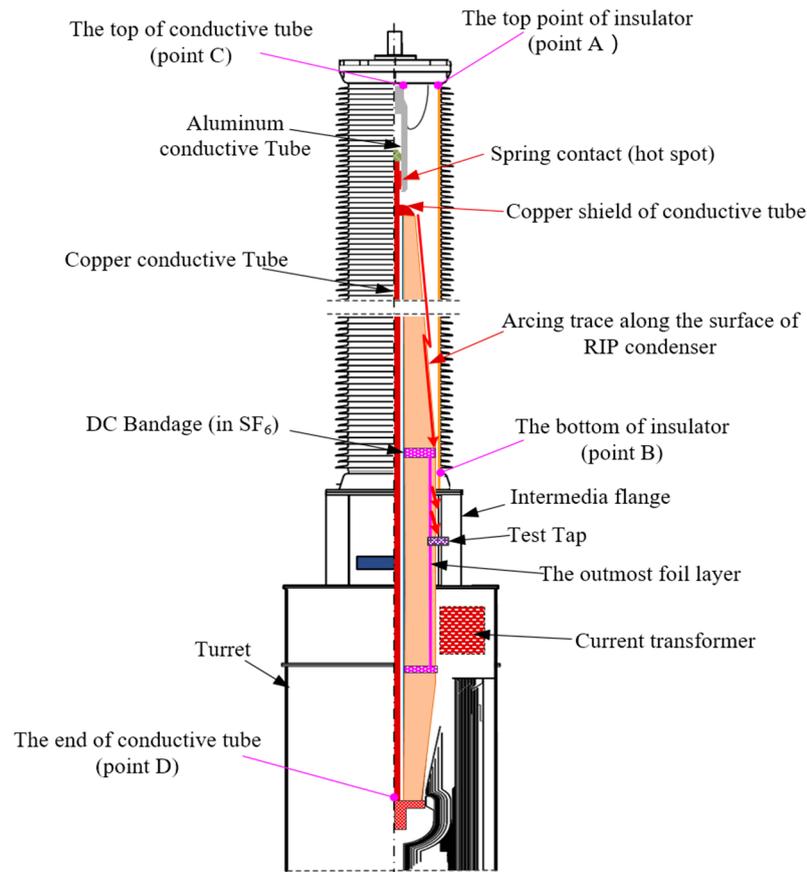
There is a clear axial arcing trace on the surface of RIP condenser, which starts from the top-part surface of RIP condenser close to the high voltage conductive tube to the DC bandage which is grounded to the earth. All these overheating and arcing trace indicate that there is an axial flashover along the RIP condenser/SF₆ interface. Axial flashover arcing path of the failed bushing is showed in Figure 5. The arcing path starts from the copper shield of conductive tube at the top of the RIP condenser, along the interface of the RIP condenser and SF₆, after passing through the DC bandage and finally enter the earth through the test tap and intermediate flange.

Figure 5. Axial arcing path along the condenser/SF₆ interface of the failed bushing.

For the failed RIP valve side bushing of Baoji converter station, there is no arcing trace outside the composite hollow insulator and the DGA result of transformer oil is normal. However, the main insulation resistance, the capacitance and the dielectric loss factor of the bushing are all abnormal, and large amount of SO₂ gas from SF₆ decomposition is also detected inside the composite hollow insulator. Based on all these test results, the type of bushing failure can be diagnosed as axial flashover along the condenser/SF₆ interface.

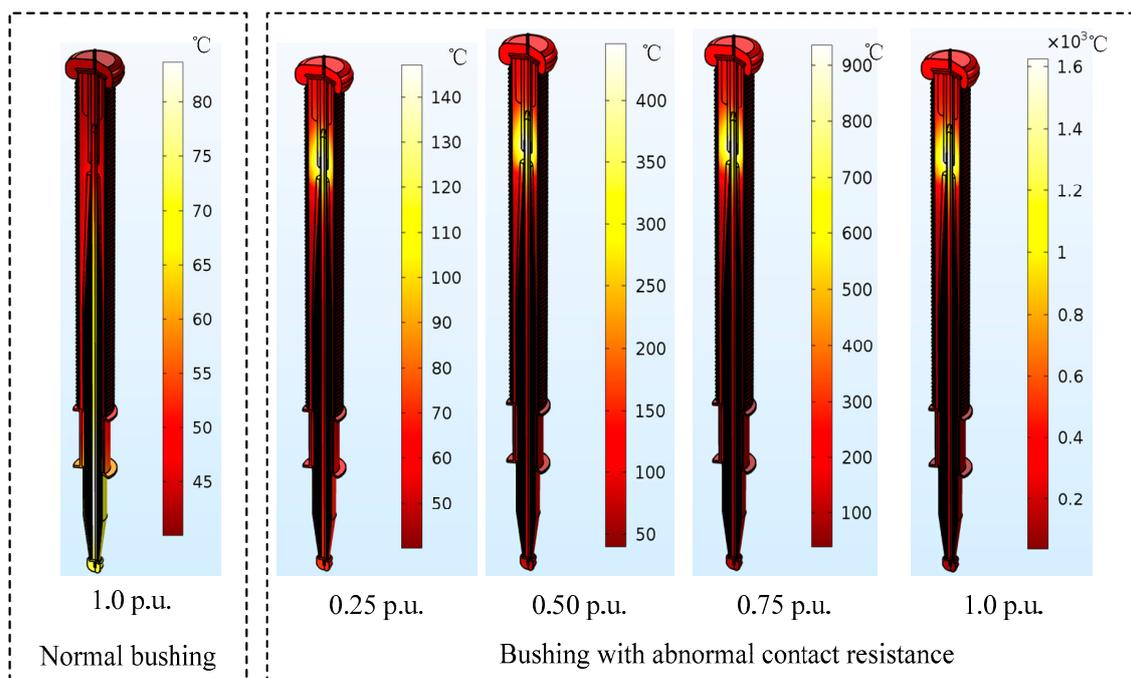
The finite element simulation model with an abnormal contact resistance between the copper conductive tube and aluminum conductive tube is established. According to Table 2, the total resistance loss $\Sigma(P_{R0_h}+P_{Rc_h})$ of the load current of 0.25 p.u., 0.5 p.u., 0.75 p.u., 1.0 p.u. is applied to the bushing model, and the simulation result of the internal temperature distribution of the bushing is shown in Figure 7. In the simulation model, the temperature in the valve side bushing oil is set to 70 °C, and the ambient temperature of the air side is set to 40 °C.

Figure 7. The temperature distribution under different load current.

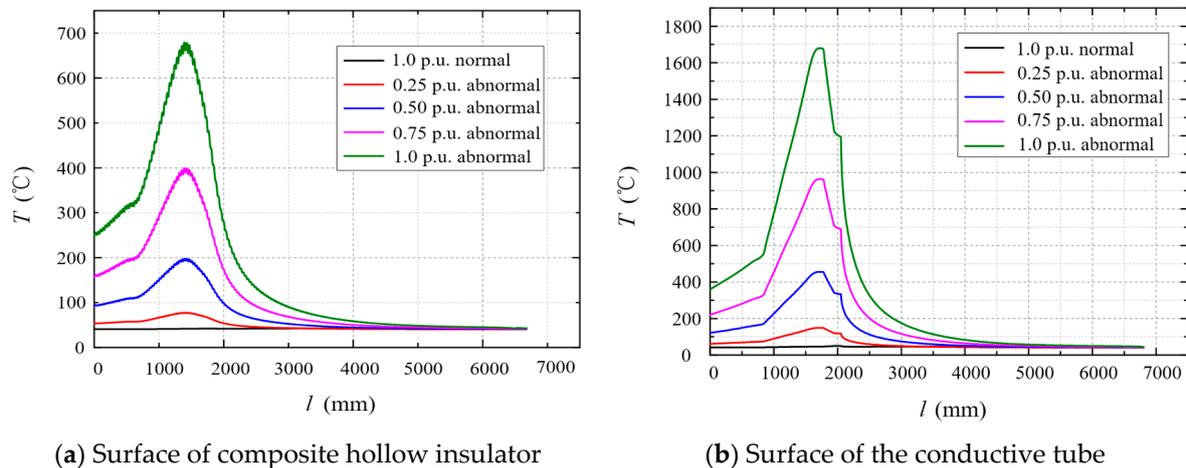
Figure 8. Temperature outside and inside the failed bushing under different load current.

It can be seen from Figure 8 that when the copper–aluminum transition joint of the bushing is normal ($R_c = 0$), the surface temperature of the insulator is 40 °C under rated load current (1.0 p.u. normal), and the copper–aluminum transition zone temperature is also 40 °C.

When spring contact of the copper–aluminum conductive tube is abnormal ($R_c = 1855 \mu\Omega$), the temperature of the silicone rubber insulator reaches 75 °C under the load current of 0.25 p.u., and the temperature of the transition joint between the copper and aluminum conductive tubes (the highest point of the purple curve in Figure 8b) reaches more than 150 °C, which is higher than the temperature limit 120 °C specified by IEC standard. Therefore, from the analysis results, it can be seen that the maximum safe operation current of the defective bushing with abnormal contact resistance is not above 0.25 p.u.

As the load current increases to 0.75 p.u., the temperature of the transition joint is close to 1000 °C, at which temperature the copper conductor will begin to melt. The temperature at the upper part of the RIP condenser close to the transition joint is also more than 200 °C. Under this extreme condition, partial material of the upper RIP condenser begins to carbonize and decompose. Carbonized decomposition products of solid insulating materials and metal melts can contaminate the interface between the RIP condenser body and the SF_6 gas, reducing the dielectric strength of bushing and ultimately causing the axial flashover along the condenser/ SF_6 interface.

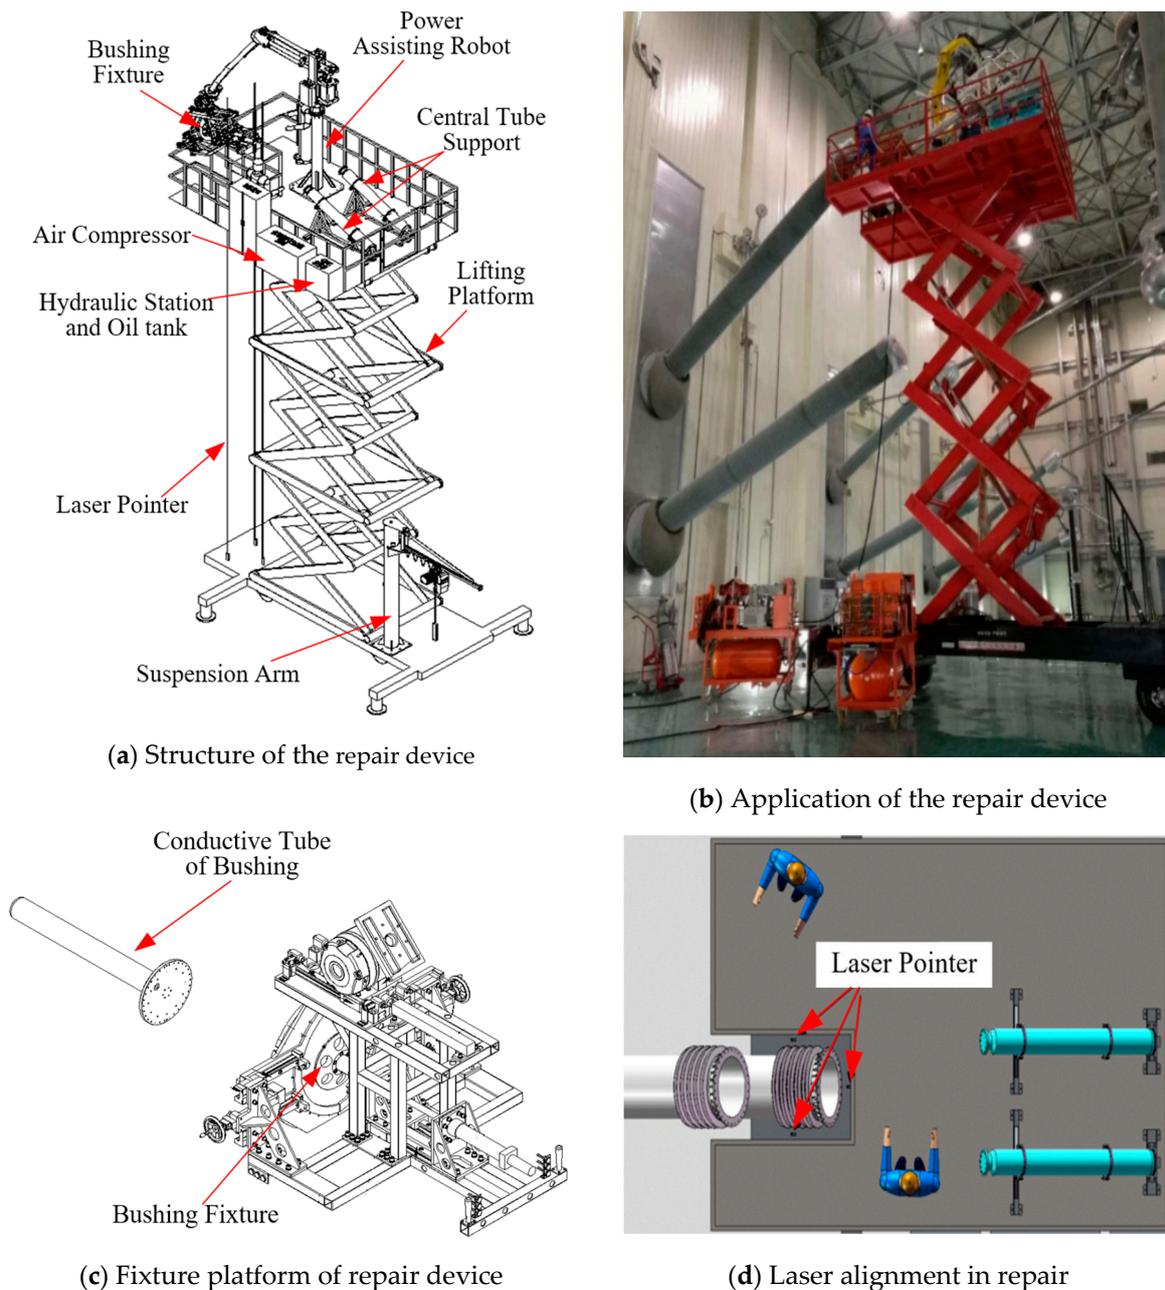
Figure 9. Structure and application of the field repair device for defective bushing.

The bushing field repair device shown in Figure 9 includes lifting platform and power assisting robot, hydraulic station, laser pointer and bushing fixture respectively mounted on the lifting platform. The device can be used to quickly and cost-effectively disassemble and assemble the defective RIP valve side bushing and its composite hollow insulator, as well as accurately control the force and distance required to disassemble and install the conductive tube with the help of the assisting robot and laser pointer.

The procedure of field repairing for abnormal copper–aluminum conductive tube transition joints on defective bushings includes pre-treatment, bushing and repair device positioning, top cover removal, defect inspection and treatment, replacement parts handling, bushing reassembling, post-treatment and testing. Using the field repair device, a total of 75 bushings with overheating hidden defects in copper–aluminum transition joints in the State Grid Corporation’s system of ± 500 kV Tuanlin, Fengjing, Baoji, Mujia and Yimin converter stations are repaired on site. All the 75 bushings
