Case Report

Analysis of a High-Voltage Room Quasi-Smoke Gas Explosion

Marit Sigfrid Bakka ¹, Erling Kristian Handal ¹ and Torgrim Log ^{2,3,*}

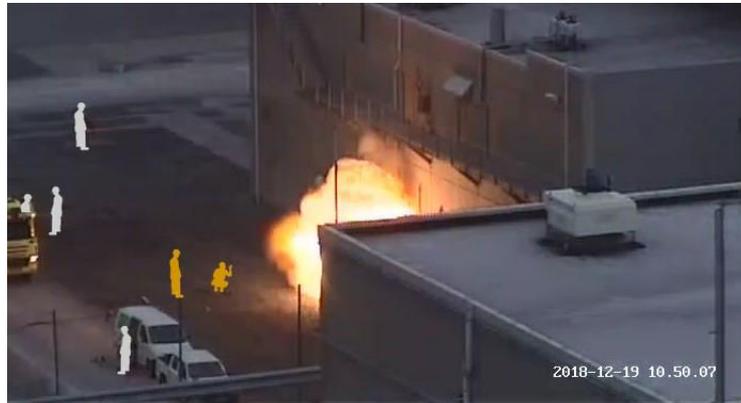
Upon arrival at the scene of the smoke source, the ERT confirmed the smoke production by briefly opening the door at 10:48:28, and then prepared for action using CO₂ hand-held fire extinguishers. The ERT leader repeatedly ordered the control room to shut down the power supply to ensure safe access. The on-call electrician, who normally has one hour to mobilize, happened to be at the facility for another job and hastened to the central control room to disconnect the high-voltage room. During this period, more smoke detectors signaled smoke in the sub-station. At the incident site, preparations were also made for fire suppression with water in case the hand-held extinguishers were not sufficient. Fire hoses were therefore arranged next to the high-voltage room door. Personnel in the ERT retreated from the high-voltage room door, while awaiting confirmation of electrical isolation. Shortly afterward, flames were observed from the high-voltage room, immediately followed by an explosion at 10:50:06, as the smoke gases in the high-voltage room ignited, violently forcing the door blades open, as seen in Figure 1.

At this point in time, no one from the ERT was in close proximity to the high-voltage room door. Nobody was injured by the fire or the explosion, but ambulance, police, and the local fire department arrived at the plant, in accordance with normal procedures. The yellow personnel indicators in Figure 1 show that the personnel had been very close one minute earlier, and that when opening the door,

Figure 1. Closed-circuit television (CCTV) photo including location of personnel during the explosion (in grey) and approximately one minute earlier (in yellow) [16].

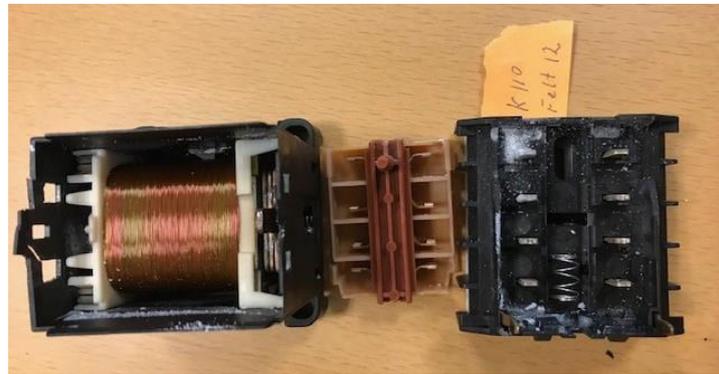
When the booster compressor was still running and the reactor spools were still engaged, the current flowing through them should have been 1770 A or 1930 A, respectively, for the start reactors of 0.3Ω and 1.0Ω . This current does not harm the reactors, while gradually heating the spools for a short period of time. Prolonged periods of heating (i.e., minutes) would, however, lead to severe overheating. The continuous heating was most likely caused by a failure in a relay, electrically insulated with polyamide, as presented in Figure 2. The investigations revealed that this relay had much friction, preventing it from operating properly. White crystals, chemically identified as adipic acid, were collected from the relay, as seen in Figure 2. Adipic acid may be a decomposition product from polyamide and may have caused the friction, leading to a stuck relay and prolonged reactor engagement.

Figure 2. Relay with traces of white adipic acid crystals [16].

Electrical components, especially those with mechanical movable parts, have a certain cycle of operation and therefore require monitoring, maintenance, and replacement at designated frequencies. In this case, a malfunctioned relay resulted in the severe overheating of the reactor spools, and thus the condition of relays should be included in the maintenance schedule.

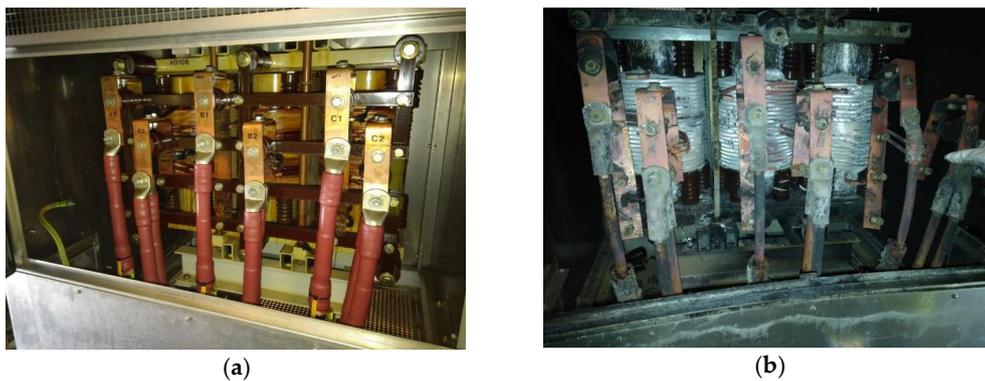
There was no separate thermal protection system monitoring the reactor temperatures. They were only monitored by the logic controlling the magnetization. As the reactor spools were continuously engaged, and heating up, they started to decompose/pyrolyze the electrical insulation materials, leading to smoke production and a potentially ignitable smoke layer trapped beneath the high-voltage room ceiling.

Figure 3. Intact reactor spools (a) and reactor spools with insignificant remains of carbonized insulation material (b) [16].

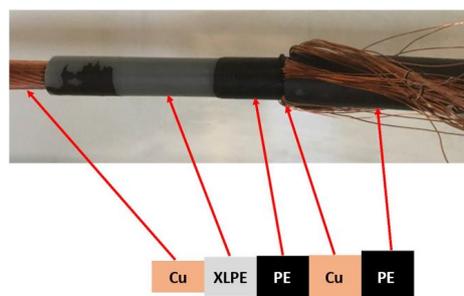
Figure 4. A representative copper (Cu) cable opened to show the layers of cross-linked polyethylene (XLPE) and polyethylene (PE) insulation, as presented in Table 1 [16].

When heating XLPE and PE to about 400 °C, ethylene, hydrogen, and soot products as well as numerous other products start to form [17]. In this particular case, about a 10-meter length of cabling was pyrolyzed, with only a minimum of residue on the cabling. According to Table 1, 10 m of cabling corresponds to about 8.3 L of PE and XLPE being pyrolyzed. It was evident that the aluminum ceiling in one of the cabinets had melted, indicating temperatures above the melting point of aluminum (i.e., above 660 °C).

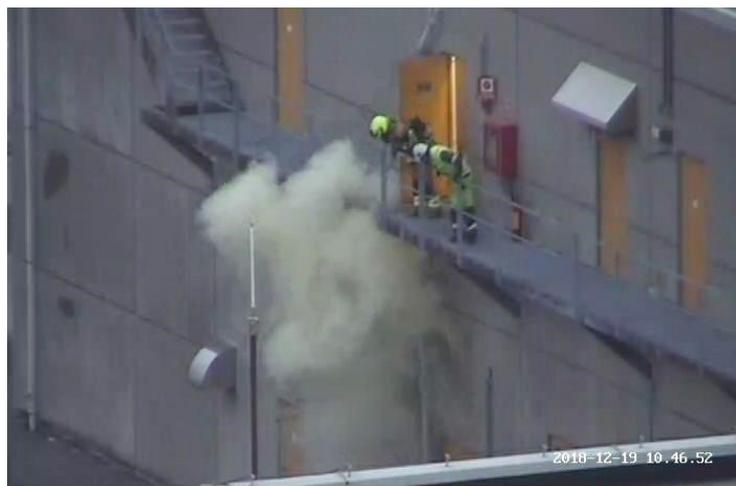
Since the pyrolysis products were hotter than the ambient air, the resulting buoyant plume entrained air, while rising to the ceiling [7]. As above-mentioned, at 10:46:52, the door to the high-voltage room was opened. This resulted partly in the ventilation of pyrolysis products, as seen in Figure 5. It can be clearly seen that the smoke was lighter than the ambient air and rose buoyantly when released through the door opening. It should be noted that the operator at ground level, not visible in Figure 5, did not see any open flames when looking into the room, either at the electrical equipment releasing pyrolysis products or in the smoke layer. The high-voltage room door was then closed, and the accumulation of combustible pyrolysis products under the ceiling continued and most likely accelerated with increasing spool and wire temperatures [17]. At 10:48:50, an operator, fully dressed in firefighter PPE, slightly opened the door to evaluate the situation and then quickly closed it. Two minutes and 25 seconds later, the smoke gas ignited and resulted in an explosion, violently forcing the door of the high-voltage room open. A two-second CCTV photo sequence of the smoke gas explosion is shown in Figure 6.

Figure 5. Pyrolysis products ventilated when briefly opening the door to the high-voltage room at 10:46:52 [16].

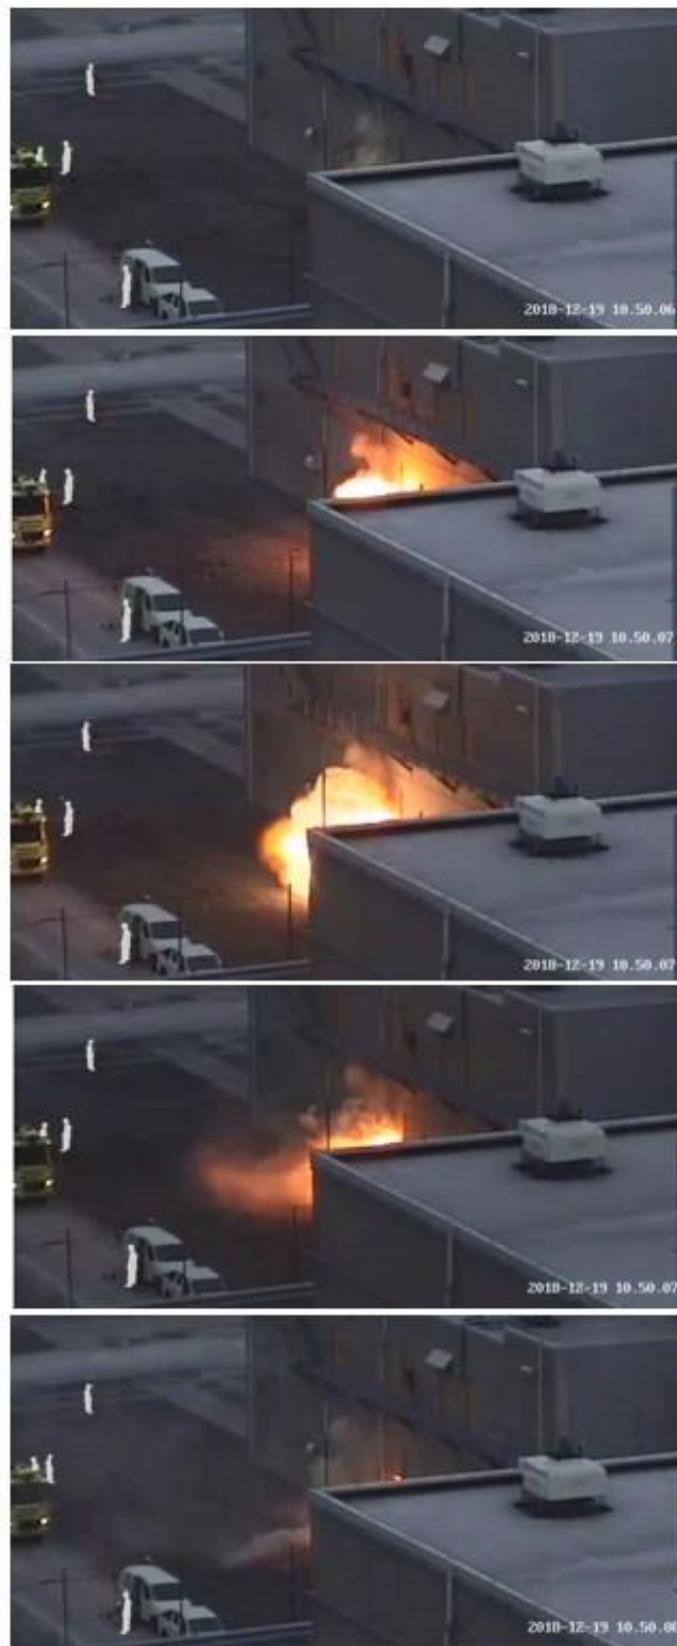
Figure 6. A two-second sequence of photos showing the explosion at 10:50:06–10:50:08. The location of personnel in close vicinity to the ignition is shown as white markers [16].

The flame colors seen in Figures 1 and 6 indicate approximate flame temperatures near 900 °C [7]. Estimating the flame ball exiting the high-voltage room door at about 100–150 m³ indicates an immediate factor 2 expansion, relative to the initial reactor room of 123 m³. If the whole room was filled with an ignitable smoke gas, a resulting temperature of 900 °C would, according to the ideal gas law, have given an expansion of factor 4 (i.e., a flame volume of close to 500 m³ should then have been propelled out through the door opening). It may therefore be concluded that the ignitable smoke gas filled a fraction of the available 123 m³ (i.e., it did not fill the whole room). This conclusion is also supported by the soot marks on the door, as seen in Figure 7, indicating soot deposits on the upper part of the door and limited soot deposits on the lower part.

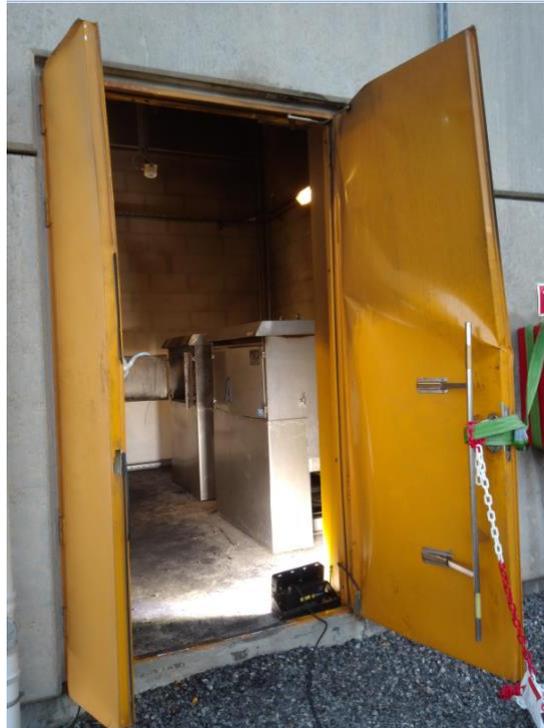
The sub-station is a solid concrete building, designed to survive certain external explosion loads. It was therefore quite robust regarding possible internal explosion forces. The weakest point was the closed high-voltage room entrance door, which was slammed open. It thereby acted as an explosion pressure vent. A photo of this double door, after the smoke gas explosion, is shown in Figure 7.

Figure 7. The high-voltage room door after the explosion [16].

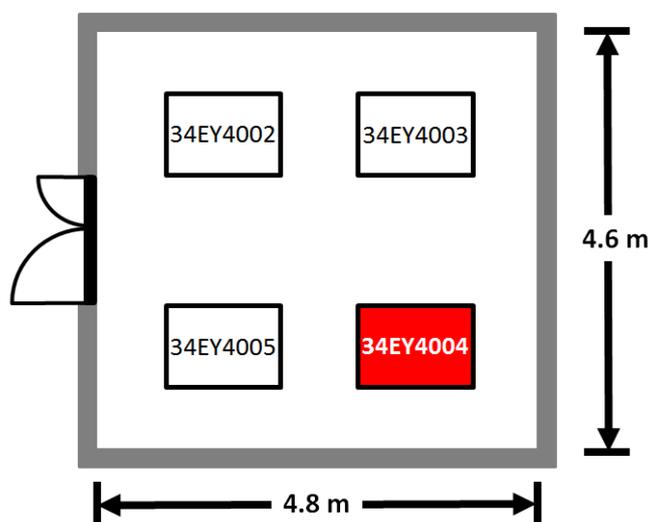
The interior dimensions and the layout of the high-voltage (reactor) room are shown in Figure 8. The volume of the room was about 123 m³. The interior surfaces were essentially exposed concrete, with very few combustibles. It basically contained the four reactor spools including their associated cabling. The reactor spool units tagged 34EY4002 and 34EY4003 were connected to other equipment at the plant and did not suffer any damage in the incident. The reactor tagged 34EY4004 was severely damaged due to overheating, as seen in Figure 3b, while the reactor spool unit tagged 34EY4005 was less damaged. Assuming that about 7 kg of electrical insulation materials were pyrolyzed, this would give a concentration of about 57 g/m³ if the whole room volume was involved, or 85 g/m³, if only the upper two thirds of the room were filled with smoke. Although some particulate materials and aerosols may have settled on available surfaces, it can be concluded that at least the upper part of the room was filled with ignitable smoke gas, with concentrations between the LFL and the UFL.

Figure 8. The high-voltage (reactor) room layout and dimensions including tag numbers and internal dimensions. The equipment that overheated is marked in red.
