Article

Detection and Diagnosis of Defect in GIS Based on X-ray Digital Imaging Technology [†]

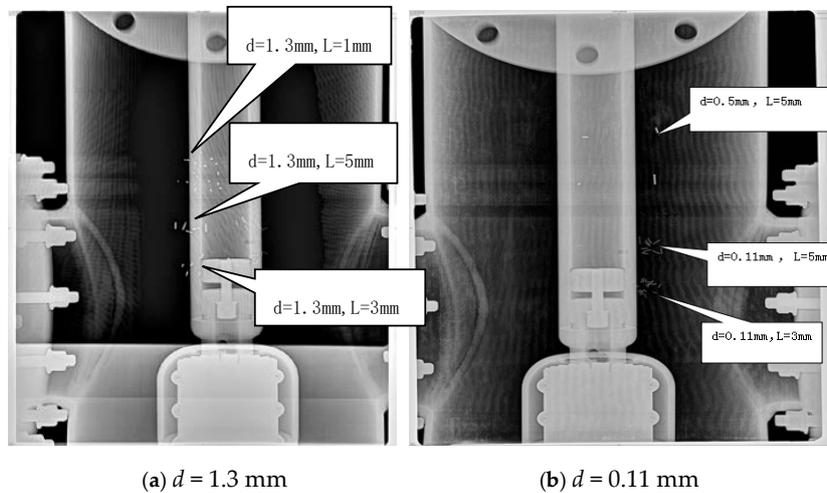
It can be seen that the metal particles with the two kinds of diameters in the GIS tank can be clearly imaged, and the particles in Figure 8 were proportional to their length. However, the metal particles with a diameter of 0.11 mm and a length of 1 mm were not clearly imaged. By comparing the length of

columnar particles of 3 mm and 5 mm, it showed that the length of metal particles with a diameter of 0.11 mm was still in the corresponding proportion. It is proved that the free metal particle can be well detected by X-ray digital imaging technology.

Figure 8. Free metal particle.

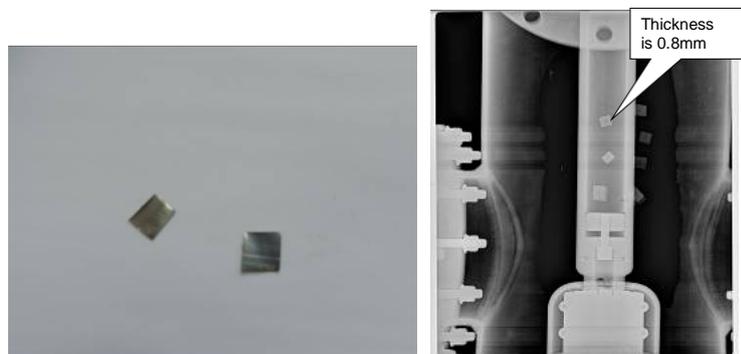
Figure 9. Metallic flaky particle.

Figure 9 shows that the image of iron-free particles is clear, and the non-metallic flaky particle could also be distinguished in Figure 10. Considering the thickness of the gaskets used in site installation process of GIS is generally over 1 mm, the X-ray digital imaging technology can be used to detect the flaky particle omitted inside the tank clearly.

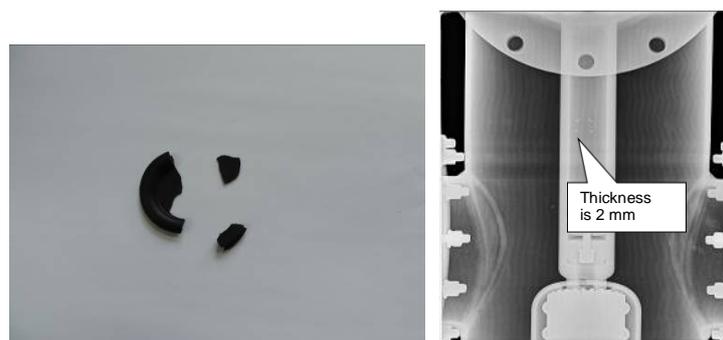
Figure 10. Non-metallic flaky particle.

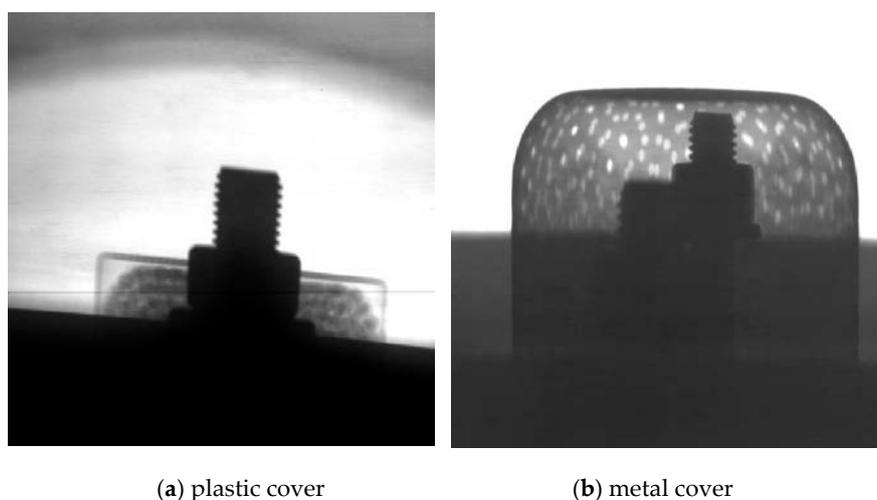
Figure 12. The images of adsorbent cover with different materials.

It can be seen that the outline and mesh of the plastic adsorbent cover are not clear, while the adsorbent (molecular sieve particles) and the corners of the cover can be seen clearly. This is mainly

due to the thin material and small density of the plastic adsorbent cover. And the outline of the cover is not clear compared with the negative.

For the metal adsorbent cover, the outline and mesh are clear, but the adsorbent is not obvious. It is because the adsorbent cover is thicker, and the stainless-steel density is larger, which increases the difficulty of X-ray penetration and the contrast of the adsorbent cover. As a result of casting technology, the cover has no corners and edges, which also reduces the electric field strength of the adsorbent cover.

According to the features above, the material of the adsorbent cover in GIS can be clearly distinguished and hidden troubles can be investigated in the visualization detection by X-ray digital imaging technology. The major problem that the adsorbent cover defect is difficult to identify and judge effectively could be solved, and this detection method provides strong technical support for condition-based maintenance of GIS equipment. Moreover, the equipment power outage and blindly disassembly inspection is also avoided.

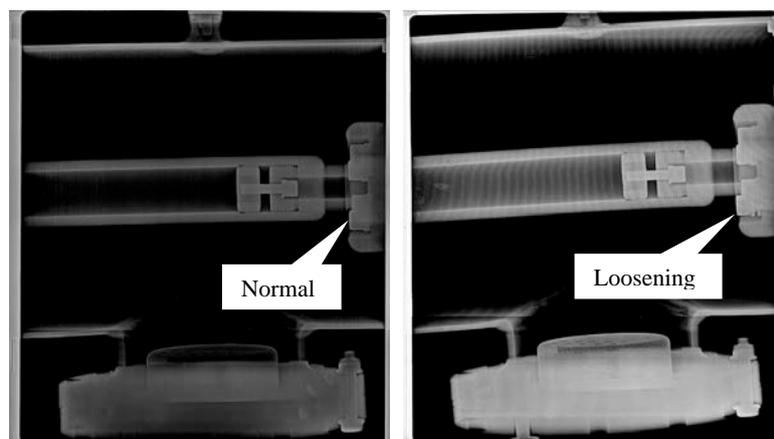
The normal and loosened metal screws are shown in Figure 13. The bolt loosening defects in GIS are visible under X-ray digital imaging. The slightly loosened bolt can continue live operation in a short time, but the gasket has loosened and may lead to floating discharge. After long-term operation, it will endanger the safety of the equipment.

Figure 13. The normal and loosened metal screws.

As the examples show in Figure 13, slight loosening of the screw (less than two threads) can be judged as a general defect. If the bolt or screw is only slightly loosened within two threads and still in the hood with no PD, it would be evaluated as a state of attention.

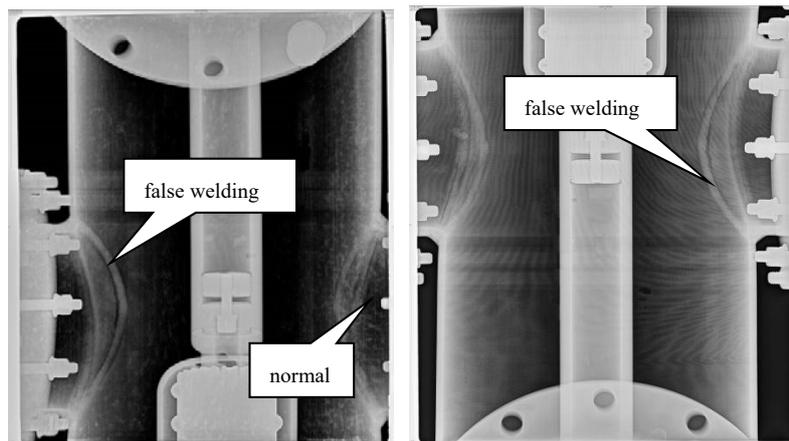
The compressed tank needs to be welded at the joint. Because the GIS tank is thick, it is easy to produce false welding. The tank may not leak gas after welding for a short time. However, after long time operation, especially when welding parts are corroded and exposed to the air directly, it will cause gas leakage and pose a threat to the safety of the equipment. Figure 14 gives an example.

Figure 14. The normal and loosened metal screws.

For GIS with false welding joints or lines in X-ray digital imaging atlas, if welding parts are found by on-site appearance inspection to be exposed in air due to the tank corrosion, it is recommended to evaluate them as an attentive state. And for non-corroded wedding joints, it can be regarded as a normal state.

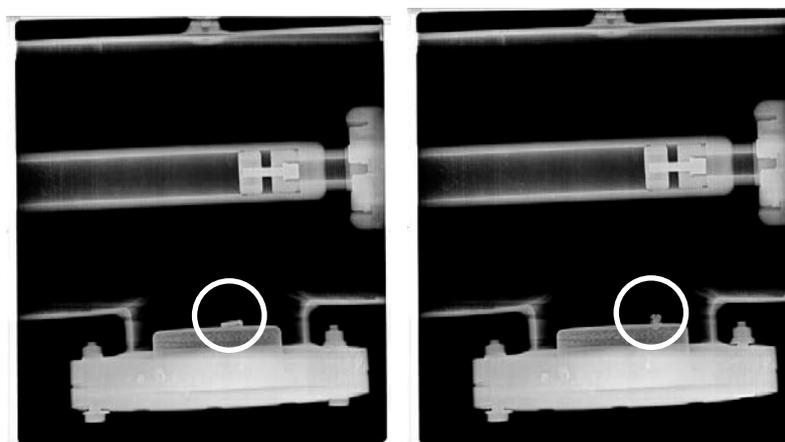
The particle trap inside the GIS is used to capture foreign bodies in metal or non-metallic impurities. Because the foreign bodies in the particle trap does not pose a threat to the electric field, the equipment can still be operated. However, if the foreign bodies are too large or accumulated for a long time, it may pose a security threat as shown in Figure 15.

Figure 15. Foreign bodies in the particle trap.

Generally, metal or non-metallic foreign bodies in the particle trap can be identified as general defects. If there are more than three foreign bodies or the height is higher than one-third of the particle trap, it is recommended to evaluate the state of attention.

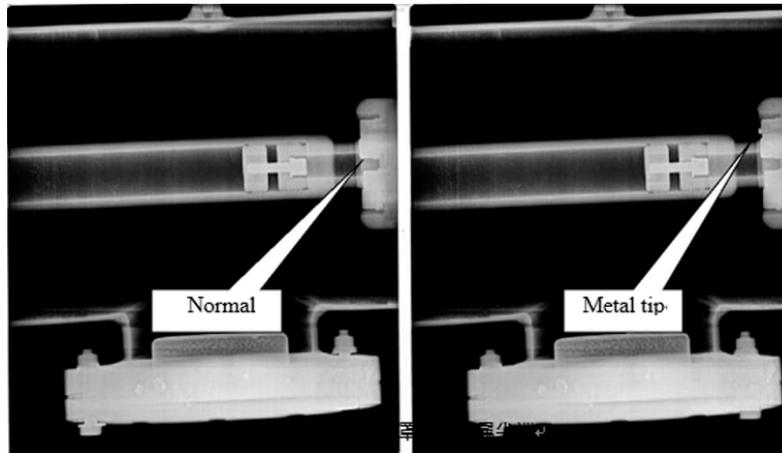
The grading shield is a part of GIS equipment to balance voltage and reduce the electric field. Generally, the metal tip in the grading shield will not pose a threat to the operation of the equipment. However, the protruding tip, especially the tip burr, which is easy to fall off, may cause partial discharge. And it can lead to breakdown failure of GIS in serious cases. Figure 16 gives an example.

Figure 16. Metal tip in the grading shield.

Thus, the defect identification basis in X-ray digital imaging is firstly determined. The sharp burrs, which are easy to fall off, can be judged as a general defect, and it is suggested to be evaluated as a state of attention. If there is no burr that is easy to fall off and only the inner corner bolt in the grading shield, it should not be judged as a general defect.

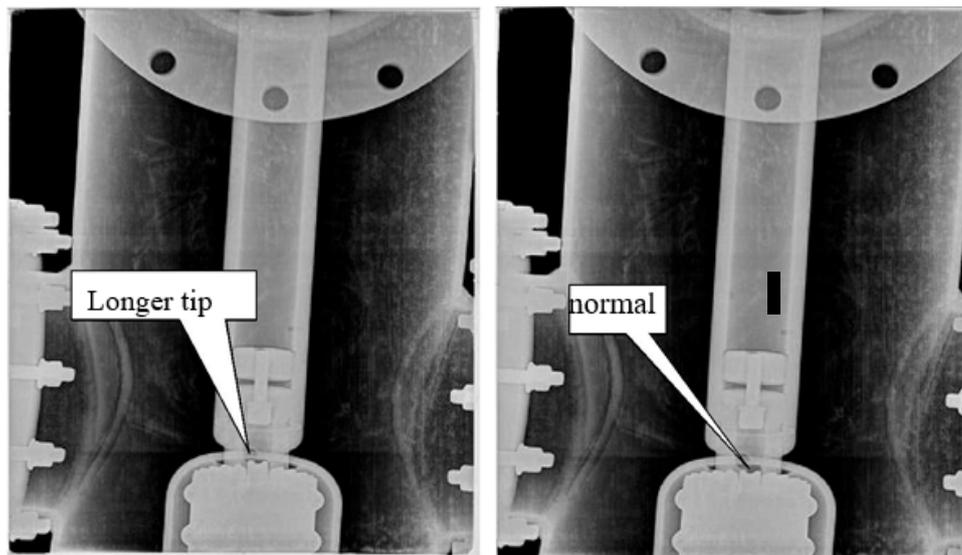
Long metal tips (such as contact fingers) in the grading shield will change and crack the electric field distribution. Serious cases will result in partial discharge and even equipment failure.

Thus, if a long metal tip in the grading shield (which has exceeded or will exceed the grading shield) can be clearly seen, it can be judged as a serious defect and evaluated as an abnormal state. Figure 17 shows a typical atlas.

Figure 17. The long metal tip in the grading shield with no partial discharge.

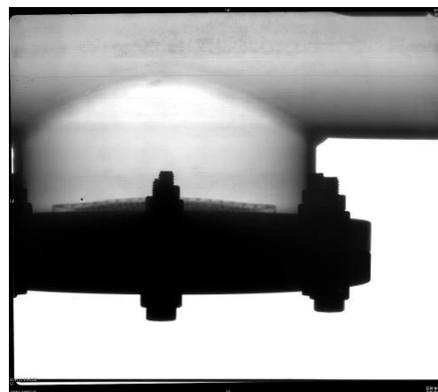
If the general-plastic adsorbent cover (need to be verified with the manufacturer) can be determined as Figure 18 indicated, it is recommended to be evaluated as a serious defect. For the post-commissioning equipment, it can be evaluated as an abnormal state.

Figure 18. Adsorbent cover made of general plastics.

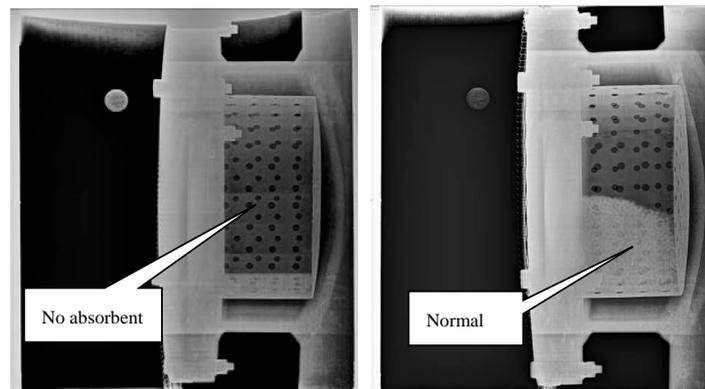
After the equipment is put into operation, the moisture content of SF₆ in the tank will naturally increase due to the difference of water pressure inside and outside the tank and the accumulation of water on the surface of the components inside the tank. The excessive moisture content will reduce the insulation performance of internal insulation materials to a certain extent, especially for solid insulation materials. In order to avoid the impact of excessive moisture on the safe and stable operation of the equipment, the adsorbent will be placed inside the GIS, which has the effect of absorbing water and reducing the moisture in SF₆. However, sometimes the factory or site installation personnel do not strictly implement the process flow, which would cause the forgotten of adsorbents installation, like Figure 19 shows.

If the missing of absorbent is found in the X-ray digital imaging atlas, while the moisture has been inspected to be not exceeding the standard, it can be judged as a serious defect and abnormal state.

Figure 19. Abnormal and normal absorbent.

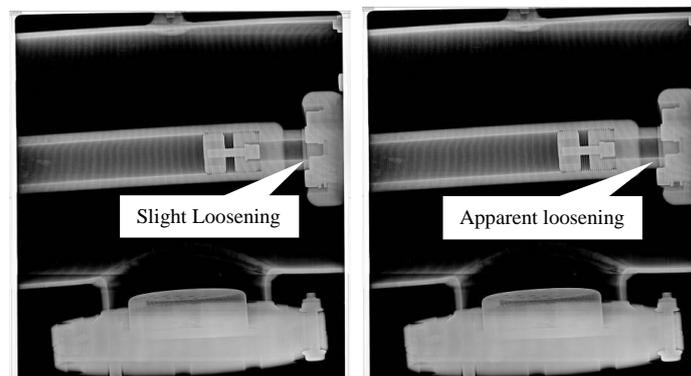
If the screw is loosened apparently (more than two threads) and partial discharge characteristic is detected, it consequently can be judged as a crisis defect and recommended to be evaluated as a serious state. Figure 20 shows the X-ray detection atlas of examples.

Figure 20. The obviously loosened metal screws in the grading shield with partial discharge.

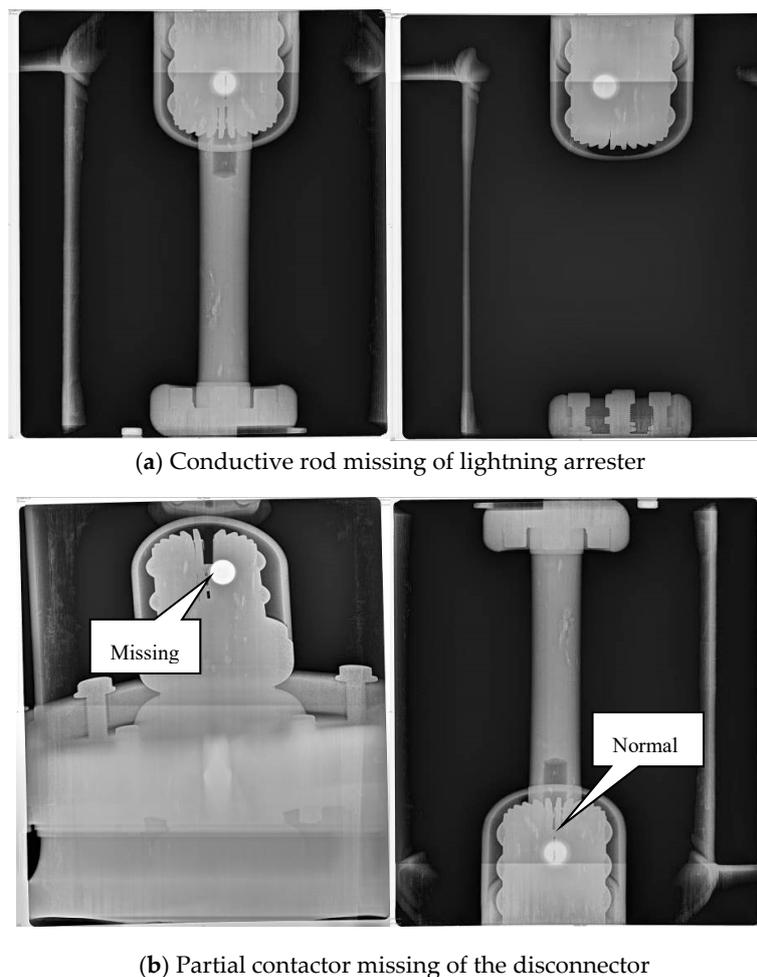
In extreme cases, some key parts of the equipment, such as a conductive rod, grading shield, are missing or partially missing because of the poor quality of the installation process. Figure 21 shows two examples of a conductive rod missing and partial contactor missing, which have been successfully found in the substation field by X-ray digital imaging detection.

Figure 21. Examples of key components missing.

This kind of defect will pose a great threat to the safe and stable operation of the equipment, and even directly lead to failure. As a result, the missing key components found in X-ray digital imaging can be judged as critical defects, and it is recommended to be evaluated as a serious state.
