Water Wall Tubes' High Temperature Corrosion Root Cause Investigation: A 300 MW Level Boiler Case

Xiaohe Xiong, Falin Chen, Liangyu Li and Houzhang Tan *

MOE Key Laboratory of Thermo-Fluid Science and Engineering, Xi'an Jiaotong University, Xi'an 710049, China
* Correspondence: hzt@xjtu.edu.cn

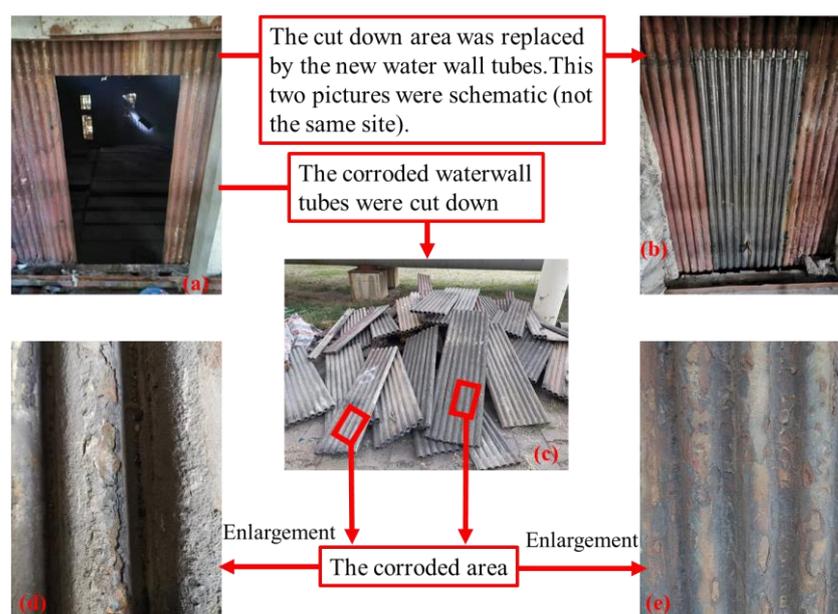
During the boiler maintenance period, after the boiler operation was stopped, the larger water wall areas were found to be severely corroded among the four walls. The thinnest tube thickness is only 3 mm, with a 50% thickness reduction rate. Generally, the water wall tube is required to be replaced by the new tube when the thickness reduction rate exceeds 30%. Hence, large areas of the water wall tubes were cut down and renewed, as Figure 1a–c shows. As for the corrosion details, large corrosion products covered the tubes, presenting a multilayer and colorful structure, as seen in Figure 1d,e. Part of the iron substrate was corroded and fell from the tube.

Figure 1. The water wall inspection during the boiler maintenance period. (a) The cut down area in water wall; (b) The repaired area in water wall; (c) The cut down corrosion water wall tubes (d) The enlargement of the corrosion tubes, I; (e) The enlargement of corrosion tubes, II.

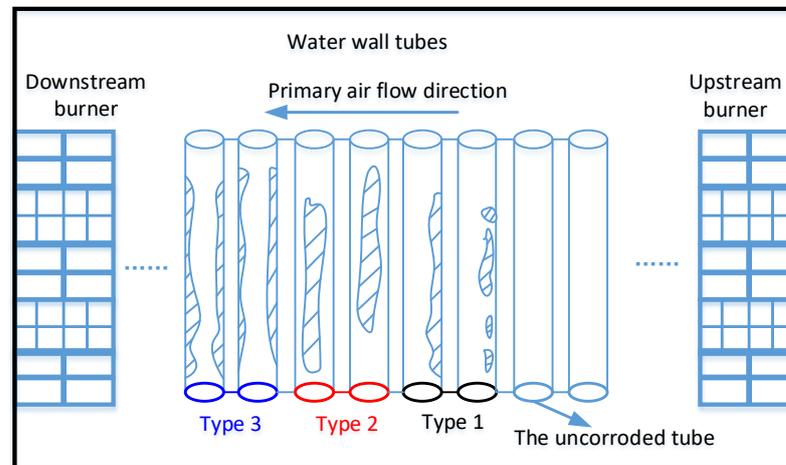
After careful observation of the inside furnace, when the boiler was stopped for maintenance, the corrosion morphology can be sorted into three types, as in the shadow area shown in Figure 2. The primary air jetted from the burners at four furnace corners formed an anticlockwise tangential flow in the furnace. For each wall (front, rear, left and right wall), near the corner adjacent to the upstream burner, the tubes are normal and uncorroded. Along with the downstream of the primary air flow, corrosion occurred on the right side of the tubes, namely type 1. As the primary air flow moved on, followed by the type 1 corrosion area, the corrosion occurred at the middle area of tubes, namely type 2. Then, continuing moving, the corrosion area occurred at both the left and right sides of the tubes, namely type 3. The corrosion location in each tube from type 1 transition to type 3

implied the change of fluid state outside the water wall tubes. Along with the direction from the upstream flow to downstream flow, the fluid state had changed from laminar to turbulent. This can explain how corrosion occurred in both two sides of the tubes (type 3).

Figure 2. Schematic diagram of three types of corrosion morphology.

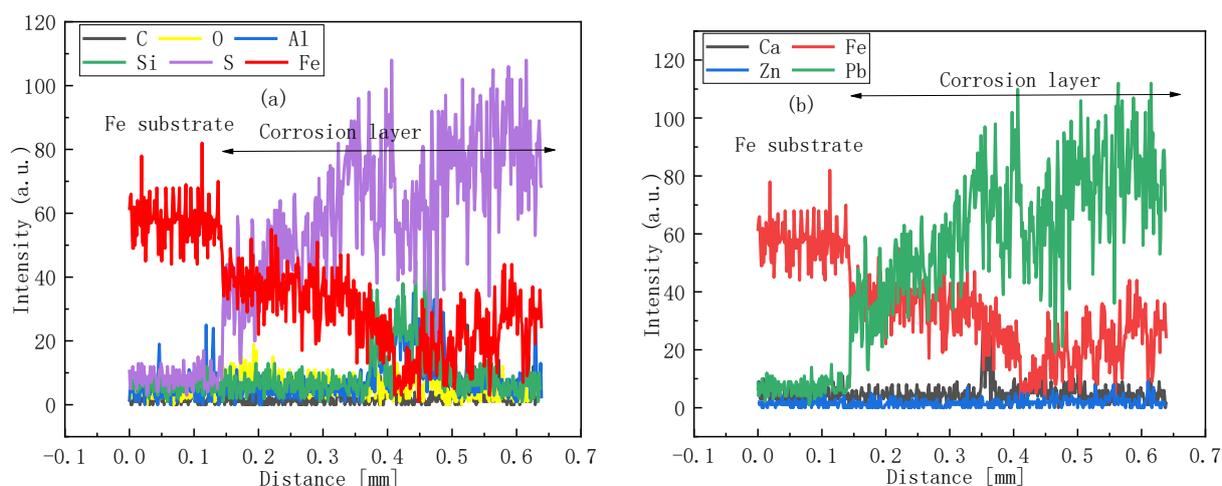
Generally, boiler high temperature corrosion caused by sulfur can be divided into two categories of H_2S corrosion and sulfate corrosion [19]. To further ensure the specific corrosion category, the sampling tubes element line scan test was conducted. Figure 4 displayed the element distribution of the ‘no coating’ processed tube. It was seen that adjacent to the Fe substrate was the corrosion layer, with a thickness of 482 μm . An apparent characteristic is the gradual decrease in iron content and the gradual increase of sulfur along the horizontal axis distance, as shown in Figure 4a. The existence of sulfur is a typical feature of H_2S corrosion. Meanwhile, the element lead (Pb) is also largely found in the corrosion layer. Along the horizontal axis direction, the larger the distance, the more the lead (Pb) content, as shown in Figure 4b. The lead (Pb) layer resulted from the PbS deposition during the coal combustion process [13].

Figure 4. The line scan results of the no coating processed tube. (a) Part I, element C, O, Al, Si, S and Fe; (b) Part II, element Ca, Fe, Zn and Pb.

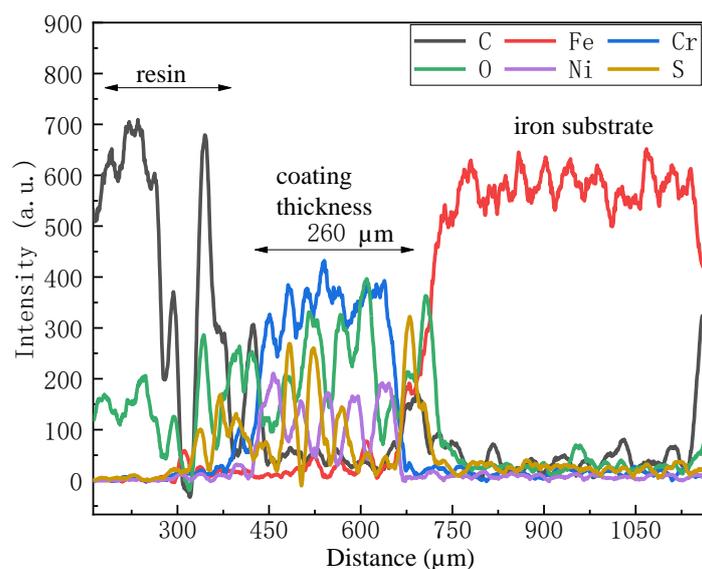
Figure 5 displayed the sample tube with the coating technology processed. Differently from Figure 4, the Cr and Ni were largely found while element Pb was not found. The elements Cr and Ni were mainly from coating material elements. The coating thickness was 260 μm . Meanwhile, the amount of sulfur was largely found in the coating layer but was rare in the substrate, showing that the existence of coating effectively prevents the sulfur from permeating into the substrate. With the aid of the coating layer, the sulfur-containing layer thickness was much reduced compared to that with no coating layer.

Figure 5. The line scan results of the coating processed tube (the data were smoothed by the Savitzky–Golay method, 50 points).

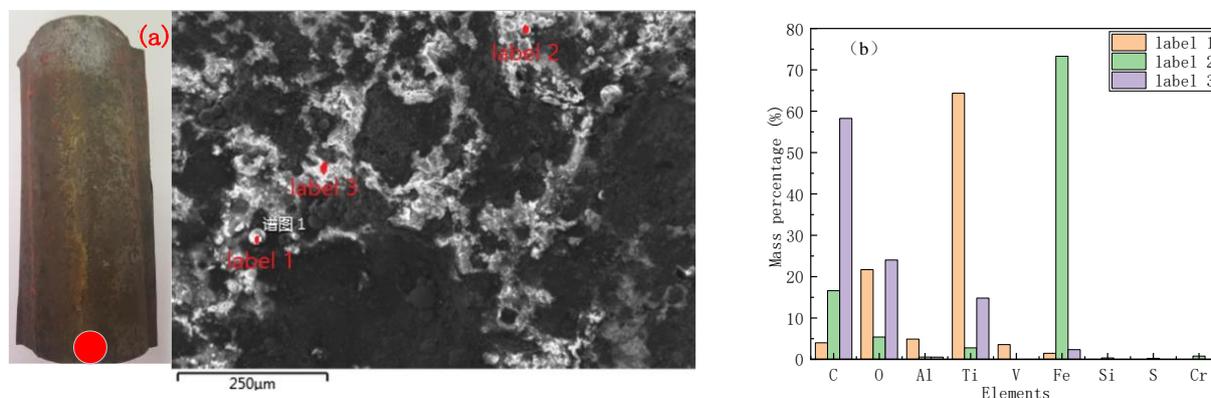
Figure 6a displayed the SEM morphology of the coating processed tube. There were many round balls with a diameter around 25 μm , as label 1 shows. The EDS results in Figure 6b showed that these round balls' element compositions were Ti, V, Al, etc., and their metallic oxides. Label 2 elements were mainly Fe and O, which were the results of iron substrate oxidation. The major label 3 element was carbon, which was from the unburnt fly ash.

Figure 6. The SEM morphology and EDS analysis of the coating processed tube. (a) Morphology of the cut down tube; (b) The EDS test results.

From the above characteristics analysis, it can be certified that the water wall tubes corrosion was caused by H_2S produced by the coal lean oxygen combustion. To further explore the corrosion rate, it is necessary to evaluate the H_2S source and concentration value.

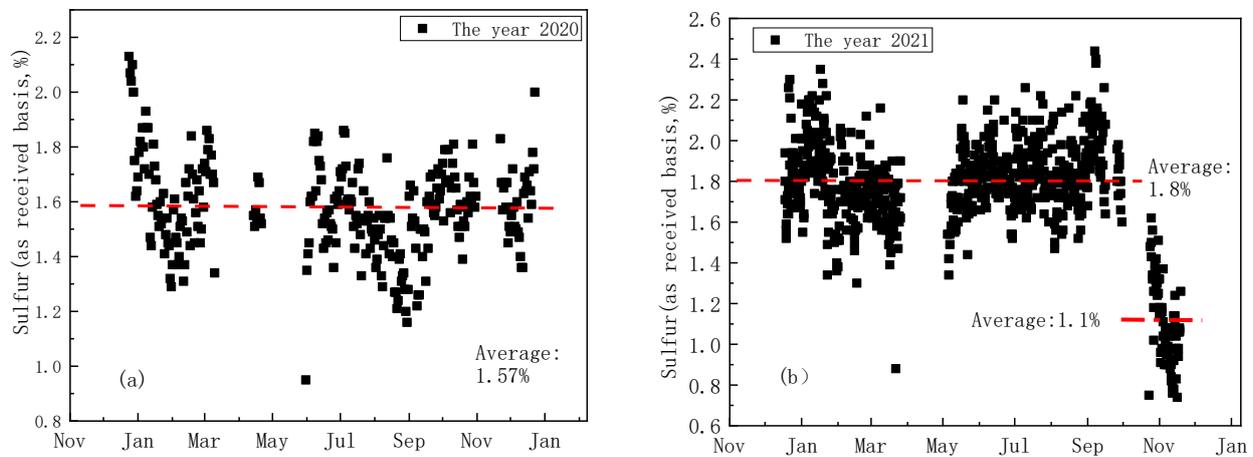
The formation of H_2S in the boiler was attributed to the coal combustion in an oxygen deficit ambience. Hence, the sulfur content in coal was, naturally, closely related with the H_2S concentration. Figure 7 listed the coal sulfur trend in recent two years. It can be seen that the sulfur was obviously larger in the first three quarters of the year 2021 compared to the same period of 2020. The average sulfur amount was 1.8% in the first three quarters of the year 2021, and the peak sulfur value reached 2.5%, which was the typical high sulfur coal. The sulfur started to decline until October. Even so, the average sulfur

was still as high as 1.1%. It was suggested to control the sulfur in coal to below 1% by coal blending technology if possible [14]. The high sulfur coal was detrimental to the control of H₂S concentration.

Figure 7. The coal sulfur comparison between the years 2020 and 2021 (The boiler was stopped for maintenance in April, no sulfur data). (a) The year 2020; (b) The year 2021.

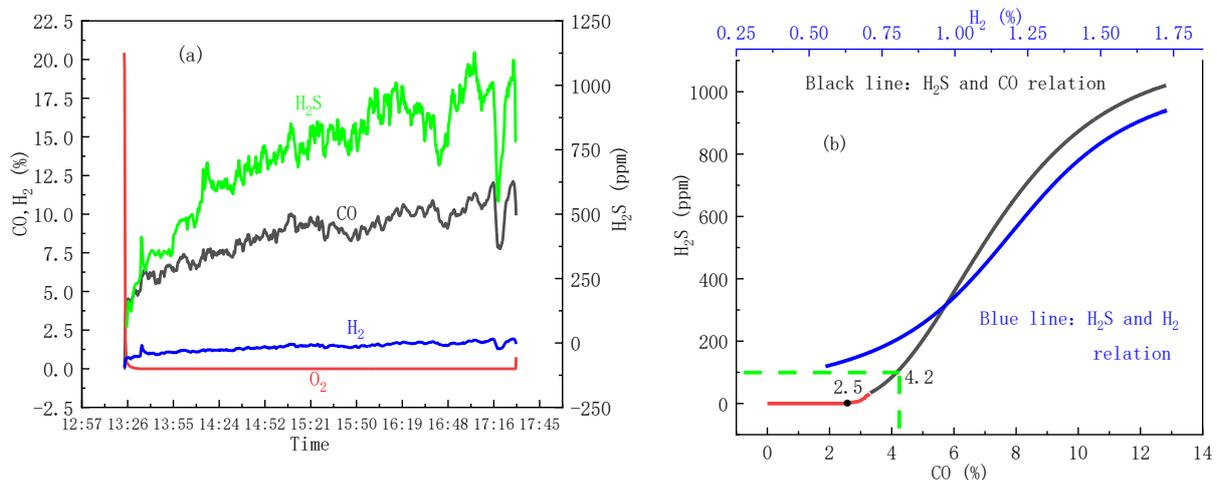
To further evaluate the reducing ambience near the water wall tubes, the H₂S, CO, H₂ and O₂ were synchronously tested after the boiler restarted operations when the maintenance was over. Figure 8a presented the test results in the boiler main combustion area. It can be seen that the H₂S and CO kept a gradual increase trend. The two parameters kept a good synchronism characteristic, i.e., increasing or decreasing concurrently. The peak value of CO reached 12%, while that of H₂S reached 1000 ppm.

Figure 8. The ambience near the water wall tube test in rear wall. (a) Flue gas species: H₂S, CO, H₂ and O₂; (b) The H₂S and CO, H₂S and H₂ fitting correlation curves based on (a).

The H₂S and CO curves were fitted, respectively, and the mutual relation can be obtained as the Figure 8b black line shown. Similarly, the H₂S and H₂ relationship can be obtained (the blue line). Fitting formulas were proposed as below, with the Adj.R-Square values of both correlations larger than 0.99.

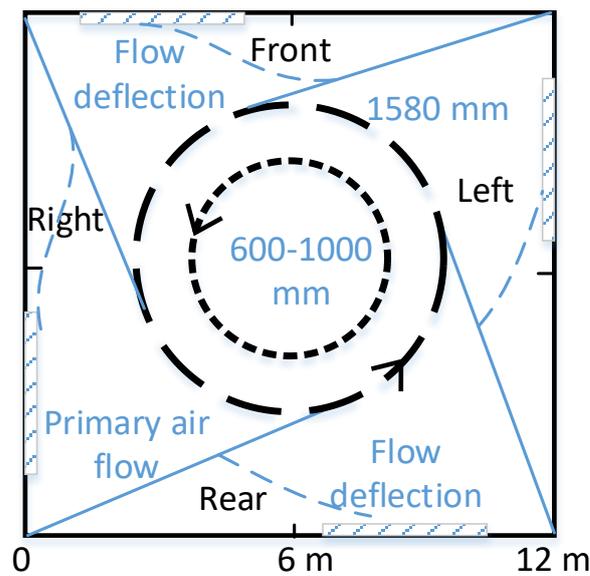
Figure 9. The diameter of imaginary circle of primary air schematic diagram.

According to this formula, even taking the upper limit value of k , the largest DICPA should be 1424 mm. That means the DICPA parameter is required to be no more than 1424 mm when designing the boiler. However, in practice, the DICPA is as large as 1580 mm. When the boiler was in operation, the real tangential circle diameter was 5 to 10 times the DICPA [22]. Hence, the primary air flows at four corners of the boiler are apt to deflect to the downstream direction with the action of upstream current. Then, the primary air would erode the tubes in the downstream area of water walls, as shown in Figure 9. The shadow area represents the severely eroded water wall tube area due to the primary air deflection. Hence, the DICPA is too large for this boiler and results in the primary air flow eroding the water wall.

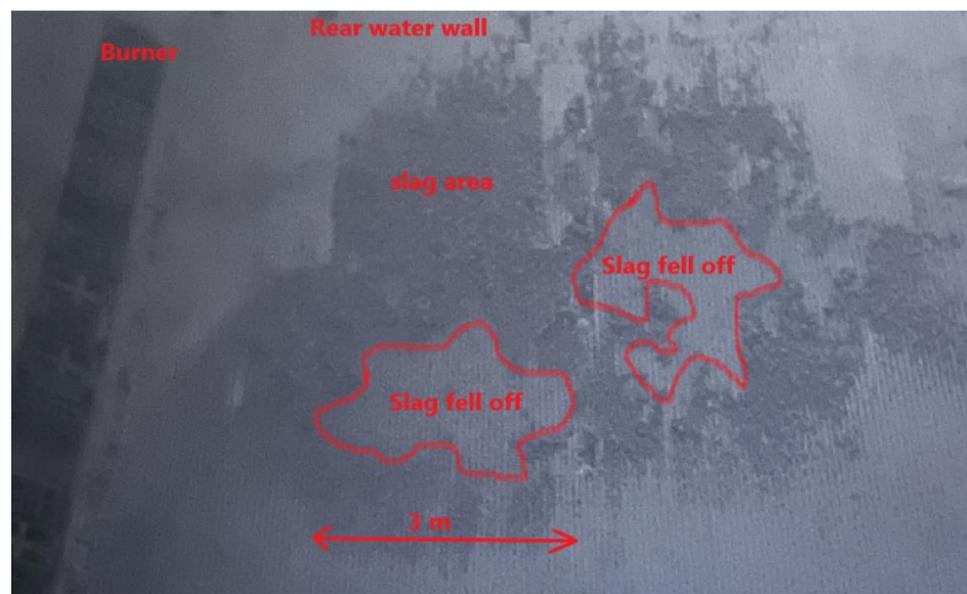
The slag adhering to the water wall tubes was a strong evidence for the overlarge DICPA. Figure 10 displayed the slag on the rear water wall during the boiler maintenance period. It can be seen that nearly the whole rear water wall was covered by the slag. The two red line areas were the traces of slag falling from the rear wall when the furnace temperature decreased during the boiler stop period. The length of one falling slag section was around 3 m. When the hot pulverized coal encountered the relatively cold water wall, the sticky coal particles in the primary air flow were condensed and adhered to the water wall. If the DICPA was smaller, the coal particles would have fewer possibilities to erode the water wall.

Figure 10. The slag on the rear water wall.

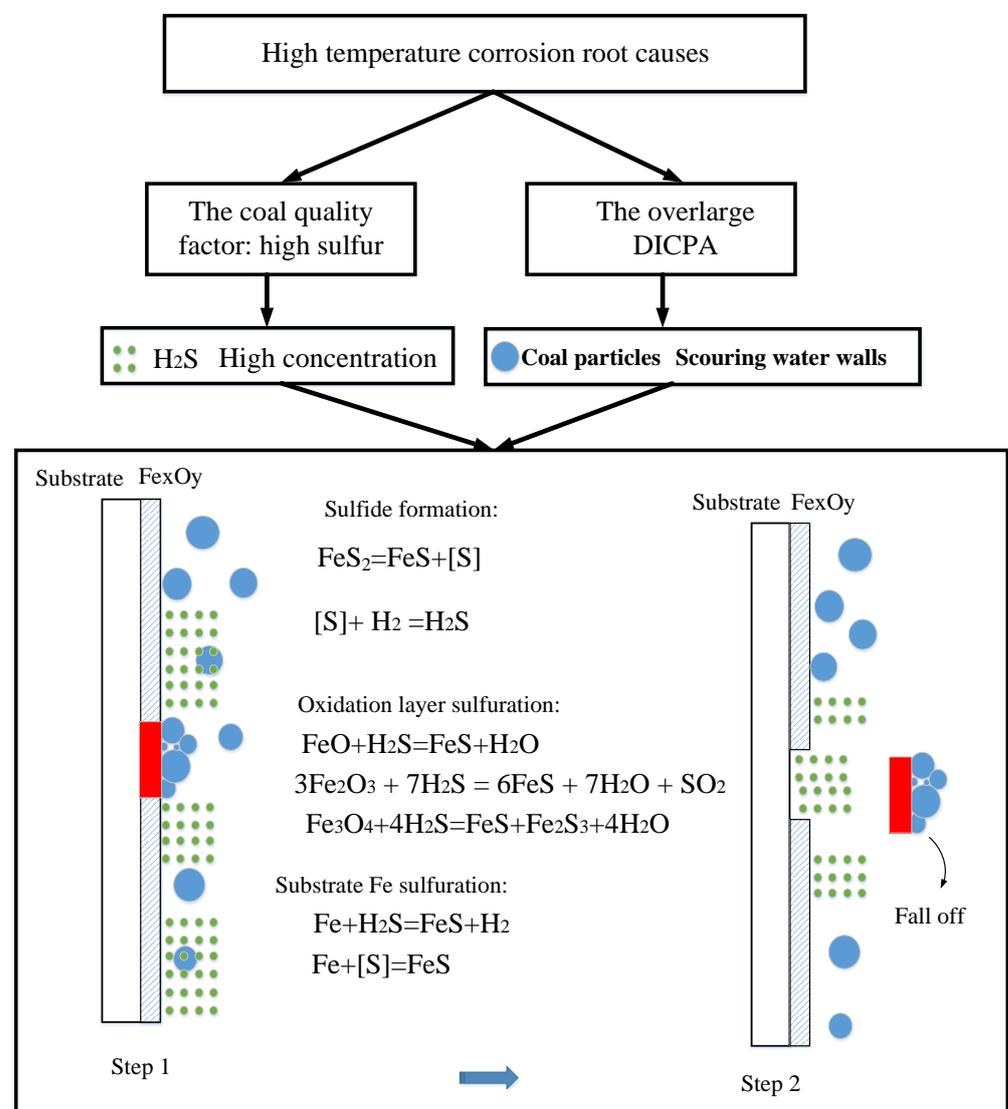
According to the above discussion, the high temperature corrosion root cause included the overly high sulfur content in coal and overlarge DICPA two factors. The over-high sulfur coal incurred high H_2S concentration near the water wall tubes when the boiler was in low NO_x operation mode. The corrosion rate was exponential to the H_2S concentration [23]. The higher the H_2S concentration, the faster the tube corrosion rate. In addition, the overlarge DICPA resulted in the pulverized coal eroding the water wall tubes in the downstream area. The fusion coal ash would be slagged on the water wall and further increased the tube surface temperature, which boosted the corrosion to a deepen extent. As for the specific H_2S corrosion mechanism, it can be seen in Figure 11. Specifically, the active sulfur atom came from the pyrite in coal. When heating, the pyrite releases sulfur atoms. Further, the sulfur atoms reacted with hydrogen to form H_2S . The active sulfur atoms and hydrogen sulfide were two strong corrosive media, which could directly reacted with the substrate iron and the iron oxide layer. In normal conditions, the iron oxidation was a protective layer.

According to the metal high temperature oxidation theory [24], a temperature of 570 °C was a critical point. Above this value, the oxide layer was consisted of FeO, Fe₃O₄ and Fe₂O₃ with a layered structure. Under this value, the oxide layer was only consisted of Fe₃O₄ and Fe₂O₃. Considering that the boiler main stream was subcritical, the water wall temperature must be lower than 570 °C. Hence, the oxide layer was composed of Fe₃O₄ and Fe₂O₃. When the oxide layer was converted into ferrous sulfide, the expansibility differs hugely between the iron oxide and ferrous sulfide layer. When the boiler undergone rapid increase or decrease in load, the water wall temperature varied considerably. With the aid of the thermal stress action, the ferrous sulfide layer had the tendency to fall from the substrate. Furthermore, the high temperature coal particles kept on scouring and deposited on the water wall. When the particles' weight accumulated to some extent, the corrosion layer, along with the coal particles, fell from the iron substrate. Then, the fresh iron substrate was exposed to the high temperature flue gas and the corrosion circle was restarted. The tubes were thinned after long period operation.

Figure 11. Water wall H₂S corrosion mechanism schematic.

content in coal. However, this is not feasible for the power plants due to the cost. The larger sulfur content in the coal usually corresponds to a cheaper price. Hence, not all plants can afford the low sulfur coal. In addition, the easiest thing for the field operator to do is adjusting the operation parameters, such as primary air velocity, secondary air velocity, coal fineness, air temperature, etc., to supply more air to the main combustion area to weaken the reducing ambience concentration. However, this would cause the NO_x increase to some extent. Hence, the key for operation adjustment is to keep a balance between the NO_x control and the corrosion rate control. According to the results in Figure 6b, if the CO concentration can be controlled under 2.5%, the high temperature corrosion would largely be relieved. However, considering the ultra-low NO_x requirement, in some of the boilers, especially lean-coal fired and anthracite fired boilers, CO lower than 2.5% is hard to achieve. If adopting the H₂S 100 ppm as a criterion [25], the CO concentration should be controlled under 4.2%. Likewise, H₂ is also in a category of reducing ambience gas. From the perspective of controlling H₂, the H₂ adjacent to the water wall should be controlled at under 2%. In this way, the water wall tubes' replacement frequency would be reduced. In addition, decreasing the DICPA is also effective path to relieve the high temperature corrosion. However, the tangential circle diameter reconstruction is a huge project. It requires a plentiful maintenance period, which is also not an easy thing for the power plants. Finally, the coating technology is also an effective tube protective measure. The aforementioned discussion illustrates the existence of a coating layer prolongs the water wall tubes' operation period. However, a factor to limit the large area coating is also the cost. To sum up, the feasible and economical measure is to adjust the operation parameter. Hence, it is necessary to install an online ambience system to monitor the H₂S, CO, H₂, etc., reducing the gases adjacent to the water wall.
