*Commentary*

## Lessons Learned from the 787 Dreamliner Issue on Lithium-Ion Battery Reliability

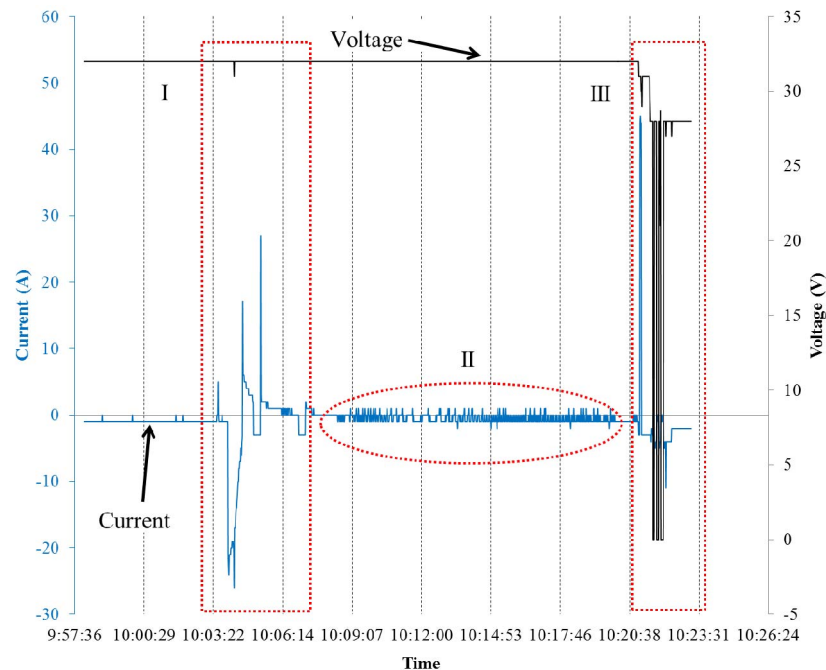
**Figure 1.** Battery voltage and current measured by the charger.

Figure 1 shows the battery voltage and current data measured by the battery charger over the full length of available data. This data can be divided into three zones. In Zone I (Figure 2), the voltage

remained constant at 32 V, except for a 1 V drop at 10:04:13. The current shows a discharge event and two charge events, as highlighted in the first box in Figure 1. The unchanging voltage is usually indicative of a constant voltage trickle charge. The discharge event may have been prompted by the APU, and the following charge events brought the battery back to its fully charged state.

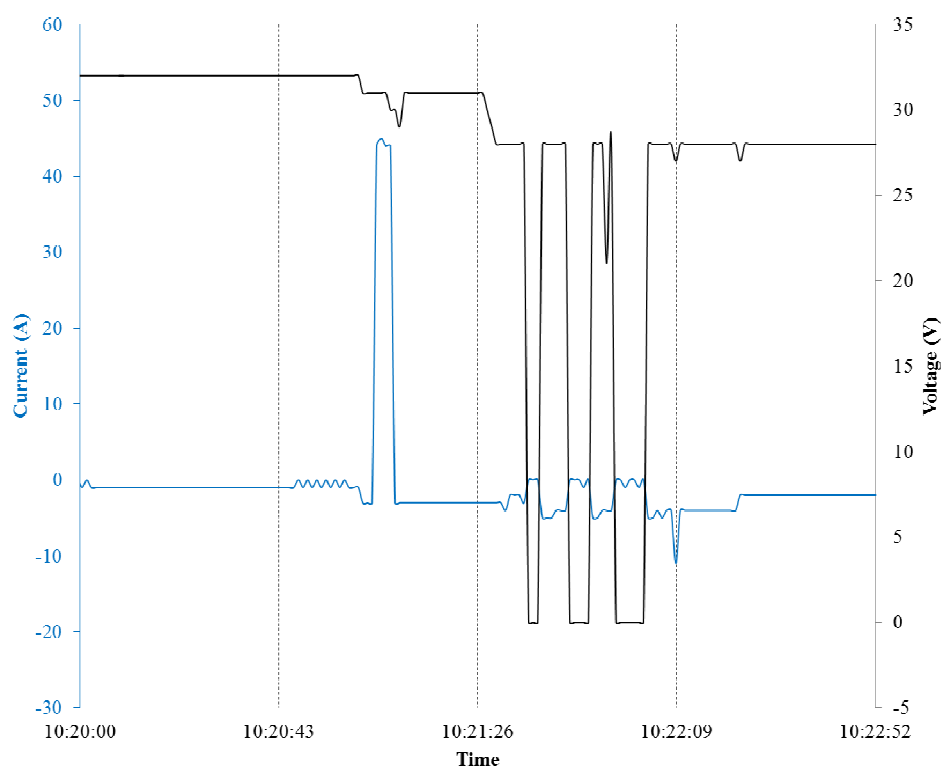
**Figure 3.** Zone III from FDR battery data.

Zone III, shown in Figure 3, presents the battery data from 10:20:00 to 10:22:52. At 10:21:01 the APU battery bus voltage decreased from 32 V to 31 V. At the same time, the current was negative, indicating either a discharge of the battery or a possible soft short circuit. From 10:21:04 to 10:21:07, the APU battery charging current increased to approximately 45 A for 4 s; however, the voltage decreased from 31 V to 30 V. This behavior is abnormal for batteries; usually, voltage increases or remains constant with a positive current. At 10:21:08 the battery switched to a discharge mode with  $-3$  A current, and at 10:21:09 the APU battery bus voltage dropped to 29 V. The voltage then increased to 31 V at 10:21:10 without a change in current draw. The engine indicating and crew alerting system (EICAS) message indicated that the APU battery failed at 10:21:15. The data shows that the battery continued to operate after the APU failure alert. At 10:21:30, the battery voltage dropped from 31 V to 28 V, and at 10:21:37 the APU battery bus voltage decreased to 0 V and returned to 28 V three times, while the current fluctuated between 0 A and  $-5$  A.

The sudden drop in voltage by 4 V was an indication that a single cell inside the battery pack was the initial starting point for the short circuit. Initiation of a short circuit will cause the potential difference in the cell to rapidly drop and approach 0 V. The voltage of the battery pack in the Dreamliner is the sum of each individual cell voltage. Therefore, a short circuit in one cell of a 32 V system would result in a 2.5–4 V drop in voltage for  $\text{LiCoO}_2$  batteries (depending on the state of charge).
