# Identification of the Destruction Model of Ventilated Facade under the Influence of Fire

**Abstract:** Ventilated facades are becoming an increasingly popular solution for external part of walls in the buildings. They may differ in many elements, among others things: claddings (fiber cement boards, HPL plates, large-slab ceramic tiles, ACM panels, stone cladding), types of substructures, console supports, etc. The main part that characterizes ventilated facades is the use of an air cavity between the cladding and thermal insulation. Unfortunately, in some aspects they are not yet well-standardized and tested. Above all, the requirements for the falling-off of elements from ventilated facades during a fire are not precisely defined by, among other things, the lack of clearly specified requirements and testing. This is undoubtedly a major problem, as it significantly affects the safety of evacuation during a fire emergency. For the purposes of this article, experimental tests were carried out on a large-scale facade model, with two types of external-facade cladding. The materials used as external cladding were fiber cement boards and large-slab ceramic tiles. The model of large-sc

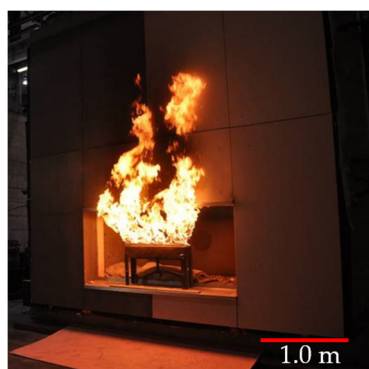
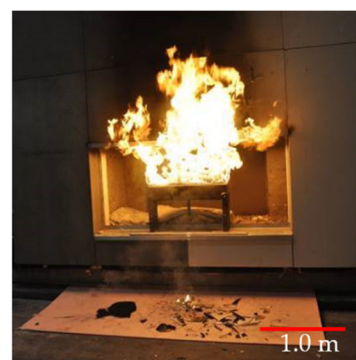
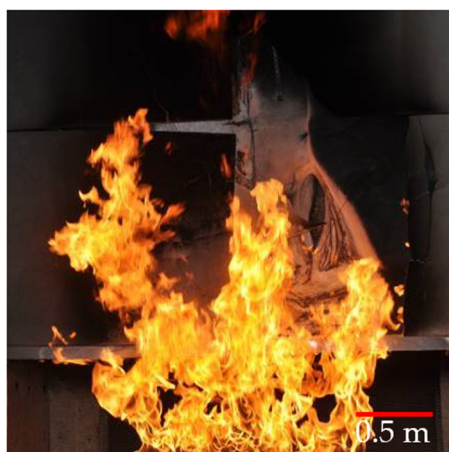
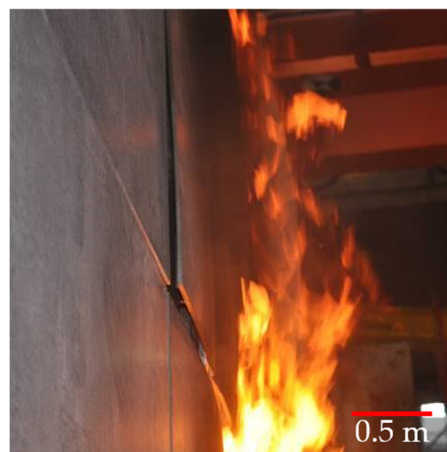
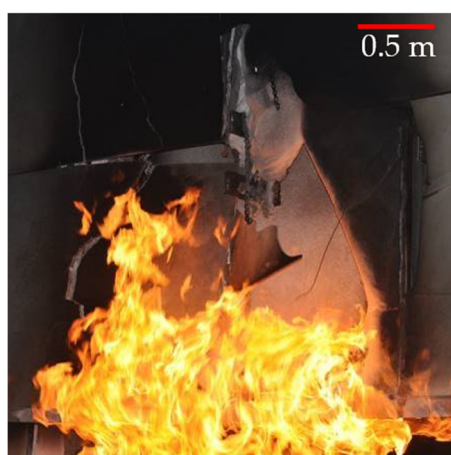
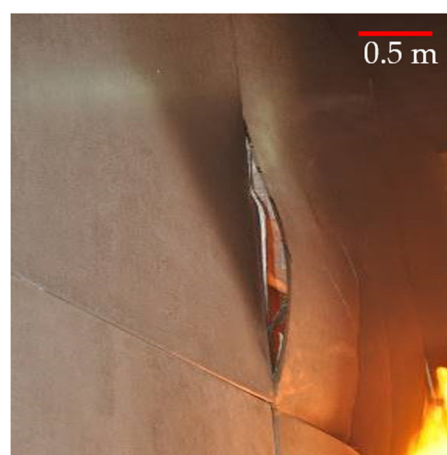
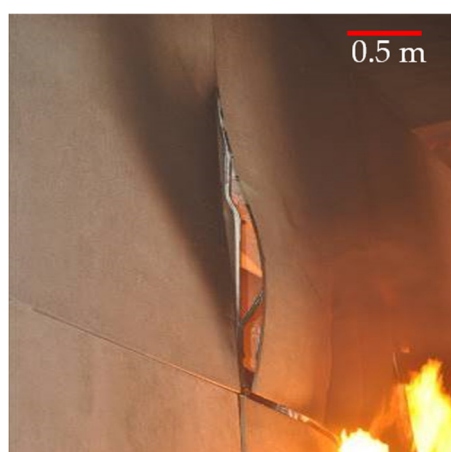
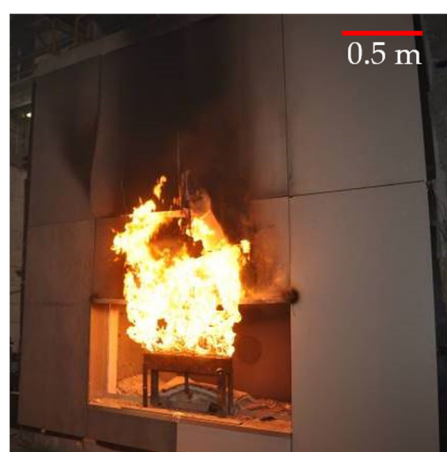
The test was carried out in a closed hall, with an ambient temperature of 18.9 °C and relative humidity of 60.7%. The test started with setting the burner and calibrating the gas release. The first 5 min of the fire revealed smoke/charring of the external cladding, no falling-off of the external cladding elements (Figure 4a).

The first falling-off of elements were observed in the 6th minute of the test, i.e., large-slab ceramic tiles elements started to fall off (Figure 4b). The subsequent minutes of high temperature impact caused greater destruction of the external cladding, particularly visible in the part where large-slab ceramic tiles were located. On 11th minute, the degradation of fiber cement boards started significantly. Figure 4c shows the initial stages of expansion of the fiber cement boards. The destruction of the large-slab ceramic tiles slowed down around 20th minute. The places where the temperature impact was highest were destroyed, and in the remaining places, large-slab ceramic tiles “tolerated” high temperatures quite well. Large-slab ceramic tiles had the greatest degradation in the first several minutes of fire. No further degradation of ceramic sinters was noticed.

**Figure 4.** Ventilated facade model view in subsequent test minutes.: (a) 1st minute of the test; (b) 6th minute of the test; (c) 11th minute of the test; (d) 21st minute of the test; (e) 31st minute of the test; (f) 41st minute of the test; (g) 56th minute of the test; (h) 61st minute of the test.

These materials destruct themselves also in another way. In the case of large-slab ceramic tiles, which have a uniform structure, the destruction takes place by cracking and falling-off of pieces of elements. In the case of fiber cement boards and their nonuniform structure, the boards, despite significant warping (deplanation) caused by high temperature (e.g., Figure 4e), do not fall off among others due to the good tensile properties of the fibers. Only complete destruction of the fibers causes the elements to fall off.

The test revealed cracking and falling-off of fragments of both fiber cement boards and large-slab ceramic tiles. This mainly concerned the external cladding located above the opening, i.e., above the fire source. Some of the claddings have detached from the grate but have not fallen off and hang on perforated steel tapes mechanically attached to the cladding. The maximum mass of a single component which fell off and dropped during the test was 1.15 kg. This was due to a safety system using a steel perforated tape and mechanical fasteners. Degradation of the large-slab ceramic tiles took place during the first few minutes, then this part of the facade was stable. Fiber cement boards behaved differently. The first minutes showed the stability of the fiber cement boards. From 11th minute, the boards started to show significant degradation progressing practically until the end of the test. If perforated steel tapes were not used, the cladding elements falling off the facade would probably be of considerable dimensions.

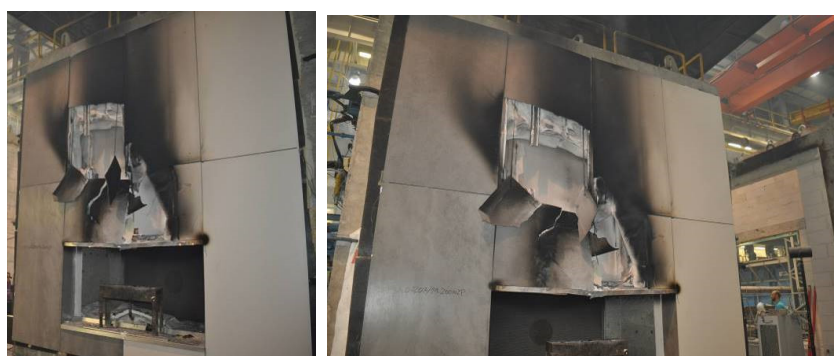
The horizontal upper splay, made of 0.5 mm thick steel sheet, deformed, but its location has not changed. The aluminum grate directly above the recess with the fire source, except in places directly sheltered by the steel top splay was burnt at a height of up to 1660 mm. Glass mineral wool was melted directly above the recess at a height of up to 1400 mm. The steel fasteners and consoles remained in place, as did the lower splay. Figure 5 shows the condition of the facade after the fire source was extinguished.

**Figure 5.** Ventilated facade model view after the fire source was extinguished and the test was completed.

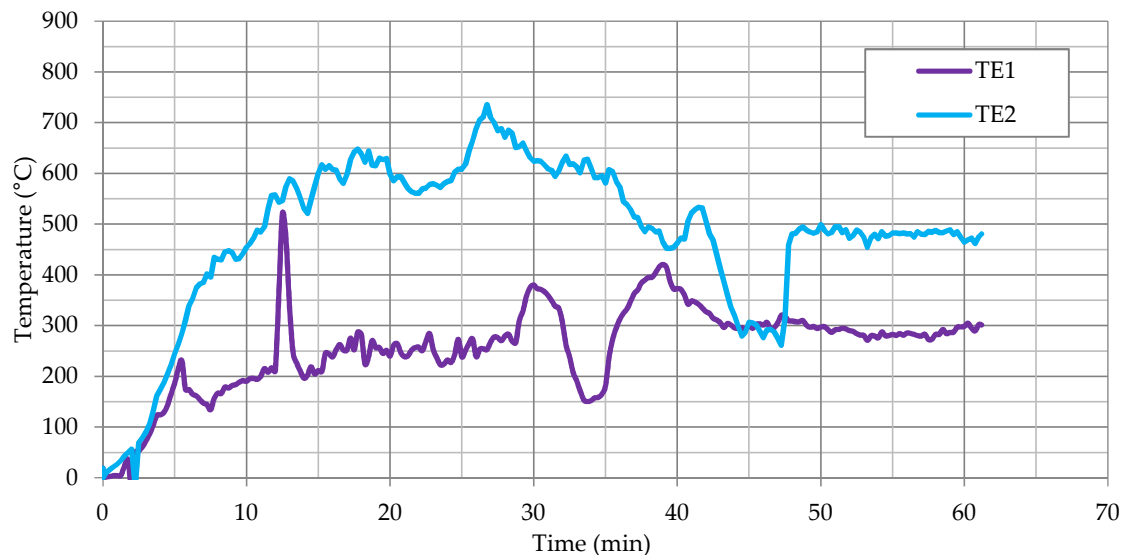
The results of temperature measurement from the thermocouples located in the part of the fiber cement boards, as shown in Figure 3, are presented as a function of time in Figure 6 for thermocouples TE1 and TE2. On the other hand, the results for TE3 and TE4 thermocouples located in the part of large-slab ceramic tiles are shown in Figure 7. The results presented for TE1 and TE2 thermocouples show high instability and temperature variations. This was due to the high development of degradation over time of fiber cement boards, especially after full development of the fire. The locations of the greatest temperature fluctuations in Figure 6 can be associated with cracking or detachment of external cladding elements.

Figure 6. Temperature measurement results for TE1 and TE2 thermocouples.

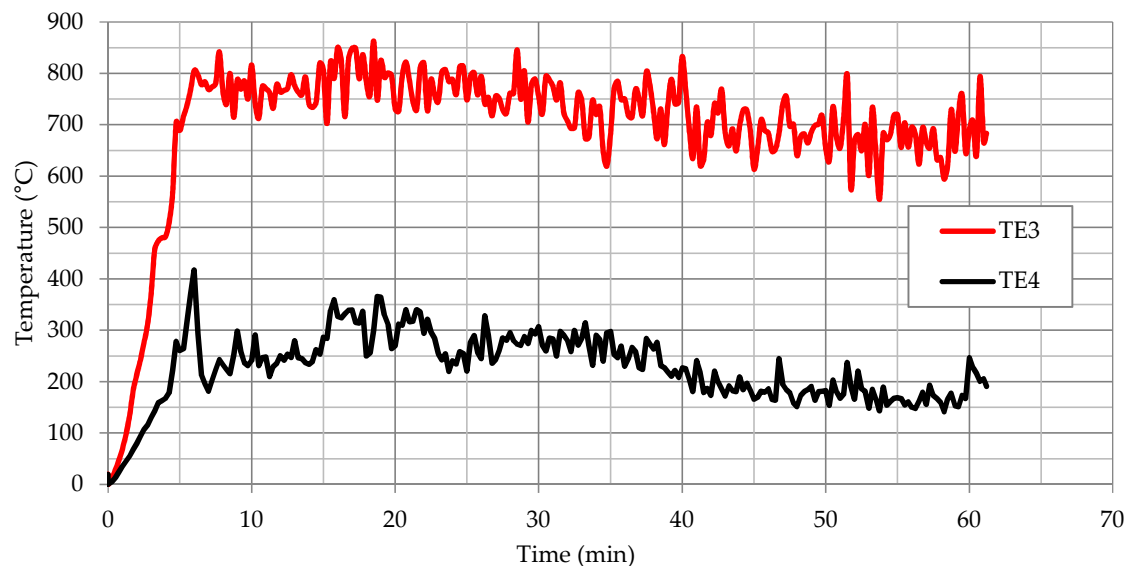
Thermocouples TE3 and TE4, as opposed to thermocouples located in a part of fiber cement boards, initially showed higher temperature increase. The power of the fire was constant, the difference in temperature was caused by the heating of the elements. In 6–7 min, TE3 thermocouples showed high stability—large-slab ceramic tiles were quickly destroyed in the central part above the fire recess. TE4 thermocouple initially showed high instability and temperature fluctuations. This was caused by the influence of lower temperature on large-slab ceramic tiles in this part of the facade. TE4 thermocouple became stable in about 15th minute when the ceramic sinters were no longer damaged by high temperature. The damage is shown in Figure 4c. This state or a slightly altered state, was maintained practically until the end of the test.

Figure 7. Temperature measurement results for TE3 and TE4 thermocouples.

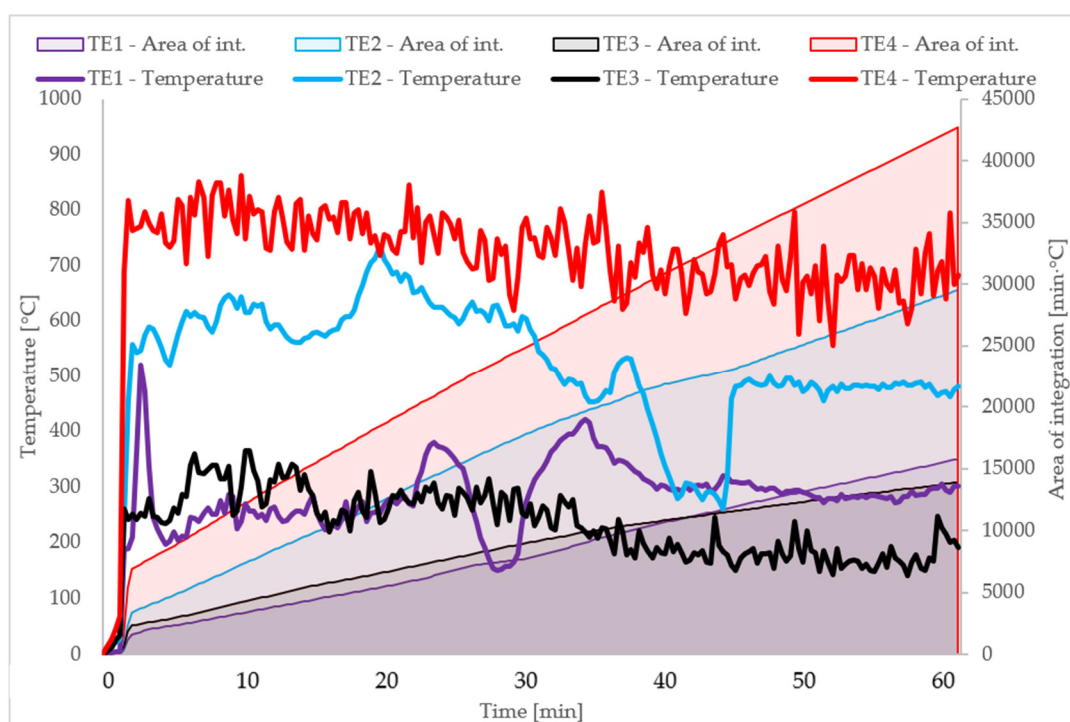
These results are shown in Figure 8 together with temperature diagrams for all thermocouples: TE1, TE2, TE3, TE4. In this graph we can observe a linear growth pattern of the integral for TE3 and TE4 thermocouples (thermocouples placed in a part of the cladding made of large-slab ceramic tiles). In addition, in the part with ceramic sinters the fire force was much higher. The maximum temperature for TE3 was  $862.7^{\circ}\text{C}$  and for TE2 thermocouple measuring the temperature in the area of fiber cement boards it was  $735.5^{\circ}\text{C}$ . The much higher temperatures in the large-slab ceramic tiles area were caused by the much faster destruction of this material, the “release” of access to the thermocouples. The falling-off of large-slab ceramic tiles made easier way to burn mineral wool, this allows maintain higher temperature. In addition, it was likely that ceramic sinters insulate thermocouples much worse than fiber cement boards. The temperature course for TE1 and TE2 thermocouples contains much more disturbances and significant faults. In addition, the integral function has a visible refraction in 34th and 39th minutes for TE1 thermocouple and 42nd and 48th minutes for TE2 thermocouple.

**Figure 8.** Temperature measurement results for thermocouples and the increasing integral for the temperature-time function.
