# Corrosion-Fatigue Failure of Gas-Turbine Blades in an Oil and Gas Production Plant

**Abstract:** This paper investigates the root cause of a failure in gas-turbine blades, made of Nimonic-105 nickel-based superalloy. The failure was reported in two blades in the second stage of a turbine-compressor of a gas turbine in the hot section. Two failed blades were broken from the root and from the airfoil. The failure took place after 20 k h of service exposure in the temperature range 700–850 °C, with the rotating speed being in the range 15,000–16,000 rpm. The microstructures of the failed blades were studied using optical/electron microscopes. Energy dispersive X-ray spectroscopy (EDS) was employed for phase identification. Results showed that failure first initiated from the root. The dominant failure mechanism in the root was concluded to be corrosion-fatigue. The failure scenario was suggested based on the results obtained.

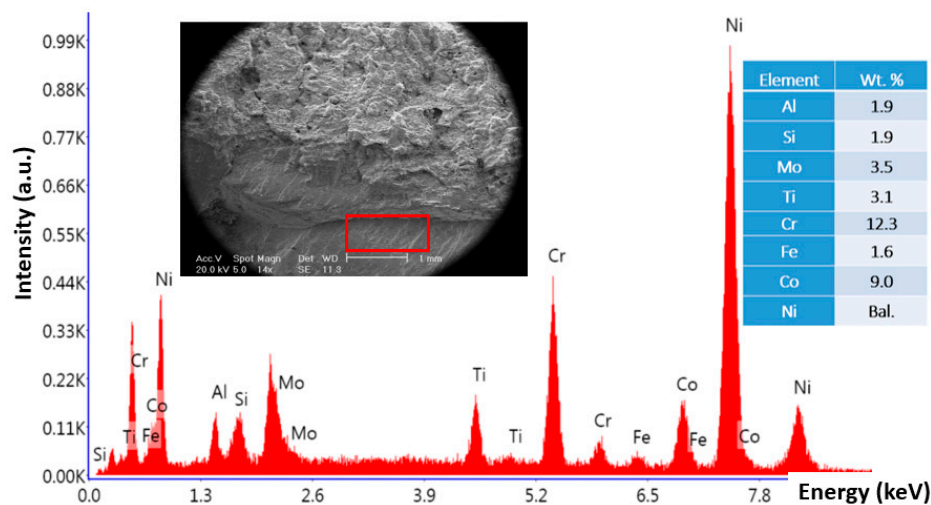
Results of EDS analysis of the microstructure further away from the edge is presented in Figure 5. There is hardly any oxygen, Na, Ca, K, and Cl in the analysis, inferring that the aforementioned corroded area is limited to few hundred micrometers from the edge.

**Figure 5.** EDS analysis of the area with beach marks in the failed blade, broken from the root.
