Material Monitoring of a Composite Dome Pavilion Made by Robotic Coreless Filament Winding

Abstract: A hemispherical research demonstration pavilion was presented to the public from April to October 2019. It was the first large-scale lightweight dome with a supporting roof structure primarily made of carbon- and glass-fiber-reinforced composites, fabricated by robotic coreless filament winding. We conducted monitoring to ascertain the sturdiness of the fiber composite material of the supporting structure over the course of 130 days. This paper presents the methods and results of on-site monitoring as well as laboratory inspections. The thermal behavior of the pavilion was characterized, the color change of the matrix was quantified, and the inner composition of the coreless wound structures was investigated. This validated the structural design and revealed that the surface temperatures of the carbon fibers do not exceed the guideline values of flat, black façades and that UV absorbers need to be improved for such applications.

Keywords: robotic coreless filament winding; lightweight dome structure; on-site inspection; thermal imaging; scanning electron microscopy; outdoor weathe

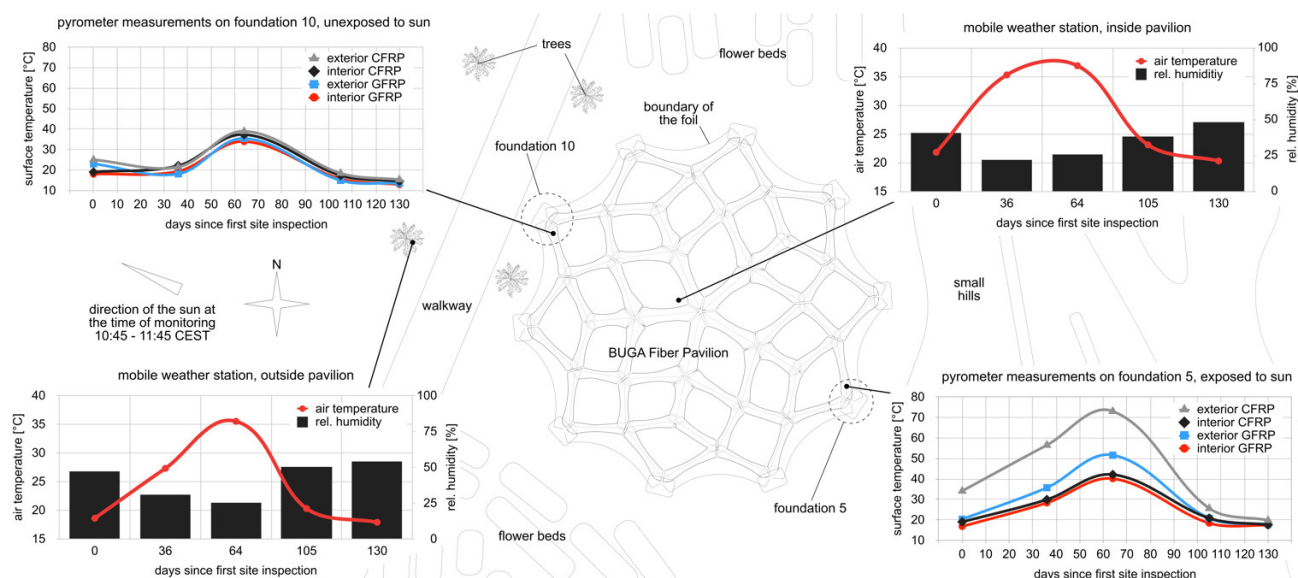
Figure 4. Floor plan of the BUGA Fiber Pavilion. The in situ measurements are indicated at their locations.

The highest temperature captured by the pyrometer during site inspections was 73.0 °C (Figure 4). It was measured at the exposed carbon reinforcement of foundation five on July 26, 2019. The outside air temperature was 35.5 °C and it was cloudless. By taking several pictures with the thermal camera and stitching them into a single frame, a vertical rise in temperature of 2.5 ± 2.0 K was found for the carbon fiber reinforcement.

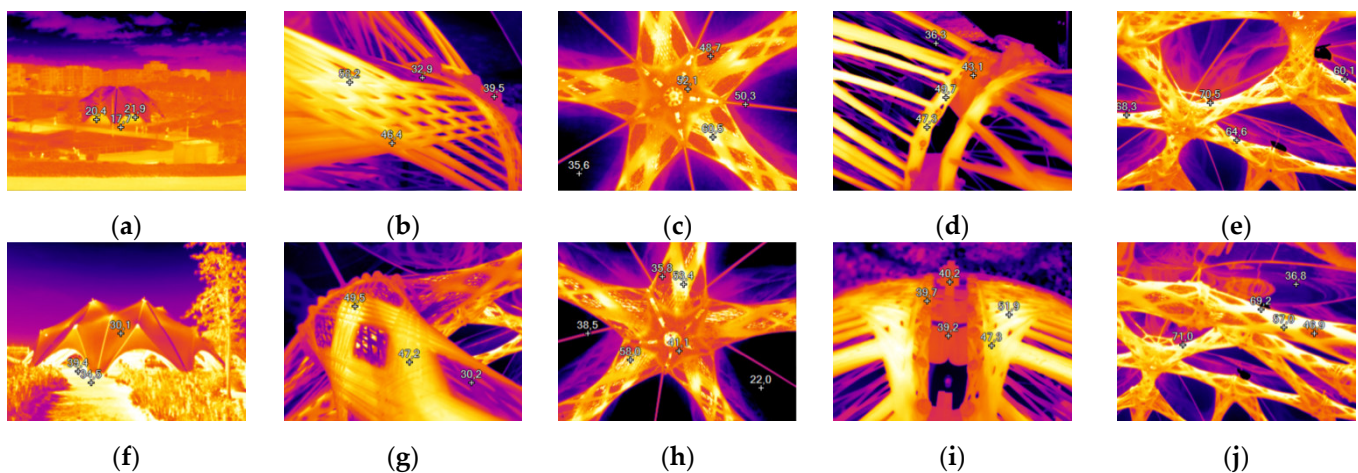
The distribution of the surface temperature could be captured for several vantage points (Figure 5). The ground temperature below the pavilion was measured to be 19% higher than in the surrounding area. Carbon fiber bundles have a 47% higher temperature than adjacent glass fiber bundles. The ETFE foil reflected thermal radiation, which can be seen on the inside of the pavilion. The foil connection elements are 58% hotter than the foil itself. It could be observed that there was a vertical temperature gradient due to a heat trap effect engendered by the foil.

The metallic connections did not disturb the temperature distribution around the load transmission elements. The metal elements were 17% colder than the carbon fibers and 19% hotter than the glass fibers. The temperature distribution over the pavilion depended primarily on sun exposure (Figure 6). Areas that were not covered by the ETFE foil were exposed to direct sunlight and reached higher temperatures.

Figure 5. Selection of representative infrared pictures of the BUGA Fiber Pavilion. Temperature markers indicate °C: (a,f) view of the pavilion as a whole, showing higher ground temperature below the pavilion (scale 4.9–24.8 °C, 4.9–56.3 °C); (b,g) detailed view of a composite component to show difference between carbon and glass (scale 18.4–58.9 °C, 17.0–56.1 °C); (c,h) center element of the pavilion with thermal reflection in the foil (scale 35.7–64.7 °C, 23.9–59.4 °C); (d,i) metallic load transmission elements not thermally interfering with the composite (scale 33.4–52.3 °C, 19.4–51.6 °C); (e,j) view of the upper components with maximum measured temperature (scale 10.6–71.3 °C, 9.1–71.6 °C).

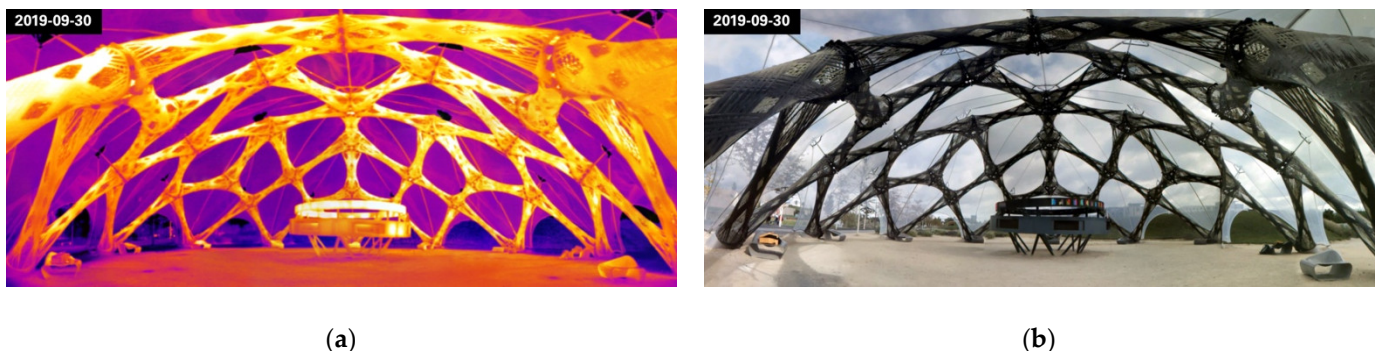
Figure 6. Stitched panoramic pictures of the BUGA Fiber Pavilion. Sun position towards the right side of the picture: (a) infrared spectrum (scale 10.0–23.0 °C); (b) visual spectrum.

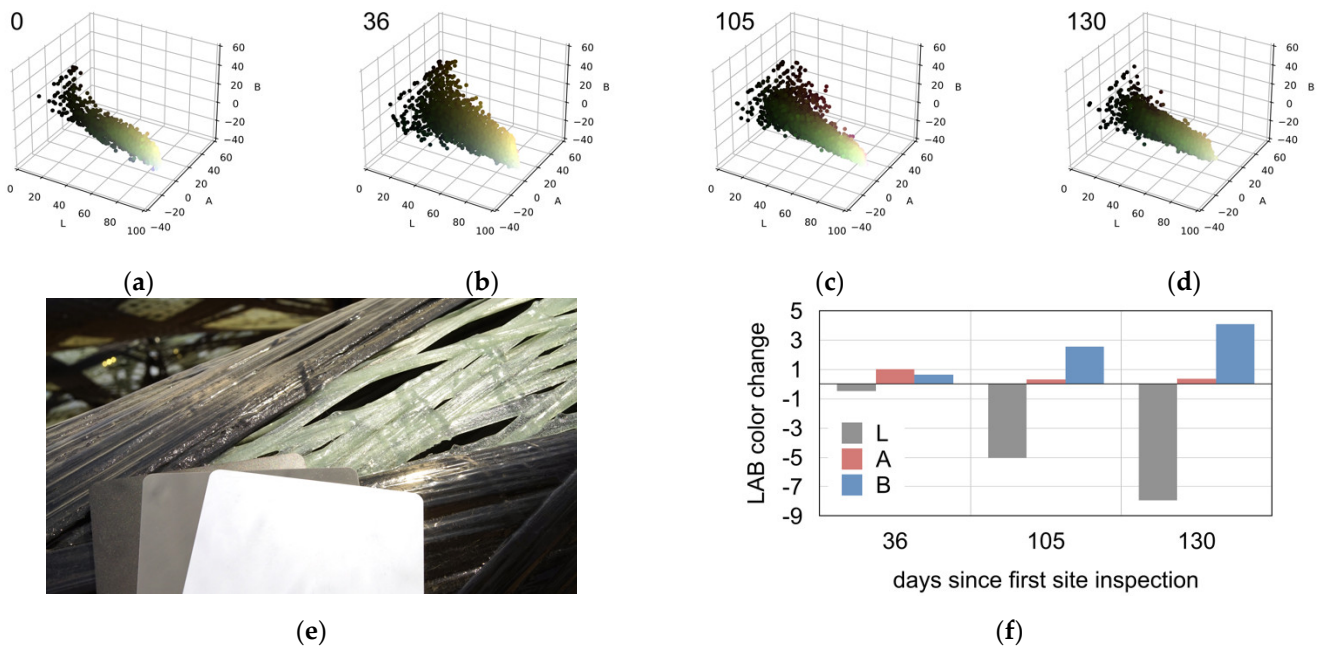
The yellowing of the matrix could be easily recognized on the glass fiber bundles towards the end of the inspection period. This change is caused by degradation of the resin system due to environmental conditions, predominantly UV irradiation. The ETFE foil offers little protection against UV light, and is more effective against rain. The UV also ages the matrix of the carbon fiber bundles; here, the yellowing was not visible since carbon is black. The average LAB color values were calculated for each site inspection appointment, revealing that there was a significant change in the B (blue to yellow) value from -8.82 to -4.75 , which represented a yellowing (Figure 7). The lightness value slightly

decreased from 81.85 to 73.90, while the A (green to red) value stayed nearly the same (from -7.73 to -7.35) over the course of all the site inspections.

Figure 7. Monitoring results of the composite yellowing: (a–d) plots of the pixel colors in LAB color space for inspection, days 0, 36, 105, and 130. (e) Example picture with reference cards. (f) Relative changes in averages for LAB values (L = 0 to 100 = black to white, A = -128 to $+127$ = green to red, B = -128 to $+127$ = blue to yellow).

The observed yellowing of the resin revealed that its environmental protection aspects need to be improved for outdoor projects involving aesthetical use of GFRP. Since the heat flux between carbon and glass fibers is not sufficient to homogenize the temperature difference during daytime, possible mechanical stresses caused by differences in thermal expansion need to be considered in future projects with a hybrid fiber system, especially in warmer contexts. Linked simulations on sun exposure could reveal bending stresses.

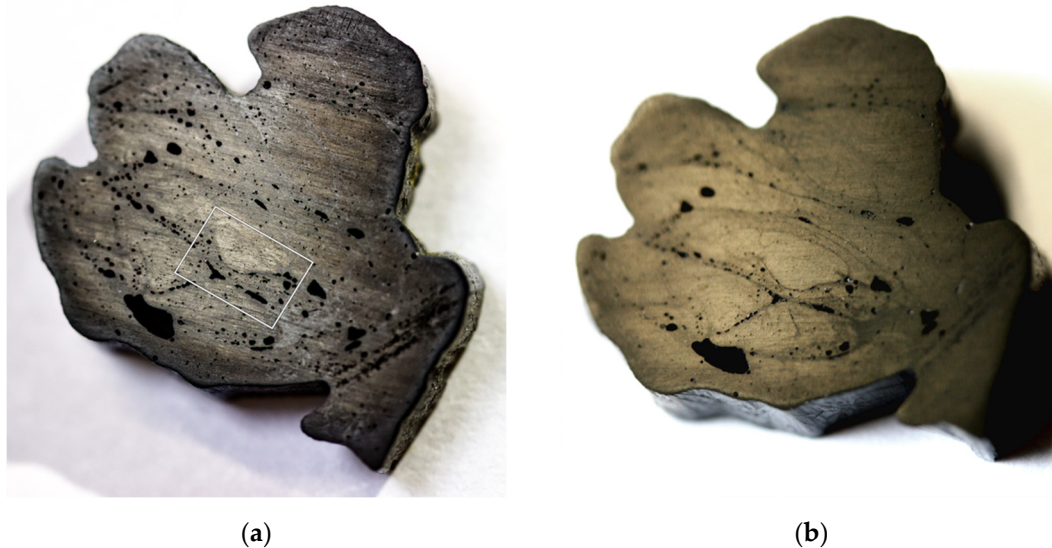
The retaining samples of the carbon fiber bundles were cut and photographed (Figure 8), as well as examined by SEM. The impregnation quality within the roving bundles was excellent among all samples. Fiber orientation was found to be perpendicular to the section's orientation, which can be seen as the filament cross-section being circular and not elliptical [40].

Figure 8. Cross-sectional view of a BUGA carbon-fiber-bundle-retaining sample containing 48×6 48K rovings: (a) picture with increased contrast and sharpness to make voids easily visible. Box shows SEM scan area of Figure 9. (b) Picture with oblique yellow lighting revealing resin bridges (matte) and rovings (shiny).

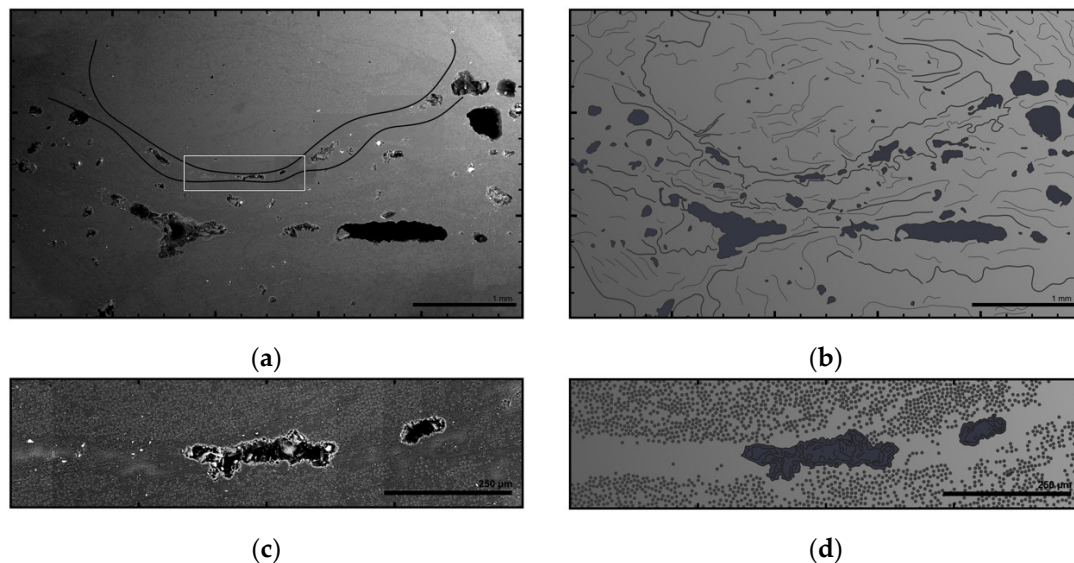
Consolidation quality fluctuates within a certain bandwidth, and it is recognizable by the size, number, and distribution of defects (Figure 9). Within a roving bundle, consolidation quality is higher due to the applied compression by passing it through the winding end effector. Between successively placed layers of fiber bundles, consolidation is worse.

On the outer surface of the fiber bundles, a resin layer is also present, which protects the fiber from environmental impacts. Here, remaining broken filaments can also be recognized due to their deviating orientation. The number of the voids negatively correlates with their size for all measured samples, similar to [41]. The porosity measured on the samples is $3.14 \pm 1.98\%$ of the cross-section area.

Figure 9. SEM scan of the fiber bundle interface area cross-section: (a) SEM scan from Figure 8 with indication of the interfaces between rovings; (b) schematic analysis of the same area, with voids and inner roving structures marked; (c) enlargement of the framed area in subfigure a; (d) schematic analysis of subfigure a with marked voids and single carbon fiber filaments.
