# Material Monitoring of a Composite Dome Pavilion Made by Robotic Coreless Filament Winding

**Abstract:** A hemispherical research demonstration pavilion was presented to the public from April to October 2019. It was the first large-scale lightweight dome with a supporting roof structure primarily made of carbon- and glass-fiber-reinforced composites, fabricated by robotic coreless filament winding. We conducted monitoring to ascertain the sturdiness of the fiber composite material of the supporting structure over the course of 130 days. This paper presents the methods and results of on-site monitoring as well as laboratory inspections. The thermal behavior of the pavilion was characterized, the color change of the matrix was quantified, and the inner composition of the coreless wound structures was investigated. This validated the structural design and revealed that the surface temperatures of the carbon fibers do not exceed the guideline values of flat, black façades and that UV absorbers need to be improved for such applications.

**Citation:** Mindermann, P.; Rongen, B.; Gubetini, D.; Knippers, J.; Gresser, G.T. Material Monitoring of a Composite Dome Pavilion Made by Robotic

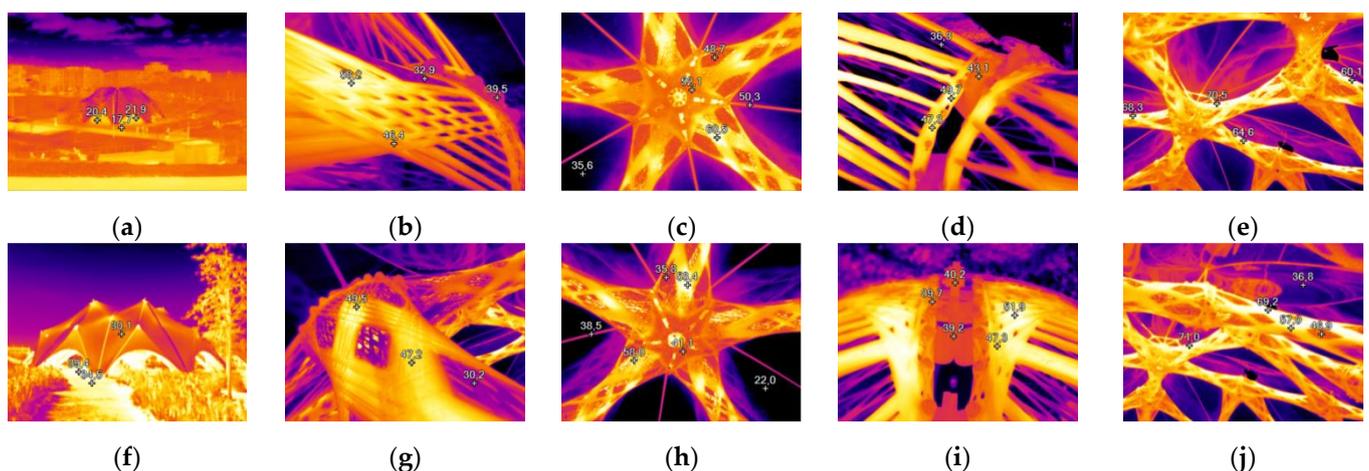
The distribution of the surface temperature could be captured for several vantage points (Figure 5). The ground temperature below the pavilion was measured to be 19% higher than in the surrounding area. Carbon fiber bundles have a 47% higher temperature than adjacent glass fiber bundles. The ETFE foil reflected thermal radiation, which can be seen on the inside of the pavilion. The foil connection elements are 58% hotter than the foil itself. It could be observed that there was a vertical temperature gradient due to a heat trap effect engendered by the foil.

**Figure 5.** Selection of representative infrared pictures of the BUGA Fiber Pavilion. Temperature markers indicate °C: (a,f) view of the pavilion as a whole, showing higher ground temperature below the pavilion (scale 4.9–24.8 °C, 4.9–56.3 °C); (b,g) detailed view of a composite component to show difference between carbon and glass (scale 18.4–58.9 °C, 17.0–56.1 °C); (c,h) center element of the pavilion with thermal reflection in the foil (scale 35.7–64.7 °C, 23.9–59.4 °C); (d,i) metallic load transmission elements not thermally interfering with the composite (scale 33.4–52.3 °C, 19.4–51.6 °C); (e,j) view of the upper components with maximum measured temperature (scale 10.6–71.3 °C, 9.1–71.6 °C).

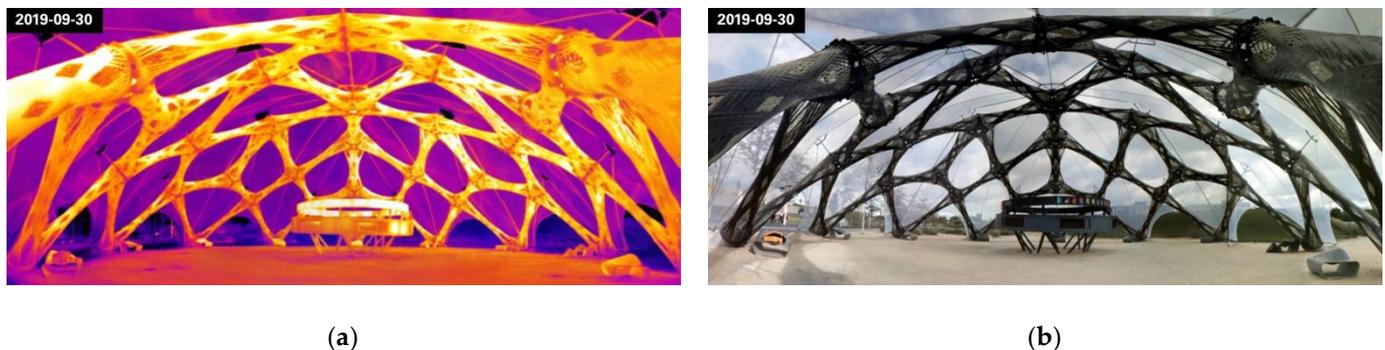
19% hotter than the glass fibers. The temperature distribution over the pavilion depended primarily on sun exposure (Figure 6). Areas that were not covered by the ETFE foil were exposed to direct sunlight and reached higher temperatures.

**Figure 6.** Stitched panoramic pictures of the BUGA Fiber Pavilion. Sun position towards the right side of the picture: (a) infrared spectrum (scale 10.0–23.0 °C); (b) visual spectrum.

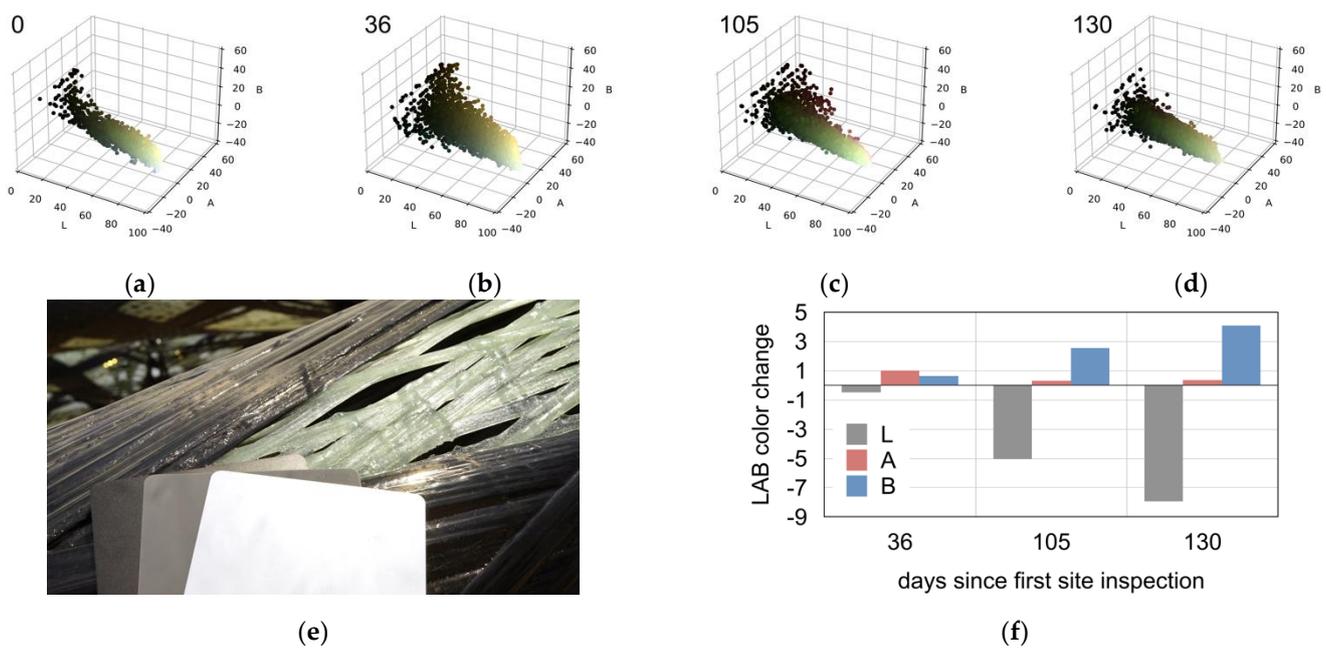
The yellowing of the matrix could be easily recognized on the glass fiber bundles towards the end of the inspection period. This change is caused by degradation of the resin system due to environmental conditions, predominantly UV irradiation. The ETFE foil offers little protection against UV light, and is more effective against rain. The UV also ages the matrix of the carbon fiber bundles; here, the yellowing was not visible since carbon is black. The average LAB color values were calculated for each site inspection appointment, revealing that there was a significant change in the B (blue to yellow) value from  $-8.82$  to  $-4.75$ , which represented a yellowing (Figure 7). The lightness value slightly decreased from 81.85 to 73.90, while the A (green to red) value stayed nearly the same (from  $-7.73$  to  $-7.35$ ) over the course of all the site inspections.

**Figure 7.** Monitoring results of the composite yellowing: (a–d) plots of the pixel colors in LAB color space for inspection, days 0, 36, 105, and 130. (e) Example picture with reference cards. (f) Relative changes in averages for LAB values (L = 0 to 100 = black to white, A =  $-128$  to  $+127$  = green to red, B =  $-128$  to  $+127$  = blue to yellow).

The observed yellowing of the resin revealed that its environmental protection aspects need to be improved for outdoor projects involving aesthetical use of GFRP. Since the heat flux between carbon and glass fibers is not sufficient to homogenize the temperature difference during daytime, possible mechanical stresses caused by differences in thermal expansion need to be considered in future projects with a hybrid fiber system, especially in warmer contexts. Linked simulations on sun exposure could reveal bending stresses.

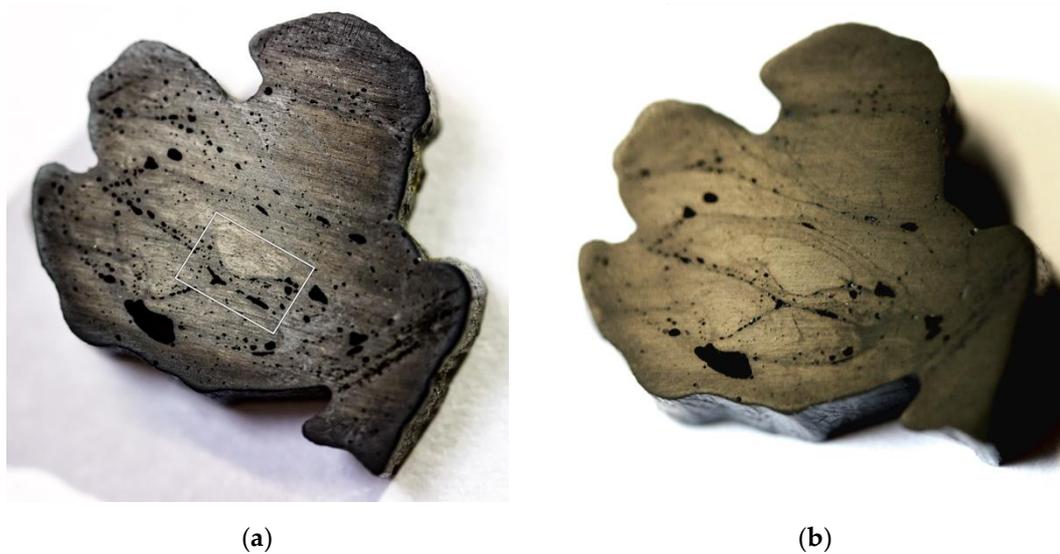
The retaining samples of the carbon fiber bundles were cut and photographed (Figure 8), as well as examined by SEM. The impregnation quality within the roving bundles was excellent among all samples. Fiber orientation was found to be perpendicular to the section's orientation, which can be seen as the filament cross-section being circular and not elliptical [40].

**Figure 8.** Cross-sectional view of a BUGA carbon-fiber-bundle-retaining sample containing  $48 \times 6$  48K rovings: (a) picture with increased contrast and sharpness to make voids easily visible. Box shows SEM scan area of Figure 9. (b) Picture with oblique yellow lighting revealing resin bridges (matte) and rovings (shiny).

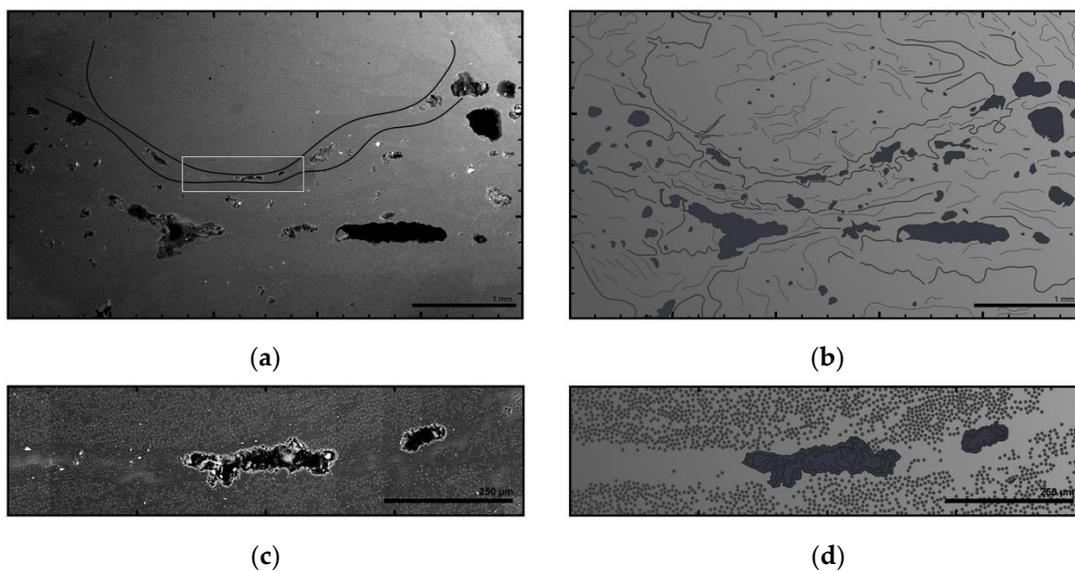
**Figure 9.** SEM scan of the fiber bundle interface area cross-section: (a) SEM scan from Figure 8 with indication of the interfaces between rovings; (b) schematic analysis of the same area, with voids and inner roving structures marked; (c) enlargement of the framed area in subfigure (a); (d) schematic analysis of subfigure (a) with marked voids and single carbon fiber filaments.

Consolidation quality fluctuates within a certain bandwidth, and it is recognizable by the size, number, and distribution of defects (Figure 9). Within a roving bundle, consolidation quality is higher due to the applied compression by passing it through the winding end effector. Between successively placed layers of fiber bundles, consolidation is worse.

The fiber bundles carry additional amounts of resin with them on the outer surface. If compression applied by the fiber–fiber interaction during the CFW process is not sufficient, the excess resin ends up between the fiber bundle layers and forms an interface. These are characterized by pure-resin layers and lined-up air-filled cavities, both of which are visible in cross-sections, even by the naked eye (Figure 8). This underlines the additive manufacturing character of RCFW.

On the outer surface of the fiber bundles, a resin layer is also present, which protects the fiber from environmental impacts. Here, remaining broken filaments can also be recognized due to their deviating orientation. The number of the voids negatively correlates with their size for all measured samples, similar to [41]. The porosity measured on the samples is  $3.14 \pm 1.98\%$  of the cross-section area.
