# Investigation of the 0.4C-35Cr-45Ni-Nb Alloy after Service in High-Temperature Steam and Hydrocarbons Environment

**Abstract:** The paper presents the results of investigation of the 0.4C-35Cr-45Ni-Nb alloy, which operated in the cracked hydrocarbon feeds and dilution steam at 1125 °C. The material originated from the pyrolytic furnace coil tubes, of which internal walls were in contact with the aforementioned medium, whereas the external walls were in contact with the flue gases. The examination included metallographic and mechanical tests on the material after service exposure, the results of which were compared with the ones obtained for the as-received non-exposed specimens. The metallographic tests revealed changes in the alloy's structure manifested by formation of significant amount of the carbides due to carburization of the alloy from the steam and cracked hydrocarbon feeds side. The central and external parts of the alloy samples (having no contact with the process medium) underwent substantial degradation but within a relatively narrow zone of the material. The investigations of hydrogen and methane content in the alloy showed a high amount of these gases, resulting f

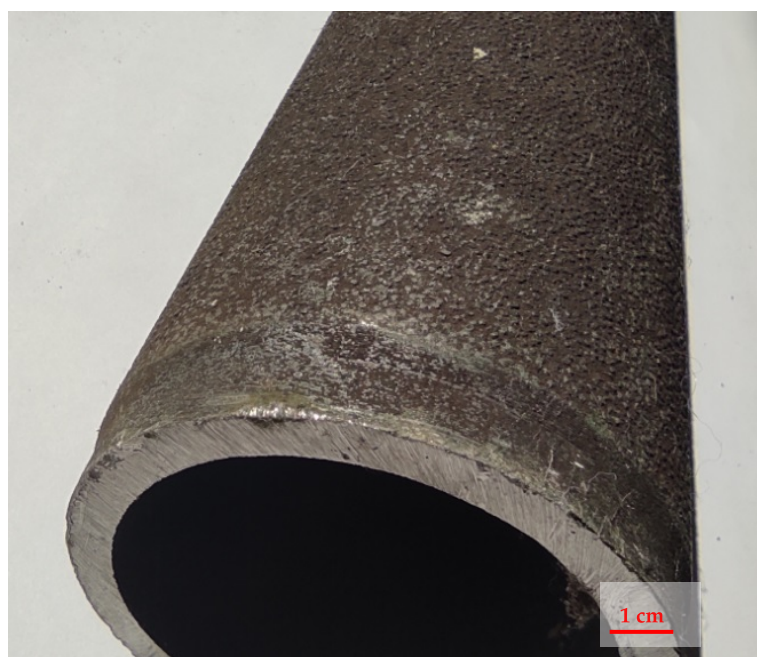
**Figure 2.** Pyrolytic furnace's coil tube subjected to investigation.

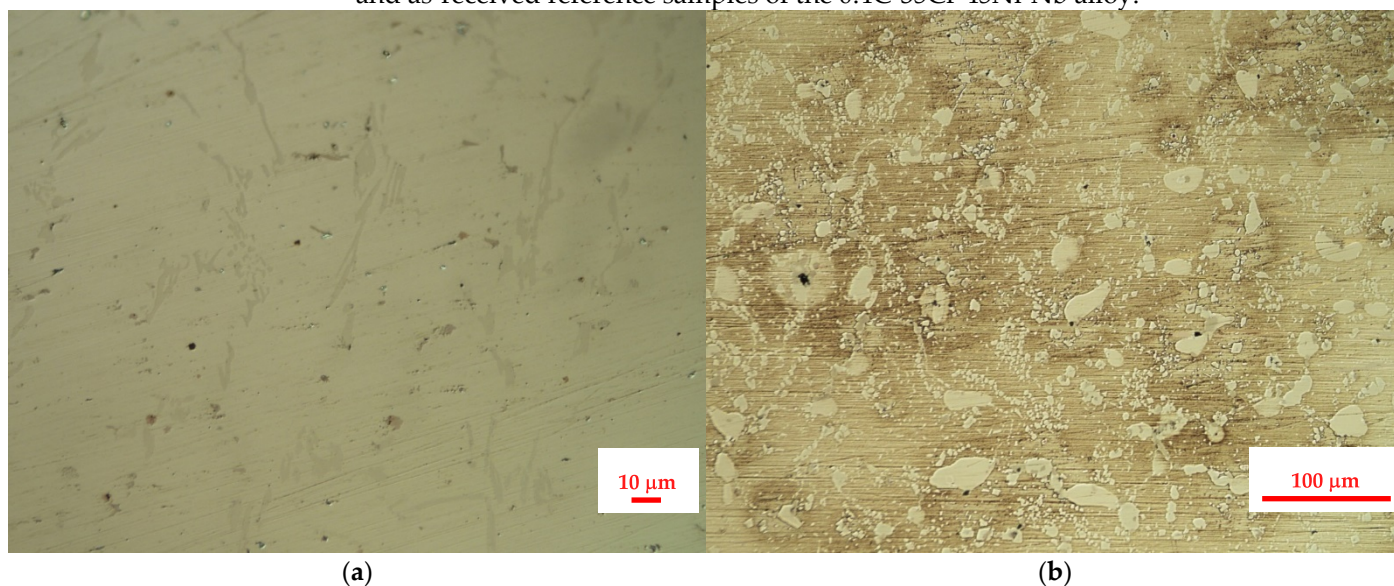
**Figure 3.** Surface images of the 0.4C-35Cr-45Ni-Nb alloy obtained during metallographic investigations: (a) as-received reference sample; (b) material after 5 years of service in the furnace.

The results of the investigation of the non-exposed reference sample are in accordance with the literature data [6–8]. The metallographic tests revealed carbides present in the form of branched lines (Figure 3a) [9,10]. The SEM image (Figure 4) shows dark structures (spot 1) containing significant amount of chromium and bright structures (spot 3) with higher niobium content with respect to the matrix. Very similar structure and elemental composition of particular phases of the alloy can be found in the paper [8].

In case of the alloy after 5 years of service exposure, one can notice a significant change in the microstructure. There are much more distinct precipitates of the carbides, which occupy a substantial area of the sample (Figure 3b). The change of microstructure results from long-term exposure to the temperature above 805–866 °C and from the influence of the stream inside the coil tubes, which favored carburization [2]. SEM and EDX also reveal chromium-rich phases (spot 1—Figure 5); however, the composition of particular phases differs with respect to the alloys subjected only to an ageing process [2,8]. This fact indicates that the change of microstructure is related to the impact of both aggressive environment and high temperature [11]. No creep process was identified, which suggests a high resistance of the alloy to this phenomenon.

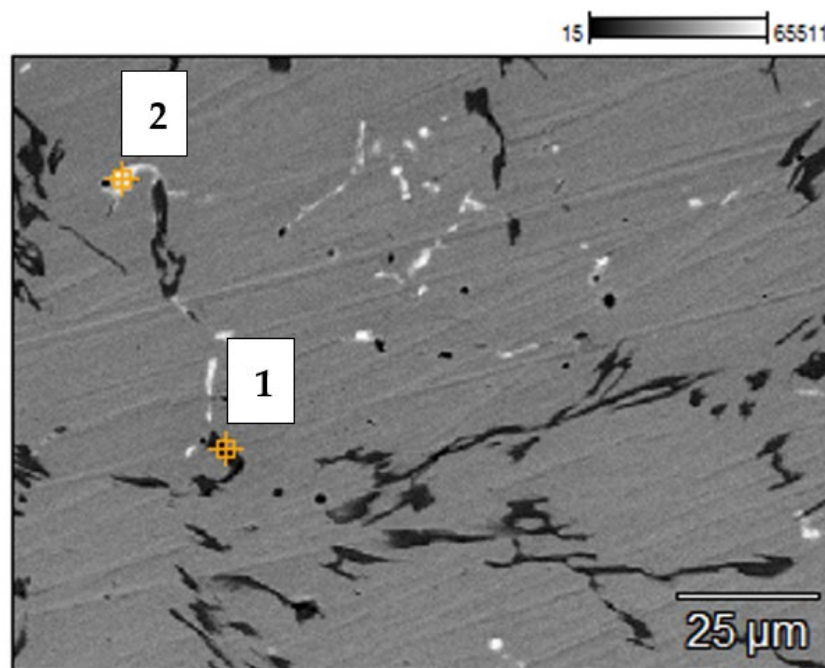
**Figure 4.** Backscattered electron (BSE) mode scanning electron microscopy (SEM) image of the 0.4C-35Cr-45Ni-Nb alloy—non-exposed reference sample's surface. Numbers indicate the spots of energy dispersive X-ray (EDX) analysis.

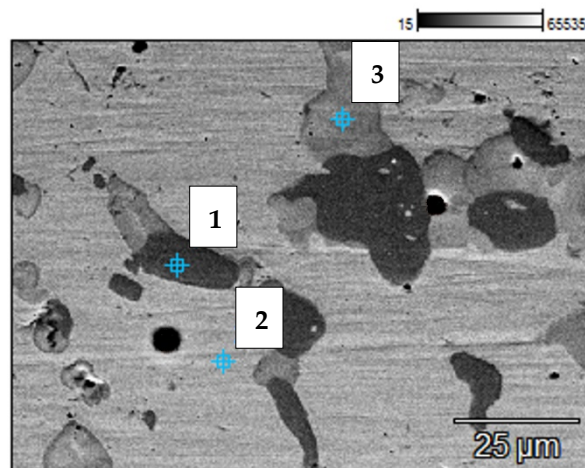
**Figure 5.** BSE SEM image of the 0.4C-35Cr-45Ni-Nb alloy —service exposed sample's surface. Numbers indicate the spots of the EDX analysis.**Table 3.** Elemental composition (weight percentage) of the service exposed sample obtained by EDX analysis at three spots on the material's surface (the places marked 1–3 in Figure 5).

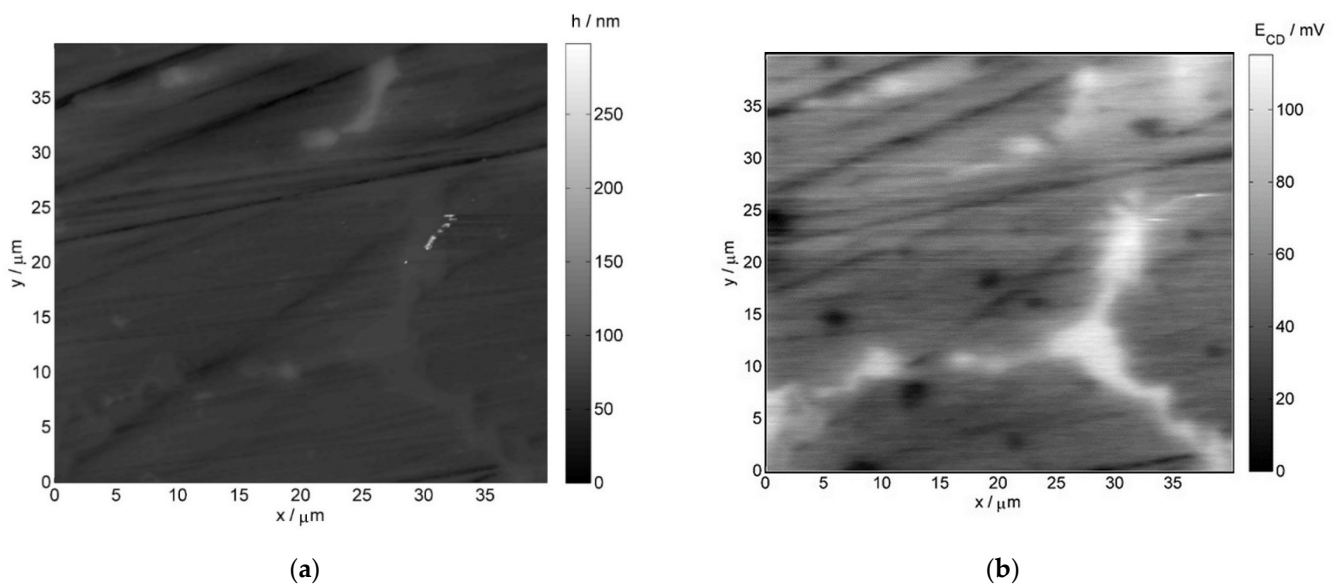
**Figure 6.** (a) AFM and (b) SKPFM images of the 0.4C-35Cr-45Ni-Nb alloy—non-exposed reference sample's surface.

In case of the non-exposed reference sample, the chromium-rich inclusions (more noble) are present on grain boundaries, which is visible on both the AFM image (brighter elevated regions) and SKPFM image (bright regions indicating higher potential as compared to the matrix)—Figure 6. After the service exposure, niobium-rich phases are clearly resolved on the AFM and SKPFM images (Figure 7). They can be identified as brighter regions on the topographical AFM image, whereas on the SKPFM image, the niobium-rich phases are dark regions due to their lower potential with respect to the matrix. These results are consistent with the EDX measurements presented earlier.

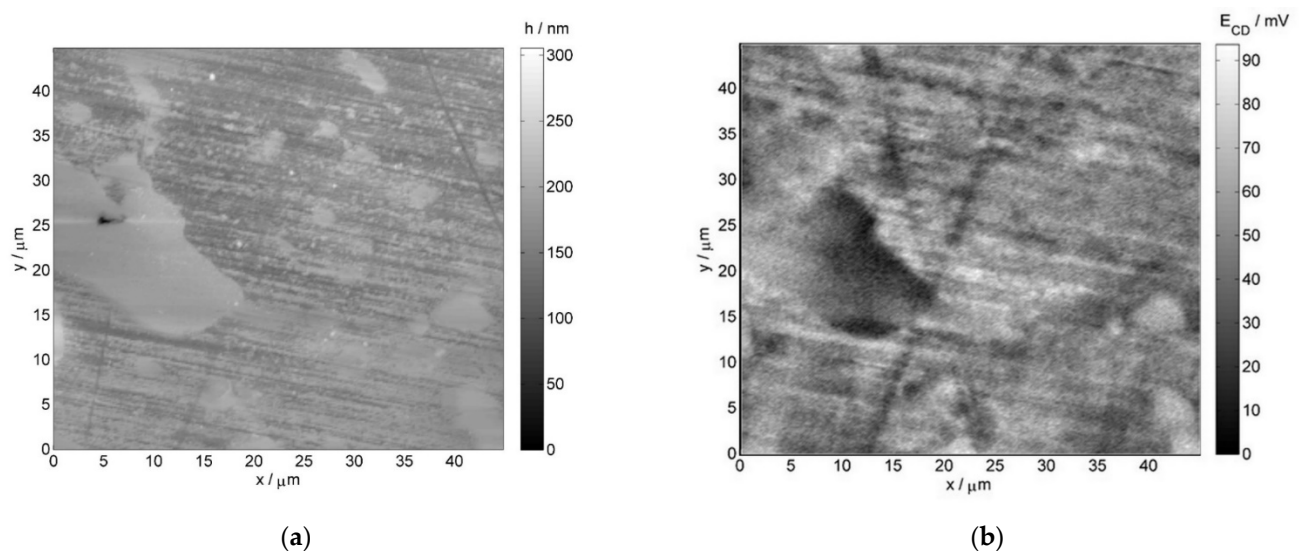
**Figure 7.** (a) AFM and (b) SKPFM images of the 0.4C-35Cr-45Ni-Nb alloy—service exposed sample's surface.

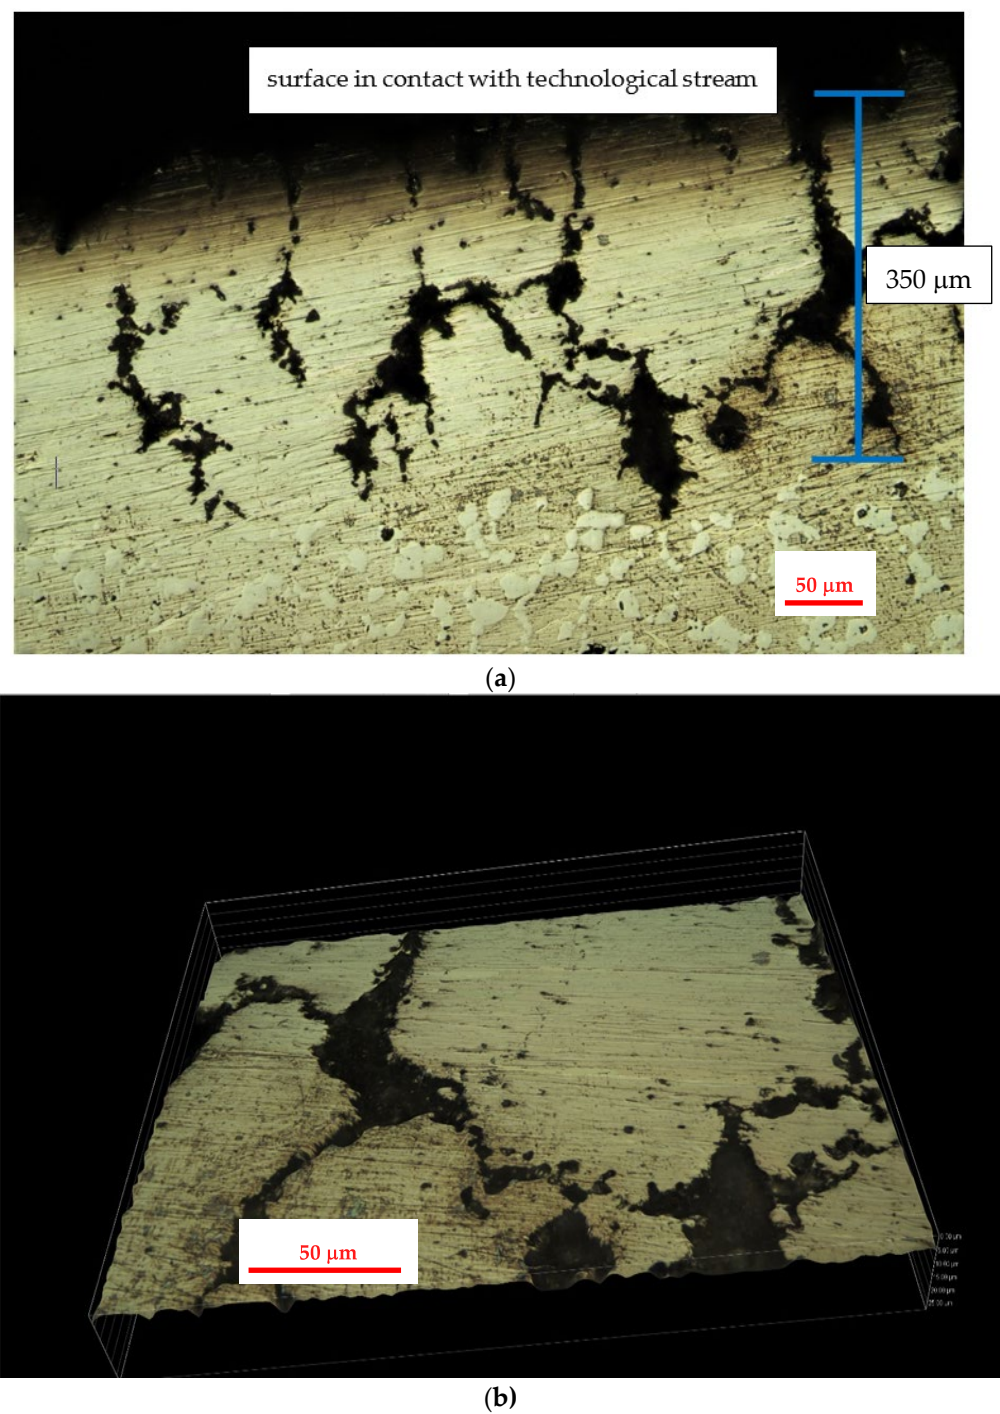
**Figure 8.** Surface images of the 0.4C-35Cr-45Ni-Nb alloy obtained during metallographic investigations of internal part of service exposed coil tube: (a) internal wall neighboring region; (b) magnification of a fragment of the region presented in (a).

The metallographic investigations show high degradation of the alloy structure in the part of the coil tube. This degradation extends ca. 300  $\mu\text{m}$  from the internal wall to the bulk of the specimen. Visible dark structures are characterized by high amount of silicon and lower content of chromium (spot 1—Figure 9) as compared to the matrix. The presence of a narrow region suffering from dechromization process is also reported in some literature sources [2,12]. Moreover, the degraded zone of the alloy is much more carburized due to the presence of coke, which is formed during thermal degradation of cracked hydrocarbon feeds. Upon service conditions, the internal part of coil tubes can be subjected to metal dusting, although no significant corrosion losses were detected [13,14].

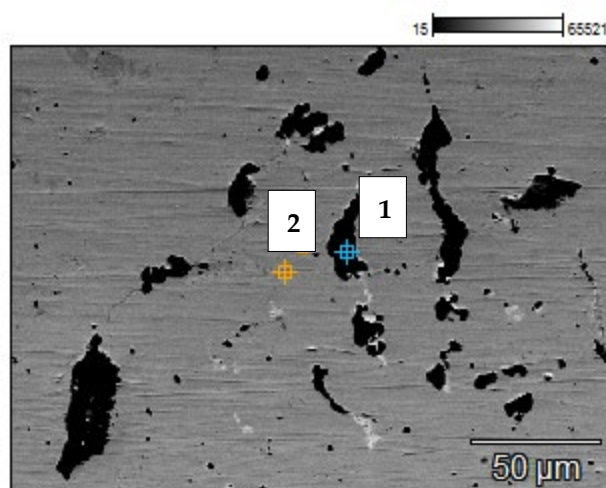
**Figure 9.** BSE SEM image of the 0.4C-35Cr-45Ni-Nb alloy surface—internal part of the service exposed sample. Numbers indicate the spots of EDX analysis.

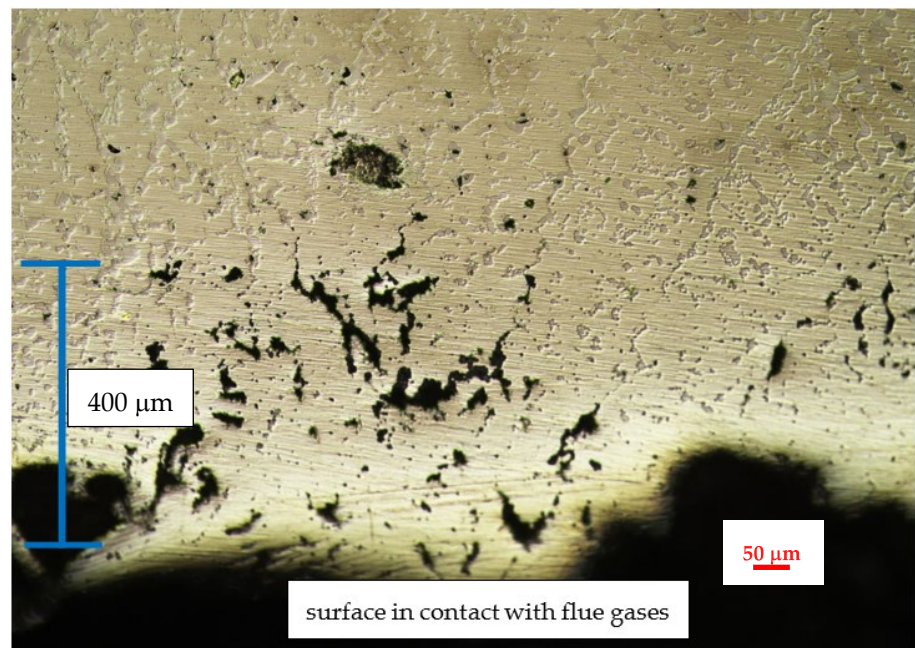
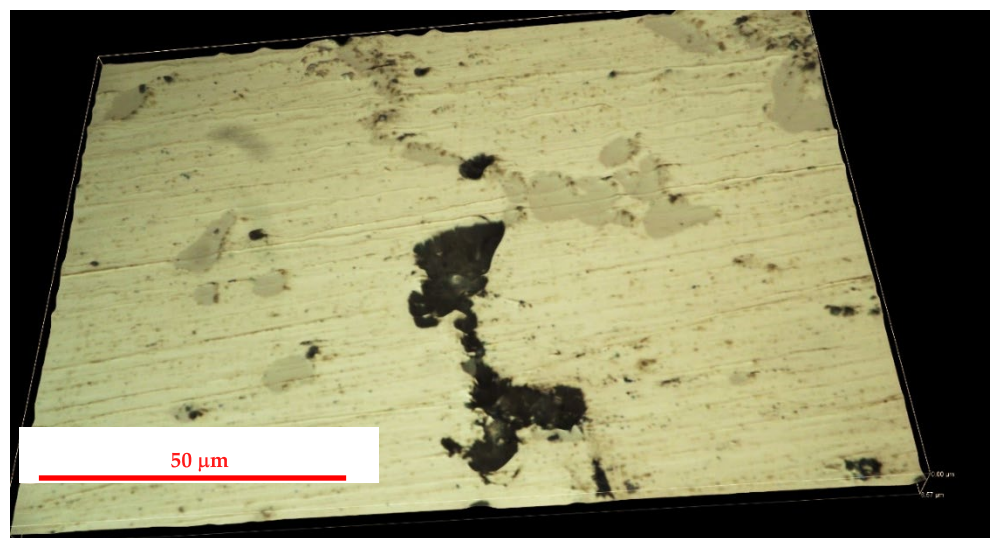
**Figure 10.** Surface images of the 0.4C-35Cr-45Ni-Nb alloy obtained during metallographic investigations of external part of service exposed coil tube: (a) external wall neighboring region; (b) magnification of a fragment of the region presented in (a).

The external part of the coil tube was in contact with the flue gases used for heating of the furnace. In the analyzed case, the fuel consisted of gas hydrocarbons, mainly methane. Oxygen content in the flue gases stream was low, which indicated no risk of the oxidation mechanism [3]. The gas fuel utilized was of high purity, thus eliminating the mechanisms of fuel ash corrosion and flue gas dew point corrosion [3]. High temperature and low content of carbon compounds in the flue gases resulted in decarburization, which is evident on the metallographic images (Figure 10). It occupies a zone of ca. 200 μm, which corresponds to the region with a limited number of carbides [11]. The entire zone of significant structural degradation covers 400 μm.

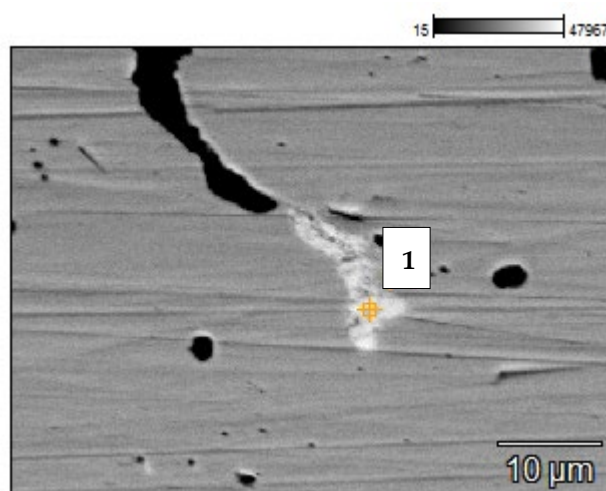
**Figure 11.** BSE SEM image of the 0.4C-35Cr-45Ni-Nb alloy surface—external part of the service exposed sample. The number indicates the spot of the EDX analysis.

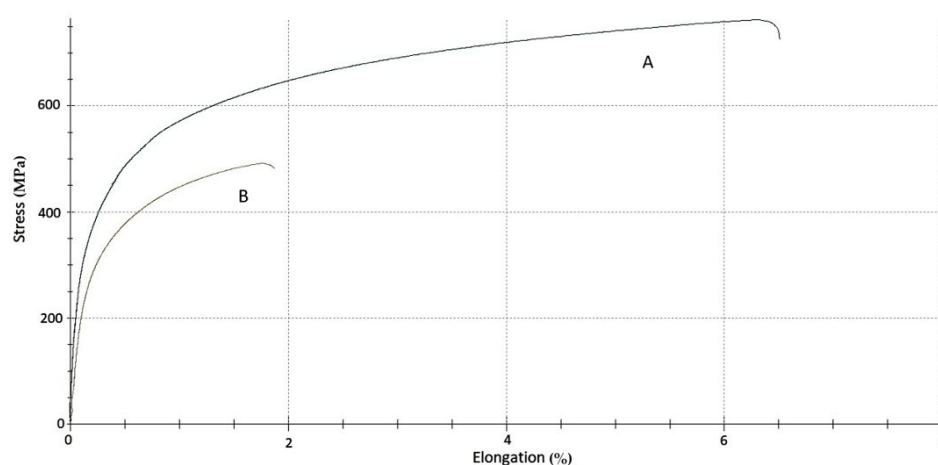
**Figure 12.** Results of mechanical tests of: (A) non-exposed reference sample; (B) service exposed sample.

The mechanical investigations revealed significant changes of the mechanical properties of the service exposed sample as compared to the reference material. Deterioration of plastic properties of the alloy is evident. The ultimate elongation of the exposed material decreased by more than three times compared to the non-exposed reference specimen. The maximum tensile stress also decreased by ca. 10%. Substantial deterioration of the mechanical properties is probably associated with the process of hydrogen and methane bubbles formation inside the alloy structure due to corrosion processes. Indisputably, it is a dangerous phenomenon (with potential negative influence on impact strength), which calls for more detailed investigation.
