# Failure Mechanisms of GFRP Scarf Joints under Tensile Load

Federal Institute for Materials Research and Testing (BAM), Unter den Eichen 87, 12205 Berlin, Germany; carineh.ghafafian@bam.de (C.G.); bpopiela999@gmail.com (B.P.)

**Citation:** Ghafafian, C.; Popiela, B.; Trappe, V. Failure Mechanisms of GFRP Scarf Joints under Tensile Load. *Materials* **2021**, *14*, 1806. <https://doi.org/10.3390/ma14071806>

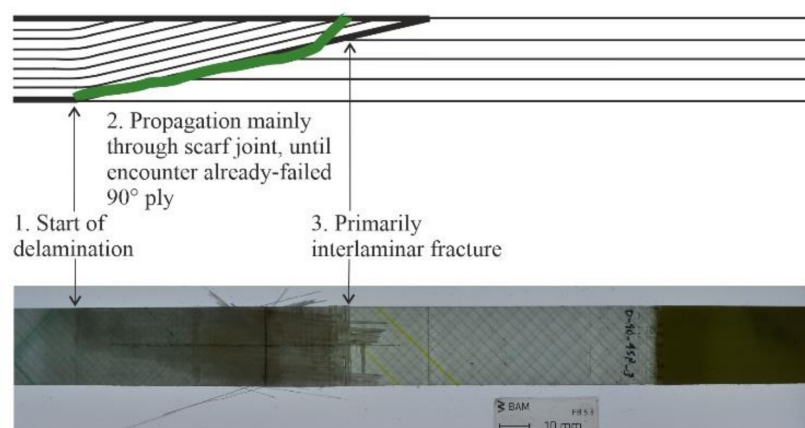
The damage initiation for the  $0/90^\circ$  repaired specimens began at the edge of the scarf joint, on the side with more repair material, shown in Figure 12. At this point is a resin fillet caused by a slight jump (0.1 mm) in material caused by the joining of the repair material with the original parent structure. As opposed to the other side of the scarf joint, where there is more parent material, this side's surface profile is not restored after repair layers are applied. This side is representative of the back side of a wind turbine blade shell face sheet which is repaired, the side in contact with the core material of the sandwich structure, illustrated schematically in Figure 18 of Section 4, and plays a more significant role in the failure of the  $0/90^\circ$  repaired specimens due to the role of the  $0^\circ$  layers influencing the specimen strength and stiffness.

**Figure 12.** Step-by-step fracture path of  $0/90^\circ$  repaired specimens under tensile load, portrayed as the top view of a real tested specimen (**bottom**) and side view of a schematic illustration (**top**).

After failure initiates at this point, there is a competition of interlaminar strength versus fiber strength at play when it comes to the propagation path. Unlike the control  $0/90^\circ$  specimens, there are no longer continuous  $0^\circ$  fibers running along the entire specimen length in the load direction that are able to carry the load. Here, the interlaminar strength is significantly lower than the fiber strength in the load direction, leading to interlaminar propagation of the failure path along the scarf joint, shown in Figure 12. Additionally, the peak shear stresses in the structure are lower with the presence of  $0^\circ$  plies [17]. This propagation in the interface between parent and repair material continues in this way until an already failed  $90^\circ$  layer in the repair is reached, after which the failure propagates for the last small portion toward the surface of the specimen through the repair material.

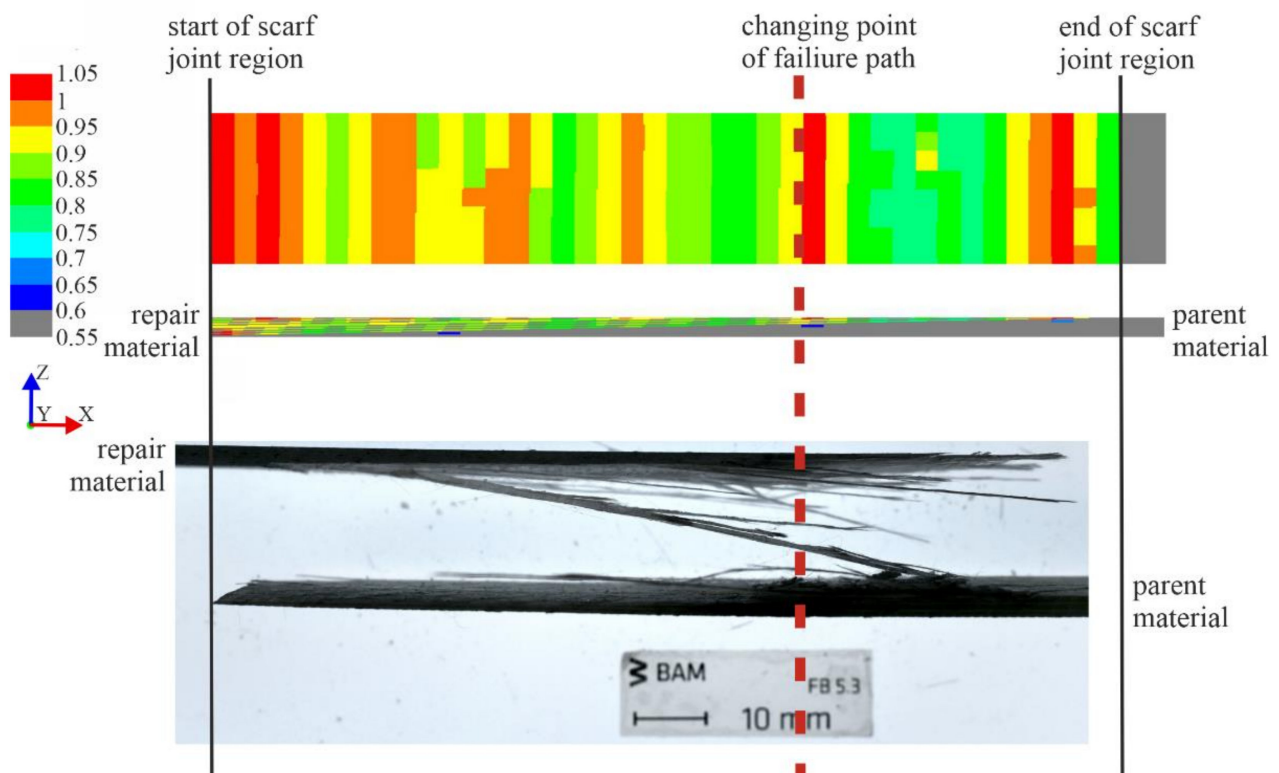
**Figure 13.** Critical regions of numerical 0/90° scarf joint specimen under tensile load at  $\sigma_x = 48$  MPa (occurrence of first inter-fiber failure (IFF)) presented as inverse reserve factor (IRF) values projected onto the specimen front and side view. In comparison, the side view of the two fracture surfaces of an experimental 0/90° scarf joint specimen tested under tensile load is shown. The scale begins at a value of 0.55 for clarity.

The side and front view of the IRF values in Figure 13 show the red critical regions (IRF value greater than 1) in the specimen within the scarf joint region, and can be mapped to the experimental damage initiation site as well as point at which the propagation path changes from interlaminar in the scarf joint to intralaminar through the repair material. Here, the fracture front, carrying the highest energy at the crack tip, encounters an already-failed 90° ply layer, namely, the first instance that a critical region comes into contact with the scarf joint interface after initiation. At this point, the failure mechanisms at play change from fiber failure versus interlaminar failure to fiber failure versus interlaminar failure versus the new option introduced by the failed 90° layer in contact with the scarf joint interface: intralaminar failure. The high-energy fracture tip then changes its direction to propagate for the last portion through the remaining repair material layers to the specimen surface until final failure. This is also noticeable in the abrupt change from smooth fracture surface between the two materials to repair material fibers that are partially still intertwined in the side view of the fracture surface of the experimental specimen in Figure 13. The critical regions in the model align to the point at which failure initiates in the experimental

From this comparison, it can be concluded that the failure path remains interlaminar until an already-failed 90° ply, namely, a region with a critical IRF value, comes in contact with the scarf joint interface. This occurs at the point marked in a red line in Figure 13. This type of fracture path change behavior has also been observed in the literature, where failure in scarf repaired CFRP specimens under tensile load occurred as cracks initiating either outside the scarf joint bond line or possibly at the bond line contacting a 90° ply, and the propagation occurred as a staircase path, changing direction into the laminate when in contact with an already-failed 90° ply. This could be explained by the effect of the interfacial joint stiffness being indifferent from that of the parent and repair substrates, thereby conveying some of the scarf joint interface strain behavior to a compliant 90° ply and including this ply as part of the joint line. The 90° ply is then forced to adopt the shear strain behavior of a ductile adhesive, undergoing a shear distortion at a magnitude on the order of that along the bond line, ultimately leading to cracks in the 90° layer [11]. This type of stepped crack path changing behavior at the bond line due to 90° plies was also observed in the literature [3,11].

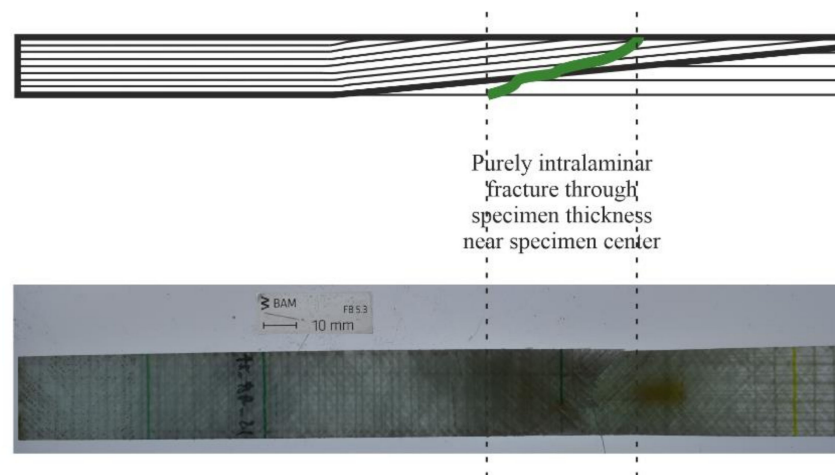
After initiation at the specimen edges, the damage propagation path of the repaired  $\pm 45^\circ$  specimens is through the specimen thickness, as is the case for the control specimens of the same orientation. This is visualized in Figure 14, which shows the failure path of a repaired  $\pm 45^\circ$  specimen. The repaired  $\pm 45^\circ$  specimens also underwent a period of localized necking before failure, which has also been observed in  $\pm 45^\circ$  FRP tensile testing of specimens without scarf joints. Video recording of the tests showed that the necking occurs near the center of the specimen, in the region in which fracture occurs, beginning at approximately  $\epsilon_x = 2.3\text{--}3\%$  strain and  $\sigma_x = 70\text{--}80$  MPa stress. This is likely due to the concentration of IFF already having occurred in this region, making the material more elastic and thereby undergoing more local deformation. This pliable local strain leads to a high increase in longitudinal strain until fracture at an average  $\epsilon_{x,\max} = 5\text{--}6\%$ , nearly double that at the start of the necking. Contrastingly, the ultimate tensile strength of the repaired  $\pm 45^\circ$  specimens is  $\sigma_{x,\max} = 80\text{--}90$  MPa, which is only less than 15% greater than the stress at necking onset.

Compared to the smooth surface showing interlaminar failure along the scarf joint in the 0/90° specimens, the  $\pm 45^\circ$  repaired specimens have a fibrous fracture surface concentrated in the region of failure, shown in Figure 15. This is a result of the unchanged intralaminar failure path through the specimen thickness, as occurs in the control specimens.

**Figure 14.** Fracture path of  $\pm 45^\circ$  repaired specimens under tensile load, portrayed as a top view of a real fractured specimen (**bottom**) and the side view of a schematic illustration (**top**).

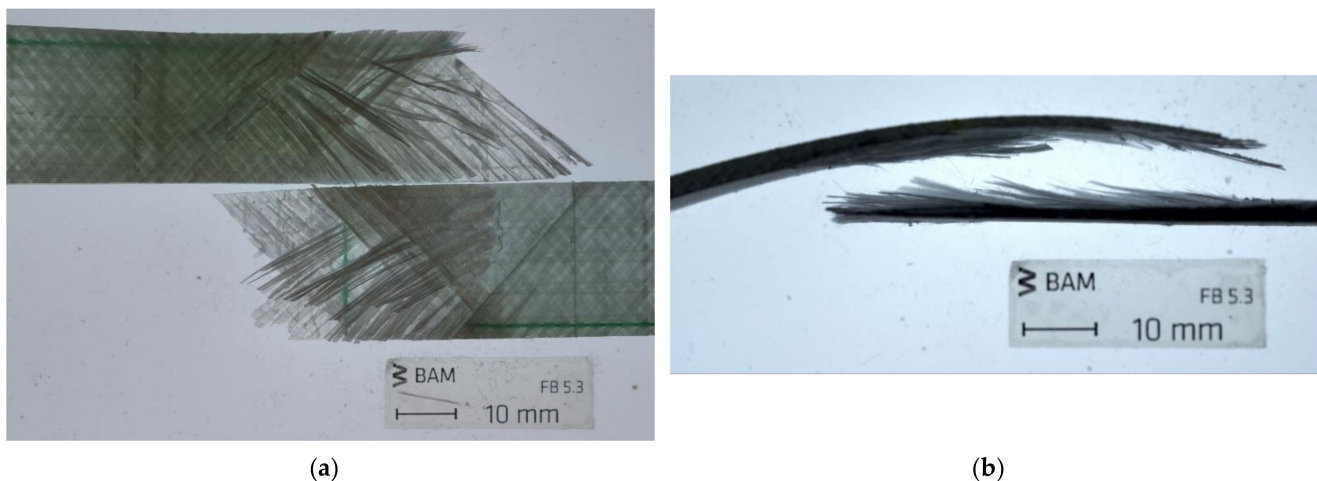
**Figure 15.** (a) Fractured surfaces and (b) side view of  $\pm 45^\circ$  scarf joint specimen under tensile load, showing fibrous remnants as a result of the intralaminar fracture path.

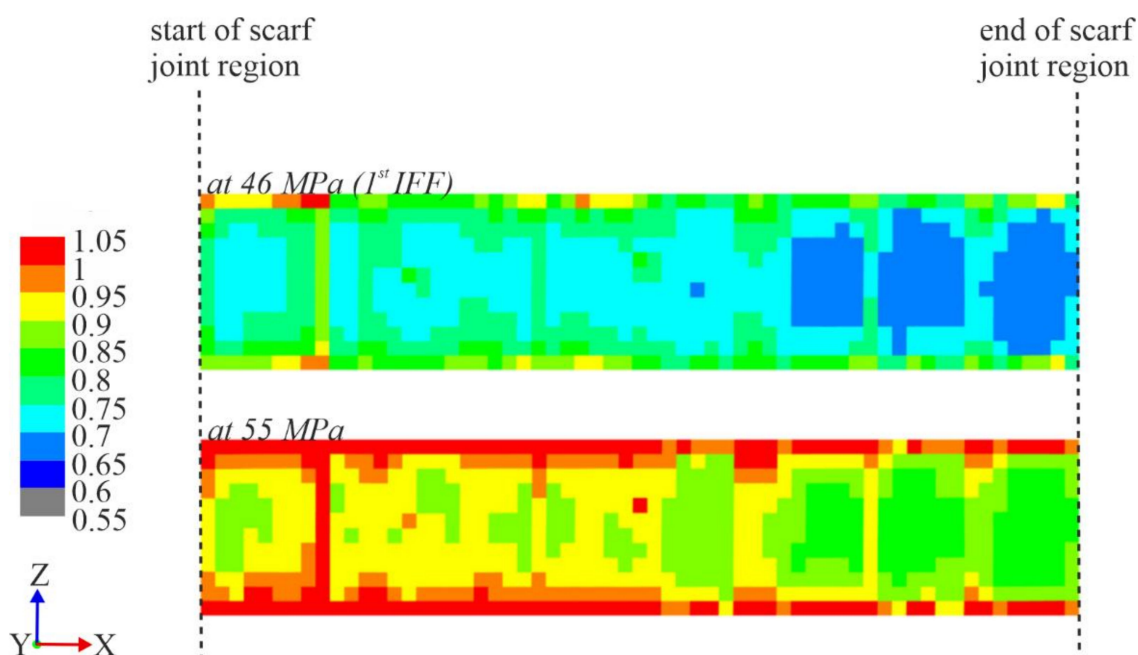
Looking at the IRF values of the scarf joint specimens in the  $\pm 45^\circ$  orientation in Figure 16, it can be seen that the critical regions were concentrated mostly along the edges of the specimen, as is the case for control  $\pm 45^\circ$  specimens under tensile load. In contrast to the  $0/90^\circ$  repaired specimen, which showed higher IRF values in the repair layers than parent material, and especially at the points which mapped to damage initiation and damage path changes, the  $\pm 45^\circ$  stress exposure seems uninfluenced by the presence of a

**Figure 16.** IRF values of  $\pm 45^\circ$  scarf joint region, showing the development of the critical regions under tensile load, viewed from the specimen top. The scale begins at a value of 0.55 for clarity.

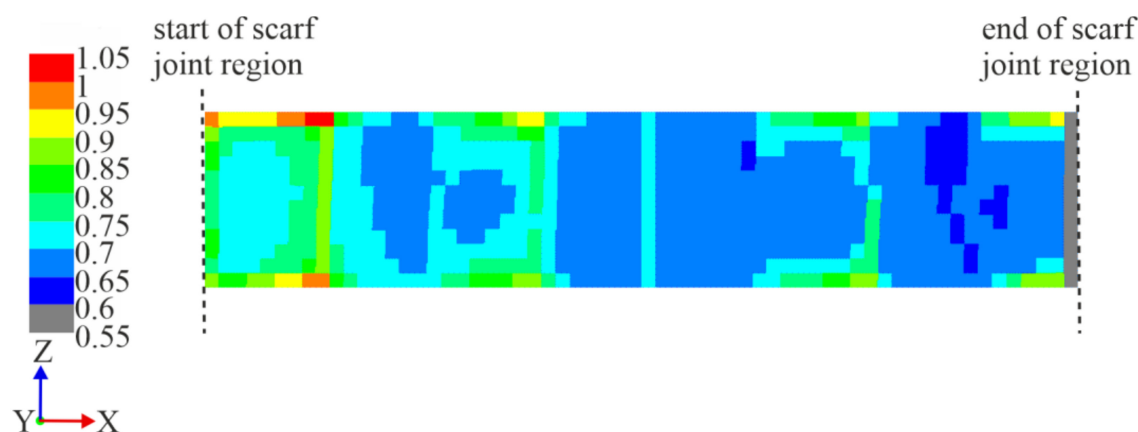
**Figure 17.** IRF values of the bottom-most repair layer of a simulated  $\pm 45^\circ$  scarf joint specimen under tensile load from the top view, shown to be the most critical layer under tensile load, where the first IFF occurs at  $\sigma_x = 46$  MPa. The scale begins at a value of 0.55 for clarity.
