# Rebuilding of Turbocharger Shafts by Hardfacing

**Abstract:** This paper presents the results of structural tests and hardness measurements of rebuilding coatings manually applied by the gas tungsten arc welding (GTAW) method on damaged surfaces of steel shafts of turbochargers of automotive engines. Single- and double-layer coatings were applied in an argon atmosphere by fusing a 1.2 mm diameter wire with a Fluxofil M58 flux core, using a current of 35A and an arc voltage of 8–9 V. The hardfacing resulted in coatings with a martensitic–bainitic structure with fine dispersed carbides rich in M23C6-type chromium. The hardness of the coatings on the rebuilt shafts averaged from about 740HV5 for the single-layer coating to about 770HV5 for the double-layer coating and was two times higher than the hardness of the tempered shafts without coatings.

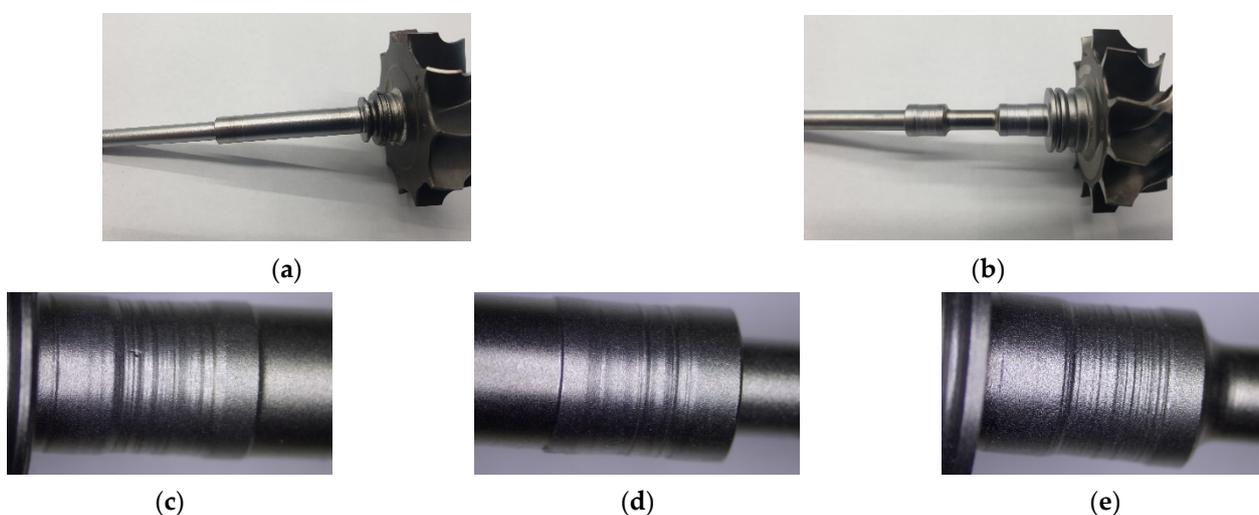
The journals of turbocharger shafts wear abrasively in the areas where the components work together (at the kinetic nodes of the shaft—plain bearing) [12]. The loose particles of hard abrasive material [13,14], during the relative movement of the friction surfaces, cause damage and destruction to the shaft journals by micro-cutting, scratching, furrowing, abrading, and tearing off the protrusions of bumps (Figure 2).

**Figure 2.** Views of the shafts with turbocharger turbine rotors. Renault Laguna 1.9 DCI, Garret 708,639 model (a); Peugeot 3071.6HDI, Garret 7534200375J6 model (b). Worn shaft journal surfaces (examples) (c–e).

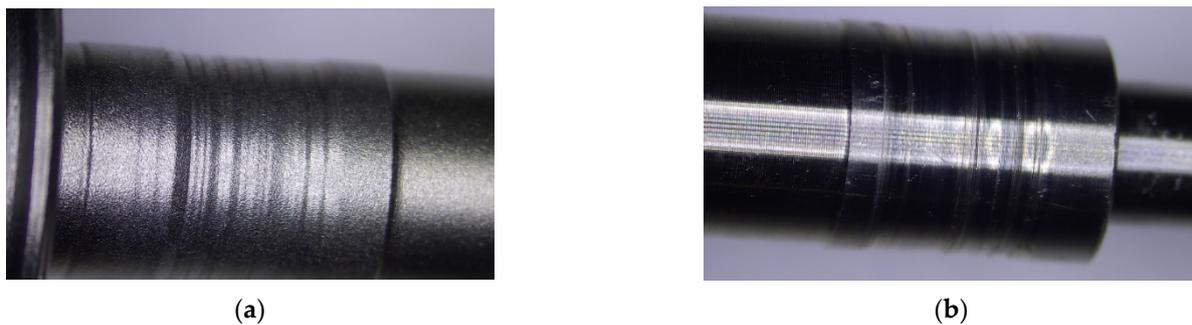
Two shafts with turbine rotors taken from the turbochargers of the Peugeot 307-1.6 HDI and Renault Laguna 1.9 DCI cars were adopted for rebuilding by hardfacing. The top layers of the journals of these shafts were severely damaged by their abrasive wear in the areas of interaction: journal-plain bearing. The thickness of the unevenly worn top layers of the journals averaged 0.2–0.3 mm. Compared to the journal diameters of new shafts of an, approximately, 7.8 mm diameter, the loss in thickness represents 4–8% of the diameter. The unevenly worn top layers of the shaft journals mainly showed deep scratches and furrowing effects caused by displaced loose particles of hard abrasive (Figure 3).

**Figure 3.** Worn top layers of turbocharger shaft journals: Renault Laguna 1.9 DCI, Garret 708,639 model (a), Peugeot 307-1.6 HDI, Garret 7534200375J6 model (b).

The rebuilding of the top layers of the shaft journals was carried out by hardfacing them with the GTAW method using argon as a shielding and plasma-forming gas at a flow rate of approximately 8 L/min, using a wire with a diameter of 1.2 mm and a flux core containing approximately 0.6% C, 1.9% Mn, 0.7% Si, 5.4% Cr, and the remainder being Fe. The hardfacing of the coatings was carried out manually using a current of about 35A and an arc voltage of 8–9 V. In order to cover the entire surface of the shaft journal, beads approximately 2.5 mm wide were laid lengthwise so that they overlapped each other by approximately 0.5 of their width ( $W$ ), according to the diagram shown in Figure 4.

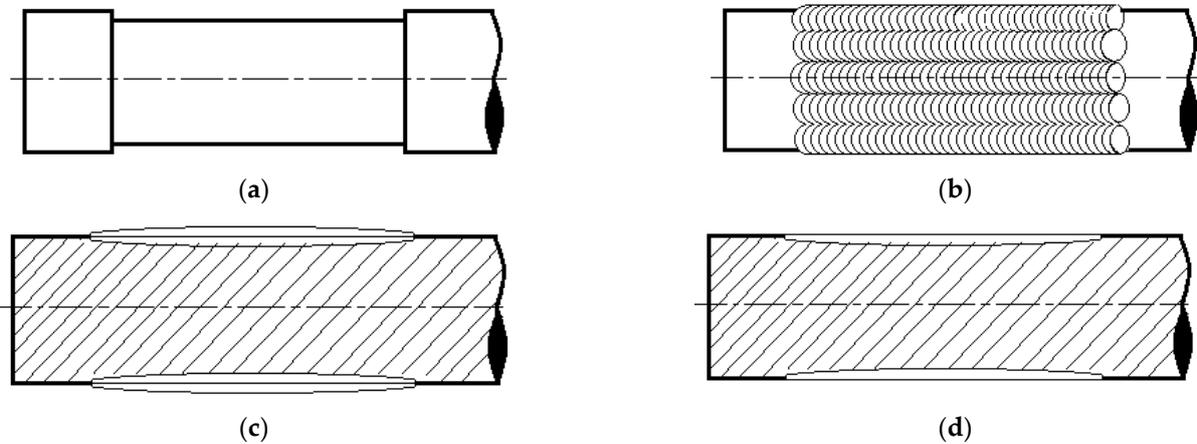
**Figure 5.** Course of rebuilding by hardfacing of shaft journals. Sandblasted surface of used shaft (a), bead pattern after coating (b,c), shaft after finish grinding (d) (diagram).

the second layer of the coating, respecting the width of the beads and the order in which they were laid. The course of the hardfacing of the turbocharger shaft journals is shown in Figure 5.

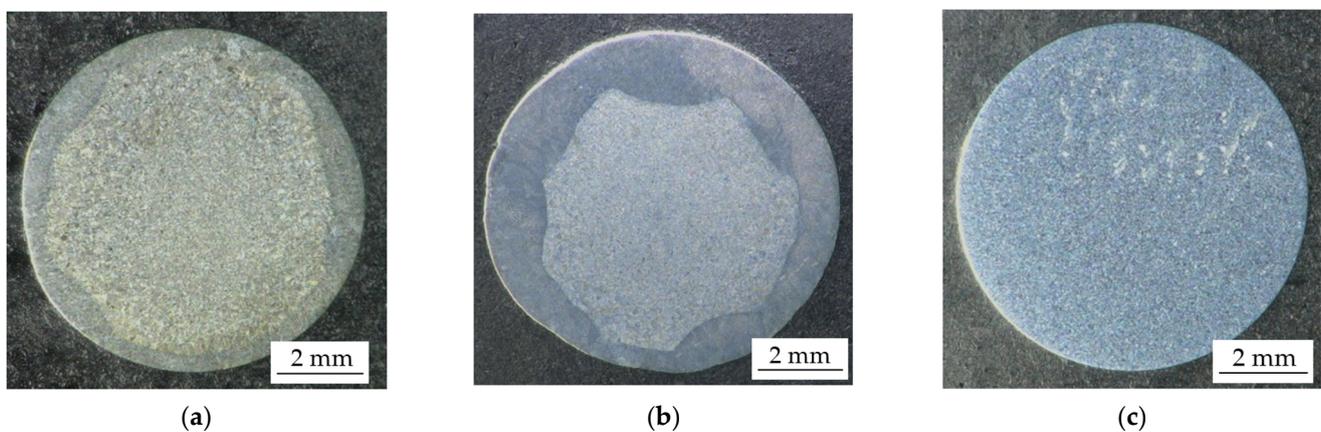
**Figure 6.** Cross-sections of turbocharger shaft journals. Single-layer coating (a), double-layer coating (b), new shaft journal (c). The specimens were etched with Kalling's reagent; 3× magnification.

The effect of the arc manual longitudinal hardfacing of the journals is uneven coating thicknesses, with the coating made by double-layer hardfacing having the greater average thickness. In both cases of single- and double-layer hardfacing, complete coverage of the journal surfaces with flux-cored wire hardfacing coatings was achieved (after finishing machining).

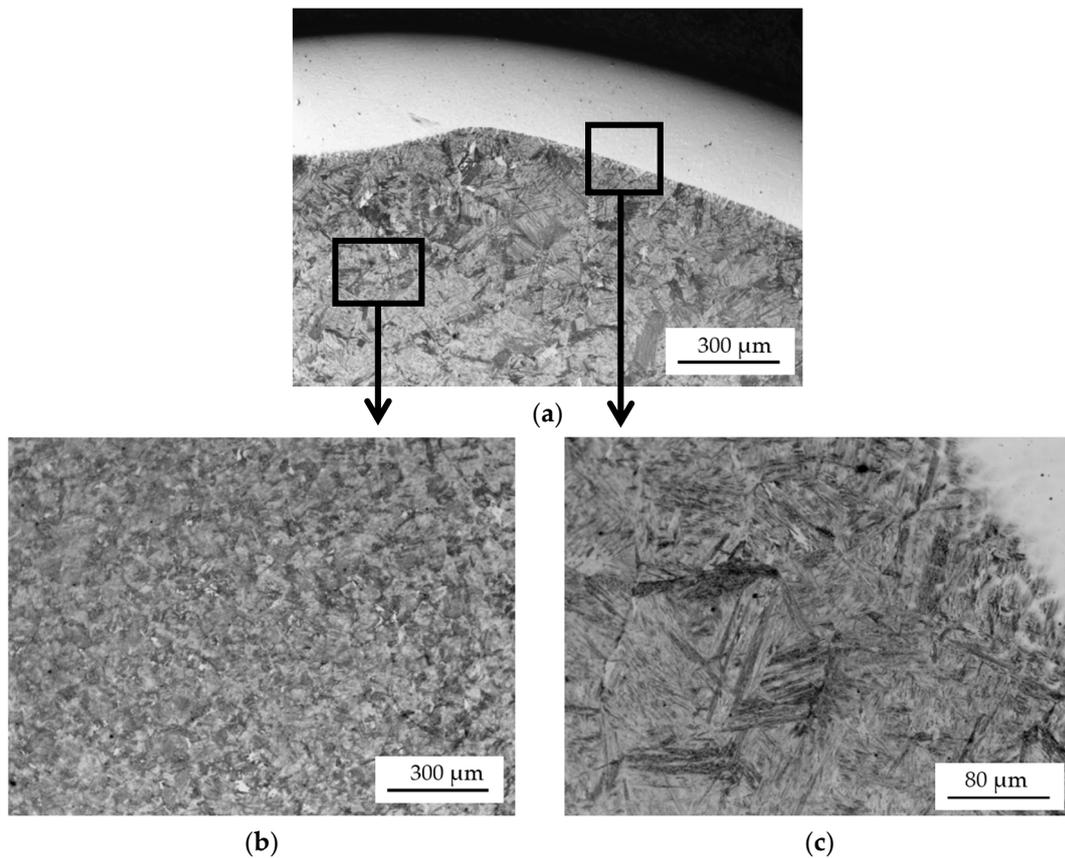
**Figure 7.** Microstructure of a turbocharger shaft journal cross-section after single-layer hardfacing: bright padding weld coating (a), shaft journal core (b), transition zone: coating—shaft journal material (c). The specimen was etched with 4% nital.

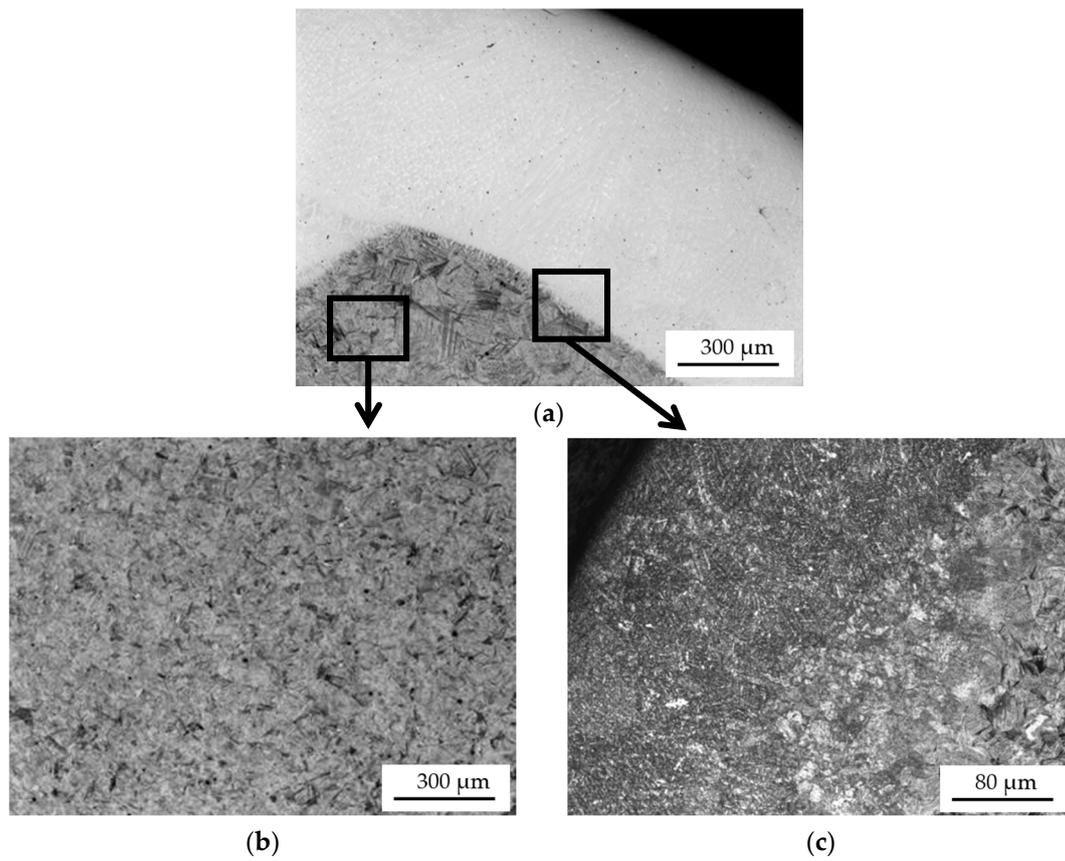
**Figure 9.** Microstructure of a cross-section of a turbocharger shaft journal after two-layer hardfacing: bright padding weld coating (etched with 4% nital) (a), microstructure of the shaft journal core (b), transition zone: coating—material (etched with Kalling's reagent) (c).

The microstructure of the two coatings arc-applied with a flux-cored wire is similar. Their microstructure, revealed by etching with Kalling's reagent (Figure 9c), is fine-grained. In contrast, the sub-coating zone and core of the single-layer hardfaced shaft is coarse-grained. The 100–150  $\mu\text{m}$  grains are coarse-grained tempered martensite. In the case of the double-layer coating, by reheating the core of the shaft journal during the application of the second coating, its structure was crystallized and it has a fine-grained structure similar to that of the new shaft journal (Figures 8a and 9b).

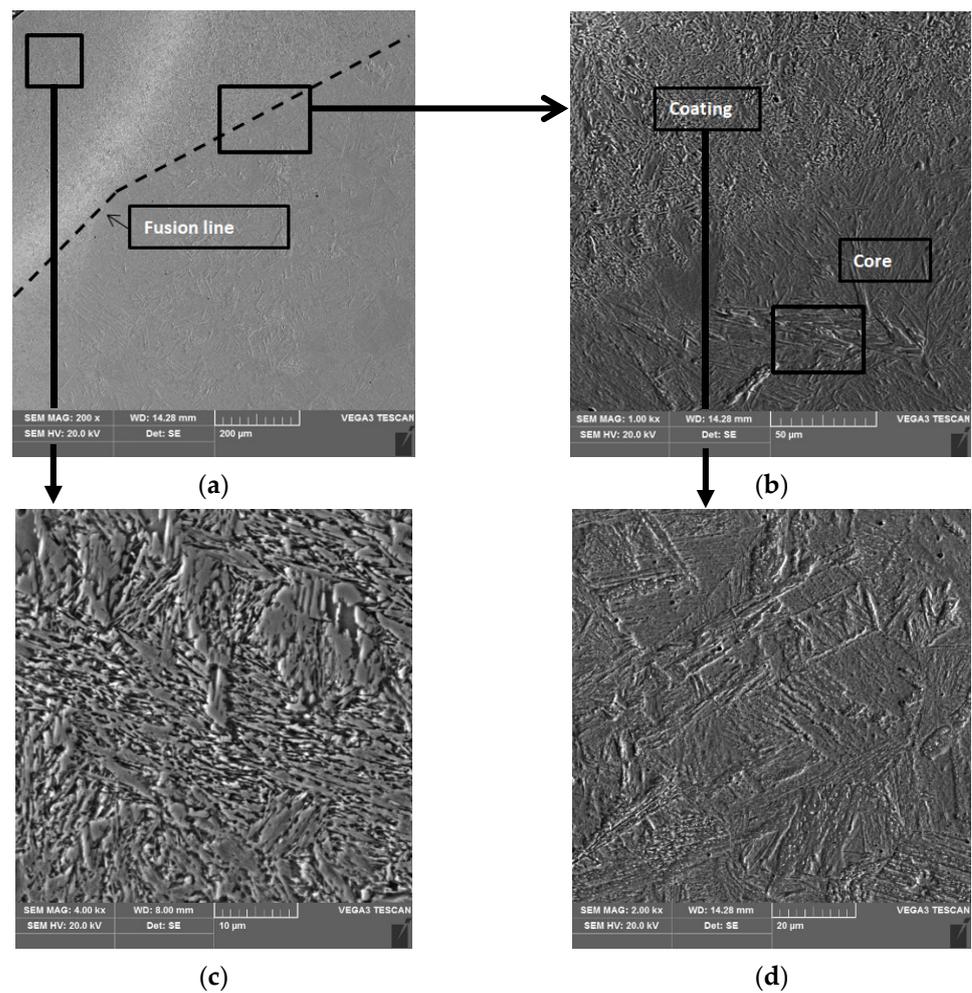
The coatings that are arc hardfaced with a flux-cored wire have a similar microstructure (Figures 10c and 12b). The structure of the coatings is a fine-acicular mixture of martensite and lower bainite with dispersed carbides. The microstructure of the core of a single-layer hardfaced shaft is coarse-grained (Figure 10d) with coarse-plate martensite and lower bainite. The core of the double-layer hardfaced shaft is fine-grained.

**Figure 10.** Microstructure of a turbocharger shaft journal cross-section after single-layer hardfacing. Transition zone microstructure, coating-core (a), detail from (a), coating-core (b), coating microstructure (c), core microstructure (d).

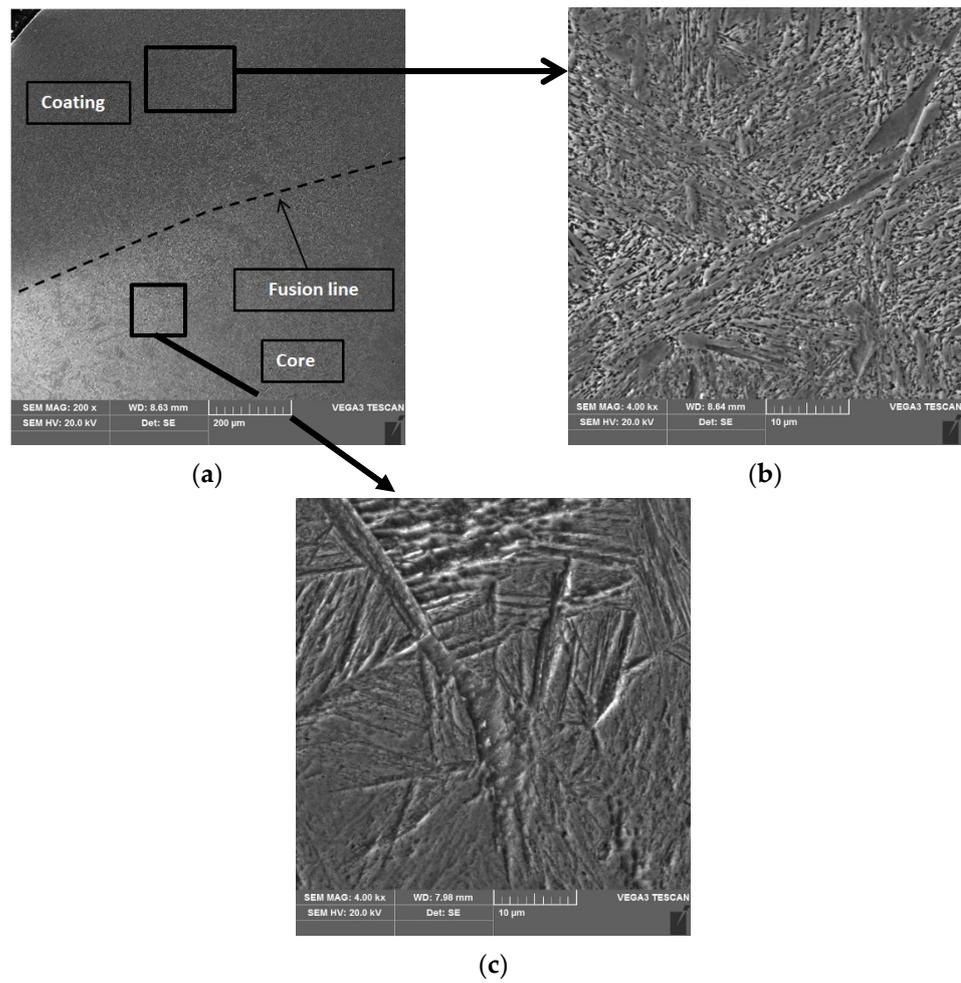
**Figure 12.** Microstructure of a turbocharger shaft journal cross-section after double-layer hardfacing. Transition zone microstructure, coating-core (a), coating microstructure (b), core microstructure (c).
