# Influence of Fire Exposition of Fibre-Cement Boards on Their Microstructure

**Abstract:** The diagnostics of materials, elements and structures after fire exposure are very complicated. Researchers carrying out such diagnostics encounter difficulties at the very beginning, e.g., how to map fire conditions. In this publication, the authors focused on the analysis of the fibre-cement composite used as facade cladding. The fibre-cement boards are construction products used in civil engineering. The fibre-cement boards are characterised by two phases: the matrix phase and the dispersed phase. The analysis of fibre-cement composite was performed using non-destructive methods. The use of non-destructive methods in the future will allow for the analysis of facades after fires without the need to obtain large elements, which will significantly reduce costs while increasing safety. The aim of the work was to determine internal changes in the microstructure of fibre-cement boards after exposure to fire. The degraded samples were compared with reference samples in the evaluation of the microstructure. An analysis was performed using a scanning electron microscope, images of backscattered e

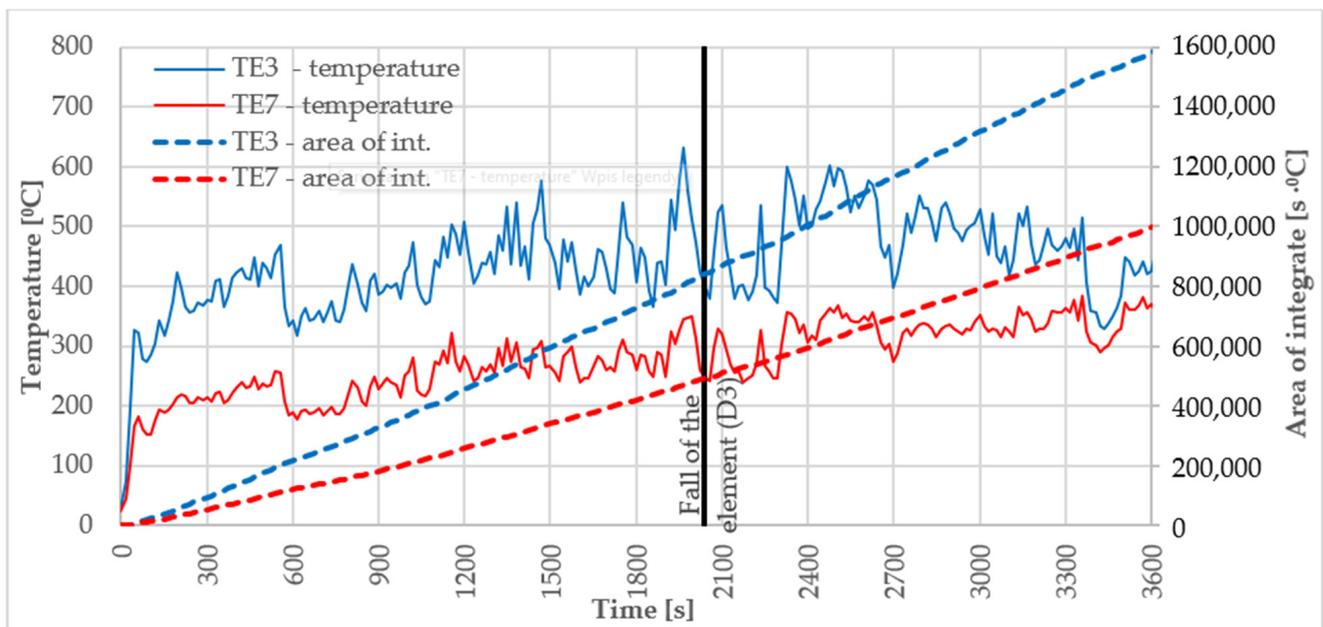
**Figure 4.** Temperature measurement results for TE3, TE7, thermocouples and the increasing integral for the temperature–time function, along with the determination of the fall-off time D3 element.

The item from which the D3 sample was collected came off during the test in the ca. 34th minute. The maximum temperatures in this location ranged between 300 and 400 °C.

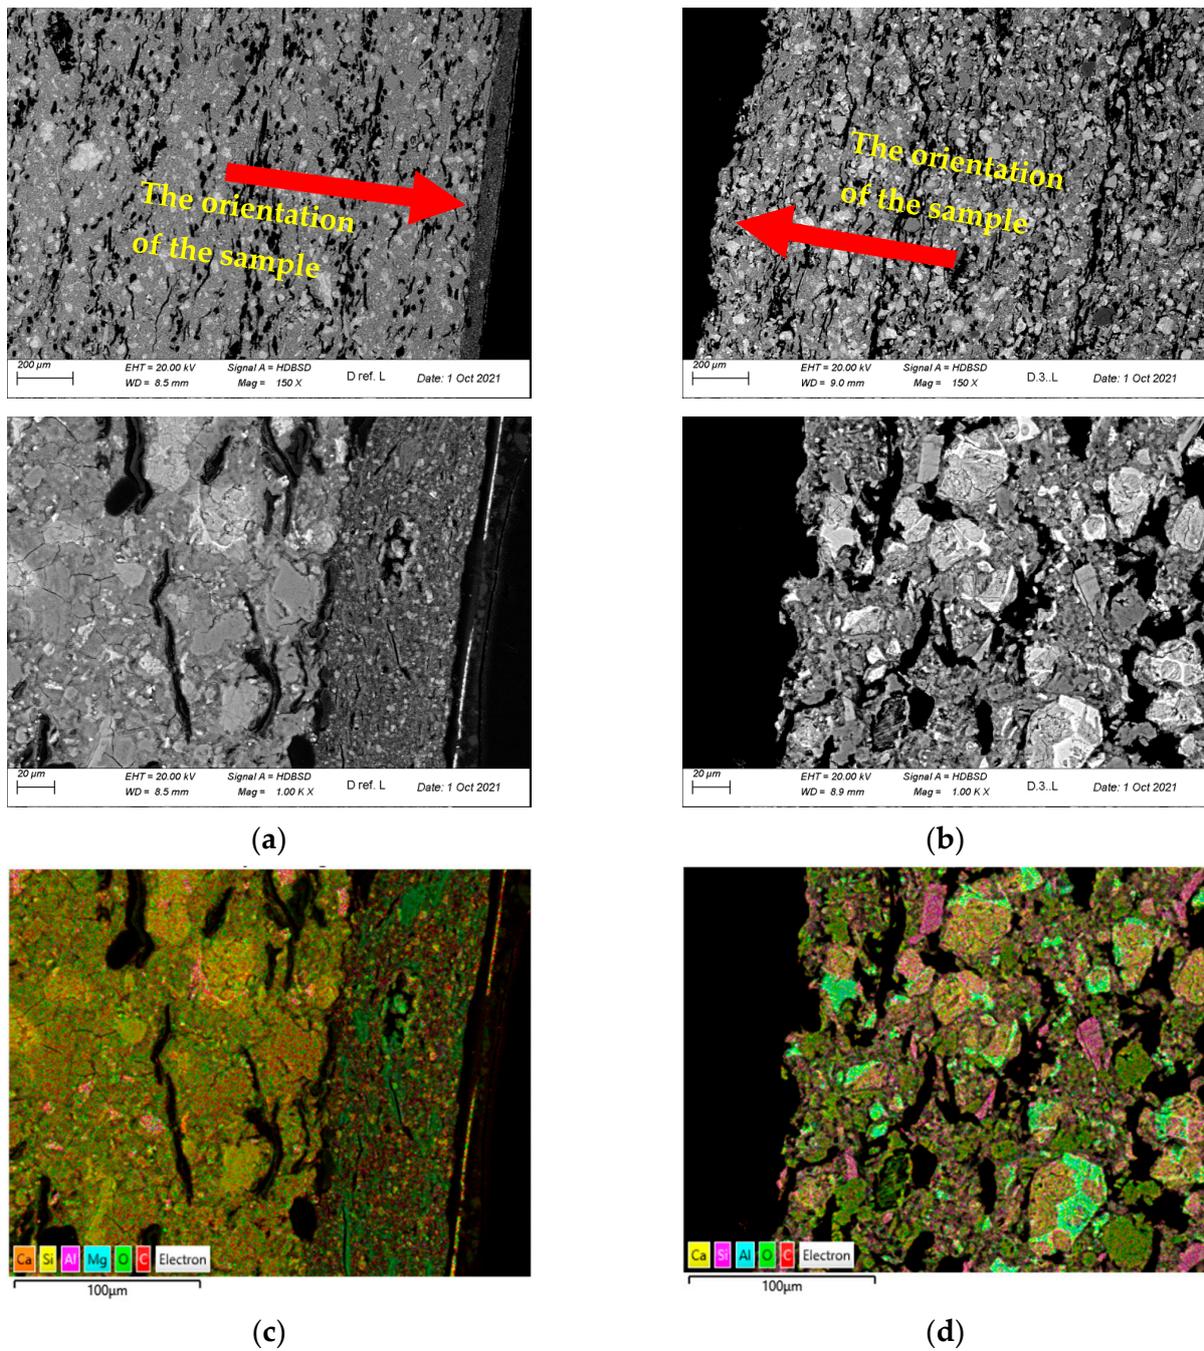
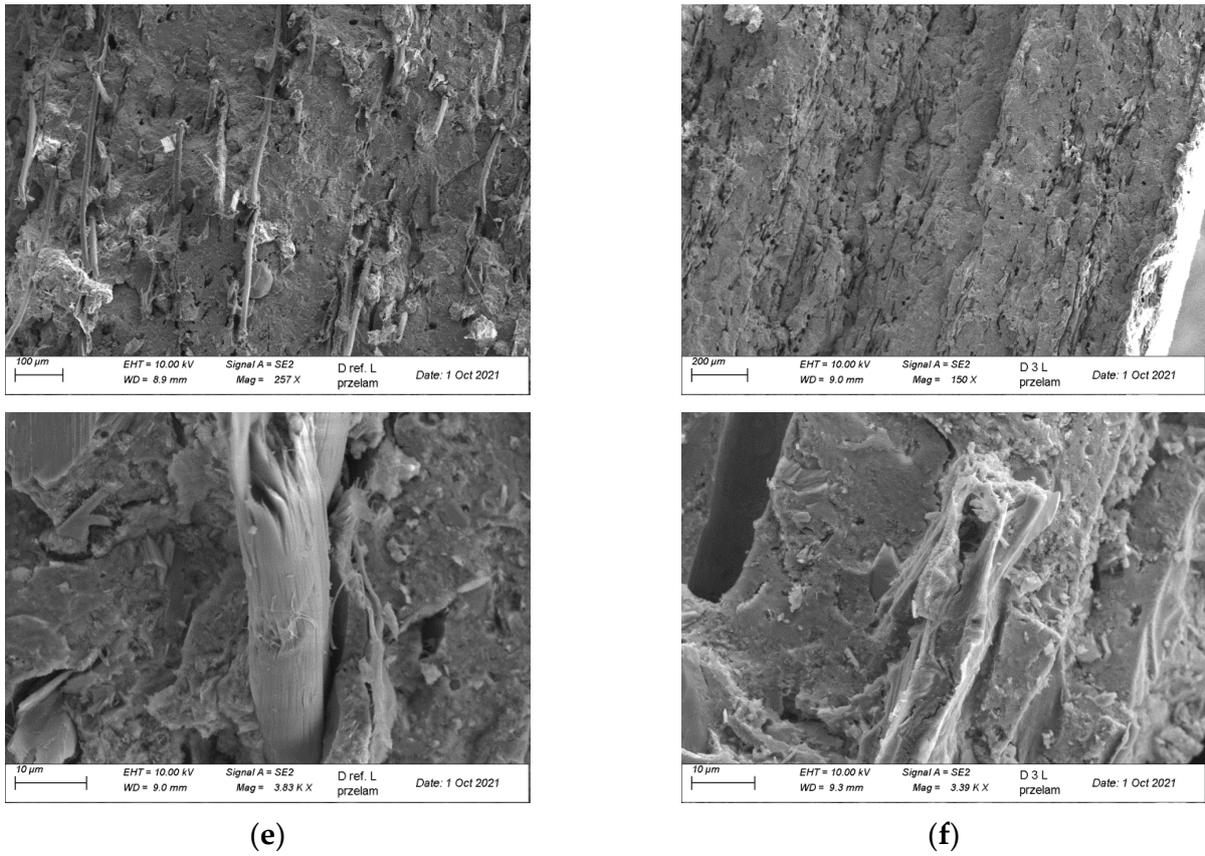
**Figure 8.** Summary of sample images of the analysed D.ref and D3 samples' structures: (a) D.ref sample—section's BSD images; (b) D3 sample—section's BSD images; (c) D.ref sample—section's EDX map; (d) D3 sample—section's EDX map; (e) D.ref sample—fracture's SE images; (f) D3 sample—fracture's SE images.

An analysis of the images shown in Figure 8 revealed the board's compact structure, with visible cement binder grains on the D.ref. sample's sections. Air pores elongated in the direction parallel to the boards' surface were present. The cellulose fibres present in the sample were typically parallel to the board's surface. The structure's apparent anisotropy

results directly from the manufacturing process. The fibres' arrangement in the structure favourably affects the composite's flexural strength. In the D ref. sample, the board's textured top layer was more compact than the substrate and relatively well-bound with the composite. Additionally, it was covered with a thin coat of paint on the outer side. The cellulose fibres observed on the fractures were well bound in the cement matrix and, as a result of the sample's bending, most fibres were broken and pulled out of the matrix, which is a testimony to the fact that the fibres' adhesion to the matrix fibres significantly exceeds the fibres' tensile strength.

During the tests on the real model, the D3 sample was exposed to temperatures between 300 and 400 °C for over thirty minutes. It revealed significant microstructure changes compared to the D ref. sample. The board's textured and thin paint layers were completely degraded and delaminated. The degraded sample's surface was not uniform and was characterised by protruding gaps. The tested composite's porosity increased significantly, which could have been caused by releasing thermal decomposition gas products and the pyrolysis of some of the composite's ingredients. At the temperature observed during the tests, one should expect a loss of non-bound and bound water from the C-S-H phase. Moreover, ettringite decomposition could occur, releasing significant amounts of steam. Furthermore, the portlandite contained in the structure could start to decompose, especially in the sample areas near the surface, where the temperature was higher. Cellulose fibres were subjected to pyrolysis throughout the board's observed cross-section thickness, leaving empty voids inside the structure; the voids were sometimes filled with solid decomposition products. An analysis of the sections' structures revealed no fibres that could transfer mechanical loads during bending. Only empty voids were observed in the cement matrix, left after the fibres; in a few cases, they were filled with decomposition products.

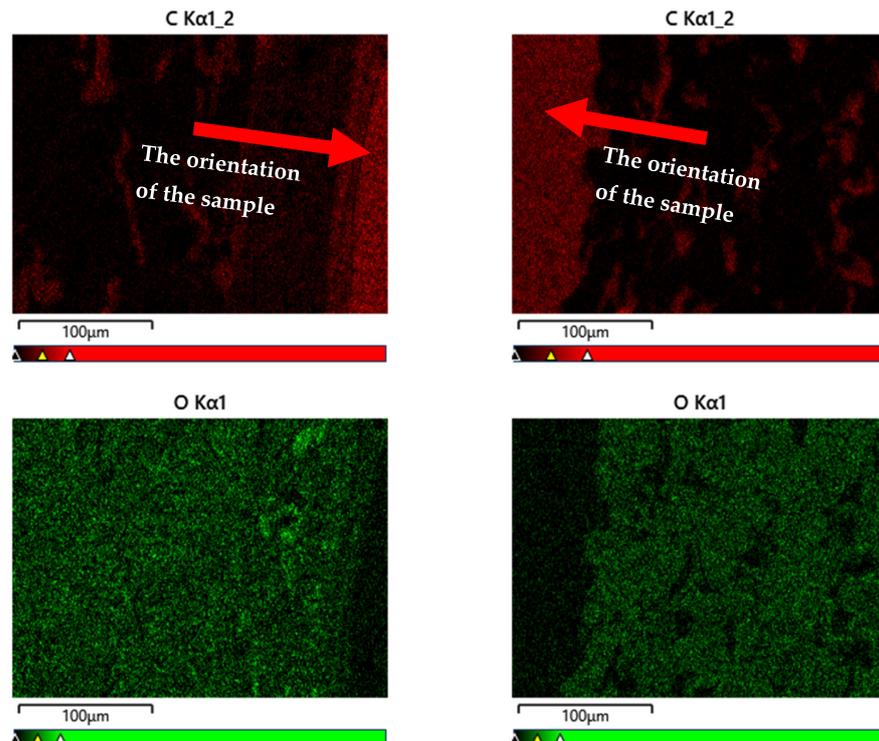
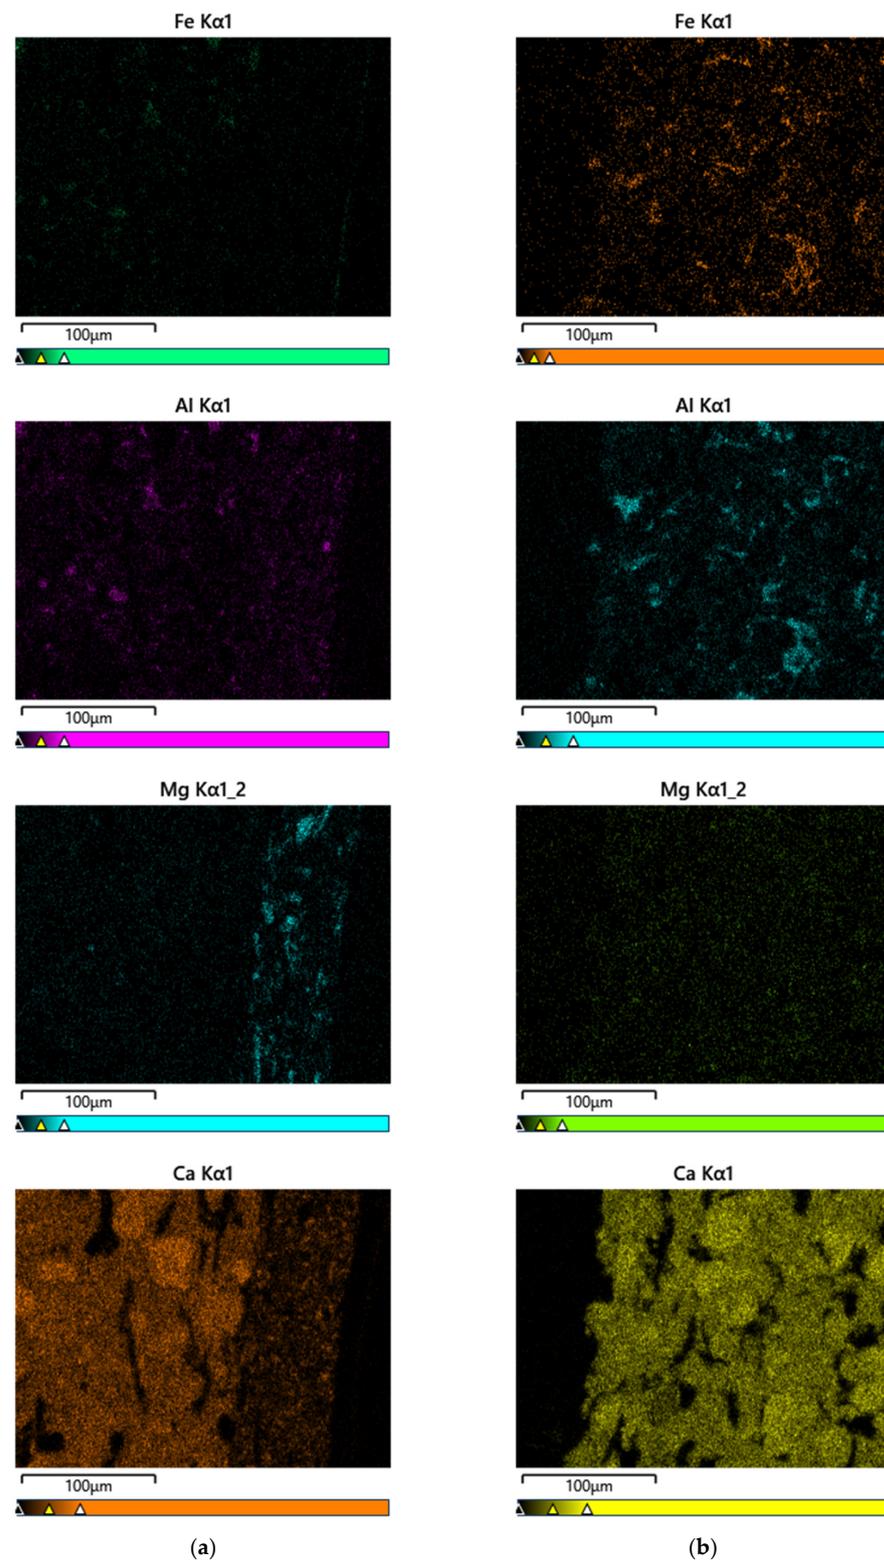
**Figure 9.** Summary of sample images of the analysed D.ref. and D3 samples' structures: (a) D.ref. sample—section's BSD images; (b) D3 sample—section's BSD images.

Figure 9 shows the D.ref and D3 samples that were analysed using the BSD image. In terms of the share of the carbon element (C), its significant share is visible in the near-surface zone—in the hardener layer and in the paint coating. These layers were completely degraded by the high temperature in sample D3. In the case of the element oxygen (O), due to the degradation of the near-surface zone of the D3 sample, its smaller amounts are noticeable. The share of the element oxygen (O) in the degraded sample is much smaller due to its participation in the combustion process (chemical reactions), where, as a consequence, after its participation in the chemical reaction of combustion, the sample is weakened.
