Erosion–Corrosion Failure Analysis of a Mild Steel Nozzle Pipe in Water–Sand Flow

Abstract: Several leaks appeared in a mild steel (MS) pipe jet nozzle installed in a direct impact test rig after a few months of operation in erosive flow at the Centre for Erosion–Corrosion Research. The locations of perforation leaks were primarily upstream, but severe wall thinning was also noticed adjacent to the exit section. In this paper, a failure analysis was carried out on the leaking of a pipe jet nozzle, and the results are discussed in detail. The investigation carried out includes visual observation, scanning electron microscopy, 3D scanning, energy-dispersive spectroscopy, and laser profilometry measurements. In addition, numerical simulations based on computational fluid dynamics (CFD) and the discrete phase model (DPM) were conducted to investigate the root cause of the failure of leaks in the pipe jet nozzle. Further CFD-DPM simulations were performed on three different pipe jet designs for liquid–solid flow conditions, and were compared to find an alternative design to prevent the failure of the pipe jet nozzles. It was found that the increase in turbulence along with multiple imp

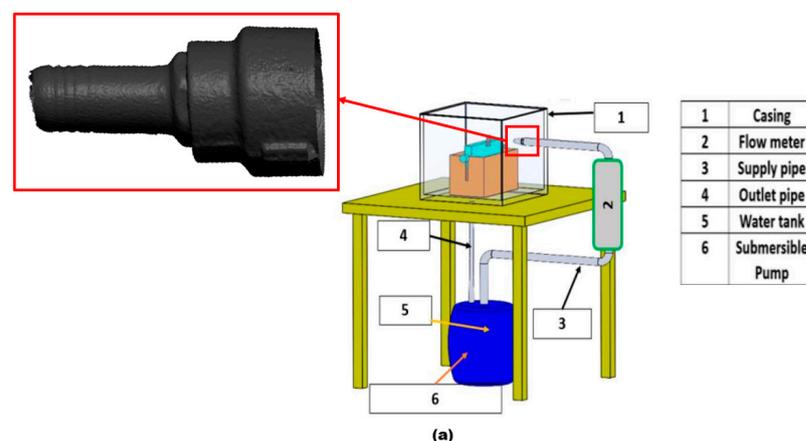
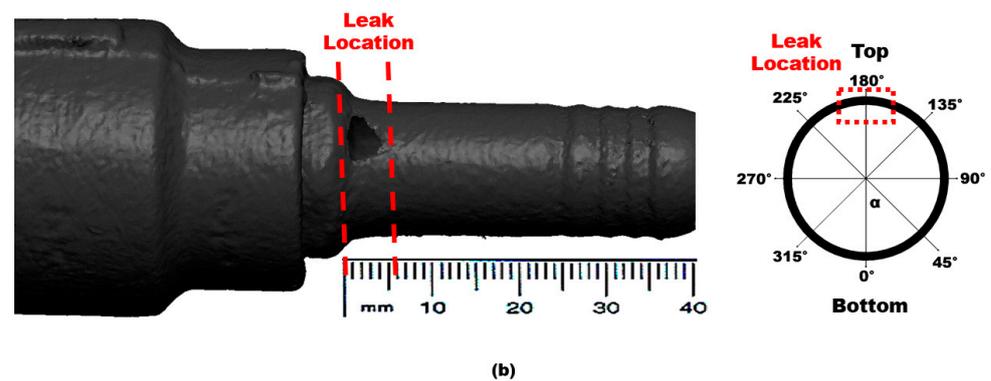
In this research, a root-cause-of-failure analysis was performed on a jet pipe nozzle connected to a direct impact test rig, as shown in Figure 1. The carrier phase flowing through the pipe jet nozzle is water with sand particles 300 μm in size. The unexpected perforation in the pipe jet nozzle took place after 300 h of operation. Then, the failed nozzle pipe was replaced with a new pipe fitting. The root causes of the failure of the nozzle pipe had to be identified to mitigate financial losses and ensure the safety of the operating process. Therefore, the reason for the failure was determined via qualitative and quantitative analysis. Computational fluid dynamics (CFD), the discrete phase model (DPM), and particle tracking techniques were employed to study the erosion-induced mechanism. Microscopic examination, roughness measurements, and confocal microscopy were used to further understand the underlying process, and related countermeasures were developed to mitigate erosion–corrosion issues. Additionally, CFD–DPM simulations were performed on three different designs of pipe nozzle to find alternative design choices for the replacement of failed nozzle pipes.

Figure 1. (a) Direct impact test rig. (b) Location of the leak on jet pipe nozzle.

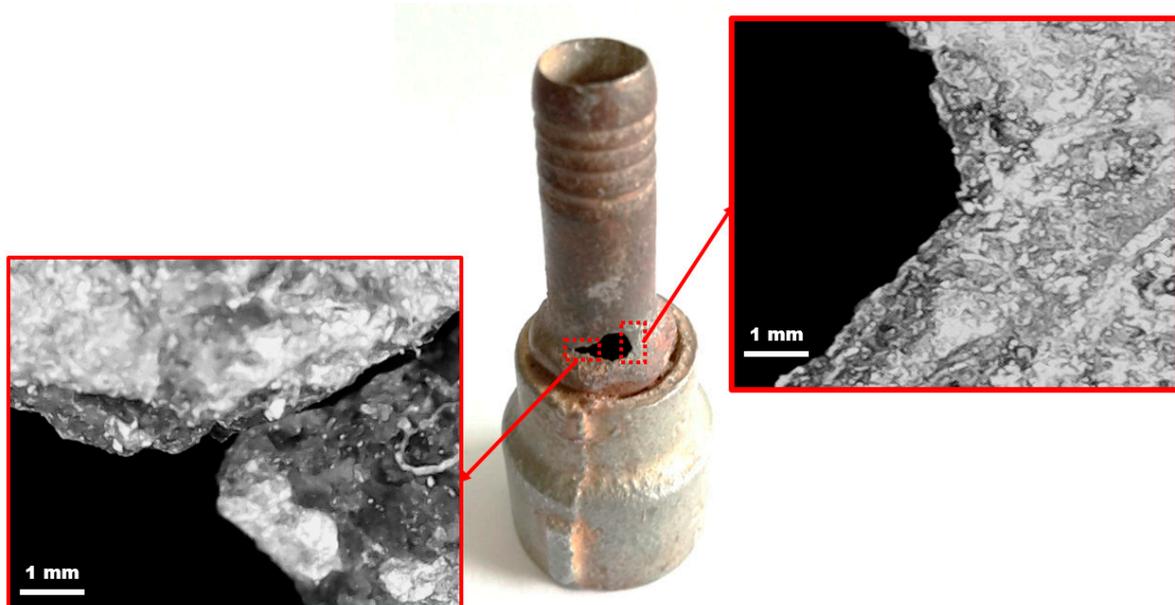
Due to long-term exposure to the slurry, the surface of the failed nozzle pipe has serious perforation traces, and the leak is located adjacent to the inlet location. Figure 3 shows the geometry of the failed nozzle pipe connected to the reducer pipe and the location of the leak. The failure was observed at the top at a 180° annular angle adjunct to the inlet of the nozzle pipe. It can be identified that the wall thinning results in the development of cracks and leaks upstream, as shown in Figure 3. The presence of cracks and wall thinning reveals the intense erosion–corrosion of material, and the combined effect of erosive wear and corrosion with high turbulent flow cause the leak perforations.

Figure 3. Macrographs of the location of the failed nozzle pipe leak.

The macroscopic appearance of elbow leaks is depicted in Figure 3. The top of the pipe close to the inlet is more prone to erosion-corrosion. On the basis of the visual inspection, the localized erosion-corrosion at the pipeline upstream is found and perforated in a spherical shape that extends in the annular direction of the pipe. This kind of failure signifies that corrosion and erosion together caused the leak. The traces of corrosion products inside the pipe indicate that erosion enhances corrosion due to the impaction of particles with carrier fluids. The erosion process is often first exposed to maximal particle impaction and turbulent flow on the pipe surface. These perforation site seen in Figure 3 suggests passive films are destroyed from the upstream section, and then the erosion-corrosion initiates as the carrier fluid impacts the surface.

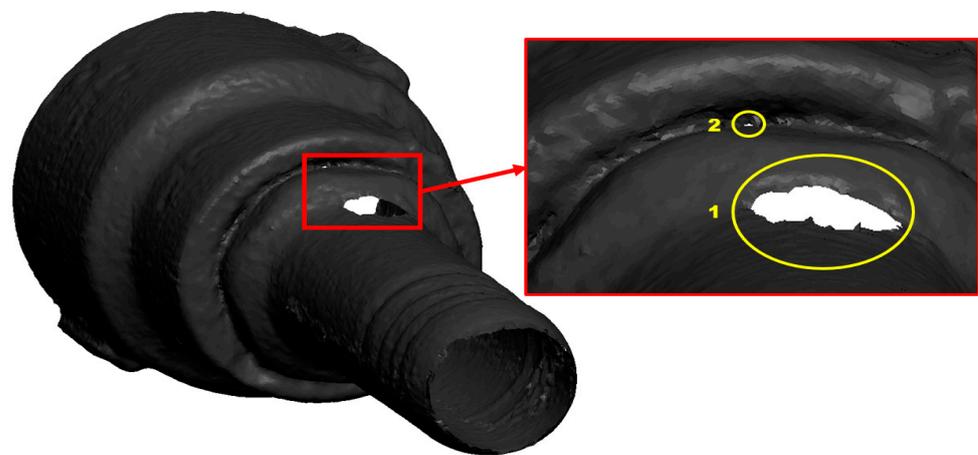
A 3D scan of leak morphology in Figure 4 shows that the leak spreads at locations 1 and 2 at the top of the pipe, with the development of sharp corners. The leak perforations at location 2 are remarkably small in diameter and are developed in a rounded shape; the leak at location 1 of the nozzle pipe shows severe degradation due to erosion and corrosion.

Figure 4. 3D scan of leak locations on the nozzle pipe.

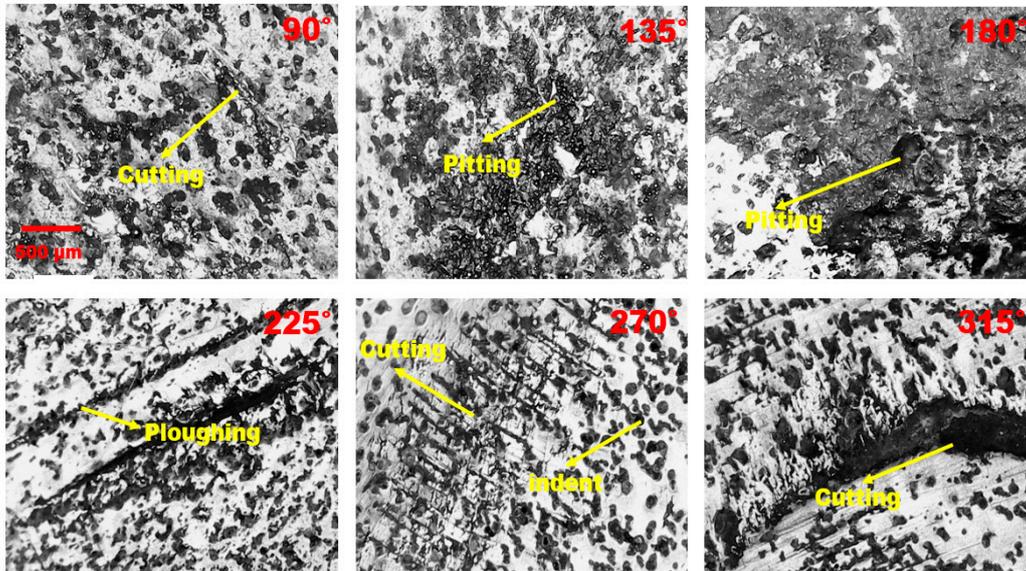
Figure 5 shows microscopic images of erosion-corrosion at different circumferential angles (α) of the nozzle pipe. The corrosion attack originated inside the nozzle and was observed adjacent to the leak according to the microscopic evaluation of the worn surface. Cutting, pitting, and indentations occur primarily on the internal surface, and the severe pitting is concentrated at a circumferential angle of 180° adjacent to the leak location. Ploughing and cutting were observed at a circumferential angle of 225° and 270° . According to the microscopic analysis, the leaks developed as a consequence of the wall thinning phenomenon, which is a particular erosion process caused by the impaction of particles and carrier fluid on the metal surface. Based on Figure 5, the extent of the rusting and the greater number of pits developed due to the acceleration in the corrosion rate at circumferential angles of 90° and 180° .

Plastic deformation can also cause the breakage of the passive oxide film in the mild steel, increase the surface energy, and further accelerate the erosion-corrosion. Thus, small pits become large leak sites due to severe plastic deformation. According to Figure 5, cutting and ploughing are observable at circumferential angles of 225° , 270° , and 315° after erosion-corrosion. Comparing our results with those of Khan et al. [3], ploughing and cutting are more obvious in the steel pipe when there is a low or medium angle of impaction between the erodent and the wall. EDX was used to examine the elemental composition of the worn surface at the inlet and outlet of the nozzle pipe. The trace of Si indicates sand particles embedded in the surface, and iron atoms' reduction in the inlet section in comparison with the outlet indicates that an oxidization reaction has taken place, resulting in severe corrosion with the development of scales of Fe_2O_3 , as shown in Figure 6. During the erosion-corrosion process, the corrosive medium eroded the nozzle's internal surface, resulting in the development of loose and soft corrosion products. The corrosion

products formed on the surface were easily removed due to particle impaction, and in turn, led to serious damage. These locations might become the origin of cracks causing spalling of the worn surface and resulting in leak perforations.

Figure 5. Microscopic images taken from different circumferential angles (α) adjacent to the leak location.

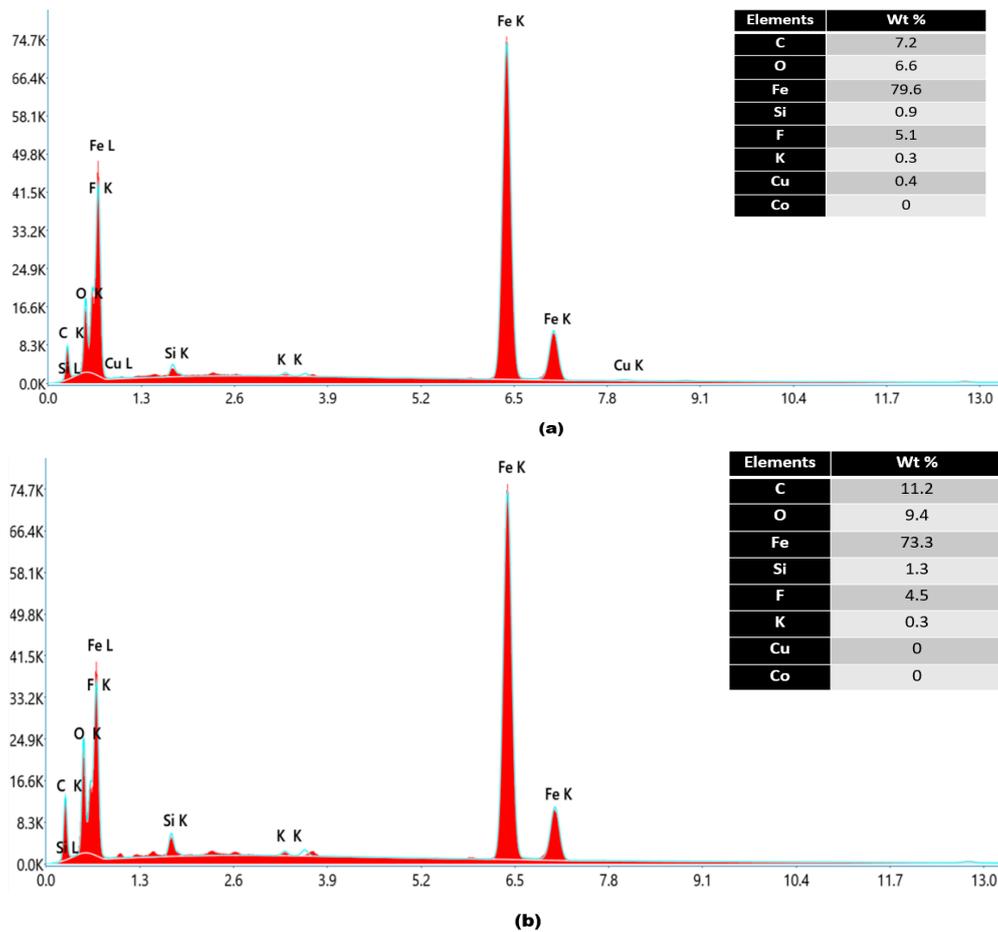
Figure 6. EDX analysis of nozzle pipe (a) inlet and (b) exit.

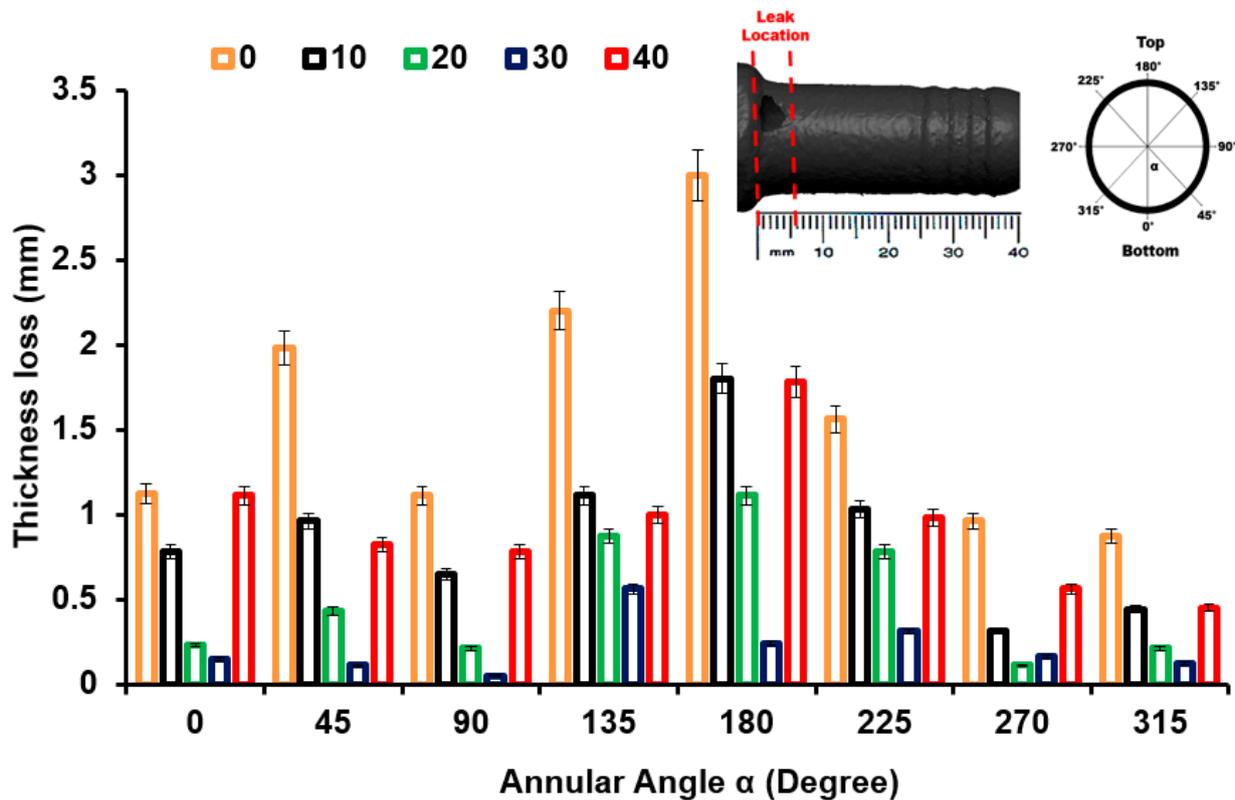
Thickness at different locations ($x = 0, 10, 20, 30,$ and 40 mm) and circumferential angles (α) were quantified by employing a digital micrometer three times at each location (Figure 7). This quantitative method for thickness reduction from upstream to downstream identifies the location of severe wall thinning.

Figure 7. Thickness loss at a different locations in the nozzle pipe.

The thickness plotted at different locations and annular angles (α) along the axial length is shown in Figure 7. Surprisingly, the inlet and outlet sections encounter maximum wall thinning. As shown in Figure 7, the thickness measured at eight circumferential angles corresponds to the positions of erosion and wall thinning. The serious erosion is mainly located at $\alpha = 180^\circ$ and $x = 0$, and the area with minimum wall thinning is located at $\alpha = 270^\circ$ and $x = 20$ mm. It was also observed that in comparison with the outlet, the inlet had a significant wall thinning due to erosion–corrosion.

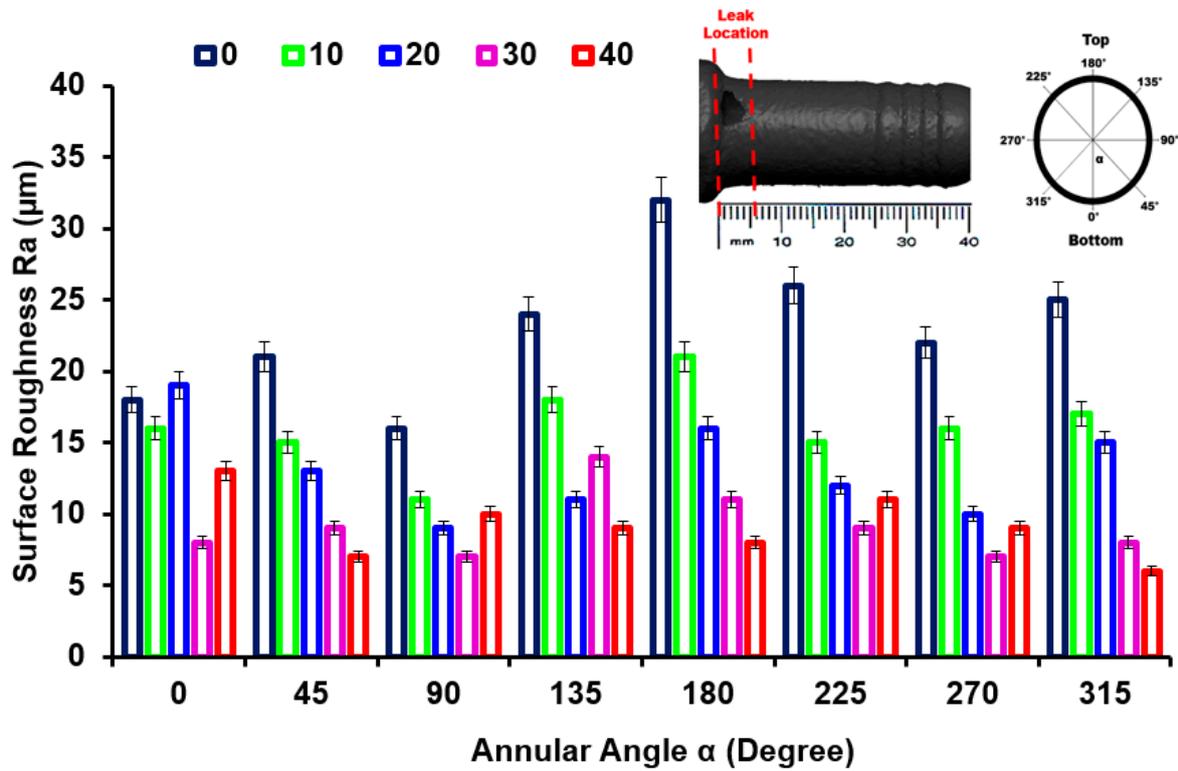
Figure 8 shows the surface roughness R_a variation from inlet to outlet after the removal of the corrosive layer. The surface roughness R_a adjacent to the leak location is $32.1 \pm 0.11 \mu\text{m}$, which is the minimum surface roughness measured adjacent to the outlet. The decreased roughness from inlet to outlet could be due to less pitting and degradation during erosion–corrosion. It can be seen in Figure 9 that there is an uneven morphology with several peaks and valleys adjacent to the leak location at $\alpha = 180^\circ$ on the $x = 0$. It can be seen in Figure 9 that there is noticeable surface degradation adjacent to the leak location, leading to the failure of the mild steel pipe nozzle during erosion–corrosion. The results also indicate that the degrading effect and strain-hardening effect on the worn surface adjacent to the inlet enhance wall thinning and cause the failure of the pipe.

Figure 8. Surface roughness R_a at different locations in the nozzle pipe.

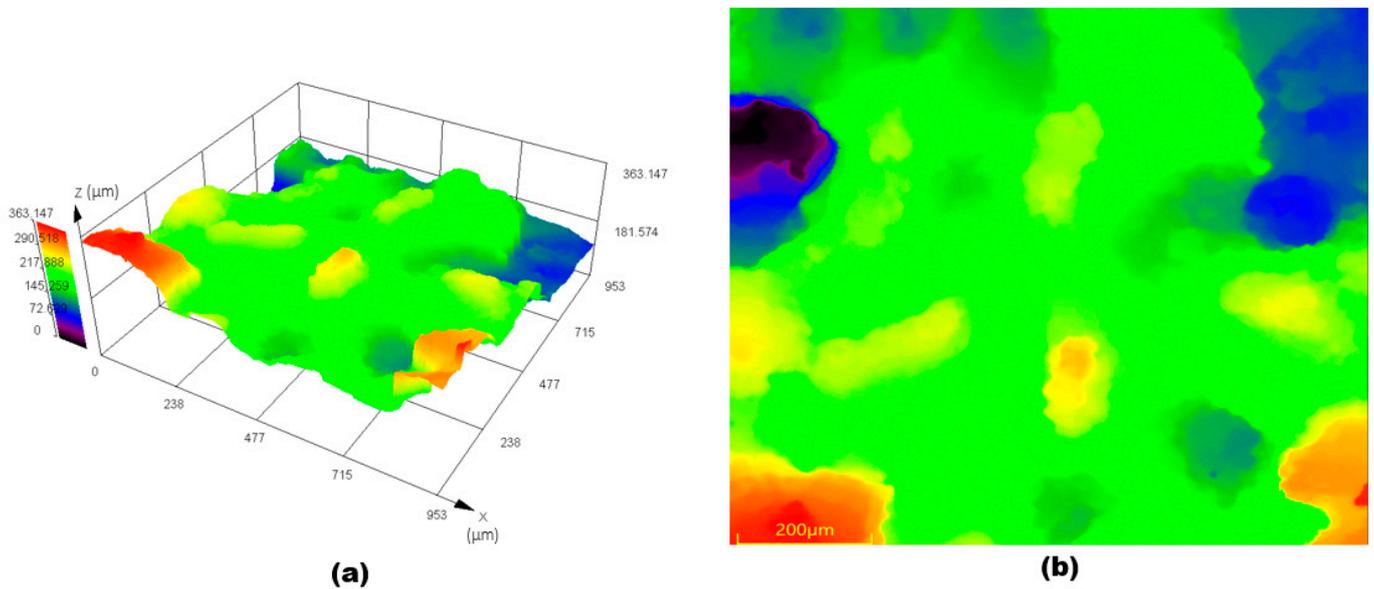
Figure 9. Surface topography of the adjacent surface of the leak location: (a) 3D profile; (b) 2D profile.

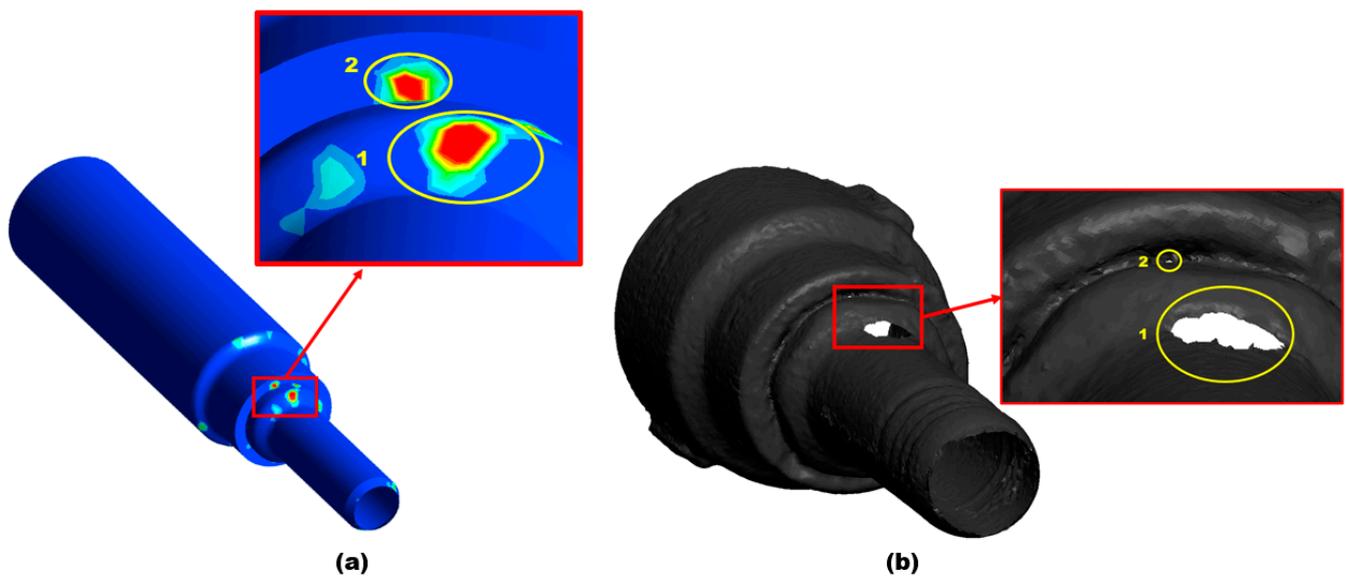
Figure 10. Location of erosion: (a) CFD-DPM simulations; (b) 3D scan.

As determined by the simulation results in Figure 10, the areas highlighted in yellow color, marked locations 1 and 2 on the top of the nozzle pipe, experience the maximum erosion and particle impactation. This indicates that the maximum erosion–corrosion located adjacent to the inlet resulted in leak sites. The corrosion process is accelerated when there are solid particles present in the flow field because they increase the turbulence of the fluid, which in turn enhances the pressure on the outer wall; the maximum erosive zone is located between $\alpha = 180^\circ$ adjacent to the inlet, resulting in a significant loss in the thickness of the wall, whereas at outlet less erosion is observed. To develop an alternative design solution to mitigate erosion near the inlet, CFD-DPM simulations were performed on three different design configurations in this study, as shown in Figure 11. In order to reduce the maximum erosion rate in the nozzle pipe, the reducer section was modified with a fillet radius, chamfer, and rectangular shape as alternative design choices. Design 1 corresponds to a failed nozzle pipe investigated via 3D scanning, thickness loss, SEM-EDS, and surface topography analysis, as detailed in Section 3.1. The choice of alternative design was made after simulating erosive wear in all four designs with similar operating conditions of failed nozzle pipes. In this study, there were four geometrical configurations (reducer section with failed pipe (Design 1); fillet radius (Design 2); chamfer (Design 3); and rectangular shape (Design 4)) as shown in Figure 11. An inlet diameter of 20 mm and an outlet diameter of 10 mm were considered for numerical simulations.

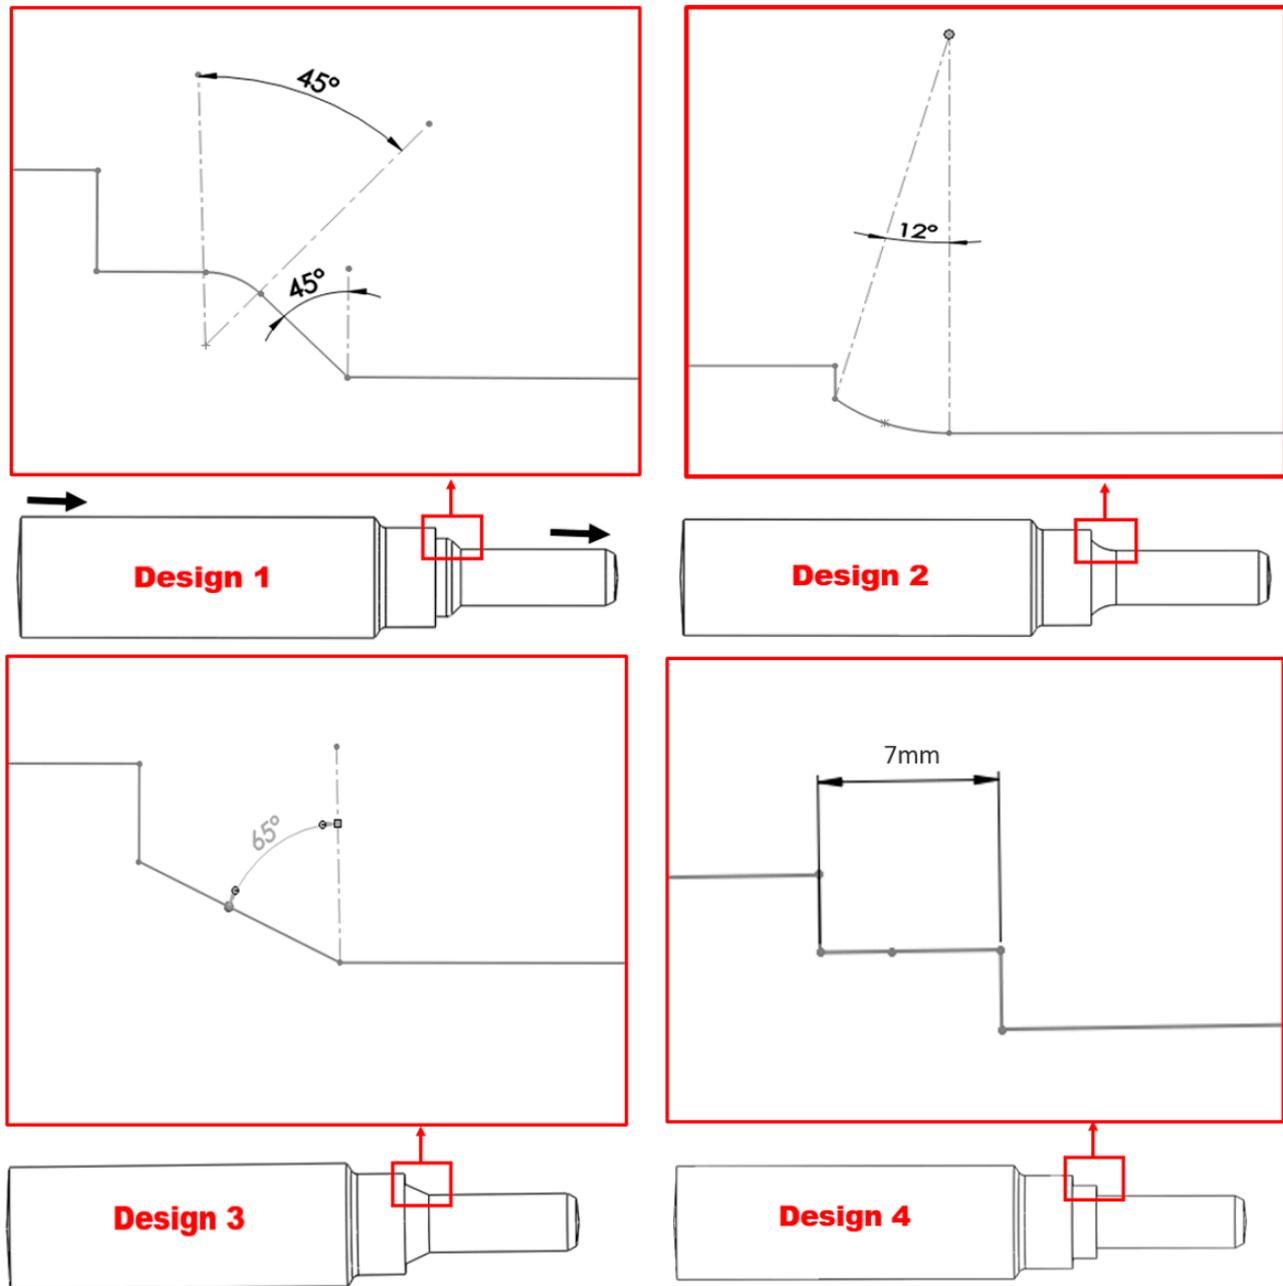
Figure 11. Different design configurations of pipe nozzle.

To reduce the maximum erosion rate of the failed nozzle pipe, three geometric configurations are proposed for numerical analysis. Design 1 corresponds to the geometry of the failed nozzle pipe. Design 3, with a chamfer reducer section, was found to be the best choice for the replacement of the failed pipe. It can be found that the CFD-DPM simulations predict the maximum erosion rate locations in failed nozzle pipes with reasonable accuracy. However, to increase the accuracy of simulations, simply spherical solid particles should be replaced by non-spherical solid particles. Moreover, particle–particle interactions should also be considered during numerical simulations.

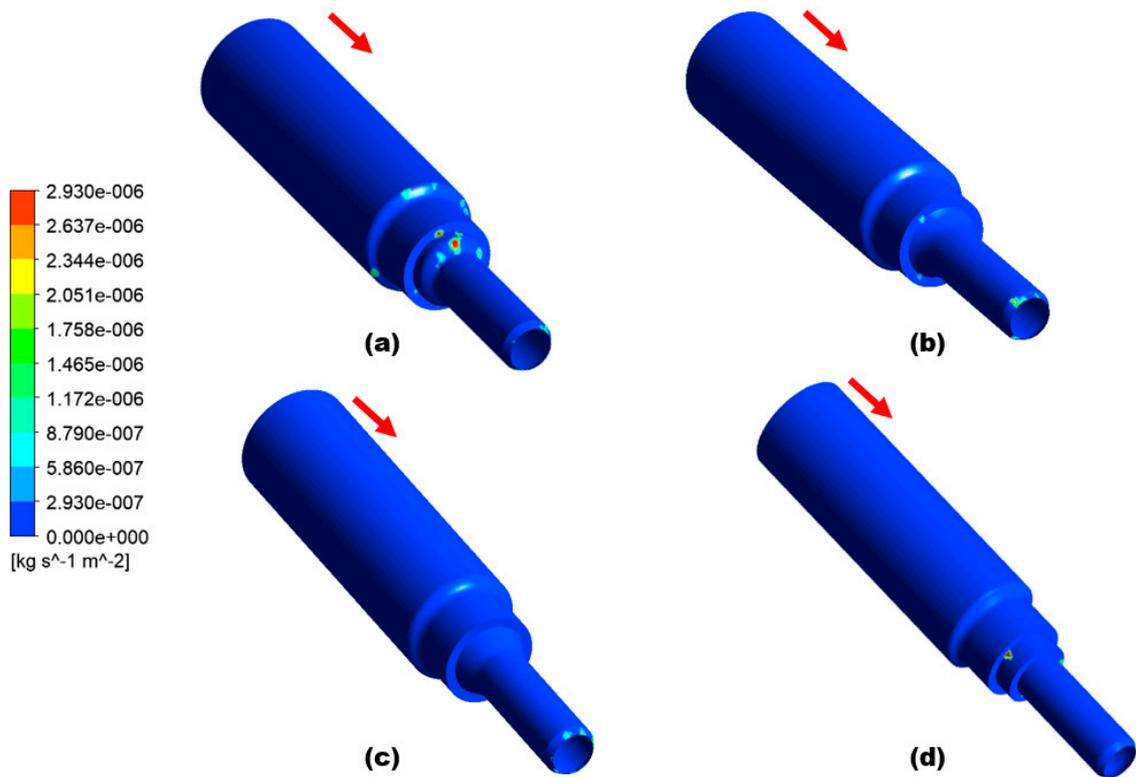
This simulation analysis shows that particle impactation and turbulence are responsible for the development of the erosion pattern adjacent to the inlet that resulted in the development of leak perforation. In Design 3, the maximum erosion rate is five times less than in Design 1, which indicates Design 3 can be used as a choice of replacement to mitigate the erosion of the nozzle pipe, as shown in Figure 12. In terms of erosive wear, the particle impact energy is strongly related to the velocity and turbulence intensity [2].

Figure 12. CFD–DPM erosion rate: (a) Design 1, (b) Design 2, (c) Design 3, and (d) Design 4.

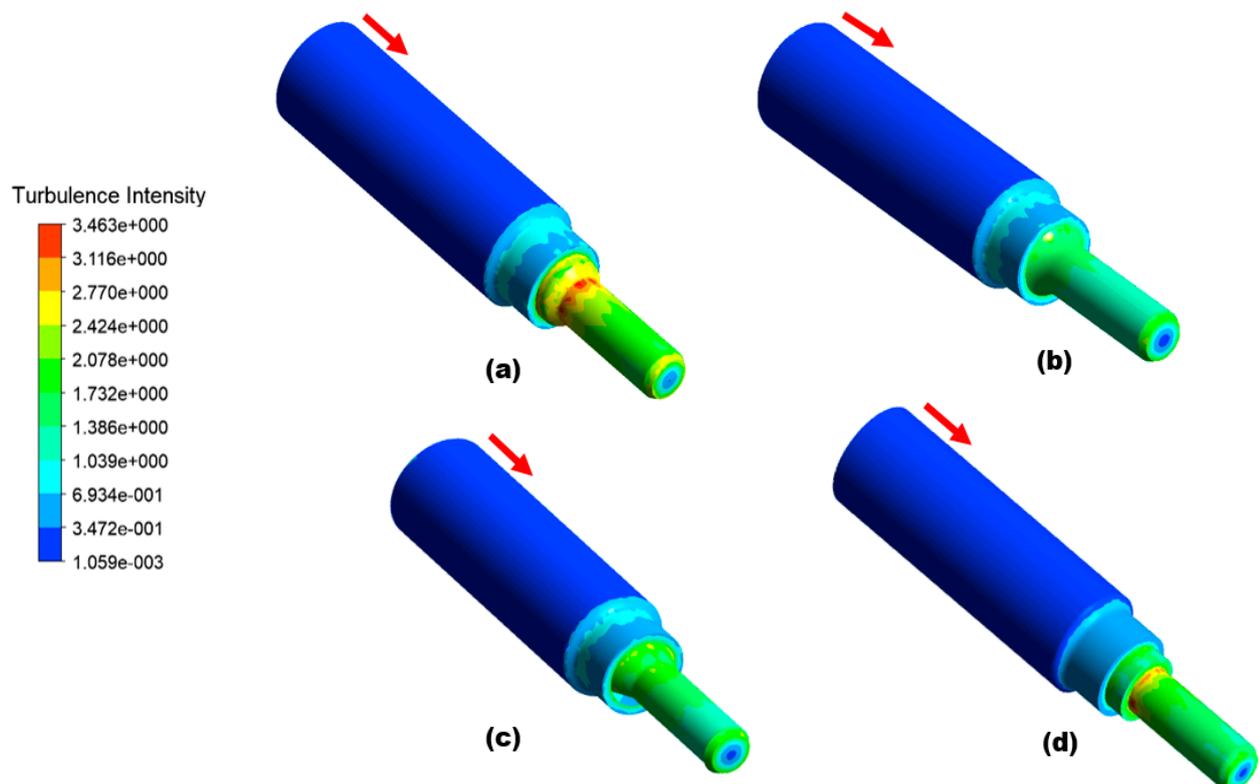
Additionally, the increase in turbulence in Design 1, as shown in Figure 13, escalates particle wall impactation and results in particle wall interaction at locations a, b, and c, as indicated in Figure 14a; it also increases the erosion–corrosion rate adjacent to the inlet. The turbulence intensity in Design 3 is significantly less than in Design 1, causing particle wall impactation near the inlet at locations a and c, as shown in Figure 14b. Under identical operating conditions, Design 3 exhibits a reduction in both turbulence and maximum erosion rate in the area with leak perforations. Consequently, appropriately changing the reducer section of nozzle pipe with chamfer can reduce the maximum particle wall impactation, as shown in Figure 14. The CFD-DPM analysis of all geometric configurations

Figure 13. Turbulence intensity: (a) Design 1, (b) Design 2, (c) Design 3, and (d) Design 4.

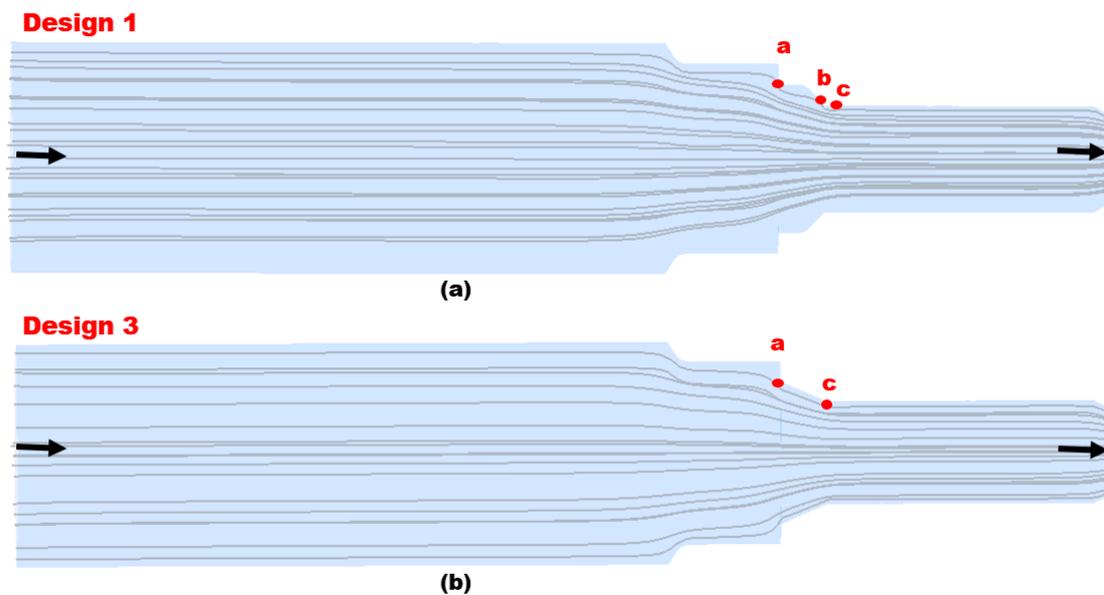
Figure 14. Particle track: (a) Design 1 and (b) Design 3.
