Failure Analysis of Cracking of Cast Aluminum Alloy Manhole Cover

Abstract: In this paper, the abnormal fracture failure of a ZL104 aluminum alloy quick-opening manhole cover of a cement tank truck is systematically studied to discover the root cause of an accident. The unloading operation procedures of cement tank trucks, the effectiveness of safety valves, the chemical composition, mechanical properties and material quality of aluminum alloy manhole covers, and the macroscopic and microscopic morphology of fractures were comprehensively analyzed. The results show that although the Mg content in the chemical composition of an aluminum alloy manhole cover exceeds the standard, it is not the root cause of the accident. The root cause of the failure is that, during the unloading operation, the operator did not strictly follow the unloading procedures. One of the buckles was in the released state, which led to uplift cracking, resulting in the successive cracking and slipping of adjacent buckles, and the manhole cover finally cracked and flew out. Based on the failure causes, suggestions are put forward to prevent the manhole cover from failing during the unloading operation of cemen

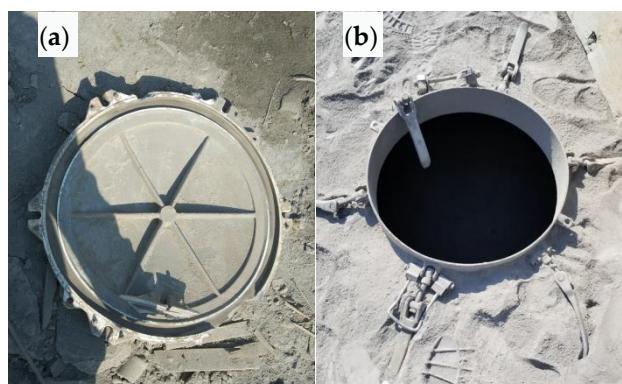
During the unloading of a cement tank truck transferring cement dust to a storage tank under pressure, one manhole cover ruptured and flew approximately 20 m away, while the other manhole cover was intact. The cracked manhole cover and its corresponding manhole ring are shown in Figure 1. The safety buckle of the manhole cover installed on the tank body has been straightened and no obvious deformation or other failure is observed on the other parts, as shown in Figure 1b.

Figure 1. Manhole cover and manhole ring: (a) broken cover, (b) manhole ring.

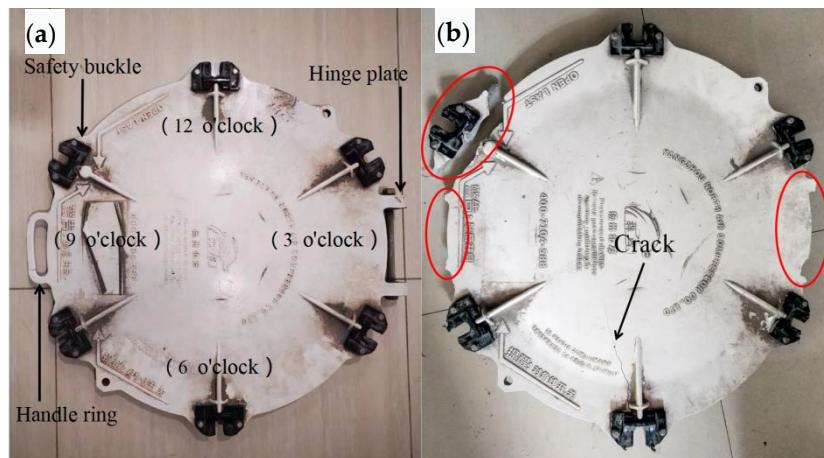
The macro morphology of intact and cracked manhole covers is shown in Figure 2. The shape of the quick-opening manhole cover of the cement tank truck is shown in Figure 2a. The nine o'clock position is equipped with a pull ring, and the three o'clock position is equipped with a hinged plate. The manhole cover is uniformly distributed with six handles for sealing (equipped with black engineering plastic pressure block), among which there is a buckle at the ten o'clock position (released last when opening). The outer diameter of the quick-opening manhole cover is about 600 mm, and the middle wall thickness of the manhole cover is about 8 mm. The nominal maximum allowable pressure is 0.25 MPa. The material is ZL104, which is molded by casting. The model of the manhole cover is TY600 × 520. The morphology of the cracked manhole cover is shown in Figure 2b. The handle ring at the nine o'clock position and the hinged plate at the three o'clock position had fallen off. Radial cracks can be seen in the sealing buckle area at the six o'clock position. The safety buckle was broken and separated at the ten o'clock position.

Figure 2. Macro morphology of manhole covers: (a) intact, (b) cracked.

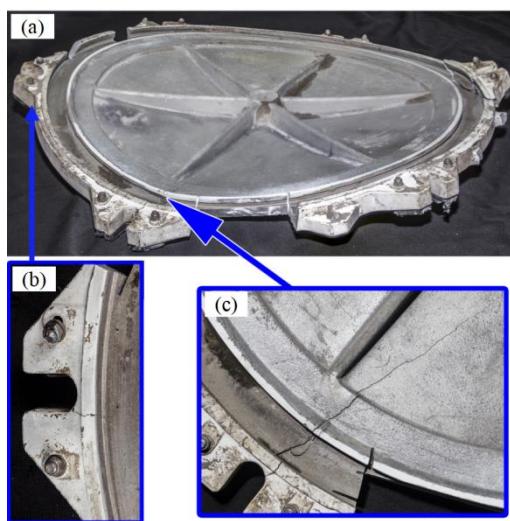
The morphology observed from the inner surface is shown in Figure 3. The six reinforcing ribs on the inner surface correspond to the six sealing buckles. There is an abnormal bulge in the sealing buckle area at six o'clock. The uplift clearance is about 68 mm, which is deformed symmetrically along the radial direction, accompanied by cracks with radial distribution, and the length is about 205mm. From the external and internal surface, the crack runs through the wall thickness, as shown in Figure 3c. Cracks originating from the inner surface can be seen at the corners of the sealing buckle at four o'clock and the sealing buckle at eight o'clock on both sides of the crack. The two cracks are intended to be related to the uplift at six o'clock, as shown in Figure 3b.

Figure 3. Deformation and fracture morphology of manhole cover: (a) overall morphology, (b) crack morphology at four o'clock, (c) crack morphology at six o'clock.

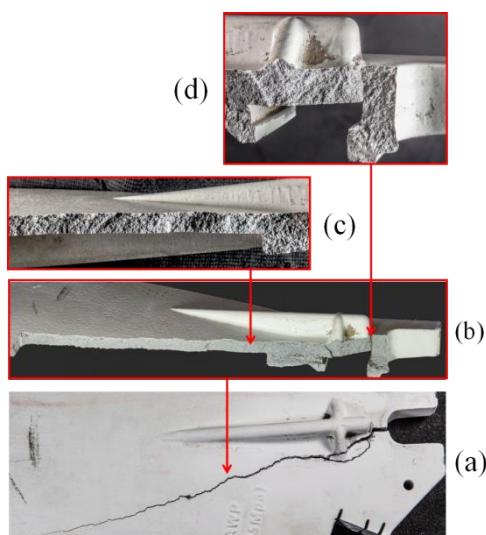
The crack morphology at the six o'clock position is shown in Figure 4a. One end of the crack is in the groove area of the seal buckle, the opening is wide, and the other end is thin, indicating that the crack starts at the outer circle groove and develops around the stiffener, with an extension length of about two-thirds of the radius. The macro morphology after crack opening is as shown in Figure 4b. No obvious metallurgical defects are found on the crack surface, the crack surface is relatively rough, and no oxidation phenomenon is found. Close observation reveals oblique spreading stripes on the crack surface, as shown in Figure 4c, indicating that the crack initially propagates towards the direction of the outer circle. It can be further seen that the crack starts at the corner of the outer surface, as shown in Figure 4d.

Figure 4. Macro morphology of crack and crack surface at six o'clock: (a) whole crack, (b) crack after opening, and (c,d) two parts of the crack surface.

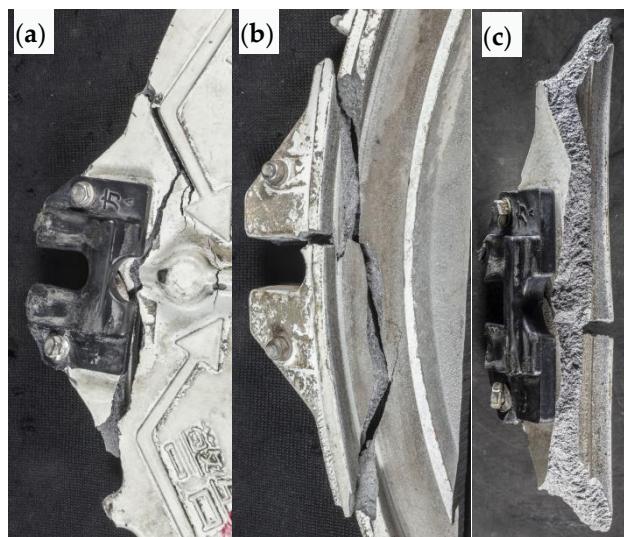
The appearance of the outer surface of the split area of the safety buckle after splicing is shown in Figure 5a. The cracks are distributed along the tangential direction of the compression block and distributed along the corner of the protruding reinforcement in

the local area on the left. From the inner cavity surface, as shown in Figure 5b, there is a short crack at the corner of the buckle groove that intersects with the tangential main crack, forming a T shape. The main crack turns at the intersection, indicating that the main crack is not formed by primary expansion. The macro morphology of the fracture surface is shown in Figure 5c. The top of the figure shows the inner cavity surface. No obvious metallurgical defects or oxidation phenomena are found on the fracture surface. The pattern of the fracture surface is rough. Its trend indicates that the crack mainly extends from the inner cavity to the outer surface, starting from the outer circles on both sides, and intersecting at the center.

Figure 5. Macro morphology of safety buckle fracture surface: (a,b) external surface and internal cavity surface morphology, respectively, of cracked block after assembly, (c) macromorphology of crack surface.

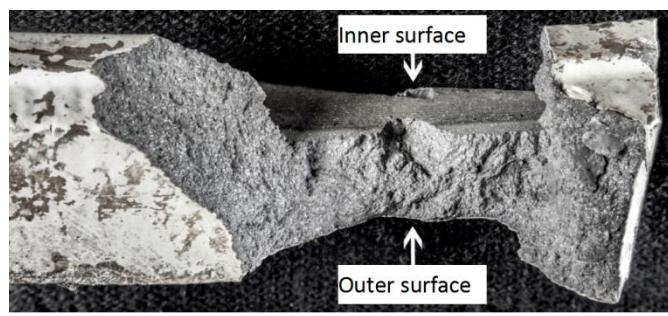
The fracture surface morphology of the hinged plate is shown in Figure 6. The top of the figure shows the inner cavity surface. The fracture surface is relatively rough, and no obvious metallurgical defects or oxidation phenomena are found. Extended stripes can be seen on the fracture surface from the outer to the inner surface.

Figure 6. Fracture surface morphology of the hinged plate.

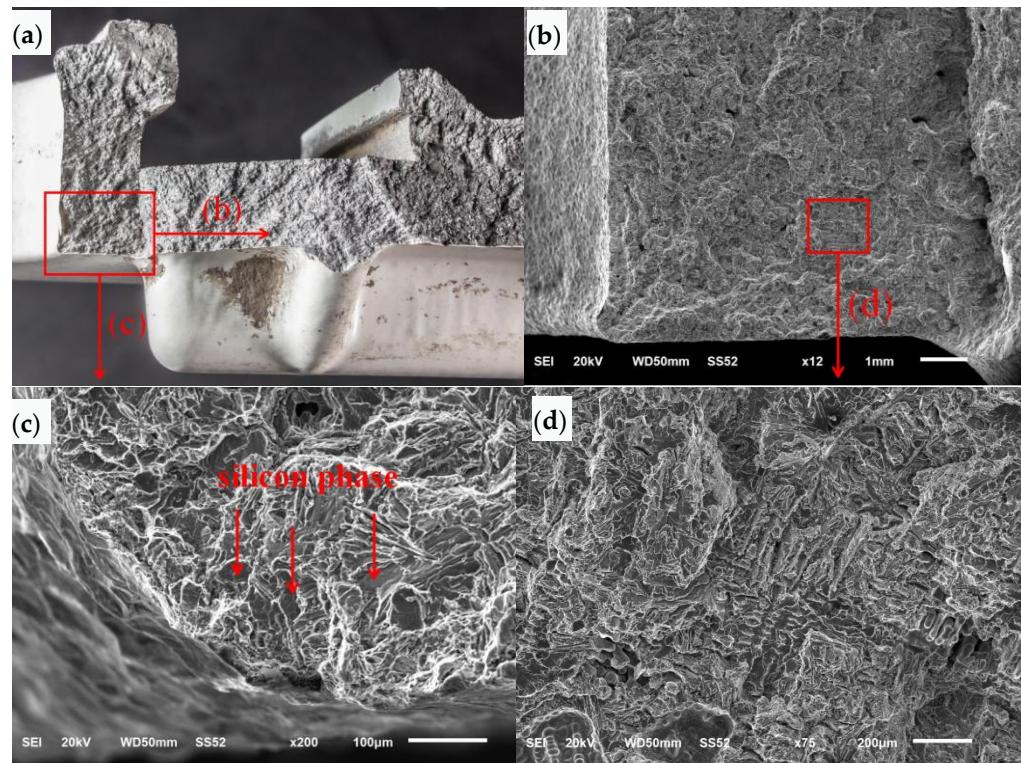
The fracture surface at the 6 o'clock position was analyzed by SEM as shown in Figure 7a. The SEM morphology of the crack initiation area at the six o'clock position is shown at low magnification in Figure 7b. The left and bottom sides of the figure are the outer surface. The crack surface extends diagonally inward from the outer surface

and the corner area of the outer surface. The SEM morphology at high magnification is shown in Figure 7c. The fracture surface is cleaved and faceted along the silicon phase. The SEM morphology in the local area of the crack surface is shown in Figure 7d. There are distributed loose defects, and the crack surface in this area is of a cellular dendrite morphology, showing free surface morphology.

Figure 7. SEM morphology of crack initiation zone: (a) fracture surface, (b) low magnification, (c) high magnification, (d) local area of the crack surface.

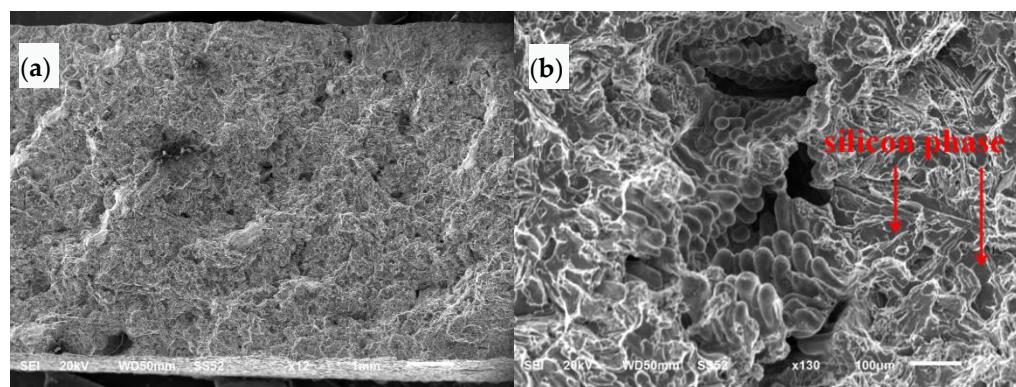
The SEM morphology of the crack propagation area is shown at low magnification in Figure 8a. The crack surface is undulated and extended stripes can be seen from the bottom left to top right. The SEM morphology of the crack propagation area at high magnification is shown in Figure 8b. The crack surface is cleaved and faceted along the silicon phase. Porous defects can be seen in local areas, and cellular dendritic morphology can be seen around the loose area, showing free surface morphology.

Figure 8. SEM morphology of crack propagation zone: (a) low magnification, (b) high magnification.

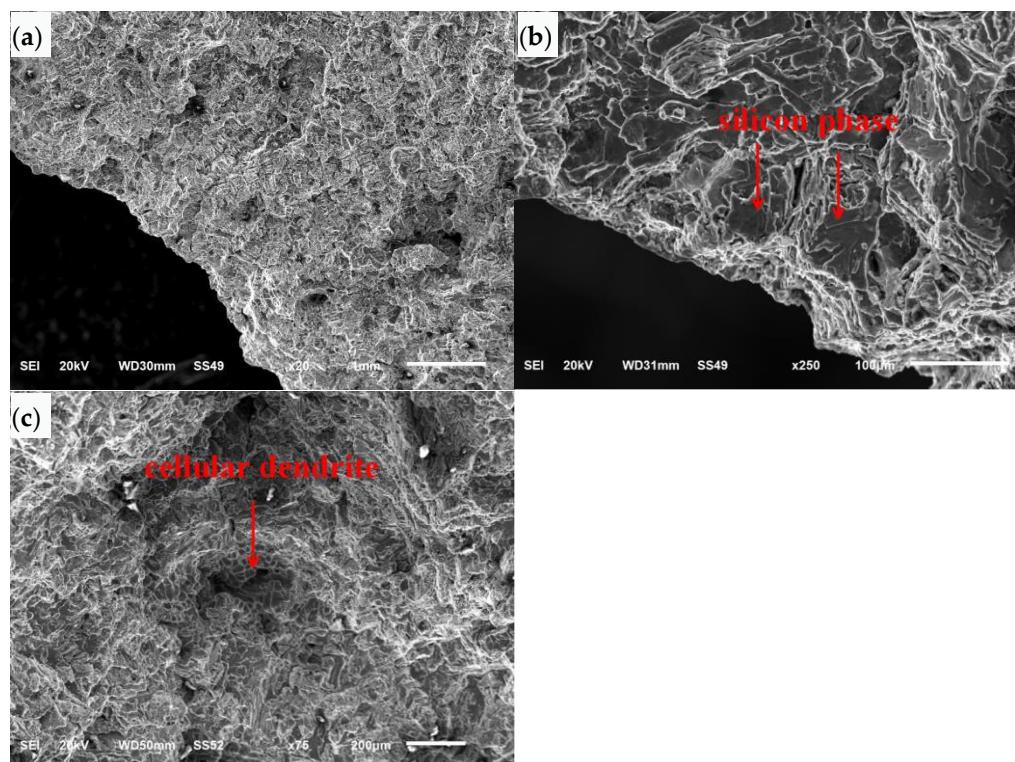
The SEM morphology of the initial area of the safety buckle fracture section is shown at low magnification in Figure 9a. The bottom left side of the figure is the surface of the inner cavity, and the top right side is the section. The section is relatively rough, and extended stripes can be seen from the beginning of the inner cavity to the outside. The SEM morphology of the initial area of the safety buckle fracture section is shown at high magnification in Figure 9b. The fracture surface is cleaved and faceted along the silicon phase. The SEM morphology of the section expansion area is shown in Figure 9c. The morphology is cleaved and faceted along the silicon phase, loose defects can be seen in local areas, and cellular dendritic morphology can be seen in this area.

Figure 9. SEM morphology of initiation zone and propagation zone of the safety buckle: (a) low magnification, (b) high magnification, (c) section expansion area.

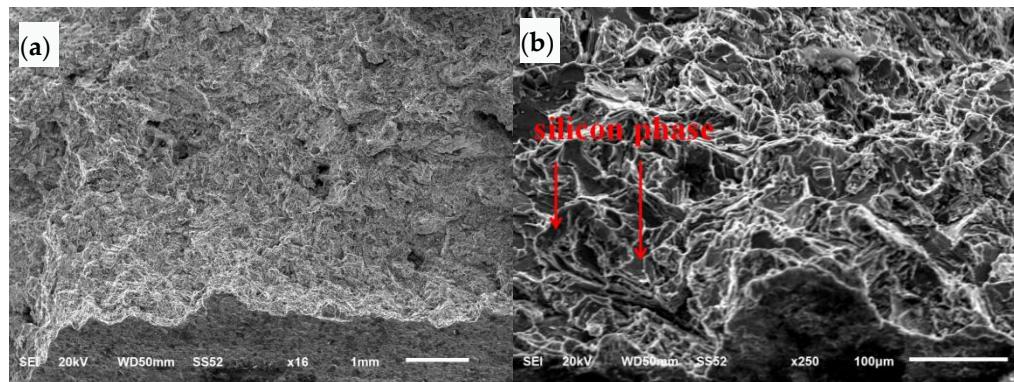
The SEM morphology of the initial area of the hinged plate section is shown at low magnification in Figure 10a. The bottom left side of the figure is the outer surface, and the top side of the figure is the section. The section is relatively rough, and extended stripes can be seen from the beginning to the top. The SEM morphology at high magnification is shown in Figure 10b. The cross section is cleaved and faceted along the silicon phase.

Figure 10. SEM morphology of the fracture initiation zone of the hinged plate: (a) low magnification, (b) high magnification.

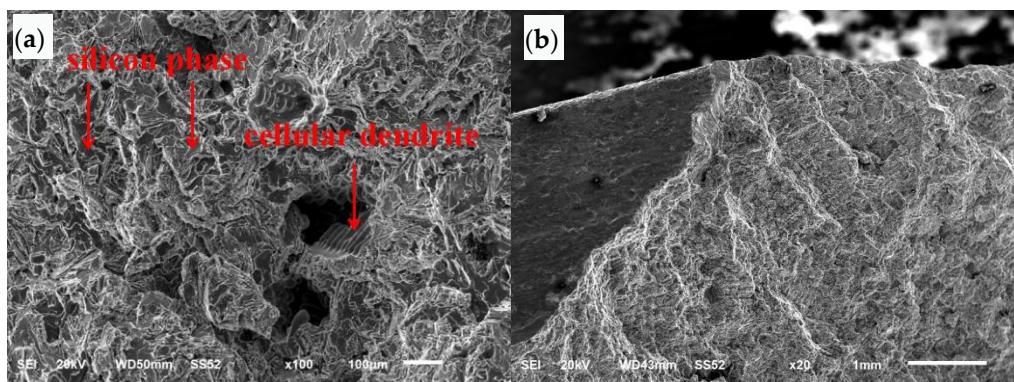
The SEM morphology of the fracture propagation area of the hinged plate is shown in Figure 11a. The morphology is cleaved and faceted along the silicon phase. Loose defects can be seen in local areas, and the section of this area is cellular dendrite. The SEM morphology of the final fracture zone of the hinged plate is shown in Figure 11b, which shows tear morphology.

Figure 11. SEM morphology of the hinged plate: (a) fracture propagation region, (b) final fracture region.

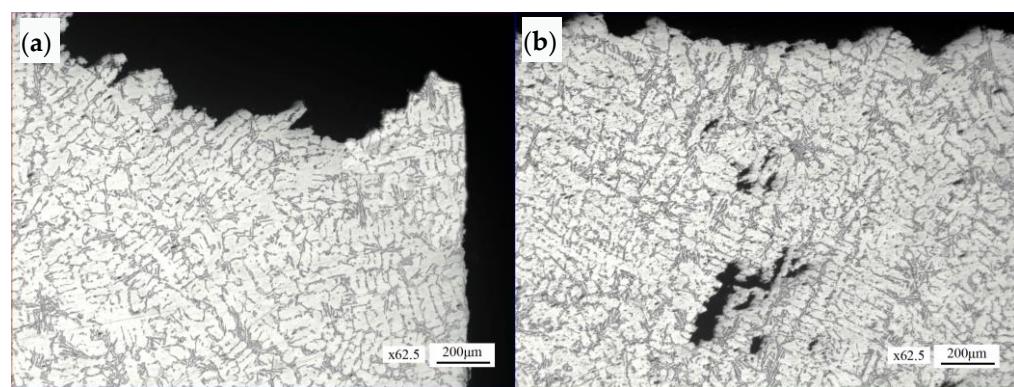
The microstructure distribution morphology of the initial area of the crack surface at the six o'clock position is shown in Figure 12a. The right side of the figure is the outer circular surface, and the top side of the figure is the crack surface. The crack surface

fluctuates. The microstructure of this area is α (Al) + Si phase. In the fracture surface propagation area, the fracture surface fluctuates greatly, multiple loose pores and pores can be seen in the sub surface area. The organization in local areas is dendritic, as shown in Figure 12b.

Figure 12. Microstructure morphology of the normal section of the crack surface at six o'clock: (a) fracture initiation region, (b) fracture propagation region.

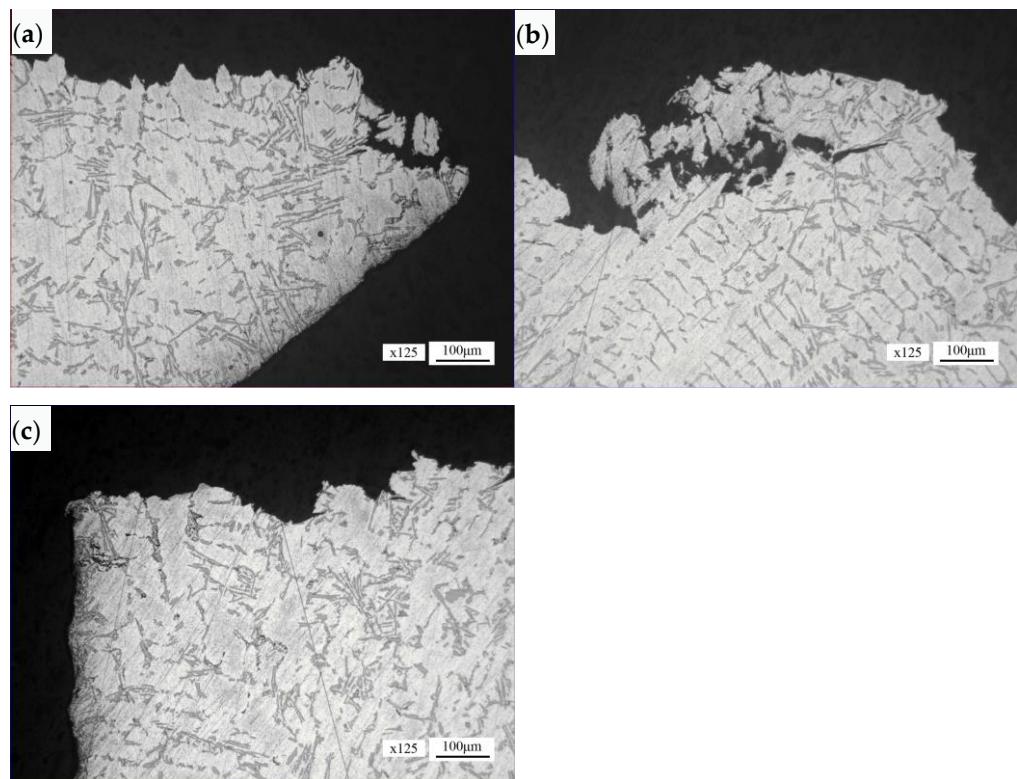
The microstructure morphology of the initial area of the safety buckle fracture section is shown in Figure 13a. The section fluctuates greatly. The microstructure morphology of the section propagation area is shown in Figure 13b. The section is relatively undulated,

and loose defects can be seen in local areas around the section, with the loose size of about $0.35\text{ mm} \times 0.16\text{ mm}$. The microstructure morphology of the final fracture area is shown in Figure 13c. The microstructure of the initial area, propagation area and final fracture of the safety buckle fracture section is α (Al) + Si phase.

Figure 13. Microstructure morphology of the normal section of the safety buckle fracture section: (a) fracture initiation region, (b) fracture propagation region, (c) final fracture region.

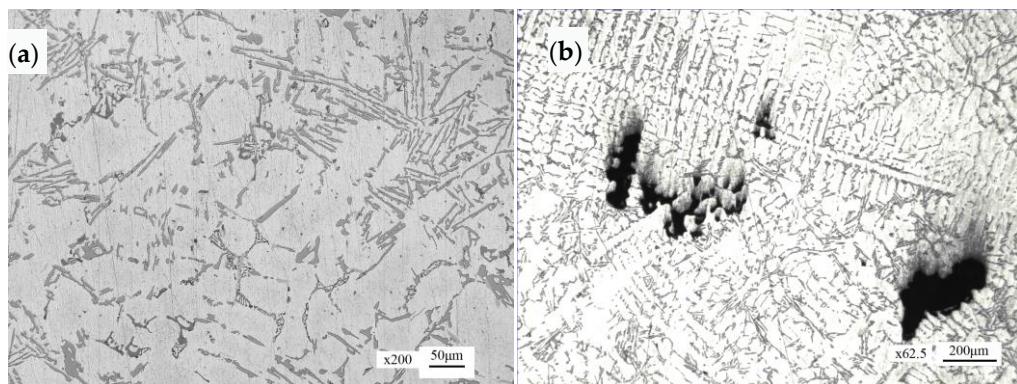
The microstructure of the manhole cover matrix is α (Al) + Si phase, with dendritic distribution in local areas, as shown in Figure 14a. In some areas, loose casting defects can be seen, and the loose size is about $0.42\text{ mm} \times 0.08\text{ mm}$, as shown in Figure 14b.

Figure 14. Microstructure morphology: (a) manhole cover matrix, (b) porous casting defects.
