# Failure Analysis of Acid-Thinned Coiled Tubing Under HTBH Conditions: Role of Inhibitor Depletion and Corrosion Asymmetry

A CT-80 coiled tubing fractured at the gooseneck during retrieval after a 2.5 h treatment with 15% HCl under high-temperature bottom-hole conditions (196 °C). The failure was investigated by dimensional measurements, metallography, Vickers microhardness testing, SEM/EDS, and FT-IR spectroscopy. Pronounced corrosion asymmetry was observed. Cumulative external wall loss reached 1.196 mm, compared with 0.292 mm on the inner wall, while the wall loss attributed to the final operation was approximately twelve times greater externally than internally. These findings suggest two different exposure histories: predominantly uniform attack of the outer wall during backflow of spent, inhibitor-depleted acid, and localized pitting of the inner wall under incomplete inhibitor coverage. EDS mapping identified Sb-rich deposits around inner-wall pits. In combination with the relevant literature, this distribution is consistent with a possible Sb–Fe galvanic effect that may have promoted local anodic dissolution, although galvanic coupling was not measured directly. The FT-IR

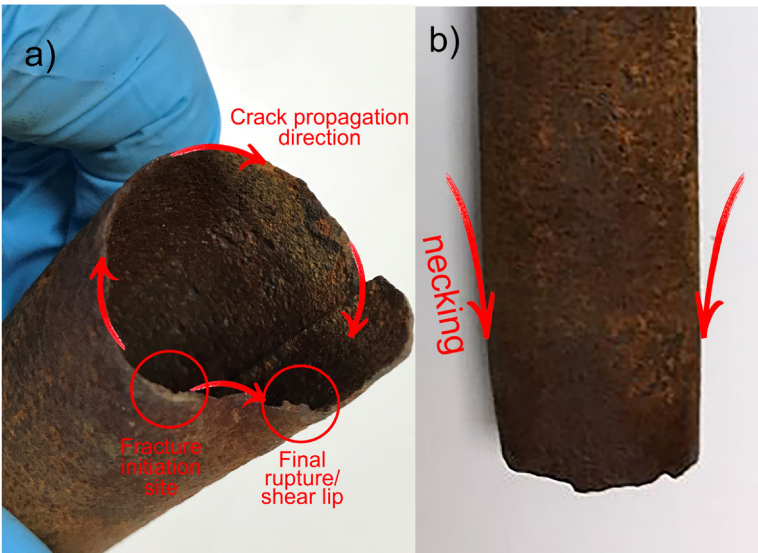
Figure 1a shows the fracture wall, where the fracture initiated at the locally thinnest section and propagated circumferentially in both directions before final separation in the shear-lip region. Figure 1b shows pronounced local necking and reduction in tube diameter at the fracture site, consistent with plastic deformation preceding overload failure [43–45].

**Figure 1.** Macroscopic appearance of the failed CT-80 coiled tubing at the fracture location: (a) fracture wall showing the identified fracture-initiation site, crack-propagation directions, and final rupture region (shear lip); (b) local necking and reduction in tube diameter at the fracture site. The annotations indicate the principal macroscopic fracture features.

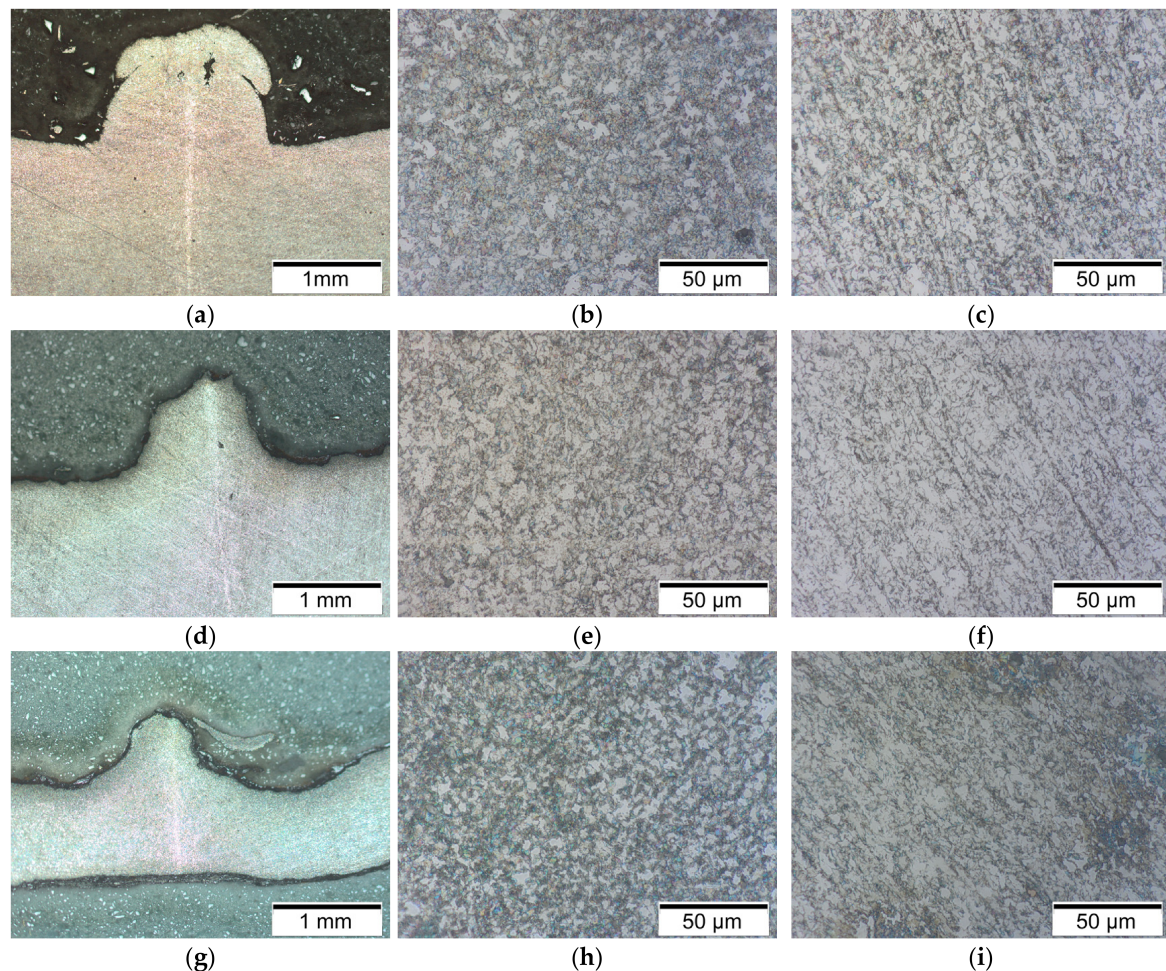
Figure 2 presents cross-sectional and higher-magnification optical micrographs of the unused reference tubing and the two service-exposed specimens. Panels (a), (d), and (g) show the longitudinal manufacturing seam at  $\times 200$  for the unused reference specimen, the specimen collected 100 m above the fracture, and the specimen collected at the fracture location (0 m), respectively. Panels (b), (e), and (h) show the corresponding longitudinal seam regions at  $\times 1000$ , while panels (c), (f), and (i) show the adjacent base-metal regions at  $\times 1000$ . The base metal exhibits a fine-grained ferritic microstructure with a rolling-induced directional arrangement of ferrite–cementite bands, whereas the longitudinal seam regions exhibit a comparatively isotropic microstructure. The microstructure and texture of high-strength strip steels are strongly influenced by thermomechanical processing and subsequent cooling conditions [48,49]. No cracks or major metallurgical defects were observed in the examined longitudinal seam or adjacent base-metal regions. Therefore, the available metallographic evidence does not support a pre-existing manufacturing-seam defect as the primary cause of failure.

**Figure 2.** Optical micrographs of CT-80 coiled tubing etched with 2% Nital for 5 s. From left to right, the columns show the adjacent base-metal region at  $\times 1000$ , the longitudinal seam region at  $\times 1000$ , and the longitudinal seam cross-section at  $\times 200$ . The rows show the unused reference tubing, the specimen collected 100 m above the fracture, and the specimen collected at the fracture location (0 m), respectively. (a) Unused reference tubing, Longitudinal seam,  $\times 200$ ; (b) Unused reference tubing, Seam region,  $\times 1000$ ; (c) Unused reference tubing, Base-metal region,  $\times 1000$ ; (d) 100 m above the fracture, Longitudinal seam,  $\times 200$ ; (e) 100 m above the fracture, Seam region,  $\times 1000$ ; (f) 100 m above the fracture, Base-metal region,  $\times 1000$ ; (g) Fracture location (0 m), Longitudinal seam,  $\times 200$ ; (h) Fracture location (0 m), Seam region,  $\times 1000$ ; (i) Fracture location (0 m), Base-metal region,  $\times 1000$ .

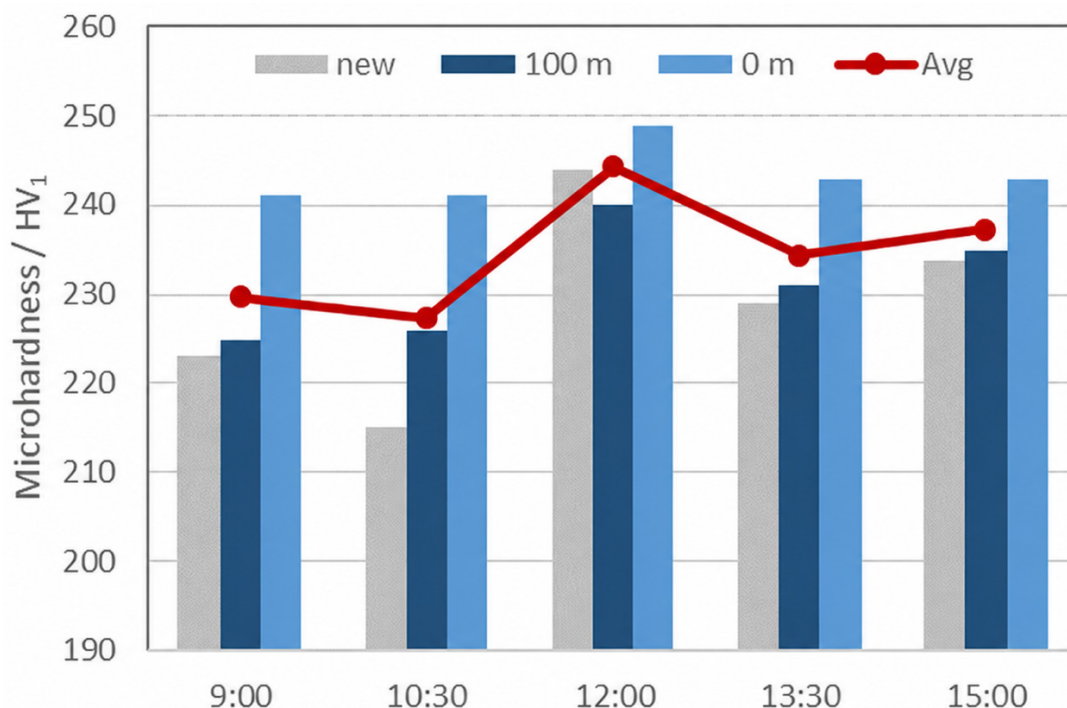
Figure 3 presents the microhardness values graphically. The longitudinal seam region generally exhibited higher hardness than the adjacent base-metal positions, consistent with the local thermal history associated with tubing manufacture. The well-exposed specimens show higher hardness than the new sample, and the sample at the fracture location (0 m, deeper in the well) shows higher hardness than the sample at 100 m above the fracture. The red line represents the mean hardness of the three specimens at each circumferential position. The Vickers microhardness values measured at the five clock-face positions relative to the longitudinal seam are summarized in Table 4.

**Figure 3.** Vickers microhardness (HV1) measured at five circumferential positions in the unused reference tubing, the specimen collected 100 m above the fracture, and the specimen collected at the fracture location (0 m). The 12:00 position corresponds to the longitudinal seam.

The maximum measured hardness of 249 HV1, recorded in the longitudinal seam region at the fracture location, approached but did not exceed the commonly referenced 250 HV threshold associated with increased SSC susceptibility in pipeline steels [54]. Whether the same criterion should be applied directly to coiled tubing remains unclear [53]. Although the measured hardness increase indicates a change in the local mechanical response of the material, its magnitude was relatively modest and cannot be attributed exclusively to hydrogen uptake. Moreover, as discussed below, no clear fractographic evidence of a hydrogen-assisted brittle fracture mechanism was observed.

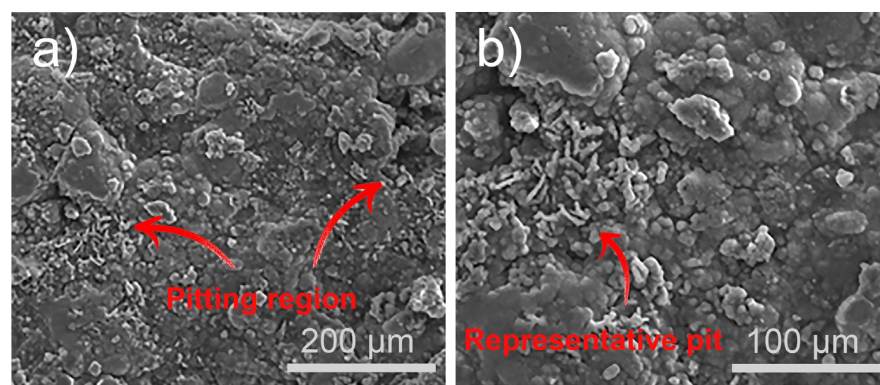
**Figure 4.** Representative SEM micrographs of pitting damage on the inner tube surface at the fracture location (0 m): (a)  $\times 500$ , showing the broader pitting region; (b)  $\times 1000$ , showing a representative pit and the associated rough corrosion-product morphology. The arrows indicate the analysed pitting features.

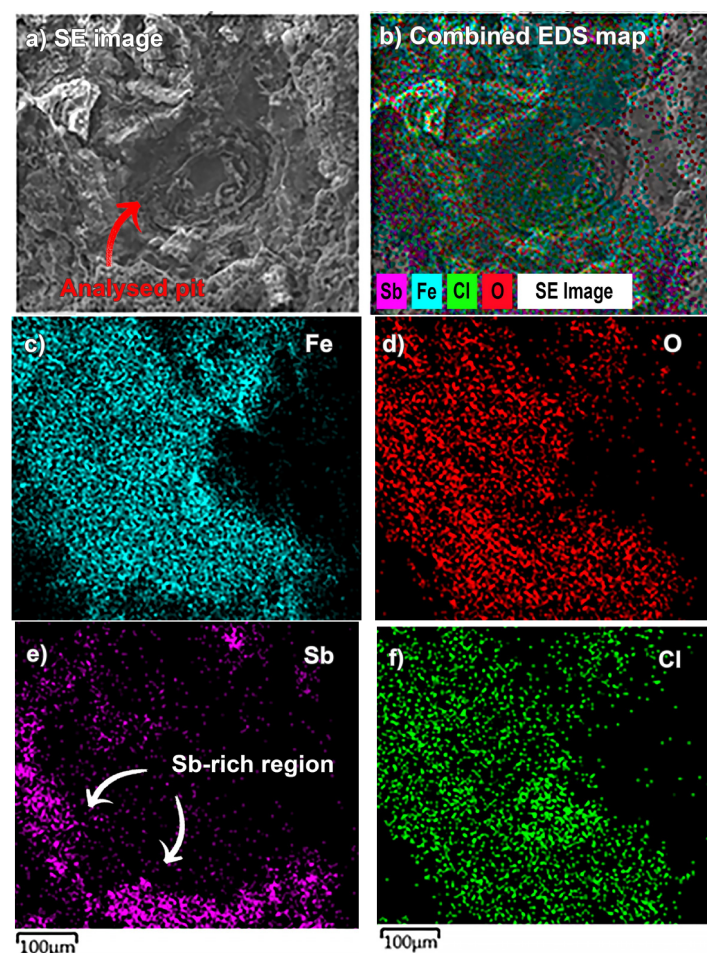
**Figure 5.** SEM/EDS analysis of a representative pitting site on the inner tube wall at the fracture location (0 m,  $\times 500$ ): (a) secondary-electron image of the analysed pit; (b) combined EDS map; (c) Fe;

(d) O; (e) Sb; and (f) Cl. All panels correspond to the same field of view. Sb-rich regions are concentrated around the pit, whereas Fe, O, and Cl predominate within the pit region.

Figure 5 shows the EDS mapping of a representative pitting-damage site on the inner wall. The secondary-electron image (Figure 5a) shows the analysed pit corresponding to the mapped field of view, while the combined EDS map (Figure 5b) superimposes all detected elements on the same area. The individual elemental maps show that Sb-rich regions are concentrated around the analysed pit, whereas Fe, O, and Cl predominate within the pit region.

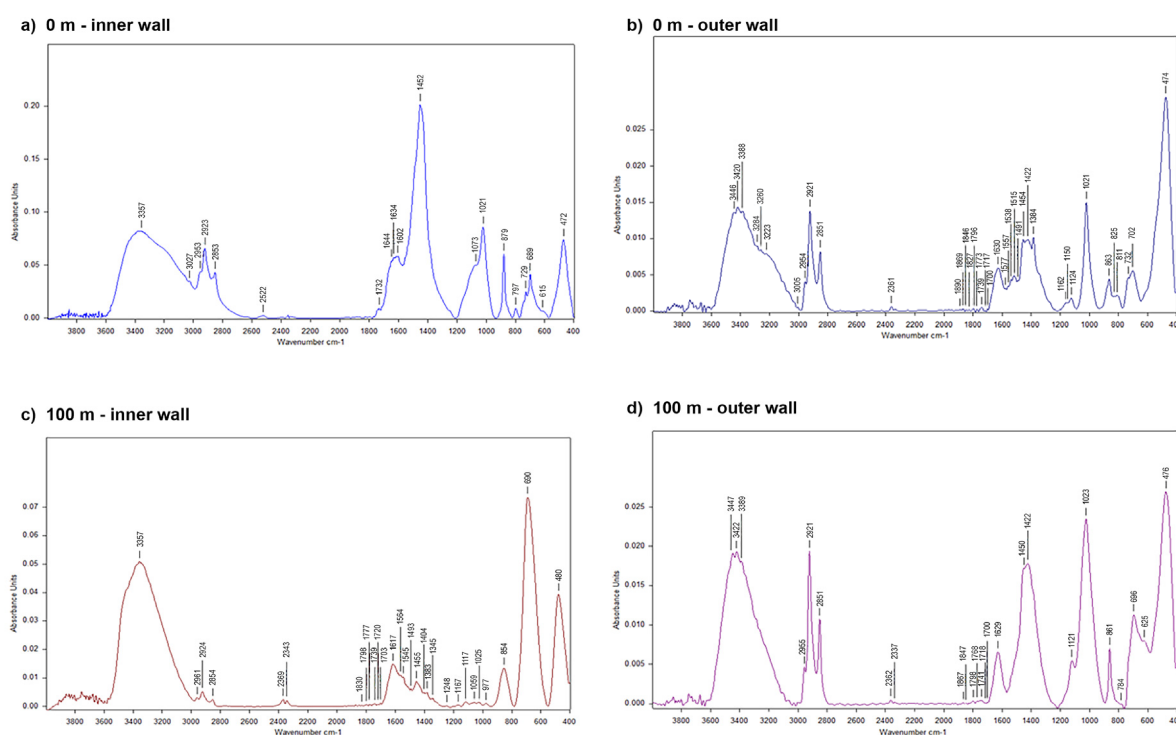
**Figure 6.** FT-IR spectra (KBr pellet method; mean of 64 scans at  $4\text{ cm}^{-1}$  resolution; pellets dried overnight at  $60\text{ }^{\circ}\text{C}$ ) of corrosion products removed from the tube surfaces: (a) 0 m, inner wall; (b) 0 m, outer wall; (c) 100 m, inner wall; and (d) 100 m, outer wall. The principal bands are tentatively assigned to O–H vibrations of hydrated oxides/oxyhydroxides, C–H vibrations of adsorbed organic species, carbonate-bearing products, and Fe–O vibrations. Bands in the  $1120\text{--}1160\text{ cm}^{-1}$  region on the outer-wall samples are consistent with sulfate-bearing species, while stronger absorption near  $690\text{ cm}^{-1}$  on the inner-wall samples may be associated with chloride-containing oxyhydroxides and/or Sb–O vibrations.

Taken together, the FT-IR spectra are consistent with the presence of iron oxide/oxyhydroxide, carbonate-bearing, sulfate-bearing, and chloride-associated corrosion products, together with thin adsorbed organic residues. These assignments are based on characteristic absorption bands reported in the literature and should be regarded as tentative phase assignments rather than definitive phase identifications [55,56]. Because corrosion layers may contain nanophase iron oxides and phases with overlapping or ambiguous spectroscopic signatures, reliable phase identification generally requires an integrated analytical approach using complementary structural techniques such as X-ray diffraction and Raman spectroscopy [57,58]. Within this limitation, the spectra support the SEM/EDS-based interpretation that effective inhibitor protection was reduced during service.

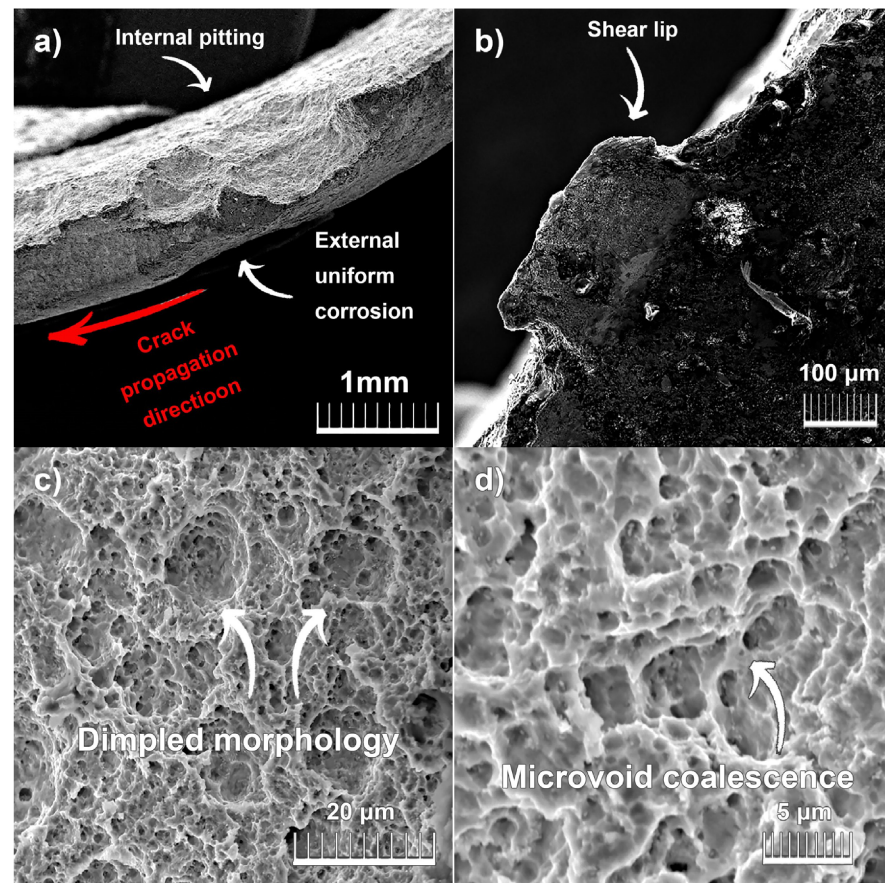
Figure 7a shows the wall at the fracture site thinned by combined external uniform and internal pitting corrosion. Figure 7b shows the detachment site (shear lip) at the end of the fracture path. The macroscopic fracture path identified in Figure 1 is consistent with the SEM observations in Figure 7, which show a corrosion-thinned wall, a final shear-lip region, and dimpled microvoid coalescence.

**Figure 7.** Representative SEM micrographs of the fracture morphology: (a) corrosion-thinned fracture wall showing internal pitting, external uniform corrosion, and the indicated crack-propagation direction; (b) final detachment region showing the shear lip; (c) dimpled fracture morphology at  $\times 2000$ ; and (d) microvoid coalescence at  $\times 5000$ . The morphologies observed in panels (c,d) are characteristic of a predominantly ductile fracture mechanism.

Figure 7c and Figure 7d show the representative fracture-surface morphology at  $\times 2000$  and  $\times 5000$ , respectively. The examined regions are dominated by dimpled microvoid coalescence, which is characteristic of a predominantly ductile fracture mechanism. No intergranular fracture, cleavage facets, or other clear brittle-fracture features were observed in the analysed regions. Nevertheless, because the hydrogen content of the steel was not directly measured, a limited contribution of hydrogen to local ductility reduction cannot be fully excluded. The available fractographic and metallographic evidence therefore supports ductile overload of a corrosion-thinned section as the primary failure mechanism, rather than a purely hydrogen-driven brittle fracture.

The fracture mechanism is therefore interpreted as progressive corrosion-assisted loss of the load-bearing cross-section, followed by mechanical overload during retrieval. External uniform corrosion and internal localized pitting reduced the remaining wall thickness. During passage through the gooseneck, the combined tensile and bending loads exceeded the capacity of the thinned section, resulting in predominantly ductile overload fracture. Hydrogen uptake may have contributed to a limited reduction in ductility, but

For future HTBH acidizing operations, this case shows that inhibitor qualification should not be based only on fresh inhibited acid exposure. The backflow stage must also be reproduced because the returning acid may be spent, inhibitor-depleted, enriched with dissolved corrosion products, and still highly corrosive. Laboratory testing should therefore include the actual bottom-hole temperature, realistic exposure time,  $\text{H}_2\text{S}/\text{CO}_2$  chemistry, and a representative acid-volume-to-metal-surface-area ratio. In addition, the inner and outer tube surfaces should be evaluated separately, since the present failure demonstrates that they can experience different corrosion mechanisms during the same operation. Post-acidizing inspection should include wall-thickness measurement and pit-depth assessment before further reuse, particularly when the operation approaches  $200\text{ }^\circ\text{C}$  or when  $\text{H}_2\text{S}$  is detected. From a failure-prevention perspective, the critical control parameter is not only the nominal inhibitor concentration in the injected acid, but also the remaining protection level during the backflow stage and during retrieval through the gooseneck.
