# Mechanical Properties and Fatigue Failure of Thermally and Thermochemically Treated C60 Steel

**Keywords:** heat treatment; oxidation; fatigue crack monitoring; C60 steel

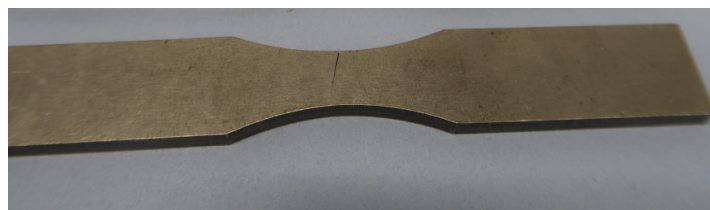
As illustrated in Figure 17, the specimen underwent a thorough testing process that led to its ultimate failure. The presence of a visible crack is evident without the necessity of conducting a CT inspection. As illustrated in Figure 18a, the frontal view of the sample following a fatigue load of 202,800 cycles is shown, while Figure 18b illustrates the upper surface of the sample. The fatigue crack was initiated in the upper region of the radius, a location where the local stress concentration typically promotes the nucleation of microcracks under cyclic loading. The length of the crack on the front surface of the sample, measured from its edge, is documented at 5701  $\mu\text{m}$ . It is evident that the width of the sample in the cracked area is a mere 8 mm, thereby indicating that the length of the crack significantly exceeds half of the width of the sample.

**Figure 17.** Hardened and tempered sample after fatigue test.

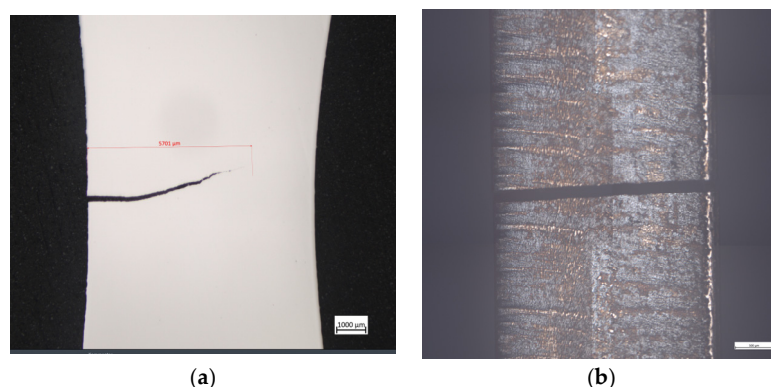
**Figure 18.** (a) The fatigue crack on the front side of sample 02 after 202,800 cycles [the crack length 5701  $\mu\text{m}$ ] and (b) the upper surface of the sample.

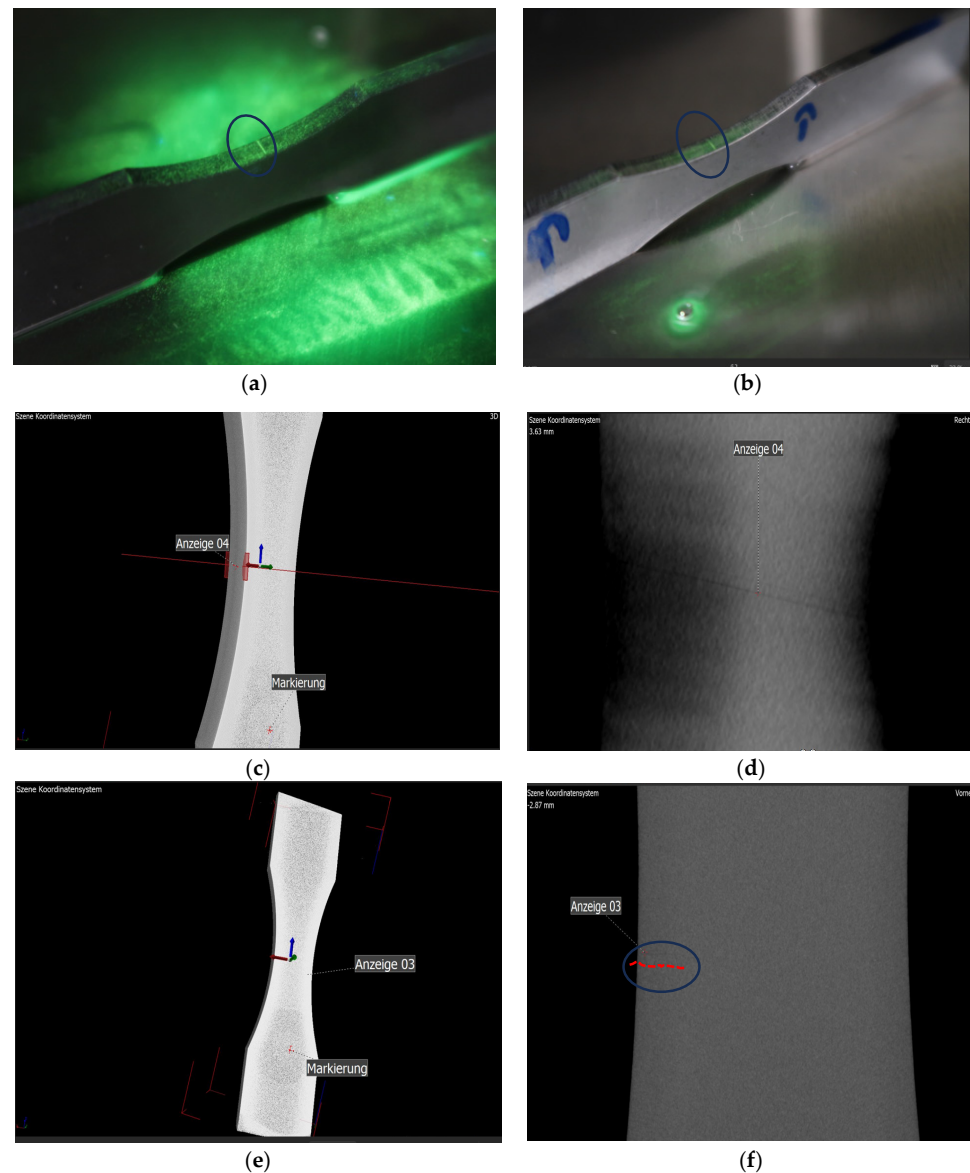
**Figure 20.** Non-destructive analysis applied to hardened and tempered sample after fatigue testing: (a,b) liquid penetrant inspection, (c) overview of CT examination: detail volume image—radius area, (d) microcrack measurement in radius area, (e) overview of CT examination: detail volume image—frontal surface of sample, and (f) microcrack measurement in the frontal surface area. The area highlighted in red represents the microcrack length, and the blue circle marks the region where the microcrack is present.

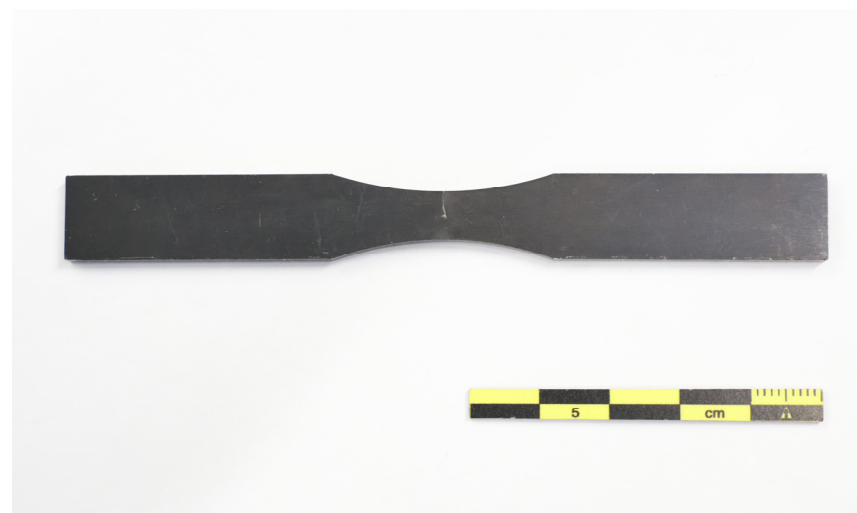
As illustrated in Figure 23, the oxidized sample was subjected to testing until failure. As with the hardened and tempered specimen, a visible crack is evident without the necessity of conducting a CT inspection. As illustrated in Figure 24a, the frontal view of the sample following a fatigue load of 1,630,529 cycles is shown. Figure 24b illustrates the upper surface of the sample.

**Figure 23.** Oxidized sample after the breaking test.

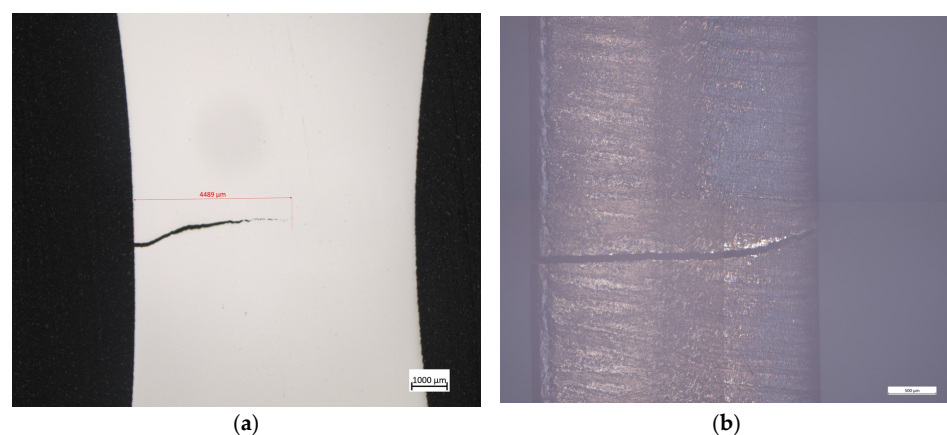
**Figure 24.** (a) The fatigue crack on the front side of sample 01 after 1,630,529 cycles, and (b) the upper surface of the sample: the crack length is 4489  $\mu\text{m}$ .

Fatigue crack initiation occurred in the upper region of the radius, where the stress field is locally intensified under cyclic loading. Its progression is characterized by a linear trajectory with minimal branching or deviation. The crack length on the frontal surface of the specimen, measured from its edge, is documented at 4489  $\mu\text{m}$ , corresponding to approximately one-third of the specimen's total width.

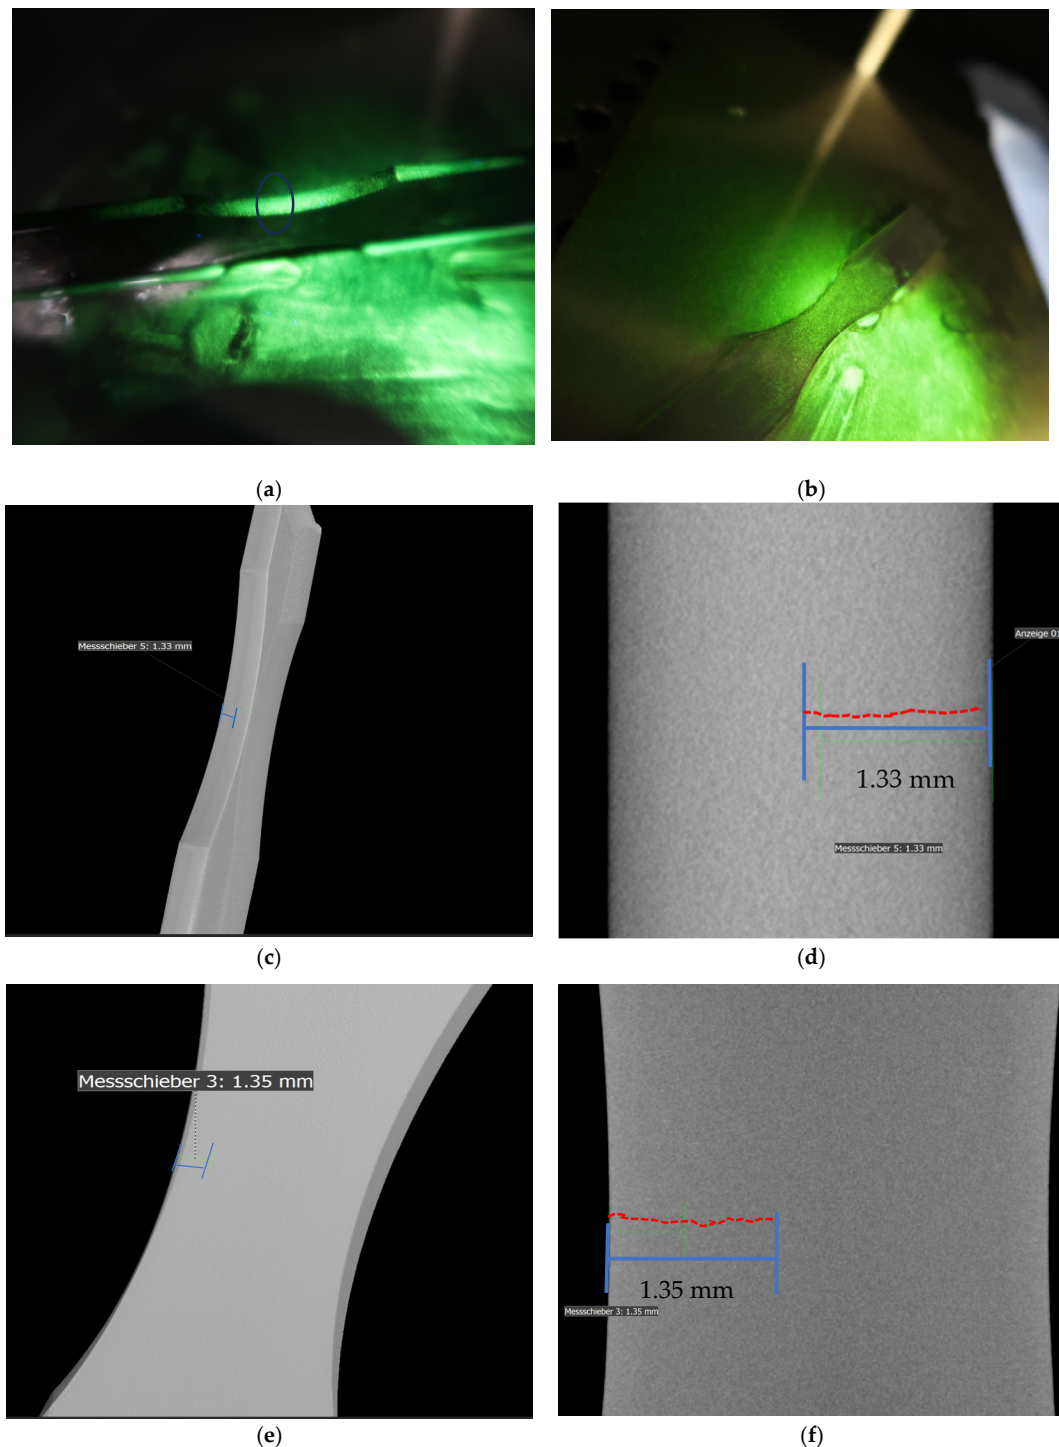
The specimen initially reveals a fracture in the radius region, which subsequently propagates to the frontal surface. The crack size in the radius area is 1.33 mm, while on the frontal surface, the crack measures 1.35 mm. This evolution of the crack suggests a propagation of the defect from the radial area to the frontal surface. Consequently, the critical points of the material are emphasized.

**Figure 27.** Non-destructive analysis applied to oxidized sample after fatigue testing: (a,b) liquid penetrant inspection, and (c) overview of CT examination: detail volume image—radius area, (d) microcrack measurement in radius area, (e) overview of CT examination: detail volume image—frontal surface of sample, and (f) microcrack measurement in the frontal surface area. The red line indicates the microcrack length, while the blue line represents the measured value obtained during the analysis.

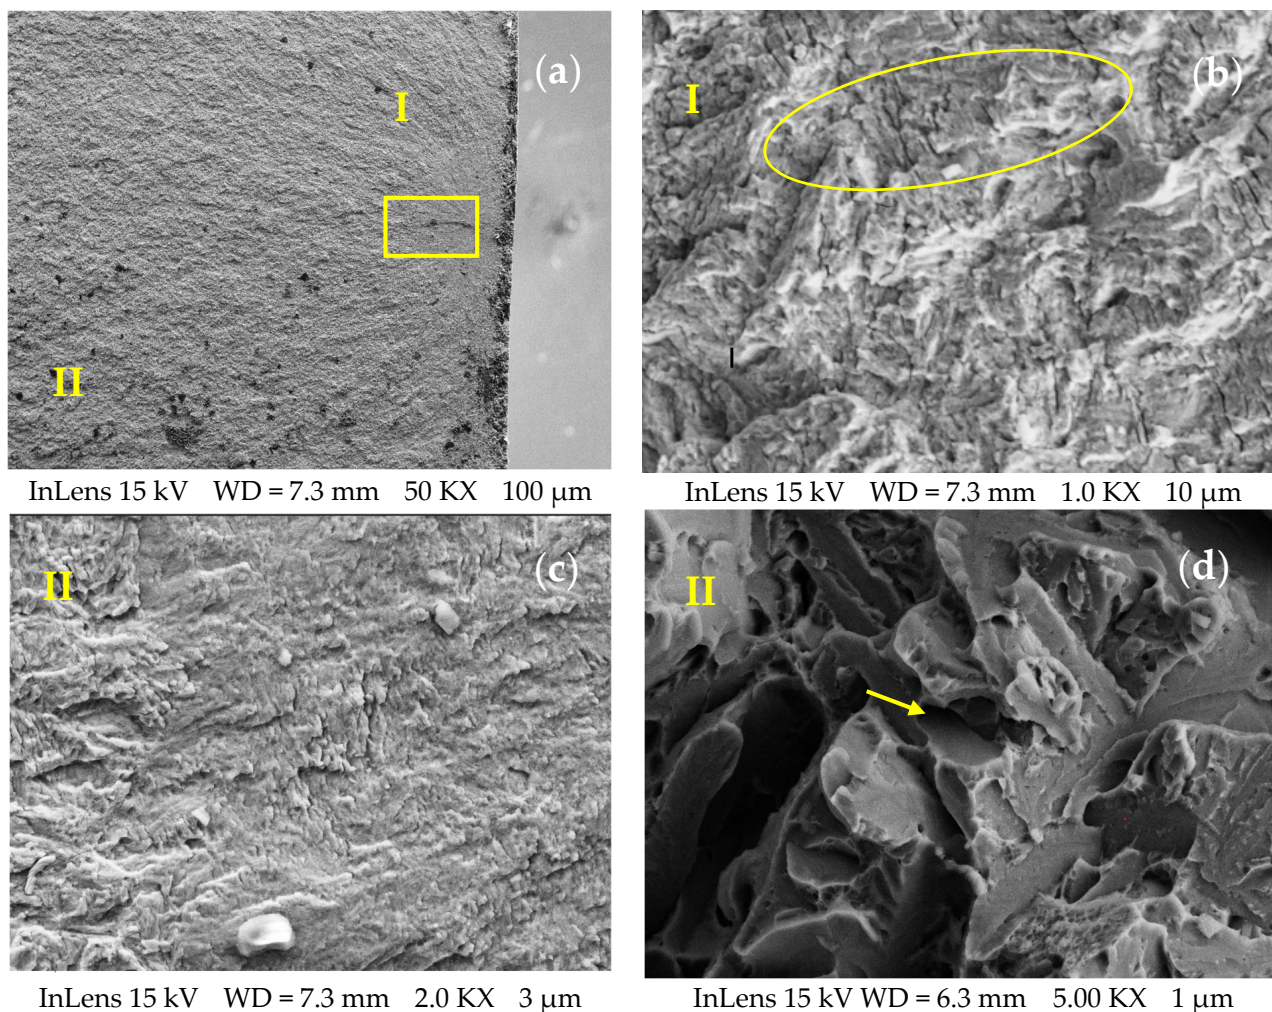
As illustrated in Figure 28a, the images demonstrate that crack initiation, demarcated by the rectangular marker, invariably occurs within the transition radius. This region is distinguished by elevated stress concentration under cyclic loading conditions.

**Figure 28.** (a) Fatigue fracture surface of the hardened and tempered sample; (b–d) detailed views of the different fracture areas.

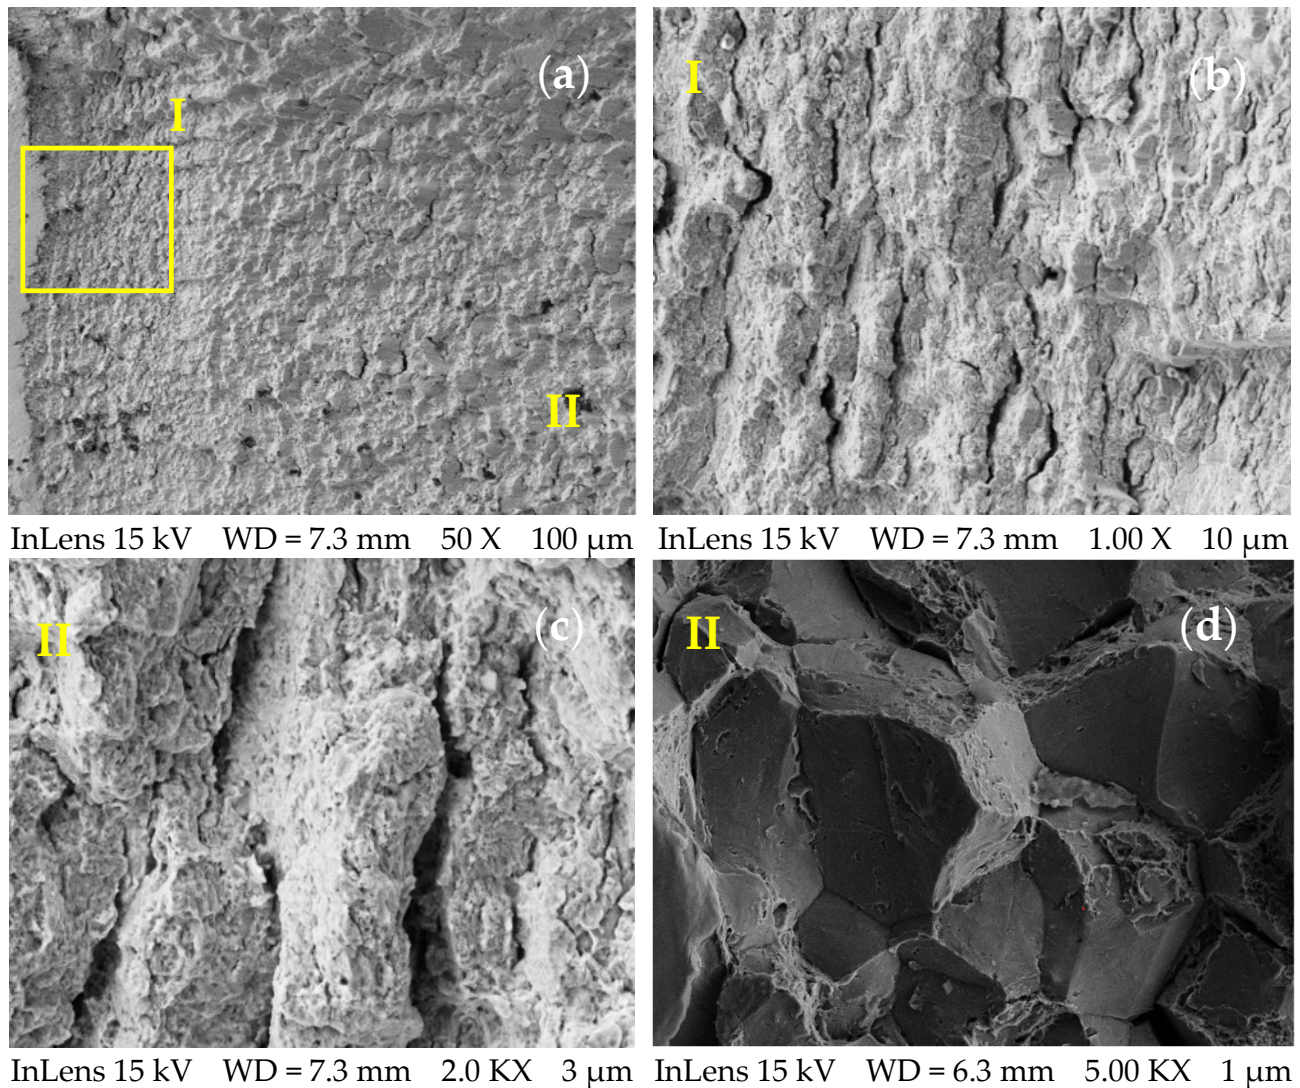
a relatively uniform morphology, characterized by a smooth crack path and an absence of substantial microcrack development. It has been established that these regions correspond to the initial stages of crack propagation. During this stage, the oxide layer remains continuous and effectively limits the opening of superficial discontinuities. Figure 29c,d, captured at higher magnifications, reveal localized areas where microcracks begin to form within the oxide layer.

**Figure 29.** (a) Fatigue fracture surface of oxidized sample; (b–d) detailed views of the different fracture areas.
