A Fracture Analysis of Ti-10Mo-8V-1Fe-3.5Al Alloy Screws during Assembly

Abstract: Titanium screws have properties that make them ideal for applications that require both a high strength-to-weight ratio and corrosion resistance, such as fastener applications for aviation and aerospace. The fracture behavior of Ti-10Mo-8V-1Fe-3.5Al (TB3) alloy screws during assembly was explored. Besides visual examination, other experimental techniques used for the investigation are as follows: (1) fracture characteristics and damage morphology via scanning electron microscopy (SEM); (2) chemical constituents via energy dispersive spectroscopy (EDS) and hydrogen concentration testing; (3) metallographic observation; (4) stress durability embrittlement testing; and (5) torsion simulation testing. Results show that the fracture mode of the screws is brittle. There is no obvious relation to hydrogen-induced brittle. The main reason for the fracture of titanium alloy screws is internal defects, around which oxygen content is high, increasing brittleness. The internal defects of screws result from grain boundary cracking caused by hot forging.

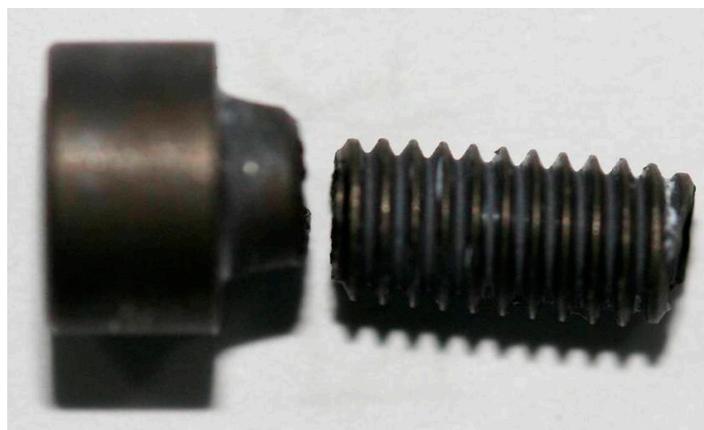
The positions of the fracture are all at the root of the screw thread, as shown in Figure 1. As shown in Figure 2a,b, the macroscopic fracture characteristics of the #1 and #2 screws are substantially the same: (1) the center of the screw fracture appears dark-colored, and some axial cracks on it are similar to void; (2) a large number of reflective facets (reflective facet) are shown, and there is no reflective facet around the fracture edge, which appears gray; (3) no macroscopic plastic deformation was visible. As shown in Figure 2c,d: (1) The color of the #3 and #4 screws fracture centers are brighter compared with the #1 and #2 fractures, and there are also a large number of reflective facets as well as many non-reflective facets around the gray fracture edge; (2) the gray area of the #3 fracture edge is relatively larger; (3) no obvious plastic deformation exists.

Figure 1. Fracture position of screw.

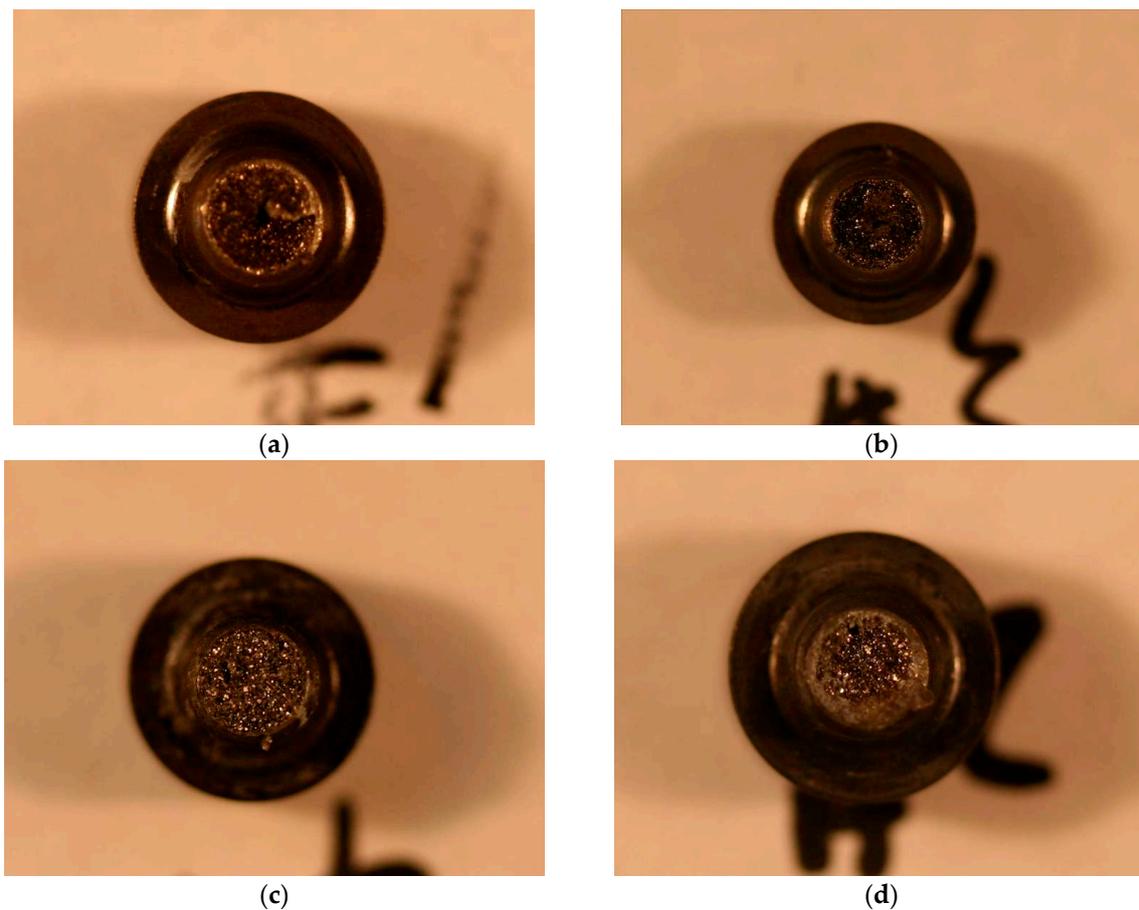
Figure 2. Fracture surface macro appearance of the (a) #1; (b) #2; (c) #3; and (d) #4 screws.

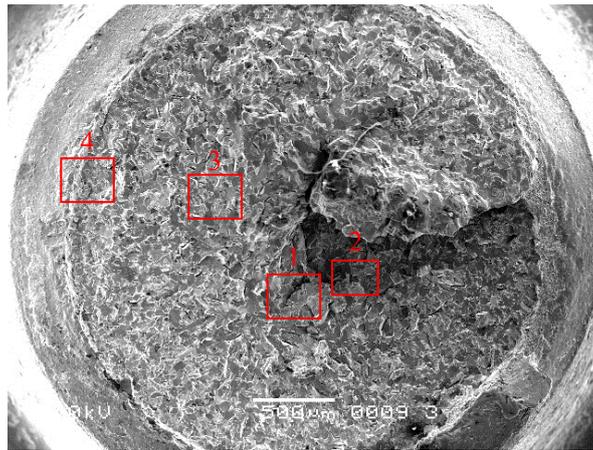
The four fractured screw specimens were firstly dipped into an acetone solution and cleaned with an ultrasonic washing machine for 5 min. Then, they were observed with an FEI Quanta 600 Field Emission scanning electron microscope (SEM). The #1 and #2 screws have the same microscopic appearance. Figure 3 shows the entire fracture surface of #1 screw. The axial crack can be clearly seen in the center of the fracture surface. Grain boundary cracking characteristics were observed around the axial crack. The major fracture surface morphology of the screw around the axial crack is a cleavage river pattern, occupying the entire fraction of the fracture surface, as shown in Figure 4a (Region 1 in Figure 3). Judging from the river pattern, the axial crack is the fracture origin. A high magnification of the axial crack indicates that the crack defects were formed during the manufacturing process, as shown in Figure 4b (Region 2 in Figure 3). Small granular white objects are visible in Figure 4b. The grain boundary cracking characteristics around the axial crack can be seen in Figure 4c (Region 3 in Figure 3). Morphologies such as dimple can be seen in the margin of the fracture surface, as shown in Figure 4d (Region 4 in Figure 3).

Figure 3. Low magnification of fracture surface of #1 screws (500 μm).

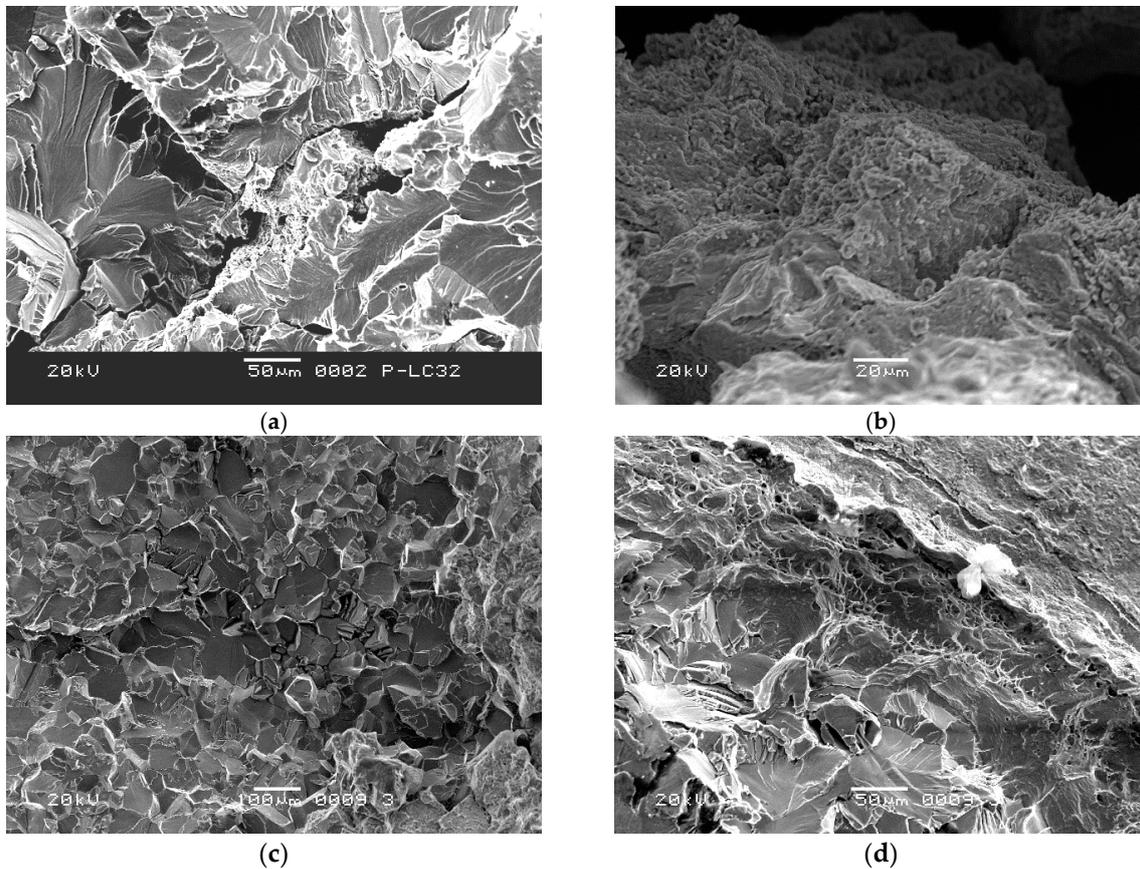
Figure 4. (a) Axial cracking and cleavage characteristics in the center of the fracture surface (Region 1 in Figure 3, 50 μm); (b) High magnification of the axial crack (Region 2 in Figure 3, 20 μm); (c) Grain boundary cracking characteristics around the axial crack (Region 3 in Figure 3, 100 μm), (d) Dimple morphology in margin of the fracture surface (Region 4 in Figure 3, 50 μm).

In this paper, the grain boundary cracking characteristics were observed around the internal defects, such as the axial crack and the tiny crack in the middle of the fracture surface. Thus, the internal defects of screws should result from grain boundary cracking caused by hot forging. After forming the defects, it is further extended in the subsequent cold working process and consistent with the axial direction.

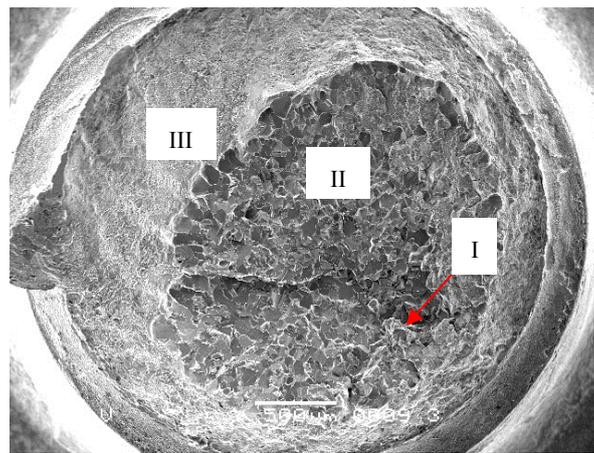
The #3 and #4 screws have the same microscopic appearance. Figure 5 shows low magnification of fracture surface the #4 screw. The fracture consists of three regions. Tiny cracks along grain boundaries can be seen in Region I (Figure 6a). Region II shows cleavage morphology, occupying an approximately half fraction of the fracture surface, with a small quantity of grain boundary cracking characteristics (yellow square in Figure 6b). Region III shows dimple morphology (Figure 6c).

Figure 5. Low magnification of fracture surface of the #4 screw (500 μm).

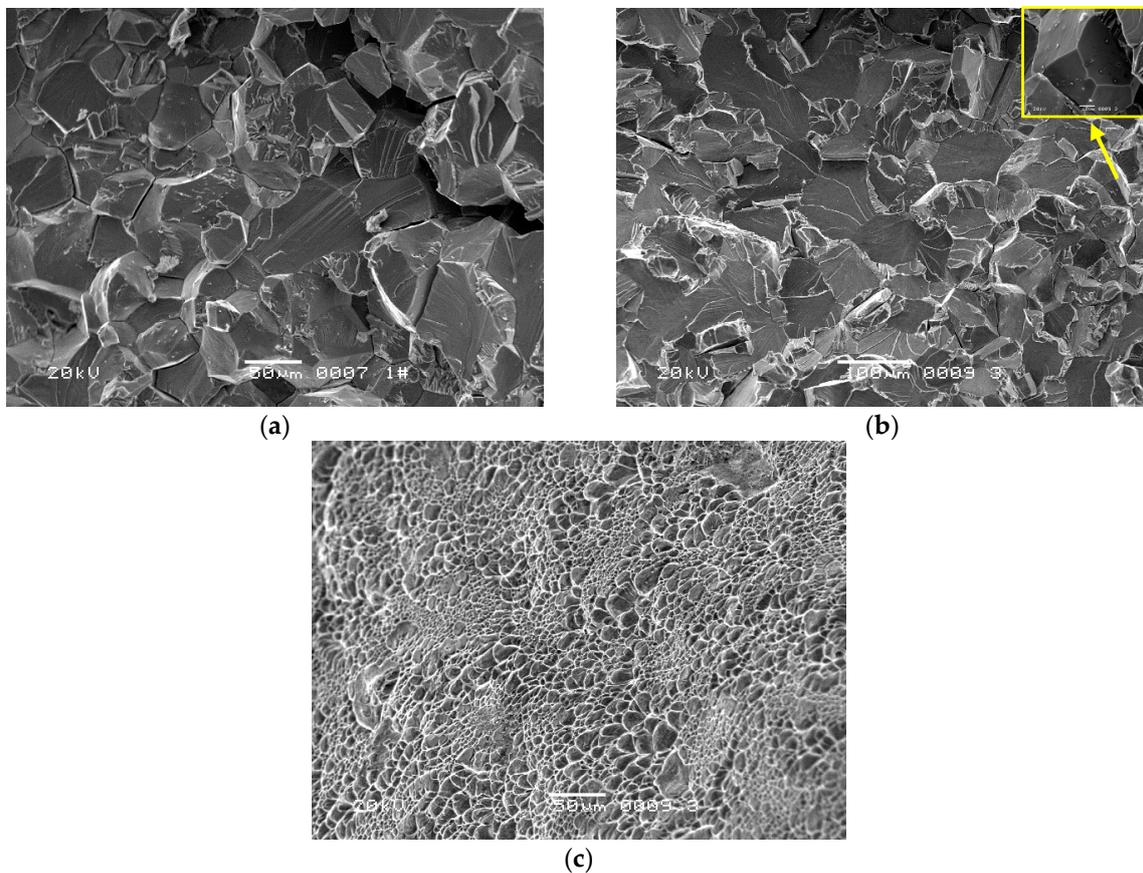
Figure 6. (a) Grain boundary cracking and cleavage morphology in Region I (50 μm); (b) Cleavage morphology and Grain boundary cracking in Region II (yellow square, 10 μm); (c) Dimple morphology in Region III (100 μm).

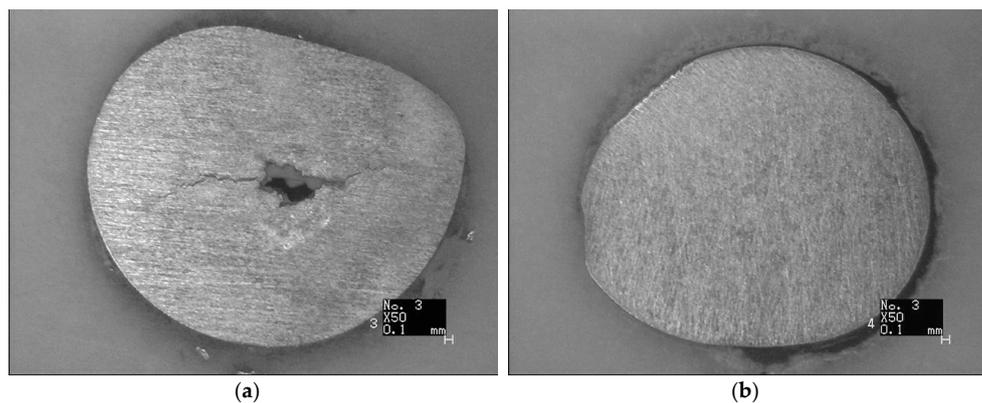
Metallographic specimens were cut perpendicular to the axial direction, 3 mm away from the fracture. Afterwards, the metallographic specimens were ground, polished, and etched (in a HF–HNO₃ solution). The metallographic specimen of the #1 screw shows the axial crack similar to void (Figure 7a). In addition, no obvious cracks were observed for the #4 screw (Figure 7b). Furthermore, there is no evidence of material defects.

Figure 7. (a) Metallographic structure of axial through-wall crack; (b) Metallographic structure of #4 screw.

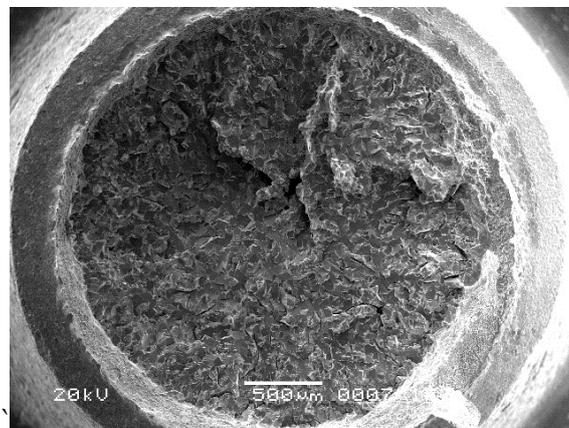
According to the principle of random sampling, fifty screws of the same production batch were employed to conduct the torsion simulation test. The torsion test was conducted using an MTS machine (CTT1501) at room temperature. The load increased 0.05 N·m every 0.2 s towards the maximum value of 2.5 N·m. The test condition was the same as the actual assembly process, and the torsion moment was no more than 2.5 N·m. During the test, when the torsion moment was not up to the specified value, two screws fractured. The fracture positions of the two screws were the same as that of the failure screws, which were located at the root of the screw thread. Fracture characteristics are the same as the failure ones, indicating that the failure is a batch problem, as shown in Figure 8.

Figure 8. Low magnification of fracture surface in torsion simulation test (500 μm).

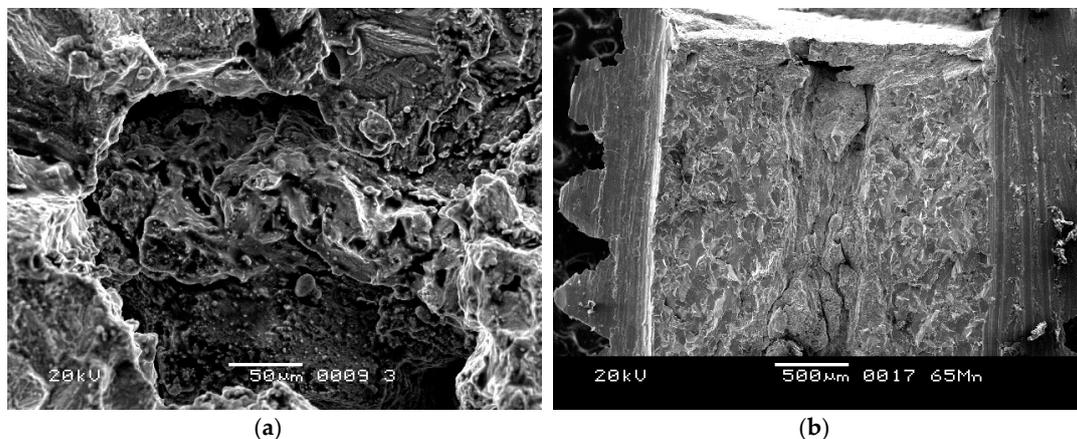
Due to the high stress concentration, screws usually fracture at the root of the thread. These fractures always start at the surface or sub-surface [23,24], whereas this batch of screws fractured at the root of the thread, originating from inside the screws. This is because of the internal defects, such as the axial crack and the tiny crack, in the screws, confirmed via microscopic and metallographic observations. During the assembly process, there is significant stress around the defects. When the stress exceeds the critical value, brittle fracture occurs. Figure 9 shows the oxidized screw, which is a failure in the production process of another batch, with significant defects. As is the typical oxidation morphology, small granular white objects can be seen in the fracture, as shown in Figure 9a. Figure 9b shows the morphology of the defects along the axial direction. Compared with Figure 9a, the small granular white objects can also be observed in Figure 4b, implying that the #1 screw was oxidized. However, the morphology of the oxidation was not observed in the fracture surface of the #4 screw. On the other hand, the EDS results, illustrated in Table 2, validated oxygen in the fracture surface of the #4 screw. This is due to the fact that oxygen dissolves in titanium to form an interstitial solid solution [25,26]. A titanium–oxygen solid solution and oxidation increase the brittleness of the titanium alloy [27]. Based on this analysis, we conclude that the main reason for brittle fracture of the screw is the internal defects, with oxygen increasing the brittleness.

Figure 9. (a) Oxidation fracture morphology; (b) Morphology along the axial direction.
