Analysis of Reasons for the Structural Collapse of Historic Buildings

Keywords: cultural heritage; damage to historic buildings; failure analysis; masonry structures

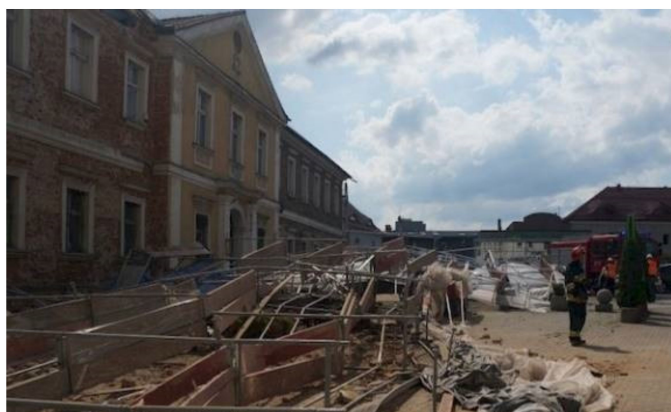
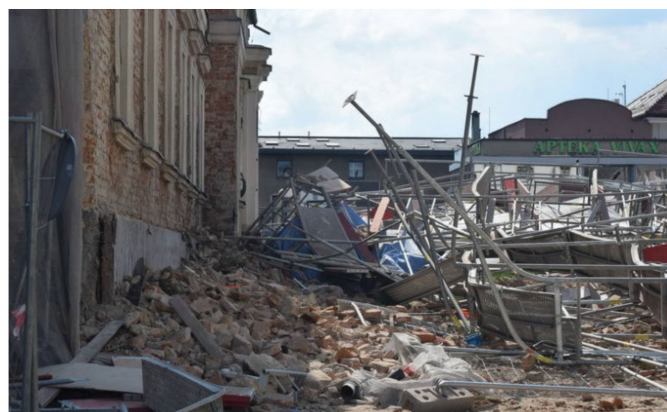
Renovation works in the Palace began in September 2018. On 19 August 2019, at ca. 2 p.m., the cornice broke at the north-east side of the front façade, and then a 50-m-high scaffold at the front façade collapsed under its own weight. Two workers from the construction company were injured. The collapsed scaffold blocked the road and the square in front of the Palace and damaged three parked cars. Photographs of the collapse are presented in Figures 3 and 4.

Figure 3. View of damage from the elevation side.

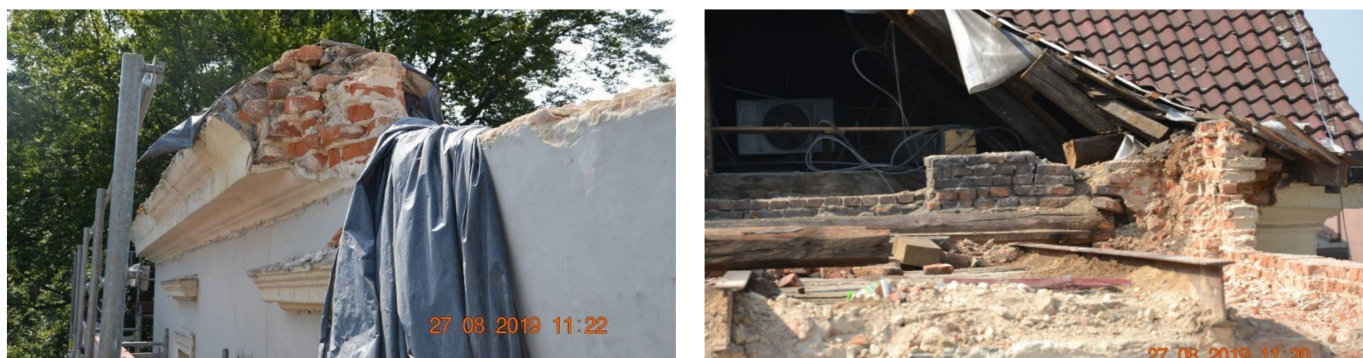
Figure 4. Remains of top cornice.

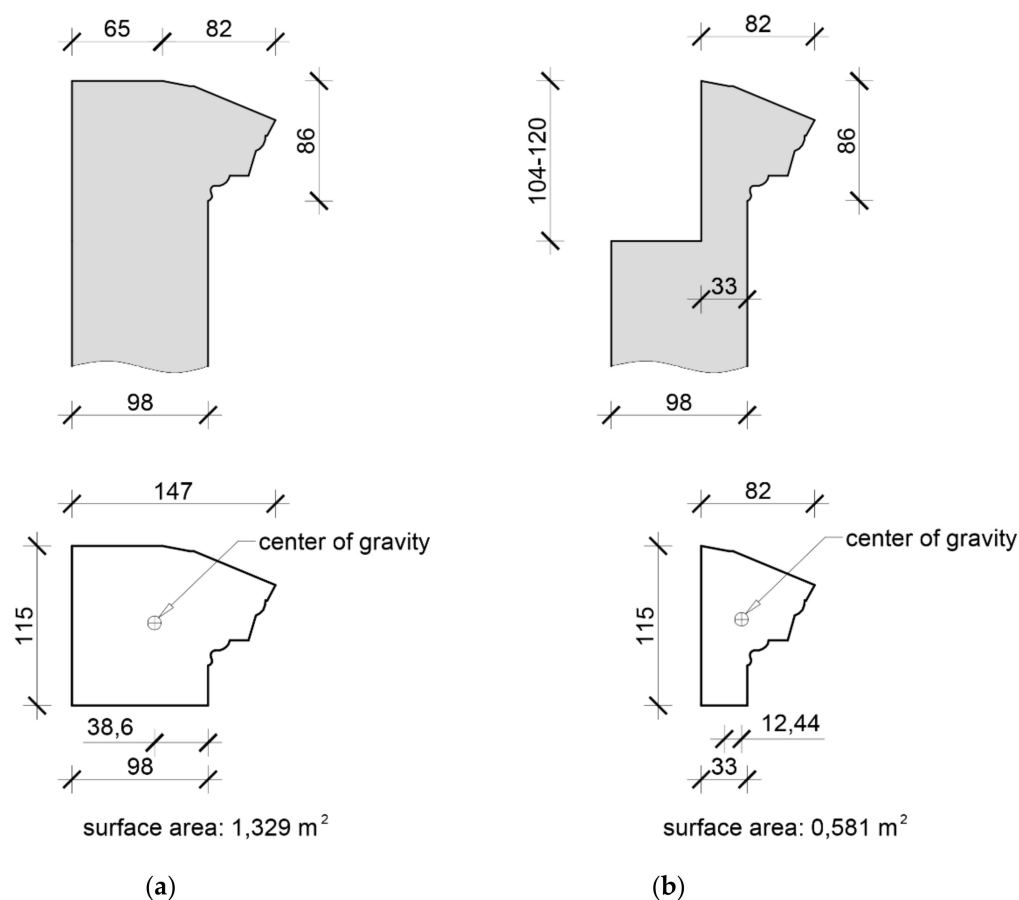
The collapse occurred after the part completion of stage 1. Figure 11 shows the cornice geometry before and after dismantling. The center of gravity after dismantling was at the outer edge of the wall. The structural calculations were performed via the standard EN 1996-1-1 [25]. The characteristic bending strength of the wall in the failure plane parallel to the bed joints was equal to 0.1 N/mm^2 . Calculations showed that the bearing capacity rate for the model without cornice dismantling was 17.4%. In contrast, the ratio of characteristic forces was 107% (close to actual values) for the different dismantling options. However, the calculations did not include the dynamic impact of the manual jackhammers used for the dismantling works.

Figure 11. The geometry of the cornice masonry before (a) and after works performed in stage 1 (b).

It should be noted that the partial dismantling of the cornice wall caused the thinning of this wall to the thickness of one brick. The measurements indicate that the thickness of the thin wall was 33 cm, and the predominant brick was 31 cm thick. The designer did not allow for a transition period in the works, which resulted in the described collapse.

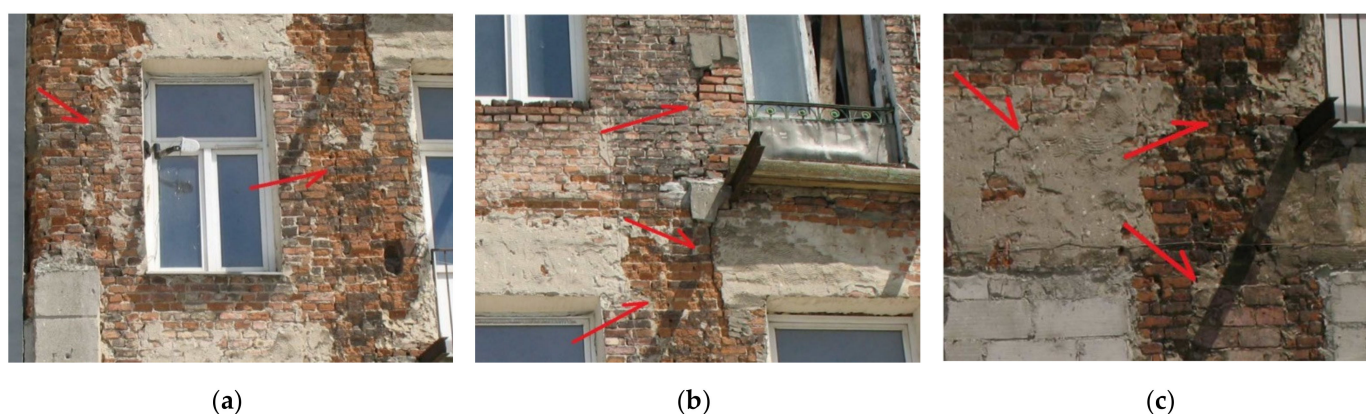
Figure 14. The collapsed area before commencement of the works: (a) wall on the second floor, (b) structural slab above one floor, (c) structural slab above the ground floor.

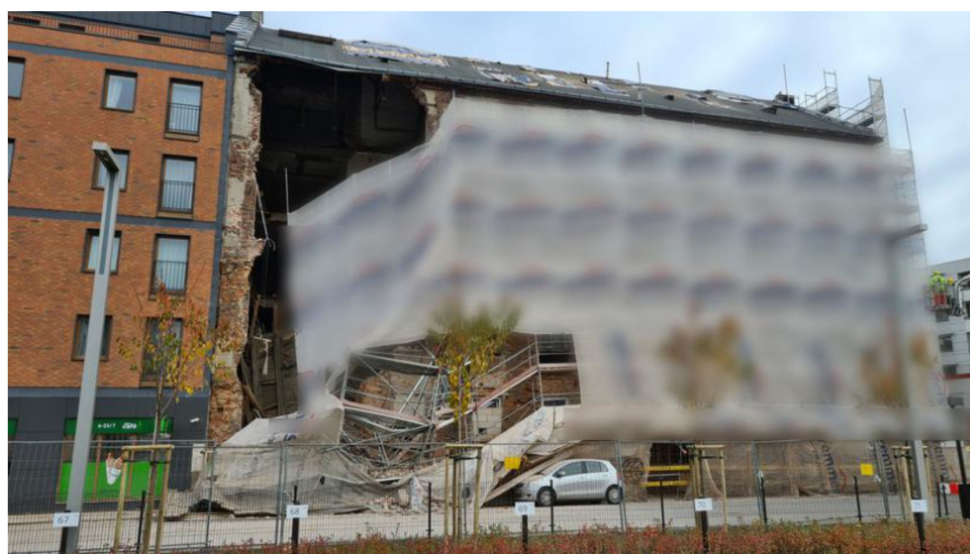
On 8 November 2020, at ca. 10:15 a.m., about one-third of the front wall of the tenement with the timber-framed floor collapsed. This collapse occurred on a Sunday, which is not a working day, so there were no workers on site. The wall collapse damaged the steel scaffold. Half of the scaffold collapsed along with the front wall, and the other half fell inside the building (Figures 15 and 16). The bottom part of the wall at ground-level did not collapse. Figure 17 shows fragments of the roof structure that were removed, with structural elements visible—rafters and purlins with timber boarding and asphalt covering. A fragment of the cornice in the upper part of the front wall did not collapse. Additionally, the timber-framed floor between stories collapsed along the length of the destroyed wall (Figure 18).

Figure 15. Photo taken immediately after the collapse.

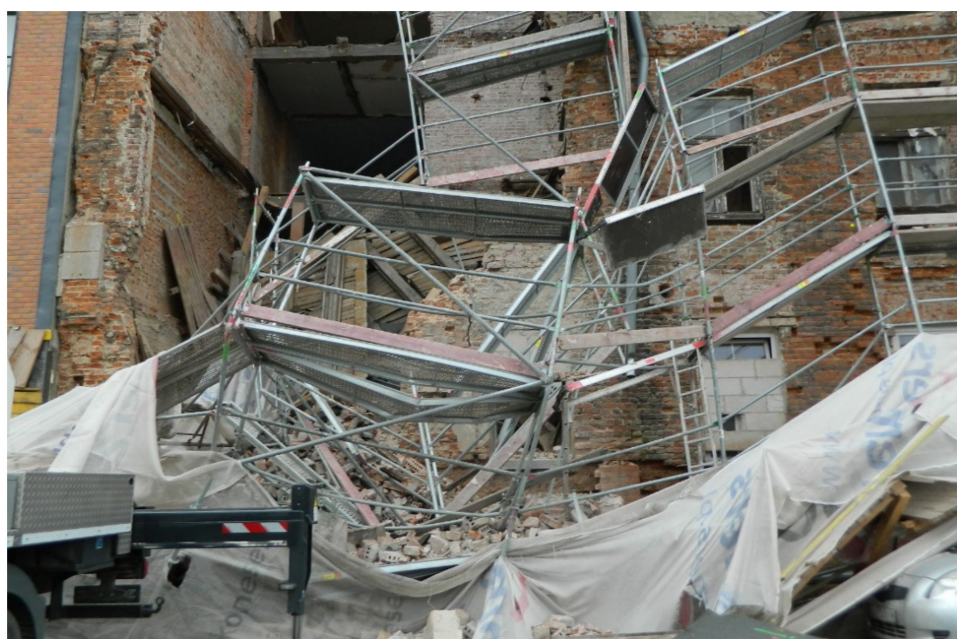
Figure 16. Photo taken immediately after the collapse.

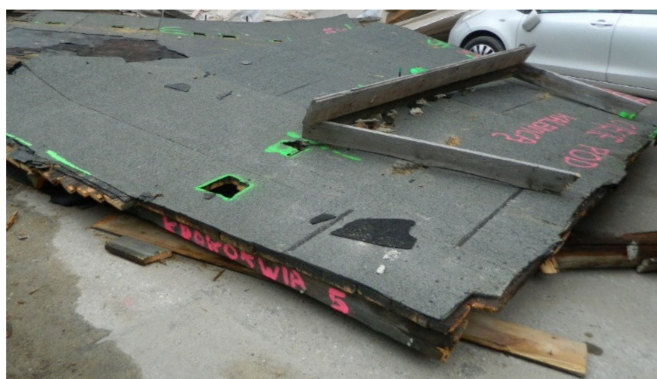
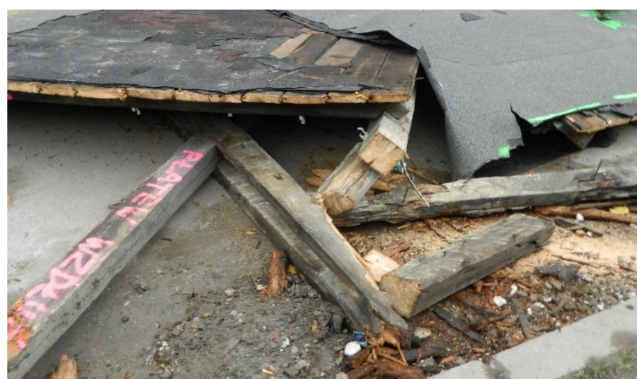
Figure 17. Elements of the roof system removed after the collapse.

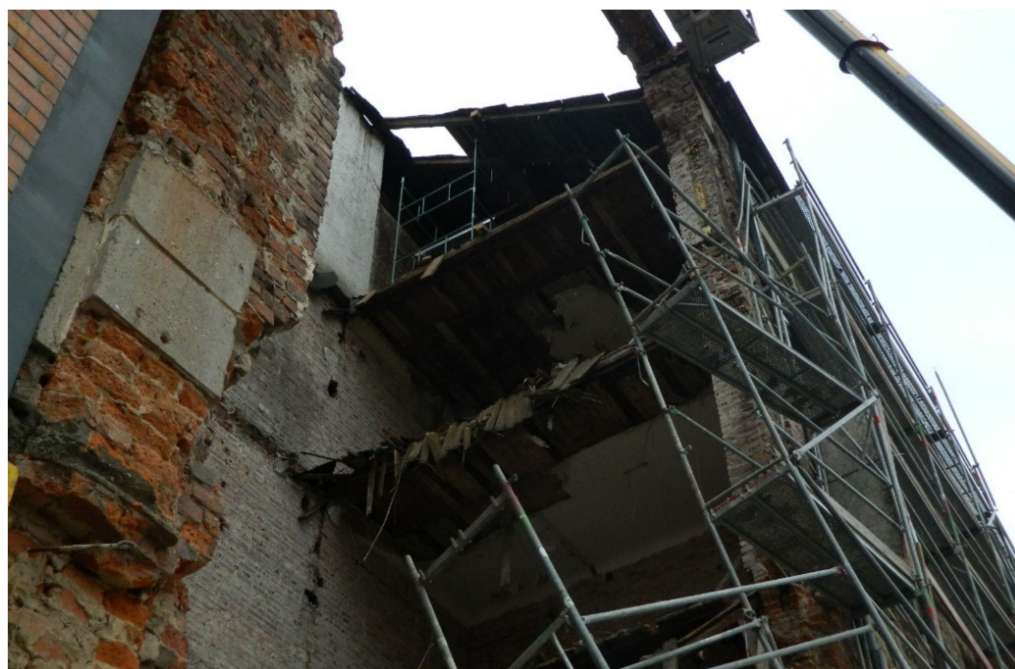
Figure 18. View of the left side of the timber-framed floor.

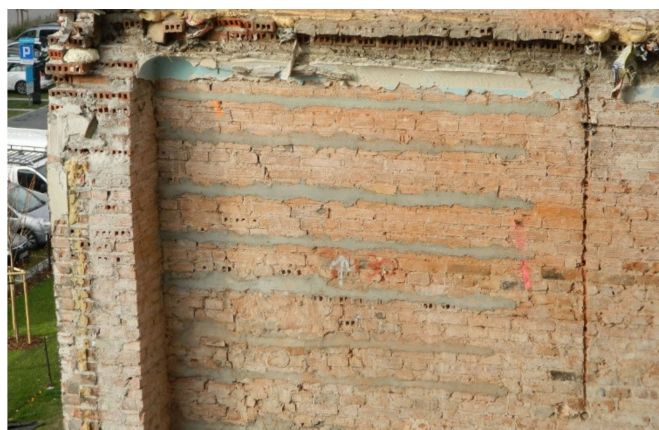
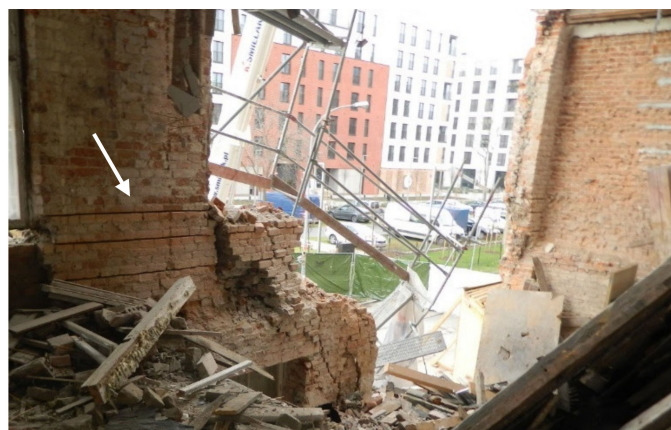
Before the collapse of the wall, cracks within it had been stitched (Figure 19a), and chases were cut for this purpose (three chases of ca. 40–50 mm deep for each overground story, embedded in the bed joints) (Figure 19b).

Figure 19. View of stitched cracks in the front wall (a) and chases cut in the front wall for stitching (b).

However, this does not mean the scaffold itself could not have contributed to causing the damage. The fastening of the scaffold to the wall probably placed additional horizontal tensile forces on the wall–floors system, thus slightly contributing to the collapse. In the authors' opinion, the lateral drift of the wall was the most important factor, which created additional eccentricities in body forces (wall weight and floor reactions). The lateral drift of the wall in the collapse zone is itself unknown, but measurements taken after the collapse indicate that it was ca. 10 cm, and the greatest lateral drift (orientated symmetrically around the damage, on the other side of the façade) was as much as 20 cm. The chases (depth of 80 mm) applied for crack stitching could also have affected the damage.

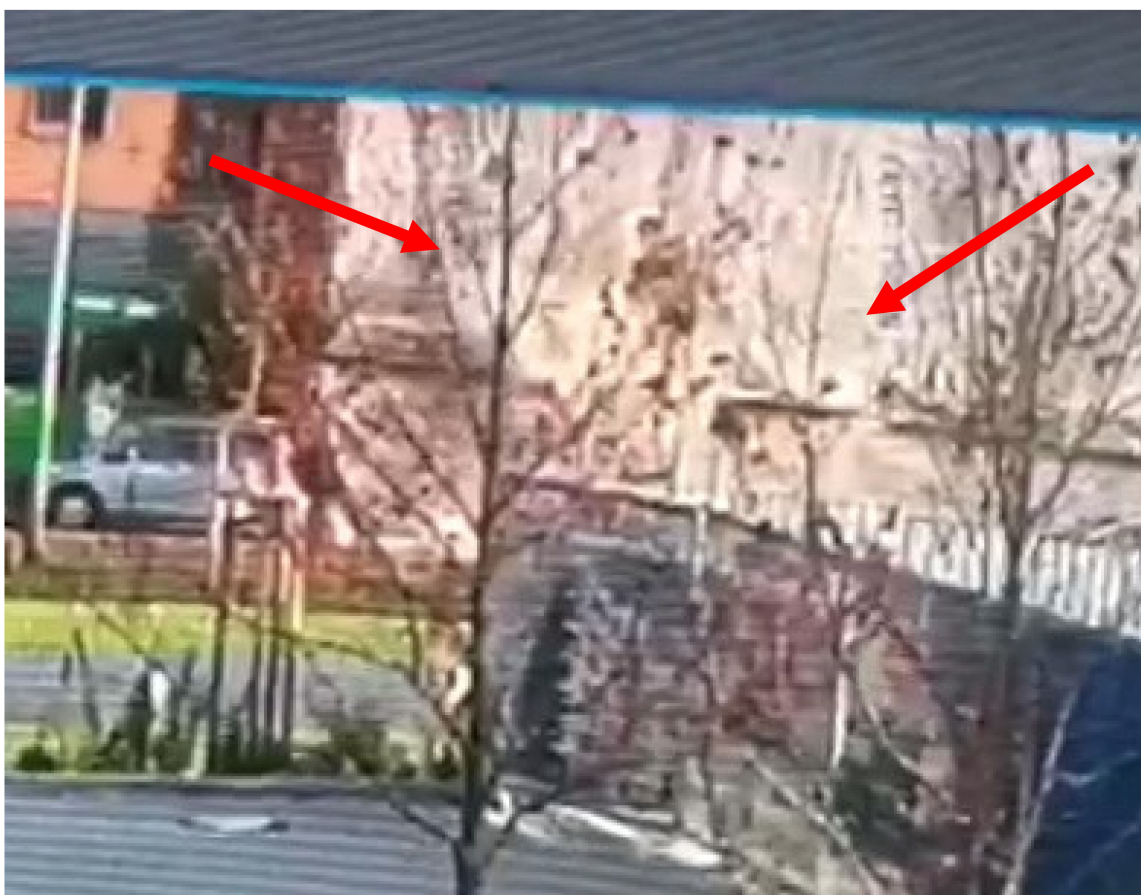
During the incident, which took place on 8 November 2020 at ca. 10:15 a.m., the collapse of the wall in question was recorded by the industrial cameras installed on the building opposite this wall. These recordings do not clearly show the reason for the collapse. Nevertheless, they indicate it took place in two stages. In the first stage, a fragment of the wall, or of the floor in the upper parts of the wall, was destroyed. This caused the clouds of smoke visible on the recording. Nevertheless, the wall itself was not destroyed. The recording shows two clouds of smoke in the initial phase, whose locations correspond to the second and third axes of the windows (Figure 24), and the first cloud of smoke appeared on the central axis. This might suggest the debonding of a fragment of the structure within the building, causing clouds of smoke to blow from these windows.

Figure 24. First phase of destruction—two visible clouds of smoke (CCTV record).

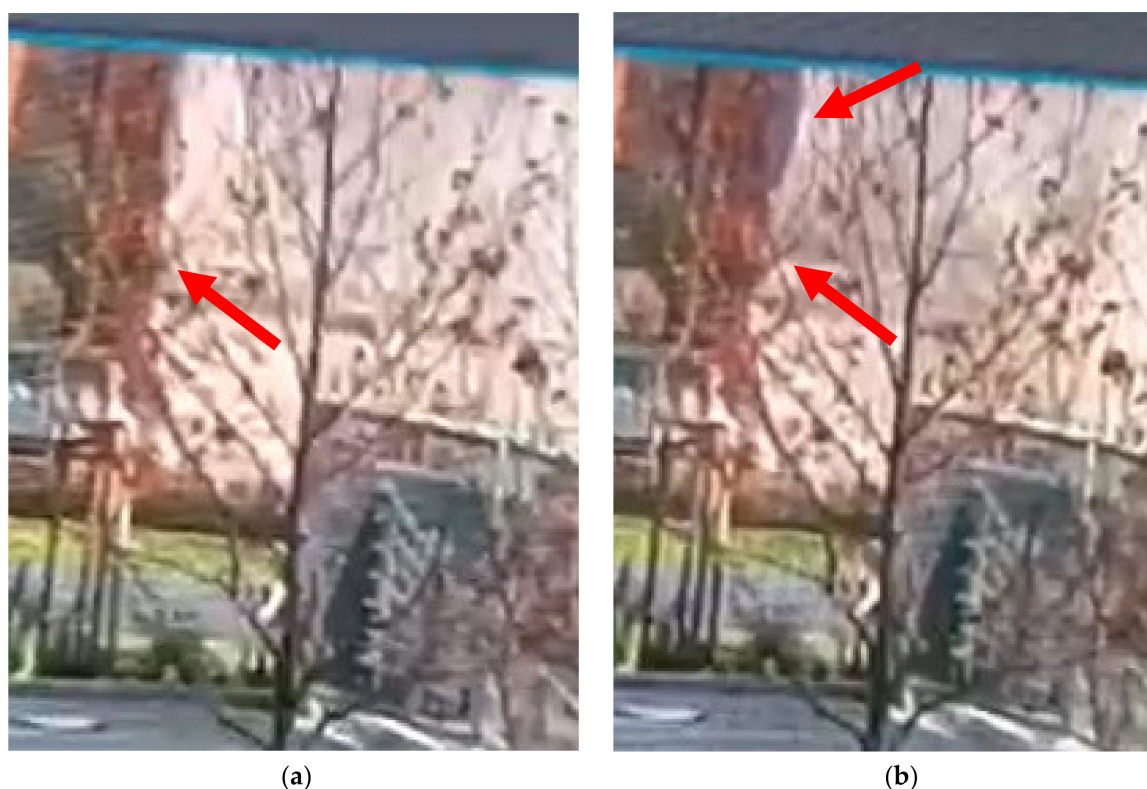
The second stage of the collapse occurred ca. 15 s later. The front wall collapsed along two window lines on the ground floor and three window lines on the floors above. The falling fragments of the wall presumably affected the stability of the rest of the wall, representing the primary cause of this collapse. The time-lapse analysis showed that the scaffold rotated at the level of the first catwalk during the collapse (Figure 25). This means that the damage was not caused by problems with the support or rebricking of the wall at the ground level, because these factors would not cause this rotation. Hence, the causes of the discussed damage should be sought in higher parts of the wall.

Figure 25. Second phase of destruction: (a) ca. 1 s before the failure; (b) onset of failure. Visible rotation of the scaffold (arrow) (CCTV record).

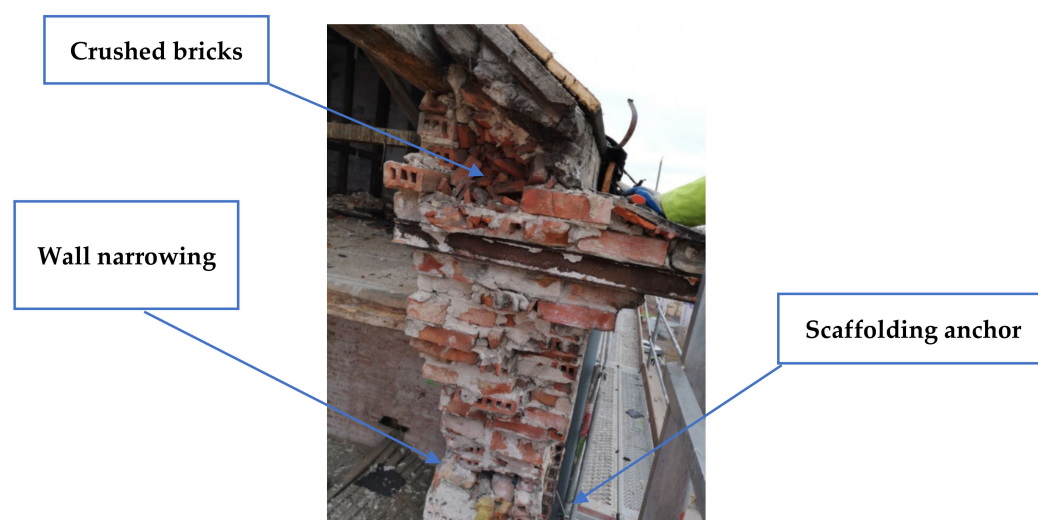
Hypotheses 3 and 4 seem to be the least probable, but the surveillance recordings contradict this (that said, they do not cover the upper part of the wall). Under Hypothesis 3, the scaffold on the collapsed wall should have fallen towards the road, and partly fallen inside the building. Nonetheless, the cornice's condition was very poor (Figure 29).

Figure 29. View of the cornice.

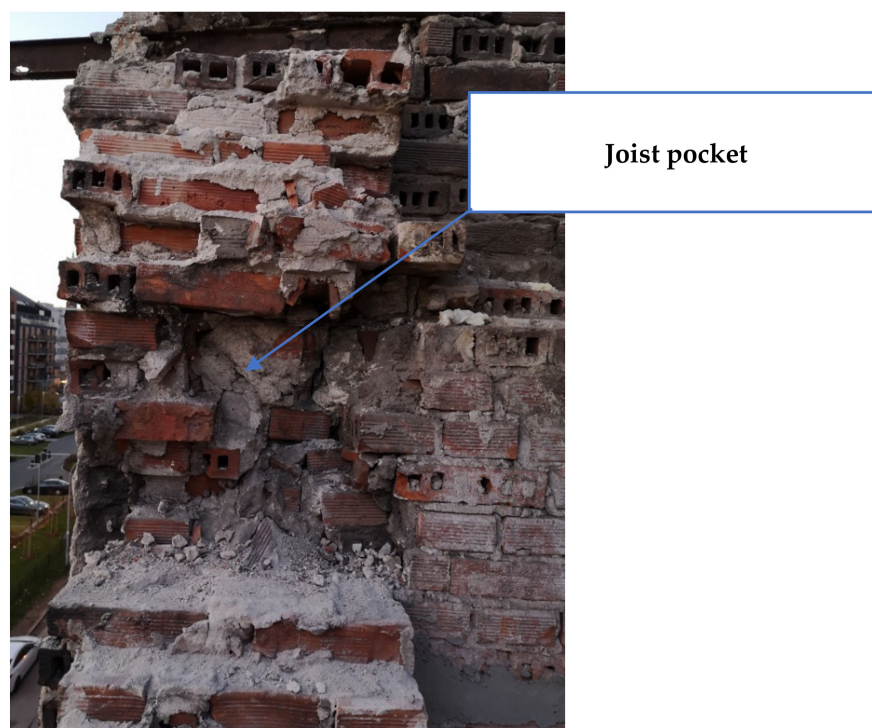
Figure 30. The first possible place of damage initiation—the floor below the top cornice.

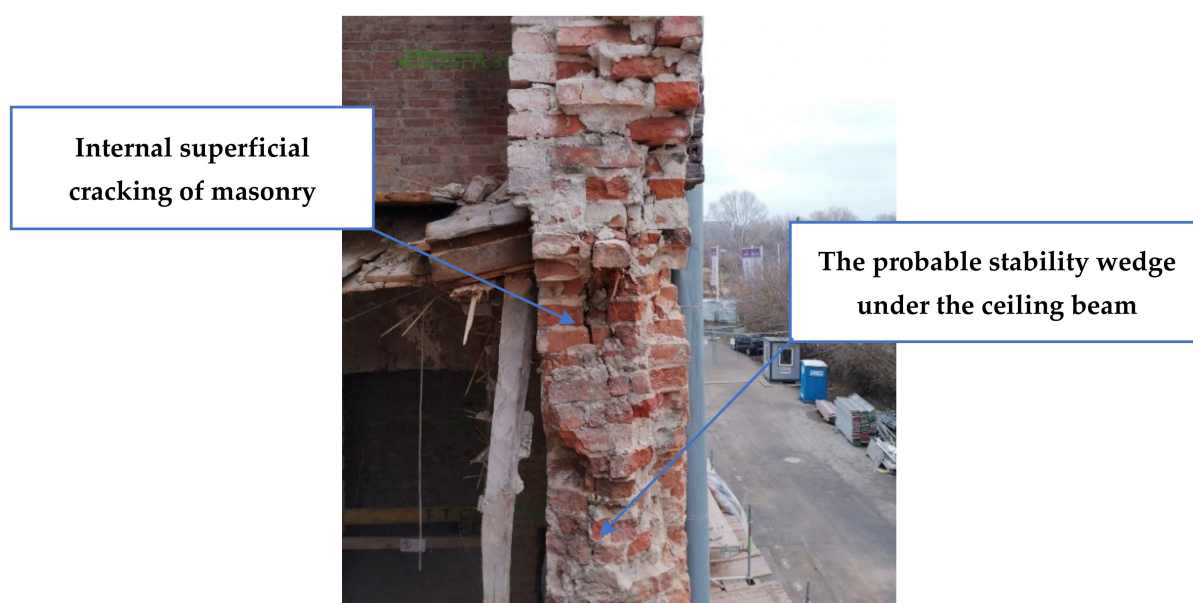
Figure 31. The second possible place of damage initiation—the narrow wall below the second story.

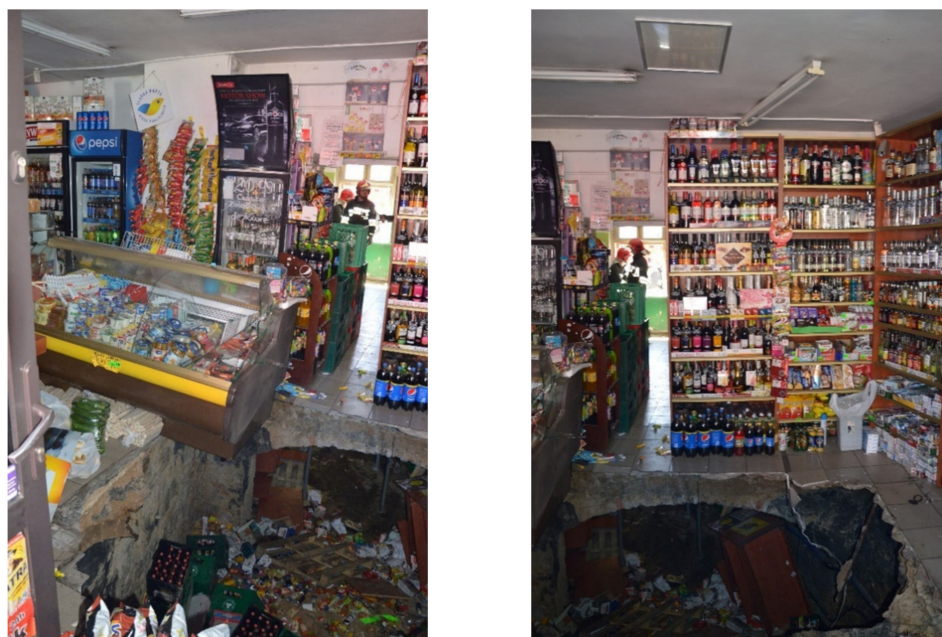
In the morning of 2 June 2017, the floor above the basement collapsed in one of the commercial units (a grocer's shop). The collapse occurred during the reception of goods. Over 9 m² of the floor collapsed. Four people fell with the floor into the basement. Fortunately, none were seriously injured. The floor failure is shown in Figure 41.

Figure 41. View of the collapsed floor.

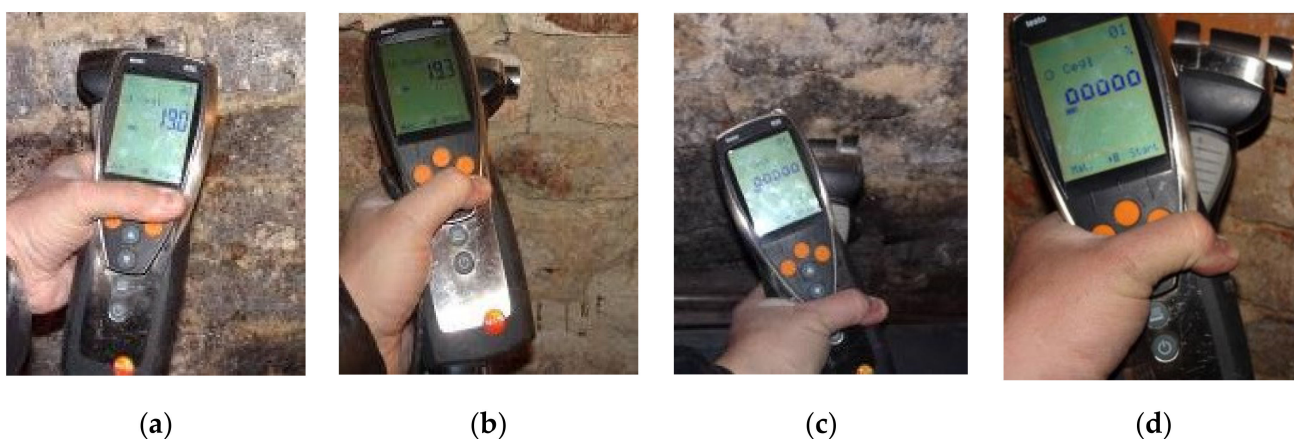
Moisture content in the walls of the steel element was tested with the ultrasonic technique. The moisture content in masonry units was assessed via dielectric measurement, using a device with capacitive sensors. The measured range in the brick was 0.2~15%, at an error lower than 2%. The test results are shown in Figure 42. The moisture content in the walls ranged from 19% to a value beyond the measurement range of the device (>20%).

Figure 42. Measuring moisture content in the wall: (a) 19.0%; (b) 19.3%; (c) and (d) beyond the range (>20%).

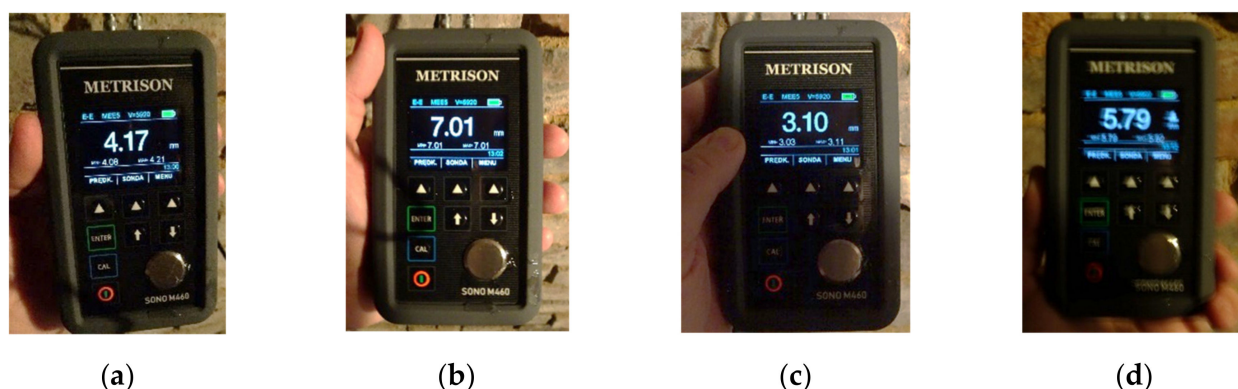
Figure 43. Measuring the thickness of steel beam elements: (a) web of the central area—4.17 mm; (b) flange of the central area—7.01 mm; (c) web at the support—3.1 mm; (d) flange at the support—5.79.

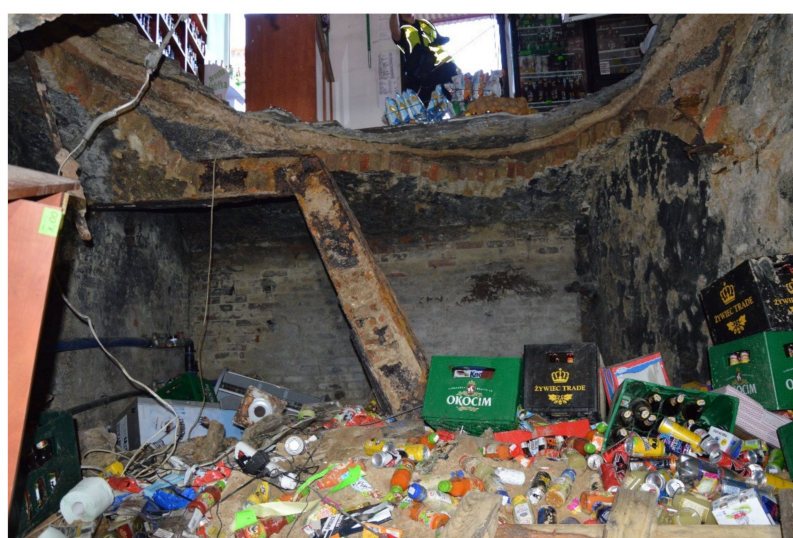
Figure 44. View of the broken beam.

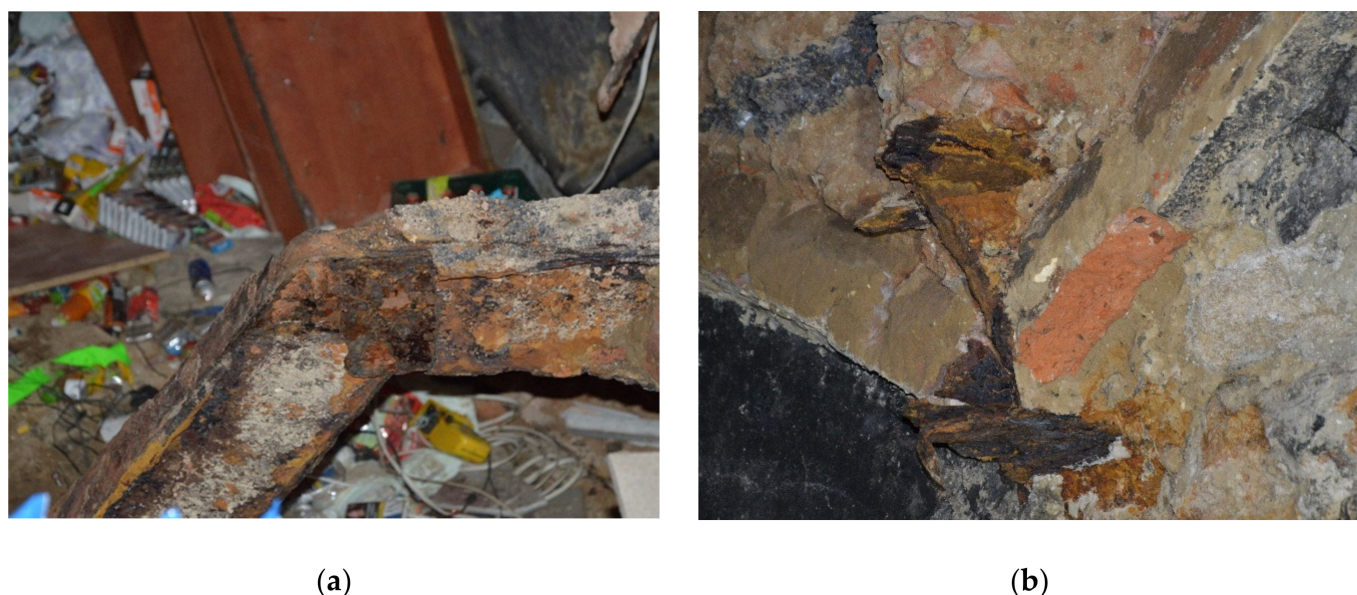
Figure 45. Details of the beam failure: (a) bending of the section; (b) shearing of the section.
