# Renovation Management Method in Neglected Buildings

**Abstract:** Renovation works to buildings are often not carried out or there are shifts in time, which causes degradation of the building. The article presents an analysis of the consequences of abandoning renovation works. The aim of this article is to present a method of preliminarily planning renovations of a MRUB (Managing Renovation in Un-renovated Buildings). This method of decision-making support is based on the consequences in the case of the omission of renovations. The omission of renovations may lead to a threat to the stability of the building's structure, threaten the lives of its users, and further damage the building by damaging further elements, or even cause a building disaster. Often, as a result of the abandonment of renovation, usually caused by the lack of the owner, improper manager, or irresponsible owners, these objects are degraded. The consequences of the failure of renovating buildings lead to irreversible processes of destruction. As a result of the research, it was found that it was not only a bad technical condition that was a prerequisite for carrying out the renovation. The consequences of the

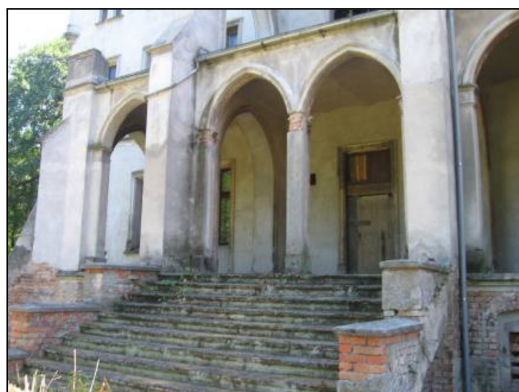
**Figure A1.** Fragment of the northern elevation. Numerous damp stains on the terrace, destroyed steps, and missing areas of plaster. Destroyed column caps.

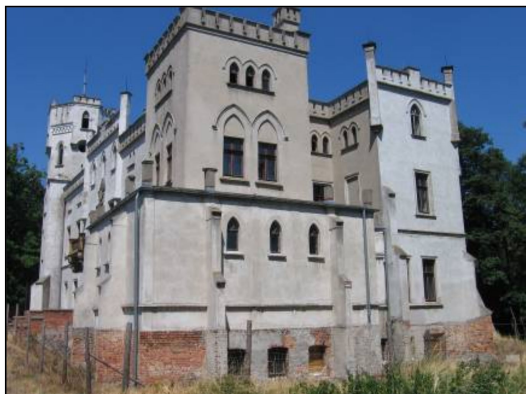
**Figure A2.** Southern elevation. View from the southwestern side. Walls covered by a cement-lime plaster applied in the 1980s. Note the lack of balustrade on the tower terrace and the lack of plaster on the foundation plinth.

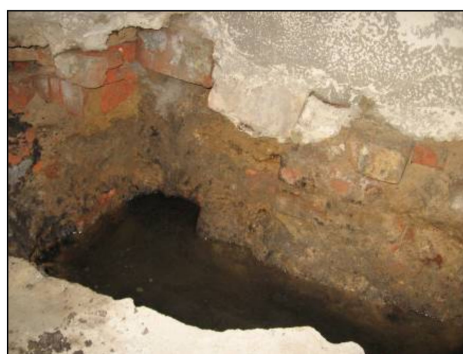
The foundation of the building is composed of a strip foundation of various dimensions with an offset of 15 cm, made from boulders on lime mortar with an addition of clay; the average diameter of the boulders is approx. 60–70 cm. The depth of the strip foundation is approximately 80–120 cm below the level of the basement floors. Uncovering of the foundations in the northeastern and southwestern part of the building has been carried out. Severe damp from the groundwater on surfaces was determined (Figures A3 and A4). The soil in areas of the foundation uncovered is loamy sand. The level of groundwater is above the level of the foundation and there is a lack of vertical and horizontal damp insulation.

**Figure A3.** Basement in the middle part of the building (fragment). Foundation uncovered. High level of groundwater means a severely damp wall.

be carried out, replacing all flashing, gutters, and downpipes. The foundation needs to be dried and the building equipped with drainage.

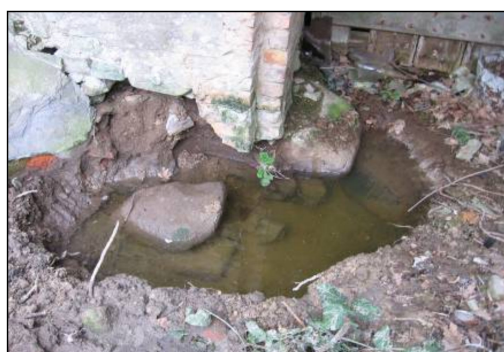
**Figure A4.** Wall of northern elevation (fragment). Foundation uncovered. Foundation from boulders and visible groundwater table.

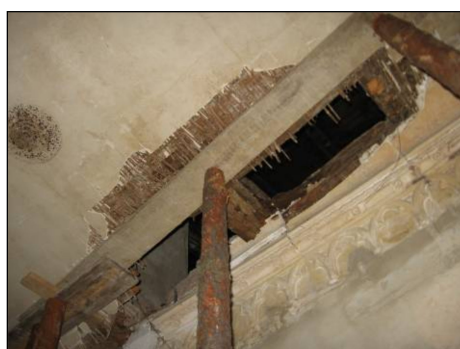
In the room upstairs, in the northern part of the building, the floor slab deflection is approximately 15 cm. The floor requires additional support. Upstairs, the ceiling beams are significantly damp. The wooden construction of the ceilings requires general repairs, partial strengthening, and the partial replacement of elements (Figures A5 and A6). Additionally, it is recommended that the wood be impregnated with insecticides and fungicides.

**Figure A5.** Upstairs fragment of ceiling above the room in the eastern part. Bad condition of the ceiling. Ceiling temporarily shored.

The wooden ceilings over the ground floor and first floor do not fulfill the specified ultimate limit states of load-bearing capacity, and the immediate renovation of the ceilings in a manner that allows for preserving as much of the historic substance as possible in an unchanged form is recommended.

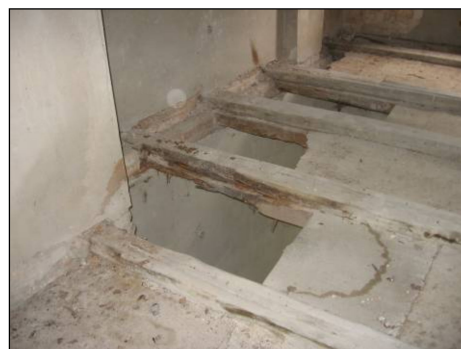
**Figure A6.** Attic fragment of the floor in the central part. Corroded ends of floor beams. Lack of flooring and ceiling.
