The Carmine Maggiore Bell Tower: An Inclusive and Sustainable Restoration Experience

Keywords: cultural heritage; bell tower; restoration; seismic safety; masonry; sustainable project

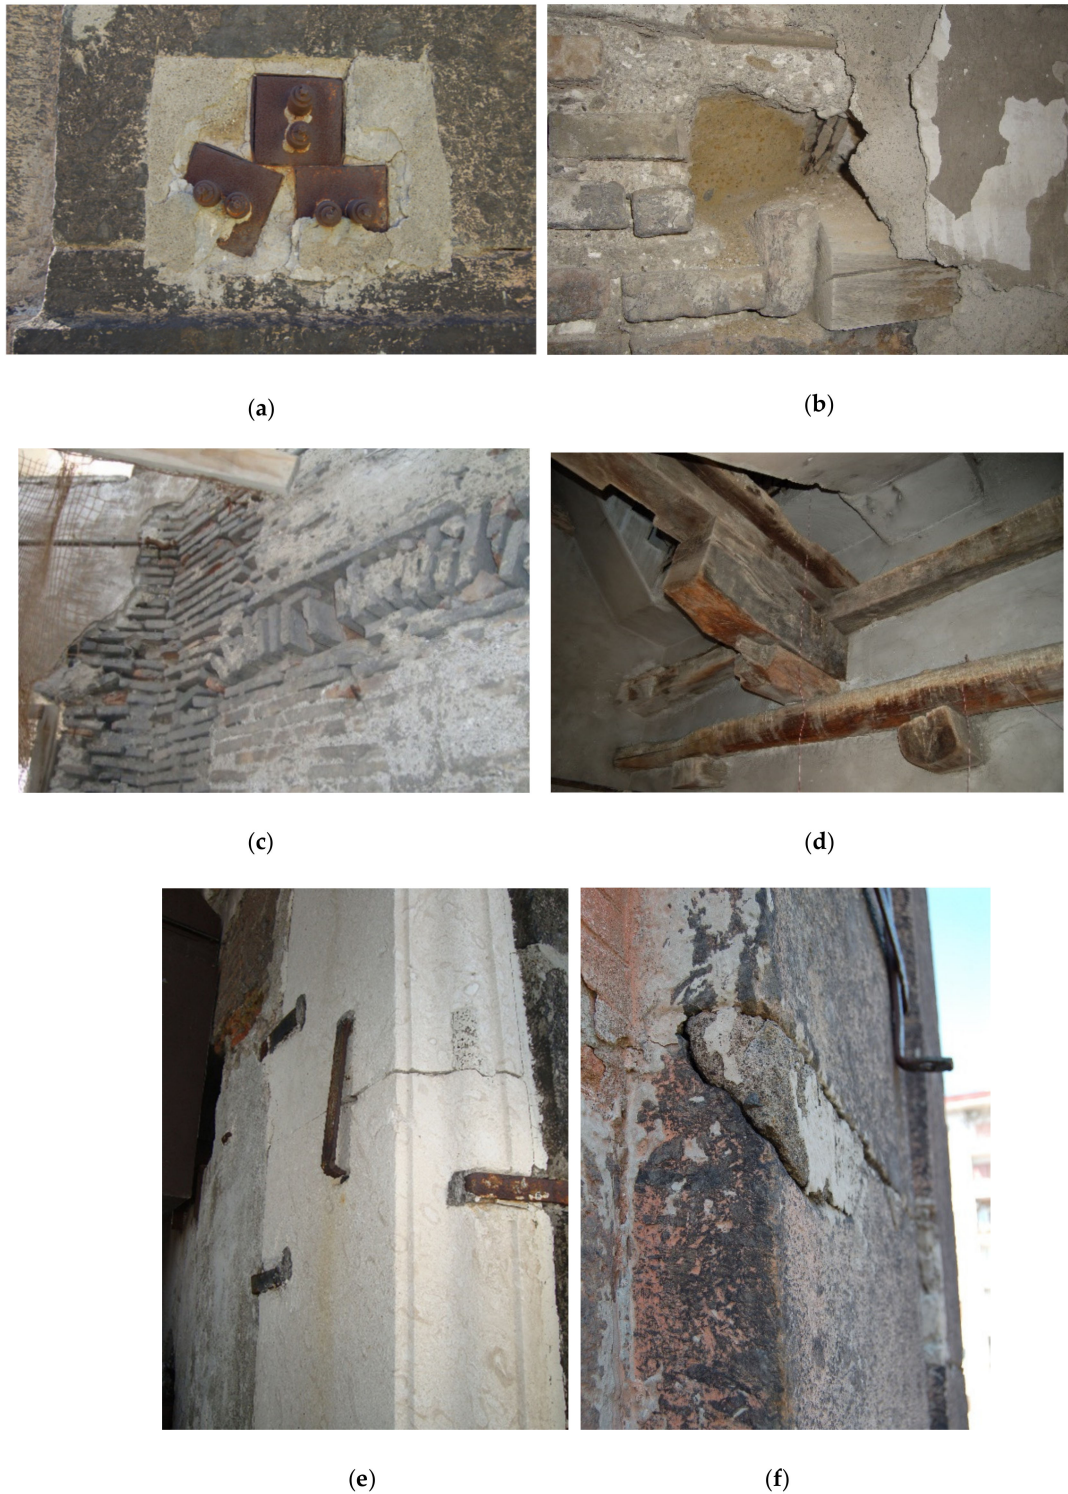
The major degradation phenomena concern (Figure 5): (a) the oxidation of tie-rods and anchor plates, especially those placed in the 1970/80s; (b) cavities in the masonry walls, which weaken structural resistant sections; (c) the degradation of the mortar joints of large portions of clay brick masonry, which sometimes also affects the bricks themselves; (d) the deterioration of timber structures, especially those supporting the main bell; (e) the oxidation of cramps and bandages anchoring cladding elements and cornices to the wall structure; (f) cracks in wall structures.

Figure 5. Degradation phenomena: (a) oxidation of tie-rods and anchor plates; (b) cavities in masonry walls; (c) degradation of mortar joints; (d) deterioration of timber structures; (e) oxidation of cramps and bandages; (f) cracks in wall structures.

- 1 The integration of the strand tie rods with new stainless steel tie rods: 30 mm diameter stainless steel tie rods were arranged, anchored to the masonry walls through stainless steel plates. Each tie rod was protected by a Teflon wrap, and the portion passing through the masonry walls was covered with a PVC tubular to allow sliding and for future maintenance.

- 3 The cracks repair: the cracks were refilled with structural mortar, sometimes improved with aggregates, to restore the masonry continuity and provide an effective interlocking. A fiber-reinforced thixotropic hydraulic lime mortar with volumetric stability, super-adhesive, compensated shrinkage, low soluble salt content (less than 10 ppm), suitable grain color, was used to avoid any risk of aggression to the existing

- 4 The filling of niches, cavities, and voids in masonry walls: the degraded stones and bricks surrounding niches or cavities were removed. The filling of niches and the masonry rebuilding were performed using elements of geometry (shape and size) and mechanical characteristics similar to the original ones, using a mortar with zero shrinkage or slightly expansive (Figure 10a).

- 5 The anti-rust treatment of the tie-rods of the late nineteenth and early twentieth century, and the replacement of the degraded steel anchoring cramps: the old cramps were replaced by injection “anchors with sock”. Stainless steel bars of 12 mm diameter were anchored for 600 mm in holes using a polyester sock, filled with a specific hydraulic mortar through an appropriate system of injection pipes. The sock, gradually filled, adapted to the geometry of the hole, ensuring the anchorage of the bar to the masonry, avoiding dispersion of material in voids and cavities, and even distribution of stresses in the masonry. Each anchorage was completed with a small stainless steel plate placed slightly under the masonry surface (Figure 10b).

- 6 The restoration of oxidized metal elements: the accessible and not notably degraded steel elements were treated by sandblasting at a pressure between 300 and 500 KPa, to remove rust until a visible metal cleaning was obtained. Subsequently, the oxidation process was inhibited through passivating chemical products, using oily inhibitors, and ferromicaceous paints (Figure 10c).

- 7 The strengthening of timber structures: degraded but recoverable timber beams were consolidated and protected by both simple impregnation and surface crack filling, using specific impregnating agents of fluid consistency and high chemical-physical compatibility with the existing wood. Where necessary, bolted stainless steel ties were arranged. The unrecoverable timber elements were replaced by elements of similar mechanical characteristics.

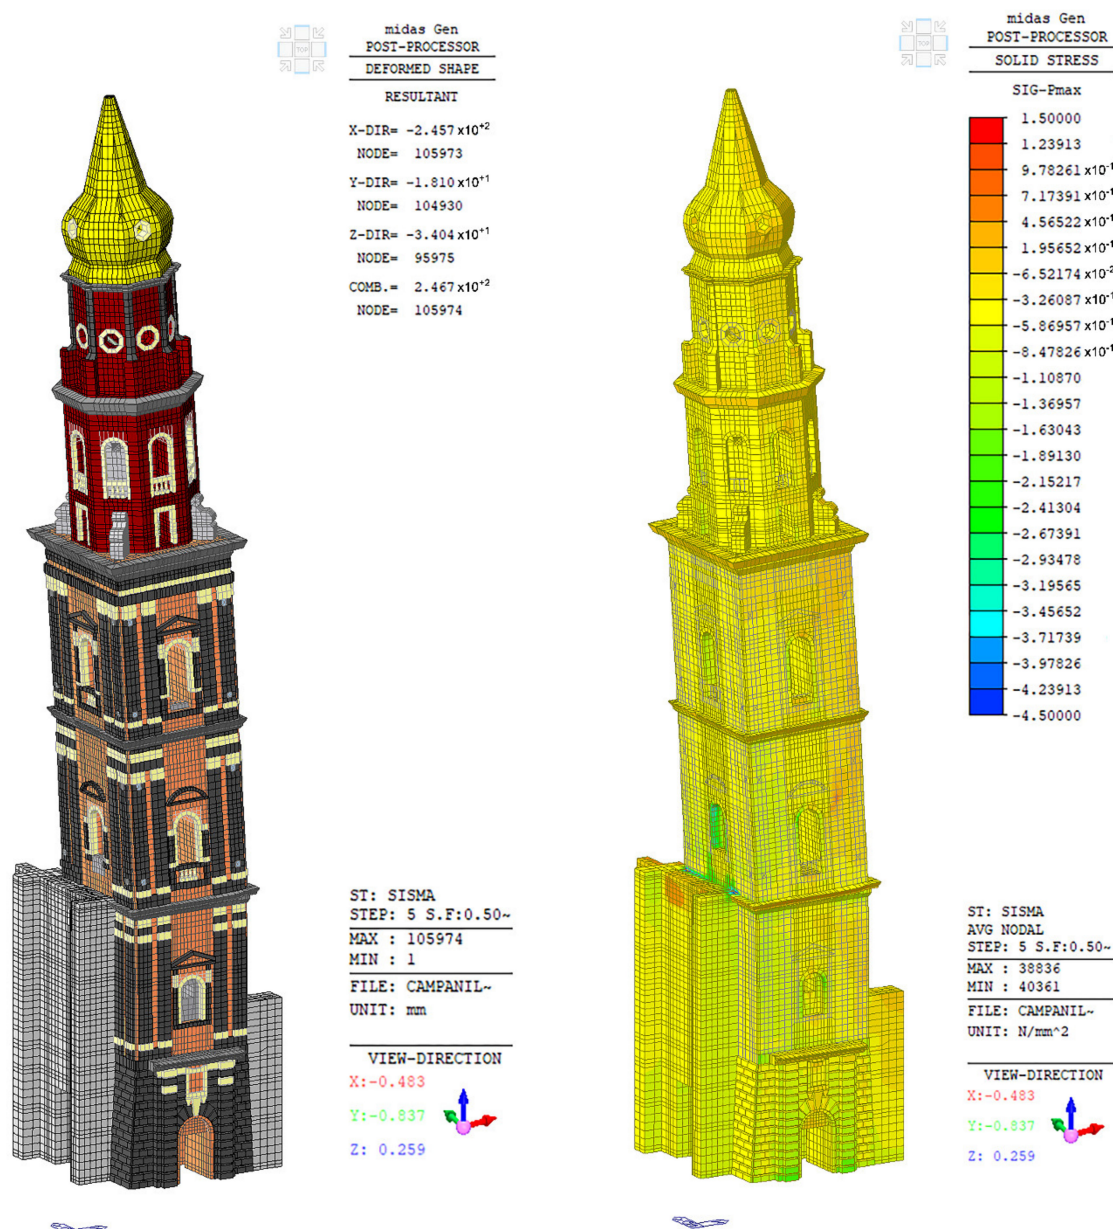
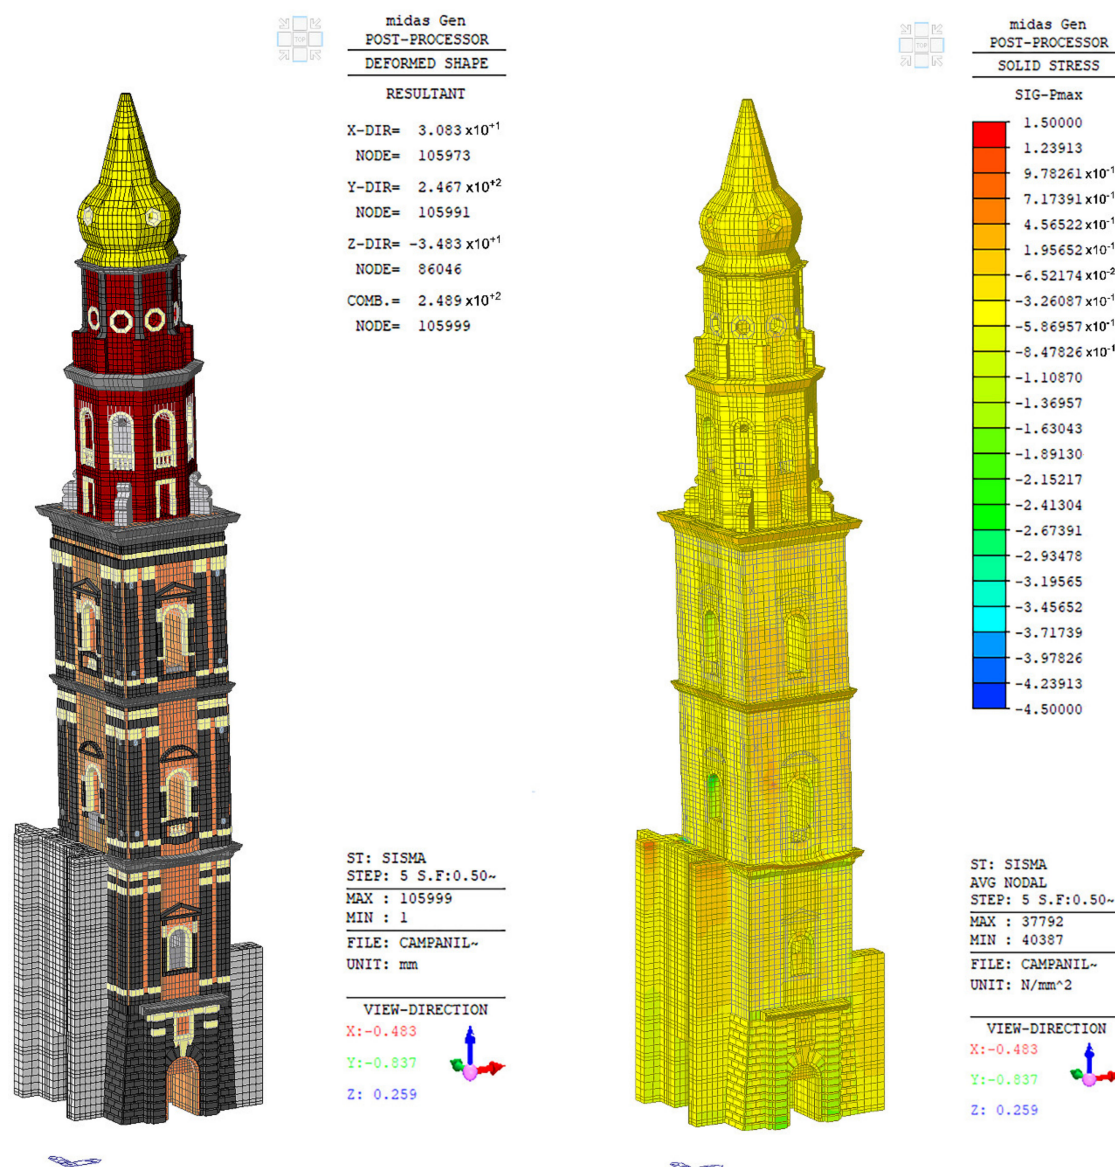
Figure 7. Non-linear static analysis: Deformed and stresses for earthquakes in North-South direction.

Figure 8. Non-linear static analysis: Deformed and stresses for earthquakes in the West-East direction.

The non-linear static analyses allowed us to analyze both the axial and shear stresses in several cross-sections of the bell tower. Figures 7 and 8 show the maximum principle stresses in all structural and non-structural elements for the level of seismic action corresponding to the displacement capacity of the bell tower specified above. The figures show the mean “acceptable” stresses in both the tuff stone masonry and the clay brick masonry, except local concentrations in singular points (some stress peaks also affect stiffer and more resistant non-structural elements). Safety indexes greater than the unit were computed as the ratio of displacement capacity of the bell tower to the code displacement demand. Adequate margins of safety against the seismic action were identified because the smallest safety index was equal to 1.94.

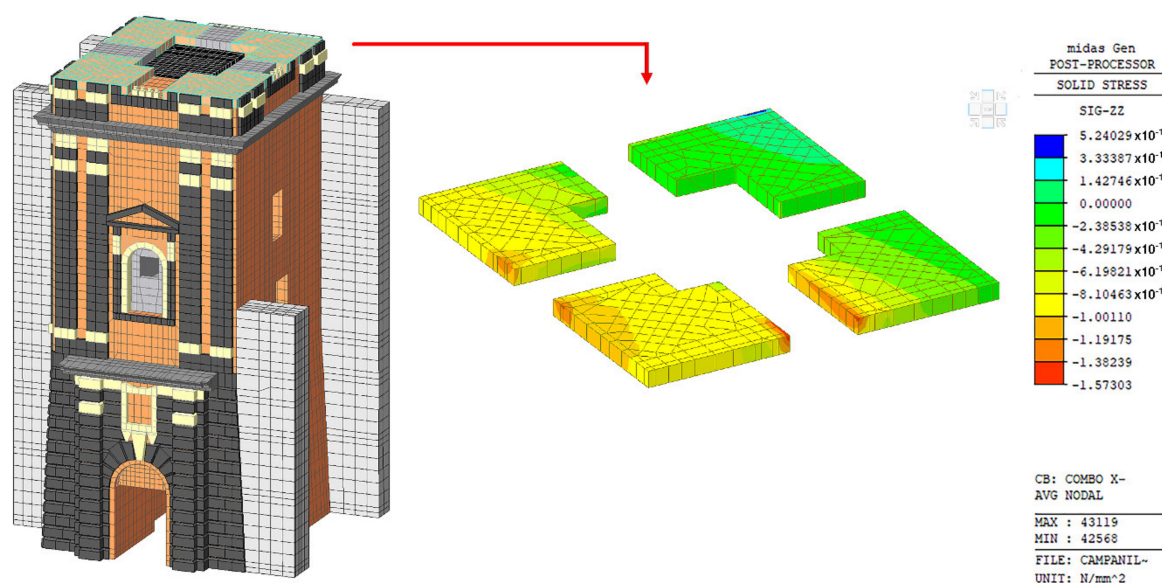
Figure 9. Distribution of the axial stresses in the section of the bell tower between 18.86 and 19.21 m.

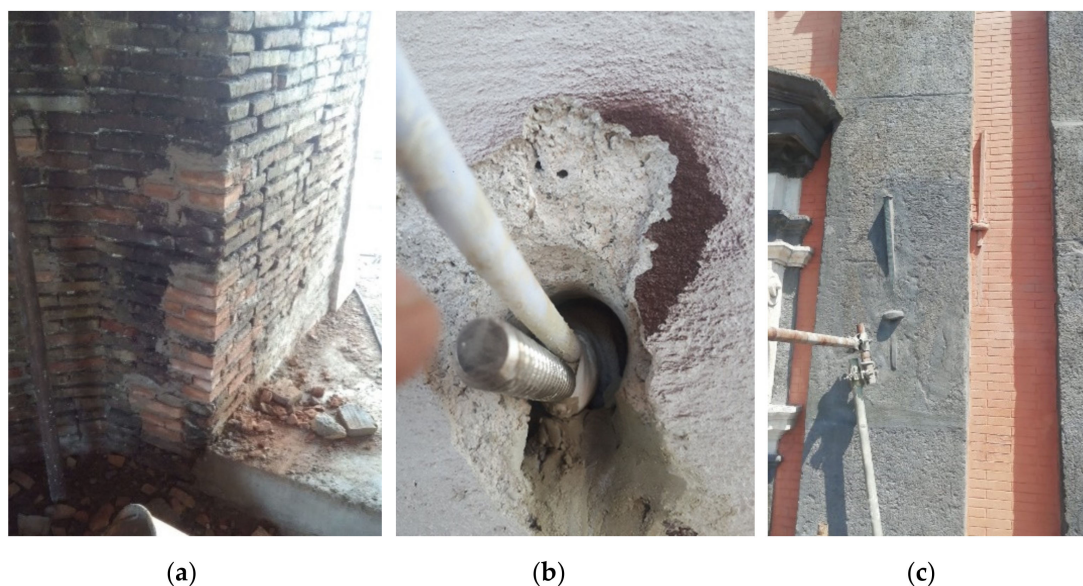
Figure 10. Masonry rebuilding (a); anchor with sock (b); restoration of oxidized metal elements (c).
