# S02 | MEADOW PASS

**Figure S1.** Analysis of the S02\_Meadow Pass, containing general information (length, height difference, time, difficulty), points of interest, pavement typology, and recommended interventions (elaboration: © Carlo Costantino; date: 18 August 2022; map source: <http://geoportale.regione.abruzzo.it/Cartanet/viewer>).

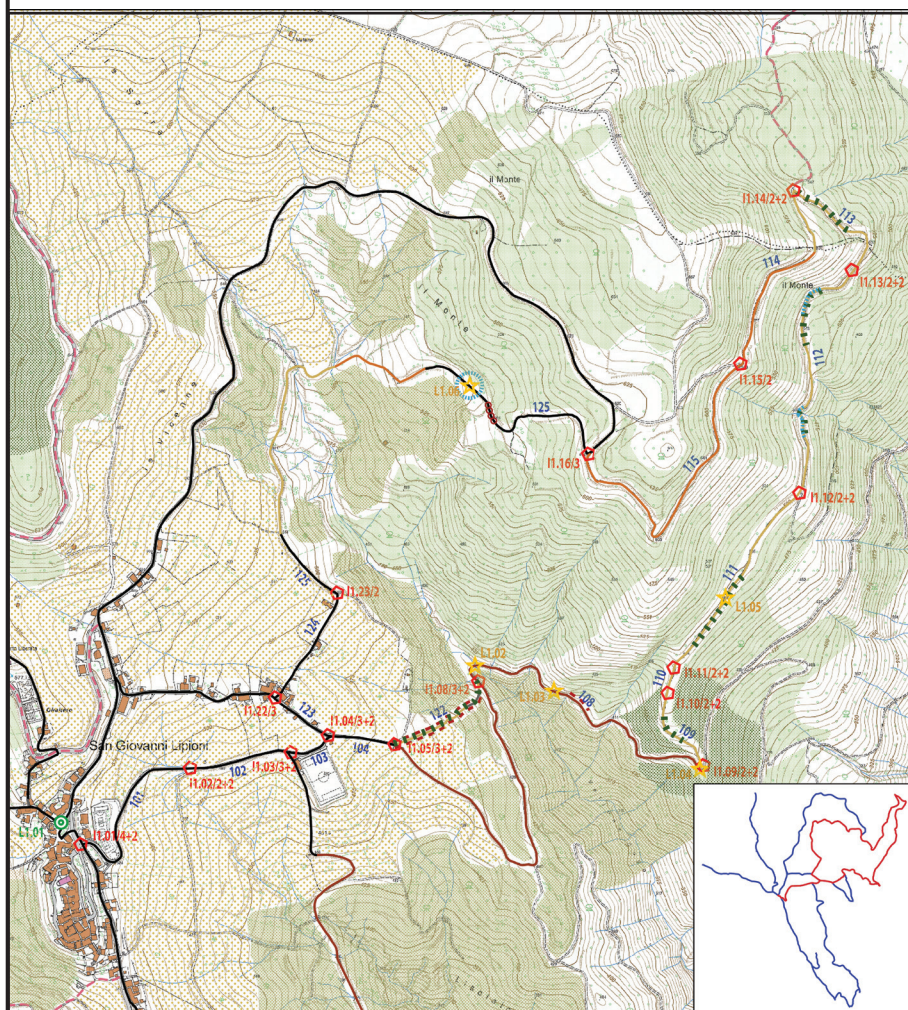
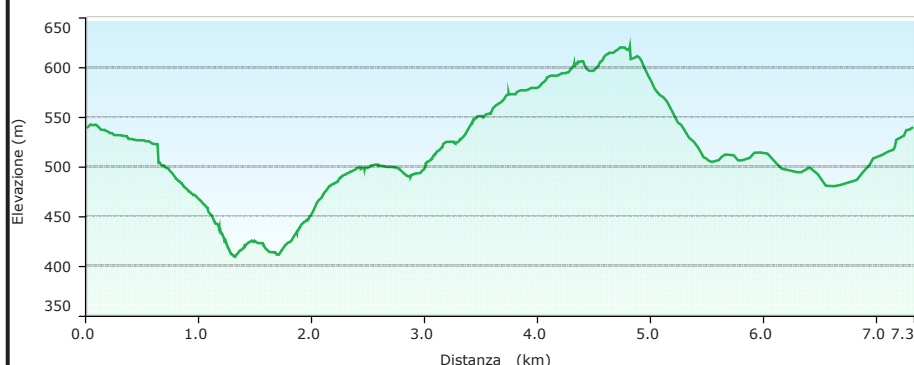
- 3.0Km Paved road
- 0.8Km Gravel drivable road
- 0.9Km Unpaved drivable dirt road
- 2.3Km Pedestrian trail
- 0.1Km Pedestrian trail with drainage issues
- 0.1Km Stone and compacted soil stairs

- 1) Restoration of damaged asphalt pavement
- 2) Stabilization of a sliding slope by using wooden piles
- 3) Trimming and pruning of weed vegetation, in particular near lime kiln
- 5) Maintenance and restoration of natural dry stone walls
- 6) Restoration of road drainage near the Prato fountain

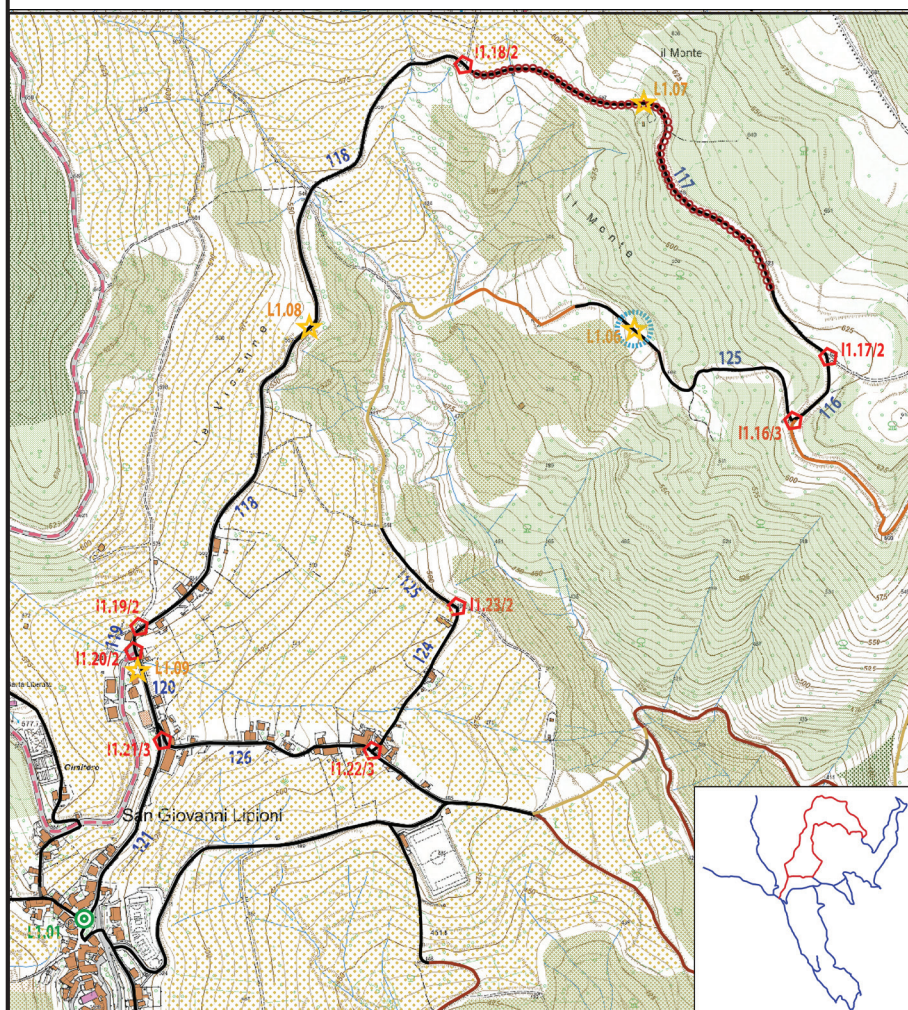
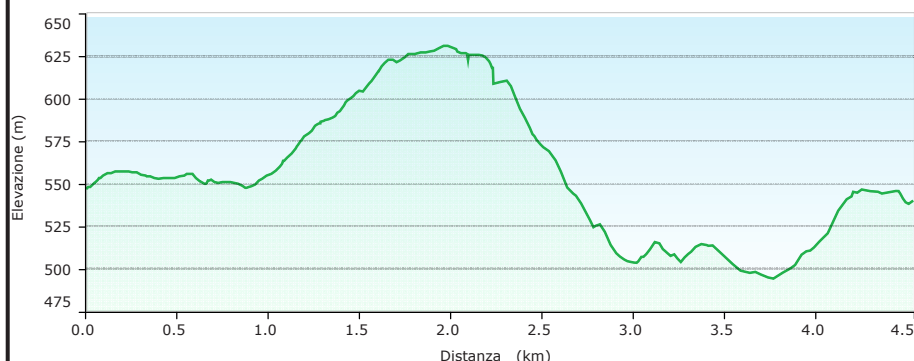
3.5Km Paved road  
 0.0Km Gravel drivable road  
 0.2Km Unpaved drivable dirt road  
 0.5Km Pedestrian trail  
 0.0Km Pedestrian trail with drainage issues  
 0.0Km Stone and compacted soil stairs

- 1) Restoration of damaged asphalt pavement
- 2) Maintenance and restoration of the unpaved and gravel road surface
- 3) Restoration of road drainage near the Prato fountain

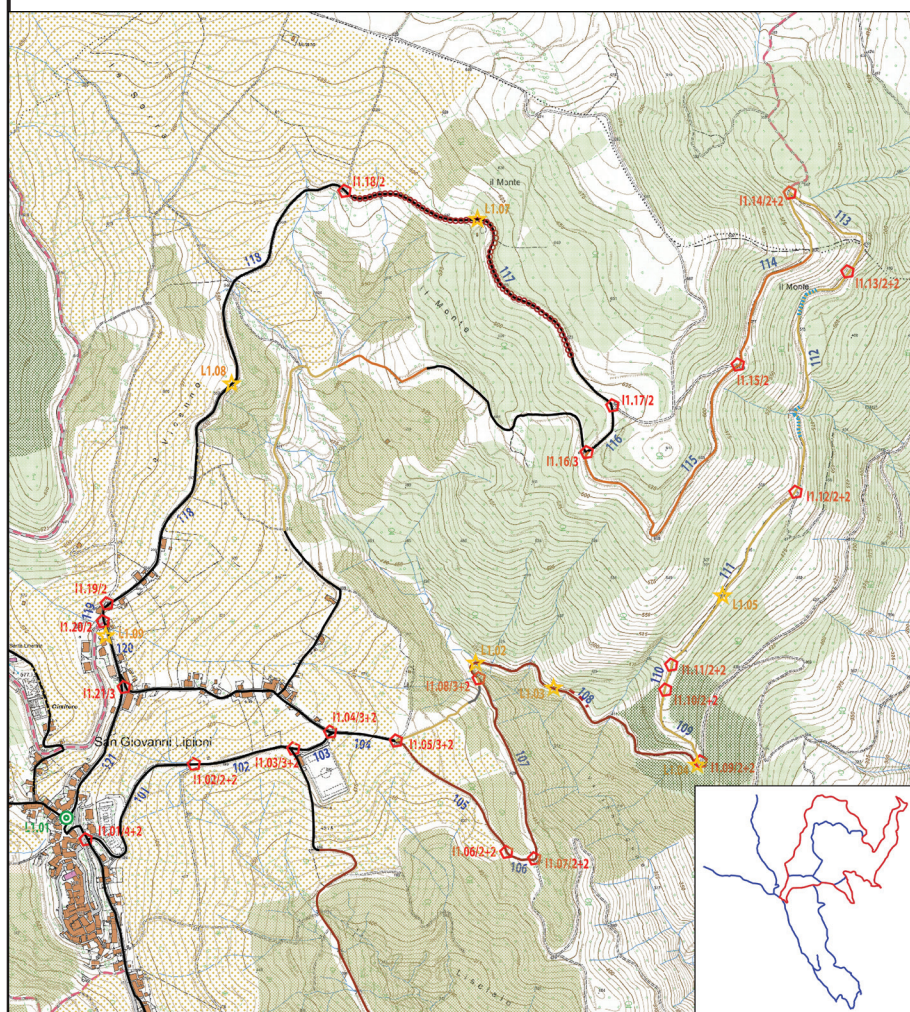
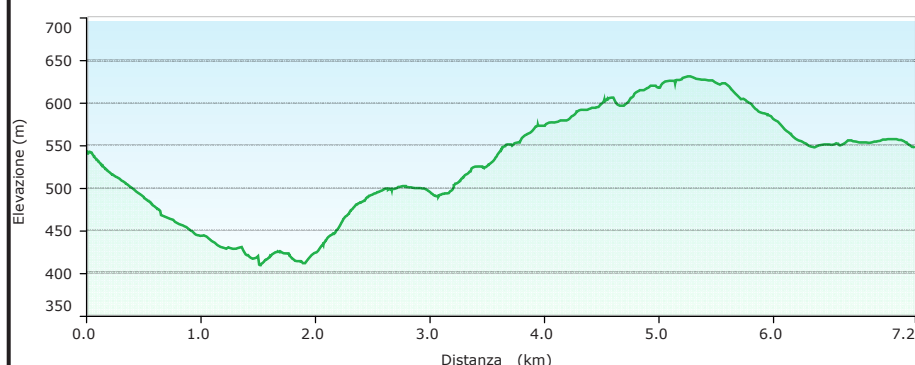
- 3.5Km Paved road
- 2.5Km Gravel drivable road
- 0.0Km Unpaved drivable dirt road
- 1.8Km Pedestrian trail
- 0.2Km Pedestrian trail with drainage issues
- 0.0Km Stone and compacted soil stairs

- 1) Maintenance and restoration of the unpaved and gravel road surface
- 2) Stabilization of a sliding slope by using wooden piles
- 3) Trimming and pruning of weed vegetation
- 4) Maintenance and restoration of natural dry stone walls

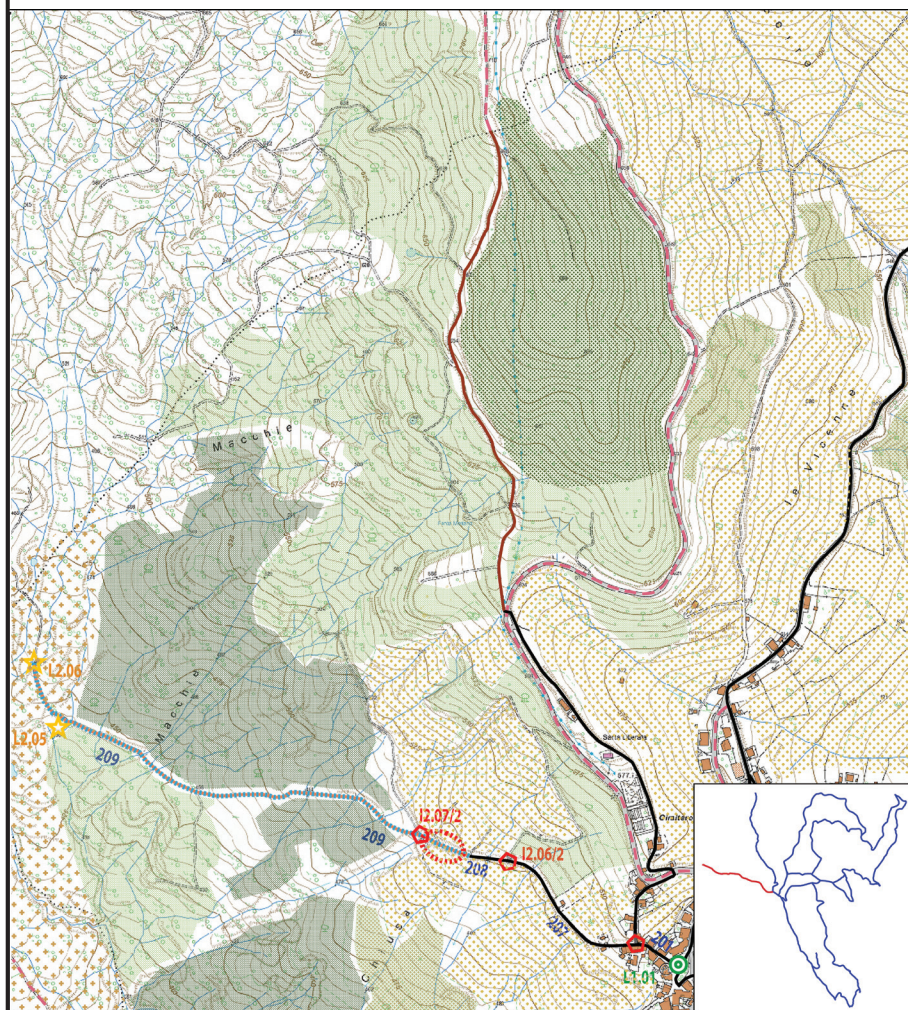
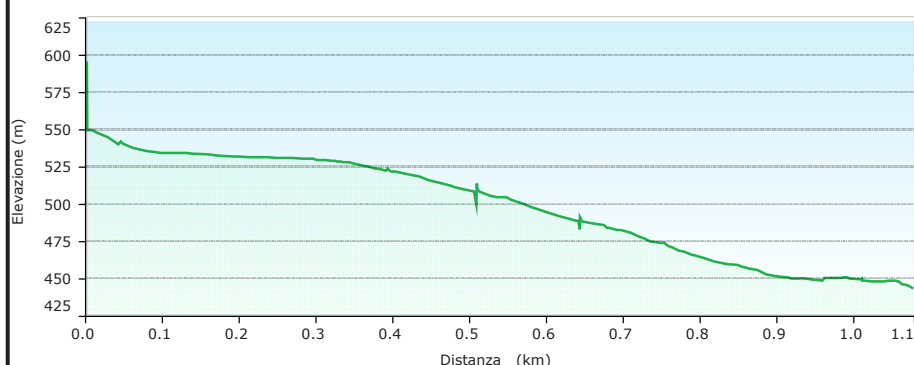
0.3Km Paved road  
 0.0Km Gravel drivable road  
 0.0Km Unpaved drivable dirt road  
 0.0Km Pedestrian trail  
 0.9Km Pedestrian trail with drainage issues  
 0.0Km Stone and compacted soil stairs

- 1) Maintenance and restoration of the unpaved and gravel road surface
- 2) Stabilization of a sliding slope by using wooden piles
- 3) Consolidation of a landslide slope

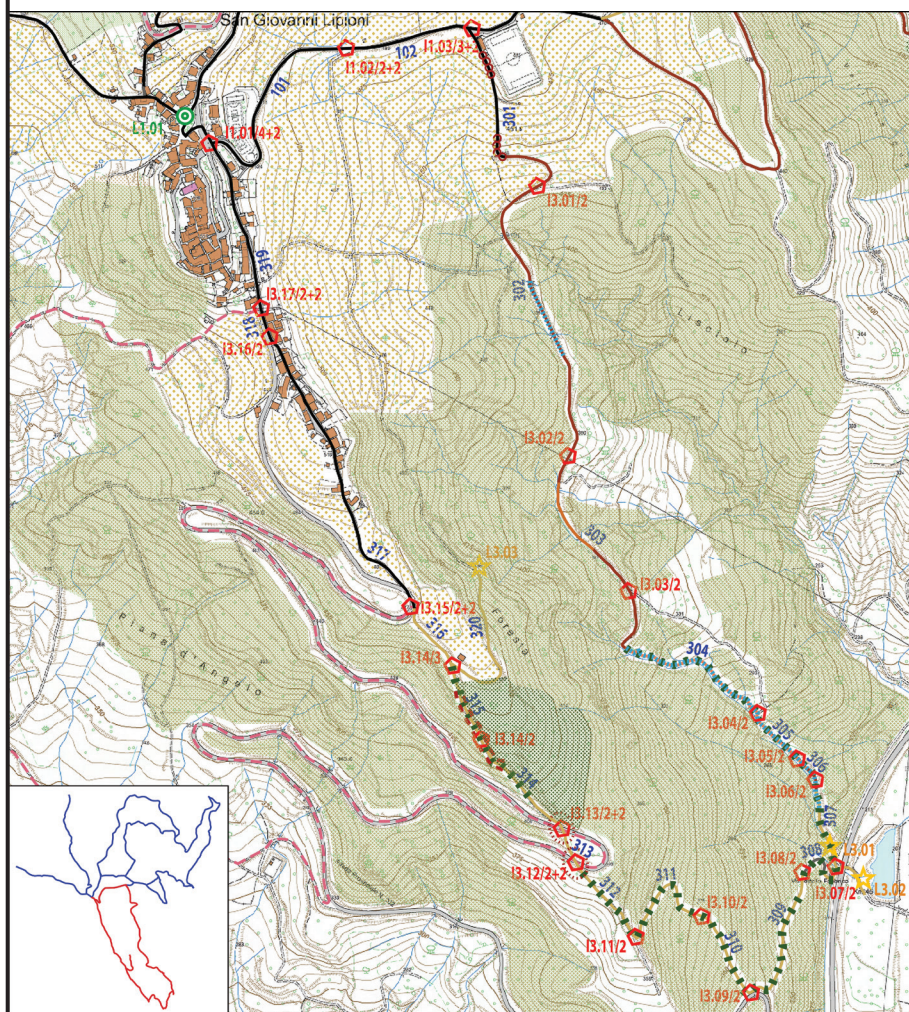
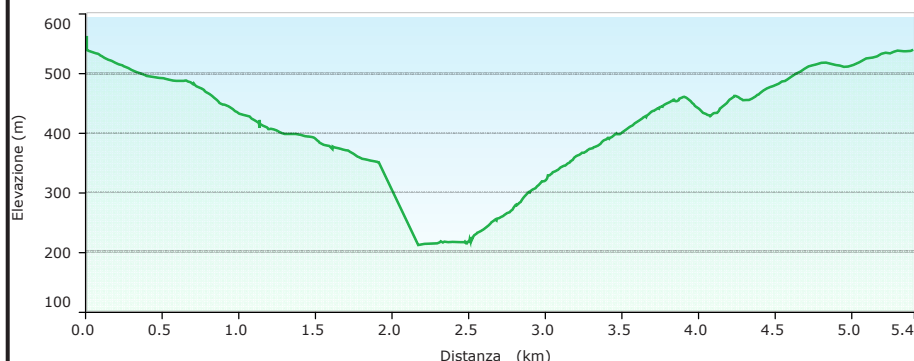
1.7Km Paved road  
 0.9Km Gravel drivable road  
 0.0Km Unpaved drivable dirt road  
 2.5Km Pedestrian trail  
 0.3Km Pedestrian trail with drainage issues  
 0.1Km Stone and compacted soil stairs

- 1) Restoration of damaged asphalt pavement
- 2) Maintenance and restoration of the unpaved and gravel road surface
- 3) Stabilization of a sliding slope by using wooden piles
- 4) Trimming and pruning of weed vegetation
- 5) Maintenance and restoration of natural dry stone walls
- 6) Realisation of two new pedestrian crossings
- 7) Cleaning and Restoration of the Old Mill
