# Post-2023 Kahramanmaraş Earthquake Assessment of Masonry Mosques and Minarets in Türkiye: Field Observations and Numerical Earthquake Analysis

Hatay (Ancient Antioch), one of Türkiye's most historically significant and seismically active provinces, experienced extensive damage during the 6 February 2023 Kahramanmaraş earthquake sequence ( $M_w = 7.7$  and  $M_w = 7.6$ ) and its aftershocks. Among the affected structures, masonry mosques and minarets suffered critical damage, revealing significant seismic vulnerabilities. This study provides a comprehensive evaluation of the seismic performance and structural vulnerabilities of masonry mosques and minarets in Hatay following the devastating 2023 Kahramanmaraş earthquake sequence. By integrating extensive field observations with advanced numerical analysis, the research documents widespread damage to both traditional kiosk-style and classical minarets, identifying critical factors such as poor local soil conditions, insufficient material strength, and lack of engineering services that contributed to structural collapses, including that of the historic Habibi Neccar Mosque. Through finite element analysis (FEA) using ABAQUS, the st

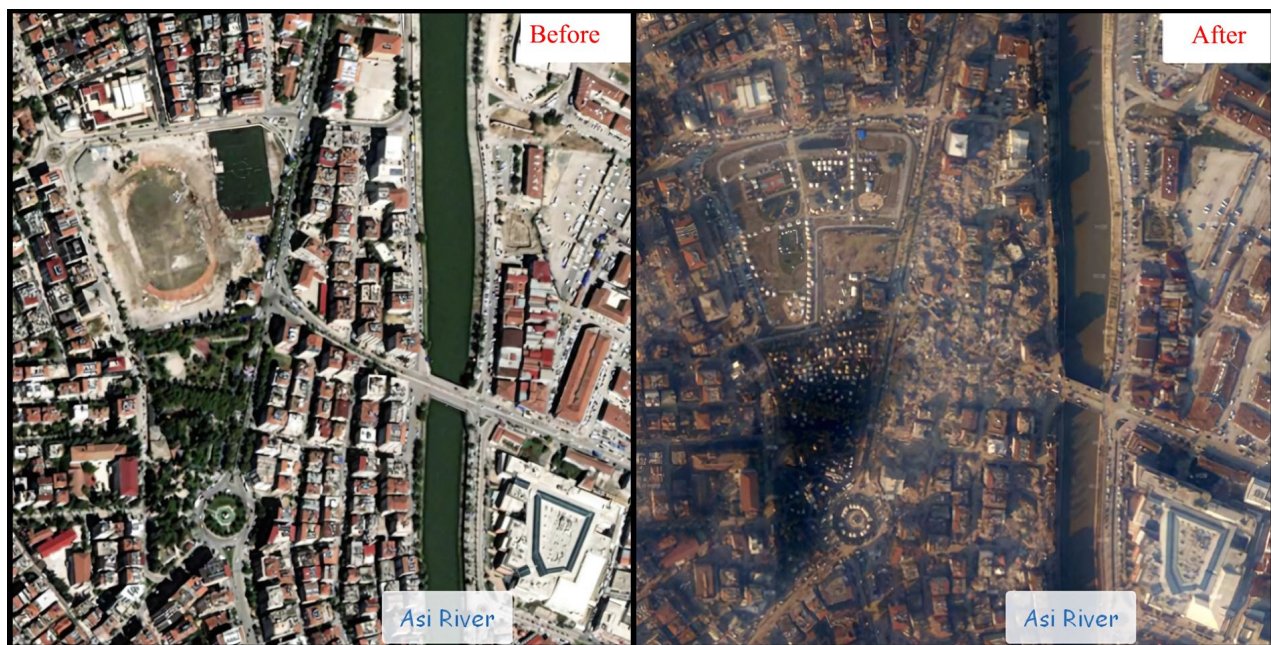
**Figure 5.** Structural damage observed along the banks of the Asi River, adapted from [47].

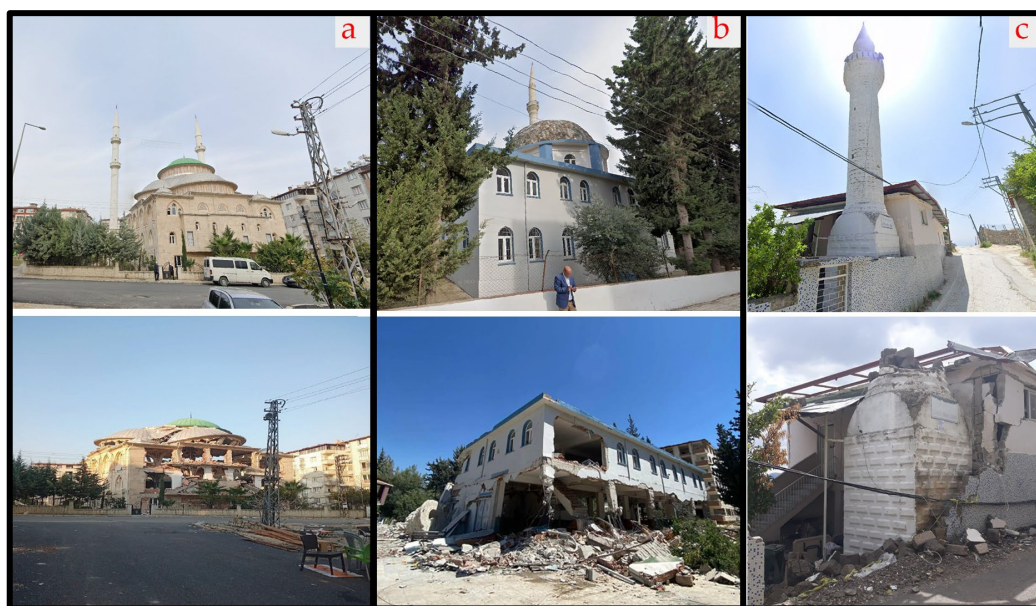
**Figure 7.** Pre-earthquake and post-earthquake images of some mosques and minarets: (a) Miraç Mosque, (b) Mehmet İpek Mosque, (c) Çökek Mosque, adapted from [49,50].

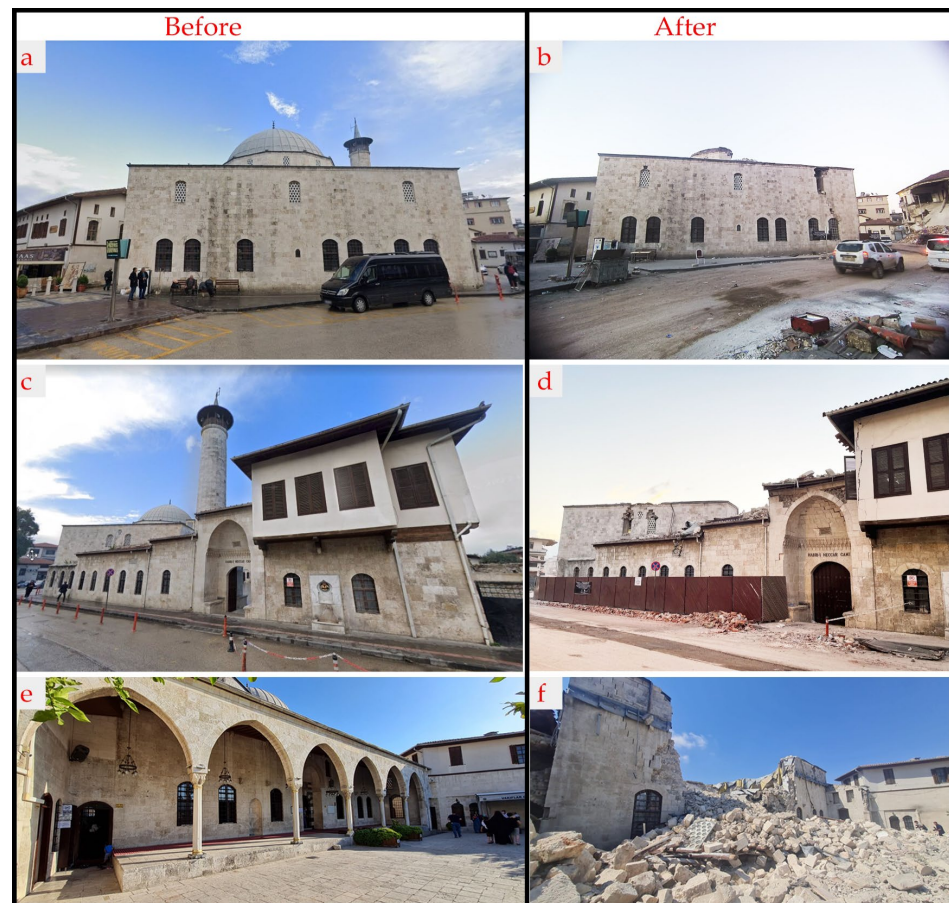
Since the Mamluk period, the structure has functioned as a mosque. Adjacent to it lies an underground burial site, which is believed to contain the head of Habib Neccar, a Figure known for his efforts in spreading Christianity, while his body is said to rest on Mount Silpius. This association has led to the mountain being named Mount Habib-i Neccar. Situated on Kurtuluş Street, the building is known to have served as a temple during the Roman era and was later converted into a church [52]. The mosque suffered severe damage during the earthquake on 6 February 2023. The main dome collapsed, the minaret was destroyed, the portico of the last congregation area was demolished, and the madrasa section sustained heavy damage as shown in Figure 8.

**Figure 8.** Habibi Neccar Mosque (a,b) front view, (c,d) entrance (e,f) courtyard (photos by Google Street View and by authors).

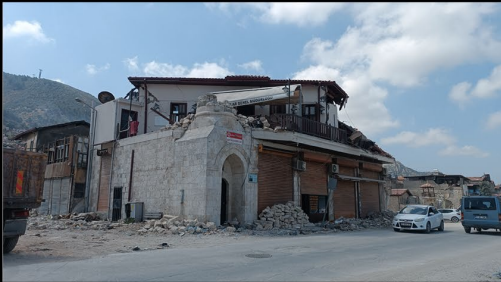
| | <p><b>Şeyh Muhammed Mosque</b></p> <p>The minaret has collapsed from the transition segment, while the mosque has sustained severe damage.</p> <p>/ Collapse</p> | <p><b>500 Konutlar Mosque</b></p> <p>Cracks have formed in the walls of the mosque, accompanied by plaster detachment, and the minaret has completely collapsed starting from the transition segment.</p> <p>/ Collapse</p> |

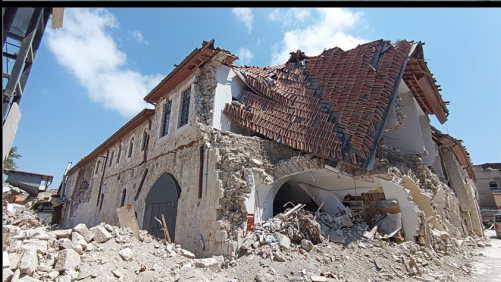
| | <p><b>Kurşunluhan Mosque</b></p> <p>The minaret has completely collapsed. The mosque's load-bearing walls exhibit significant in-plane and out-of-plane displacements.</p> <p>/ Collapse</p> | <p><b>Büyükdalyan Mosque</b></p> <p>The spire and end ornament (alem) of the minaret have collapsed.</p> <p>/ CP</p> |

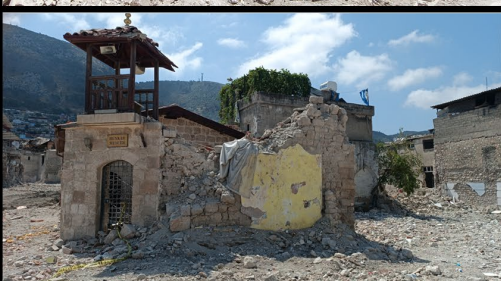
| | <p><b>Hünkar Mosque</b></p> <p>The minaret, built in the kiosk style, sustained minor damage, while the mosque itself has partially collapsed due to the adjacent construction.</p> <p>/ CP</p> | <p><b>Kırıkhan Ulu Mosque</b></p> <p>The reinforced concrete (RC) minaret has completely collapsed starting from the transition segment.</p> <p>/ Collapse</p> |

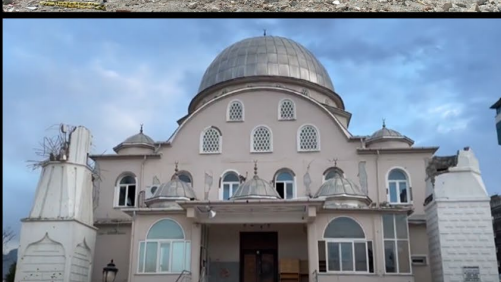
| | <p><b>Hacı Suat Yılmaz Mosque</b></p> <p>Both minarets of the mosque have completely collapsed starting from the transition segment.</p> <p>/ Collapse</p> | <p><b>Nuri Üysen Mosque</b></p> <p>Collapse has occurred above the balcony (şerefe) section.</p> <p>/ CP</p> |

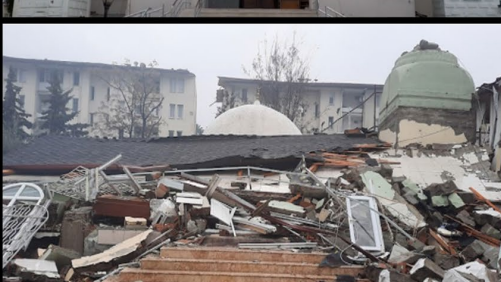
| | <p><b>Tütüncüoğlu Mosque</b></p> <p>The mosque has completely collapsed, while the minaret has collapsed starting from the transition segment.</p> <p>/ Collapse</p> | <p><b>Sarimiye Mosque</b></p> <p>The minaret has undergone collapse at the transition segment, while the mosque has sustained severe damage.</p> <p>/ Collapse</p> |

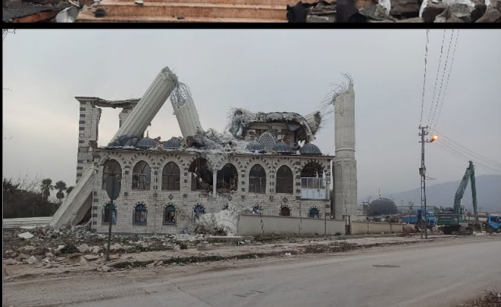
| | <p><b>Hacı Rahma Gülseren İpek Mosque</b></p> <p>The mosque sustained significant structural damage as a result of the minarets collapsing onto its main building.</p> <p>/ Collapse</p> | <p><b>Yukarıbucak Mosque</b></p> <p>The minaret collapsed starting from the balcony. Out-of-plane and inplane displacement damages were observed in the mosque's load-bearing walls.</p> <p>/ CP</p> |

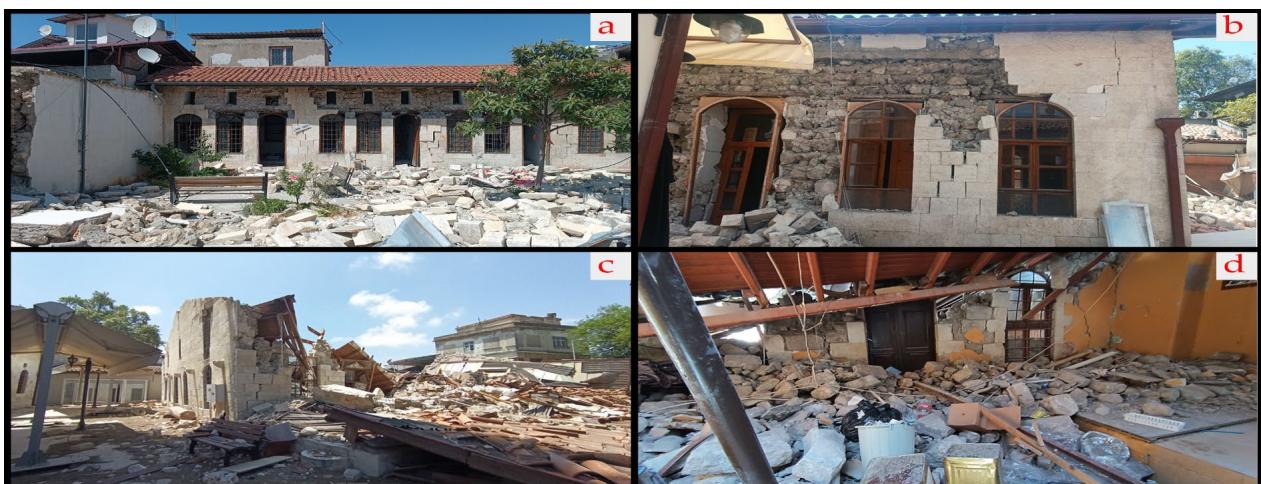
In mosques built using masonry construction, varying degrees of damage occurred due to insufficient interlocking between load-bearing walls and the effects of low material properties. Examples of damage to the load-bearing masonry walls are illustrated in Figure 11.

**Figure 11.** Load-Bearing masonry walls damages: (a) Inadequate Interlayer Bonding, (b) Closer View of Inadequate Interlayer Bonding, (c) Out-of-Plane Displacement, (d) In-Plane Wall Damage.

- In the masonry walls of mosques, inadequate interlocking between layers has resulted in separation between layers and out-of-plane displacements, leading to significant damage.

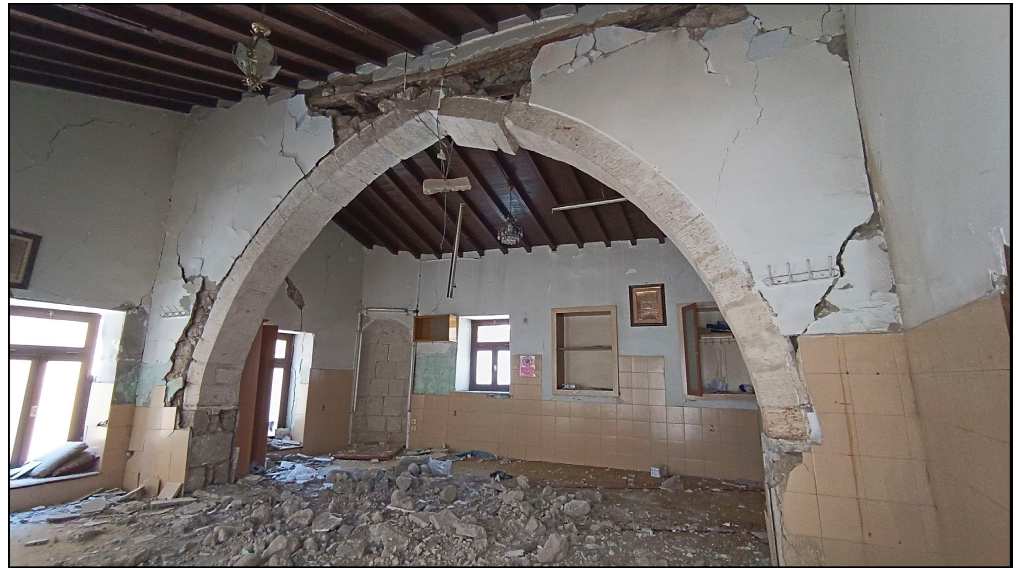
Additionally, damage to the keystone was observed in load-bearing walls constructed in an arch style. An example of this damage, which occurred in the Debruz Mosque, is illustrated in Figure 12.

**Figure 12.** Keystone damage in Debruz Mosque.

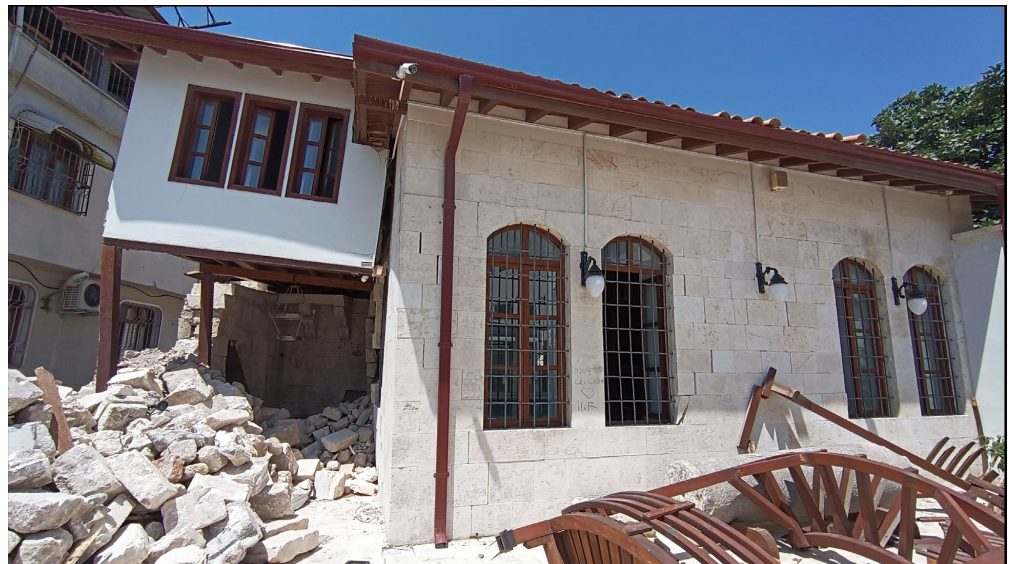
The Kürt Fakih Mosque, which exhibited soft-story mechanisms due to differences in rigidity between the floors, was at a performance level just before collapse. It is shown in Figure 13.

**Figure 13.** Prevention of collapse performance level due to soft-story (Kürt Fakih Mosque).

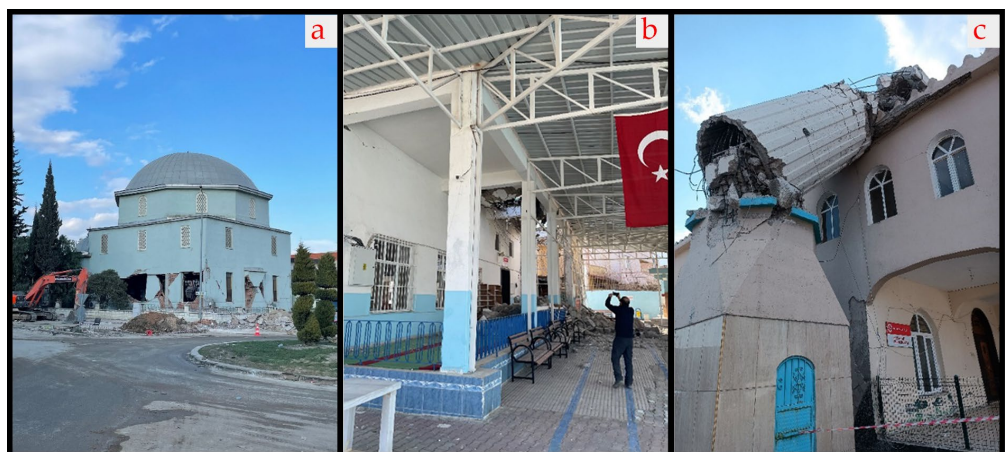
Similarly, shear cracks have occurred in the infill walls of structures built as reinforced concrete (RC). Additionally, due to insufficient reinforced concrete, total collapses have occurred in the slabs and minarets constructed of RC. These examples of damage are shown in Figure 14.

**Figure 14.** Various types of damage in the RC mosque and minaret structures (a) shear cracks in the infill walls; (b) slab collapse; (c) minaret collapse.

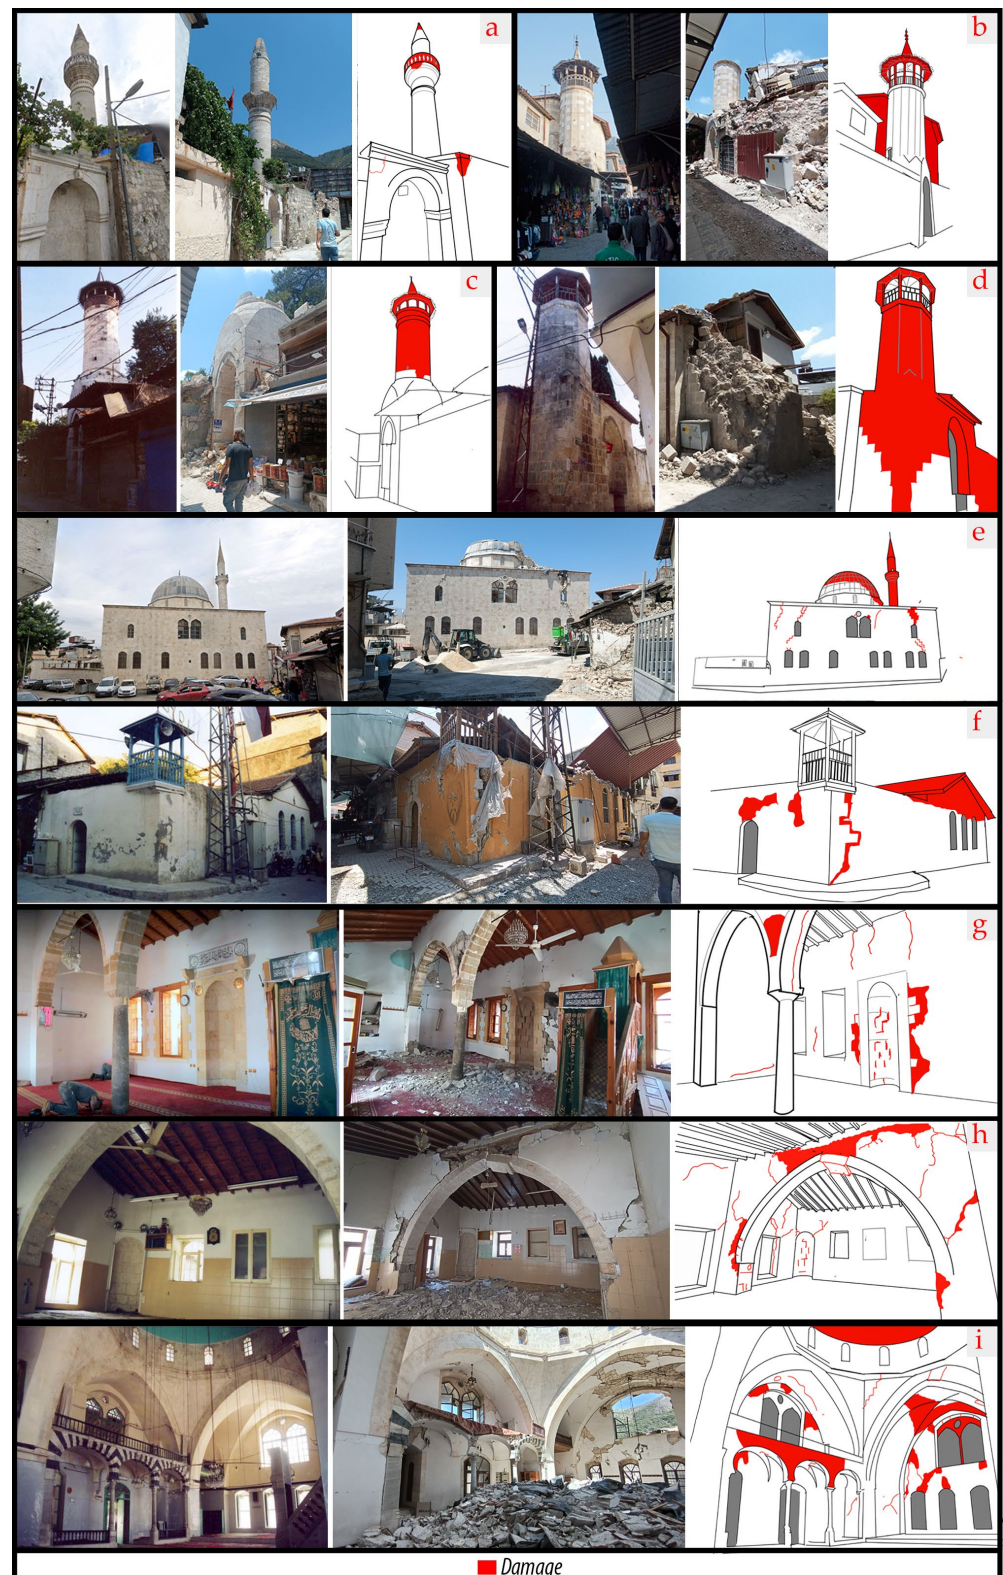
As a result of field investigations, schematic representations of the damage have been created to facilitate a clearer and more comprehensive understanding of the damage in the mosque and minaret. These are presented in Figure 15.

**Figure 15.** Schematic representations of observed structural damages: (a) Bekir Devocioğlu: Mosque damage to the conical roof and balcony, (b) Mahremiye: damage above the balcony and upper part of the body section, (c) Meydan: damage to the body and above, (d) Kürtfakih: pulpit damage or total collapse, (e) Sheikh Ali: collapse of the minaret and damage to the mosque dome, (f) Zülfikar Köşk: separation between the minaret base and courtyard wall, (g) Mahremiye: voids and cracks between voussoirs (yemerler), (h) Debruz: damage and cracks in the keystone, (i) Sheikh Ali: damage to the dome and arches, adapted from [50–52,54].
