Watch Out for the Tailings Pond, a Sharp Edge Hanging over Our Heads: Lessons Learned and Perceptions from the Brumadinho Tailings Dam Failure Disaster

Abstract: A catastrophic tailings dam failure disaster occurred in Brumadinho, Brazil on 25 January 2019, which resulted in over 270 casualties, 24,000 residents evacuated, and a huge economic loss. Environmental concerns were raised for the potential pollution of water due to tailings waste entering the Paraopeba River. In this paper, a detailed analysis has been carried out to investigate the disaster conditions of the Brumadinho dam failure using satellite images with different spatial resolutions. Our in-depth analysis reveals that the hazard chain caused by this failure contained three stages, namely dam failure, mudflow, and the hyperconcentrated flow in the Paraopeba River. The variation characteristics of turbidity of the Rio Paraopeba River after the disaster have also been investigated using high-resolution remote sensing images, followed by a qualitative analysis of the impacts on the downstream reservoir of the Retiro Baixo Plant that was over 300 km away from the dam failure origin. It is believed that, on the one hand

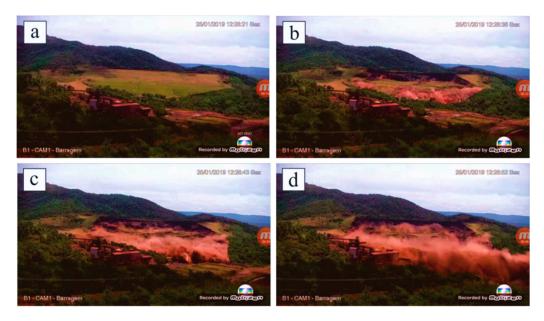
Figure 2. Video screenshots of the Brumadinho tailings dam failure [14]; (a) 25 January 2019, 12:28:21; (b) 25 January 2019, 12:28:36; (c) 25 January 2019, 12:28:43; (d) 25 January 2019, 12:28:52 (local time).

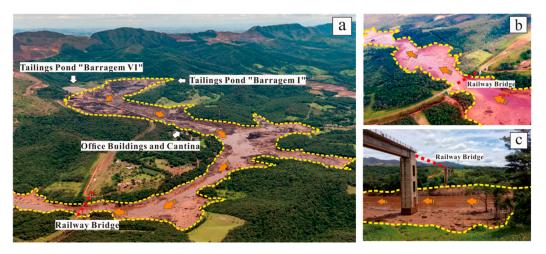
In this disaster, at least 248 people were confirmed dead, and 22 missing. Most of the victims were Vale's employees. At a railroad branch, in the Córrego do Feijão region, three locomotives and 132 wagons were buried, and four railway men were missing. Two sections of the railway bridge (Figure 3) and about 100 m of railway track were also struck and destroyed by the mud [15]. Due to the potential hazards, about 24,000 residents from several districts of Brumadinho were evacuated [16]. Many agricultural areas were affected or totally destroyed, and the local livestock industry suffered damages due to the loss of animals such as cattle and poultry [17]. In addition, the tailings dam failure spilt about 12 million cubic meters of mud and sludge [18] and some came into and ran along the

Figure 3. Disaster pictures. (a) Aerial view of Brumadinho dam disaster taken at 11:46 on 27 January 2019 [19]; (b) video screenshot of the destroyed railway bridge, 3 km downstream from the collapsed dam, on 26 January 2019 from YouTube [20]; (c) picture of iron ore railway bridge destroyed by mudflow taken on 26 January 2019 [21]. Note that the yellow line represents the extents of the areas affected by the mudflow, the red line represents the railway bridge which was damaged, and the brown arrow indicates the movement direction of the mudflow.

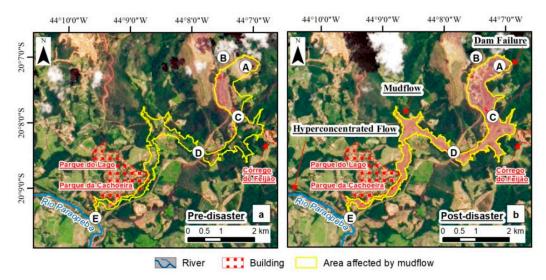
Hazard chains are the hot topic in the broader realm of natural hazards [57] (e.g., earthquake-induced chains [58], glacial-outburst-induced chains [59], and volcano-eruption-induced chains [60]). In this disaster, the dam released a mudflow of tailings after the dam failure (Figure 7b-A). The high-speed mudflow struck the mine's administrative area (Figure 7b-C) [61], destroyed the railway bridge (Figure 3b,c and Figure 7b-D), and continued to move downstream. At about 3:50 pm on 25 January 2019, the mud reached and came into the Paraopeba River (Figure 7b-E). On 27 January 2019, around 5:30 am, sirens

were sounded for the stability of the mine's adjacent Dam VI [16] (Figure 7b-B), where increased water levels were observed.

This hazard chain contained three stages including dam failure, mudflow, and hyper-concentrated flow with tailings waste (Figure 7b). The occurrence of this hazard chain is the result of a combination of many factors. Since the tailings contained a certain amount of water, it created conditions for the mudflow after the tailings dam failure. The tailings waste entered the river following the original branch channel, which in turn enlarged the impact of this disaster with extremely high turbidity and metal concentrations, lower dissolved oxygen, and change of microbial communities which would impact the growth and reproduction of aquatic creatures [62,63].

Figure 7. Comparison of pre- and post-disaster Landsat 8 images [64]. (a) Pre-disaster remote sensing image (14 January 2019) [27]; (b) post-disaster remote sensing image (30 January 2019) [28]. A = location of the destroyed tailings dam and the tailings pond "Barragem I" on 25 January 2019. B = location of tailings pond "Barragem VI" which appeared as an early warning of stability on 27 January 2019. C = location of the destroyed cantina and office buildings. D = location of the destroyed railway bridge (Figure 3b,c). E = location of the entry point of the mudflow into the Paraopeba River.

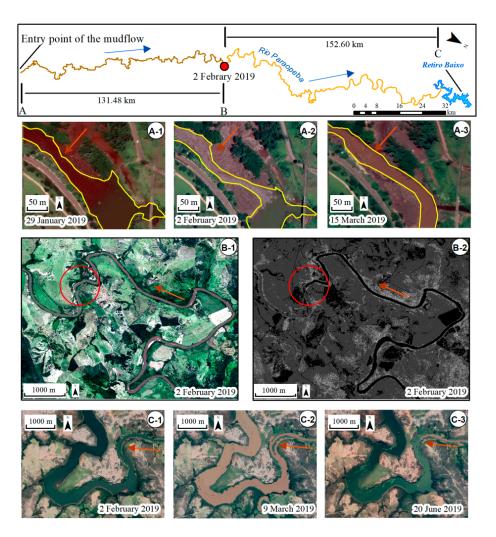
Through the examination of multi-temporal Google Earth images, the transport process of waste in the Paraopeba River can be observed (Figure 8). Comparing Figure 8A-1 with 8A-2, a large amount of waste entered the river several days after the failure, which might block the river for a certain period. Figure 8A-3 shows that due to the increase of precipitation in the later period (Figure 13), the water level of the river increased and eroded a new channel.

Figure 8B-1 shows the location of the waste as of 2 February 2019. It can be observed that the color of the right river section is vermeil, compared with the left section (red circle). The length of AB reach is 131.48 km with a height difference of about 60 m. It took less than a week for the waste to transport from A to B. After the waste entered the Paraopeba River, the transport speed of waste in the water was affected by many factors, such as concentration and stream gradients [65,66]. In addition, according to remote sensing images of Google Earth, it appears that the barrier of some small river dams in the Paraopeba River might also slow down the movement of the waste. Figure 8B-1 is a true-color image of tailings in rivers, and the change of water color in the circle position can be observed. In order to make the watercolor contrast more obvious, considering that the green and red bands are sensitive to the sediment [67], the ratio between these bands were calculated. As can be seen in Figure 8B-2, there is an obvious change in water color at the red circle.

Figure 8. Transport process of waste in the Paraopeba River. A—1, 2, 3 = images of the entry point of the mudflow into the Paraopeba River, the yellow lines are used to mark the river boundary; B—1, 2 = images on 2 February 2019 around point B in the Paraopeba River, the watercolor change can be seen; C—1, 2, 3 = images of the entry point into the Retiro Baixo.

Comparing Figure 8C-1 with 8C-2, the influence of waste on the water body was obvious after it entered the reservoir of hydropower station—Retiro Baixo. A few months later, the watercolor recovered due to the deposition of sediments. Based on the analysis of Figure 5 and multi-temporal Google Earth images, a table of sediment transport time node was generated (Table 4) in order to make the interpretation of sediment transport clear.

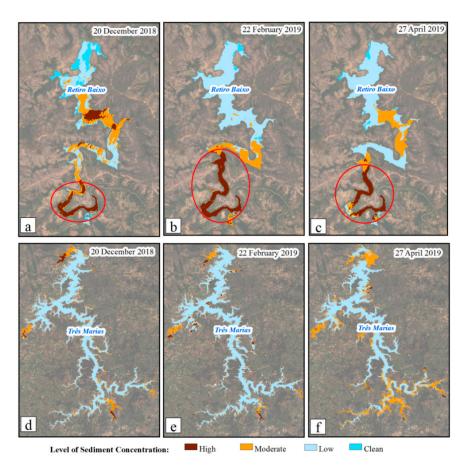
The sediment index was obtained using the SI calculating method. Figure 8 shows the pre- and post-disaster sediment concentrations. Contrasting the area of high sediment concentration where the river enters into the Retiro Baixo reservoir (Figure 10a–c), it had a larger area of 3.66 km² compared with 1.89 km² on 20 December 2018 and 2.49 km² on 27 April 2019 with a 2-month interval spanning this disaster. It can be observed that the sediment plume had a great impact on the reservoir of the Retiro Baixo Plant, over 300 km from the failure location, while less impact on the reservoir of the Retiro Baixo Plant. This result is consistent with Vale's evaluation [73]. It appeared that small river gradients and obstruction of the reservoir barriers played an important role in slowing down the tailings waste moving into the São Francisco River. It is not hard to find out that this disaster event had little impact on the Três Marias reservoir (Figure 10d–f).

Figure 10. Level of sediment concentration of Retiro Baixo and Três Marias. (a) Level of sediment concentration of Retiro Baixo on 20 December 2018; (b) level of sediment concentration of Retiro Baixo on 22 February 2019; (c) level of sediment concentration of Retiro Baixo on 27 April 2019; (d) level of sediment concentration of Três Marias on 20 December 2018; (e) level of sediment concentration of Três Marias on 27 April 2019.

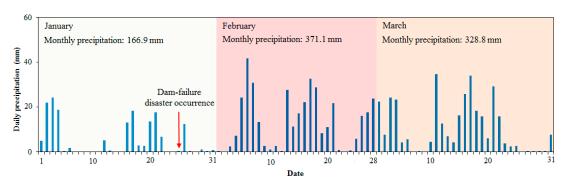
In this section, weather effects are examined. Daily precipitation data in Brumadinho were obtained from the World Weather Online website [90]. It appeared that precipitation increased the water content of the tailings pond before the dam failure event, increased the pore pressure, and thus induced failure initiation, which could be an important triggering factor for the tailings dam collapse (Figure 13). Although there was less rainfall in January than in February and March 2019, the rainfall in January 2019 sometimes reached the peak of monthly rainfall in some years from the perspective of multi-year rainfalls (Figure 14).

Figure 13. Daily precipitation in Brumadinho during the period from January to March 2019 [90].

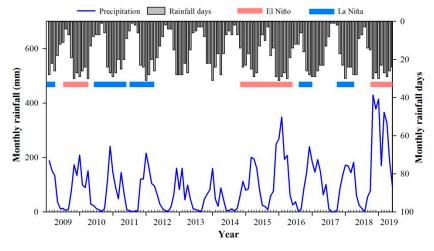
Figure 14. Monthly precipitation in Brumadinho during the period from 2009 to 2019 [90].

Extreme weathers in Brumadinho are linked to El Niño conditions from September to January typically [93]. A major El Niño event has been recorded since October 2018, and there were unusual rainfalls before the disaster (Figure 14) [94]. The increase of soil water content created conditions for the dam instability.
