Flow Analysis through Collector Well Laterals: A Case Study from Sonoma County Water Agency, California

Abstract: The Sonoma County Water Agency (SWCA) uses six radial collector wells along the Russian River west of Santa Rosa, to provide water for several municipalities and water districts in north-western California. Three collector wells (1, 2, and 6) are located in the Wohler area, and three collector wells (3, 4, and 5) are located in the Mirabel area. The objective of this paper is to highlight the performance of the three collector wells located in the Mirabel area since their construction. The 2015 investigation showed a lower performance of Collectors 3 and 4 compared to their original performances after construction in 1975, while the performance of Collector 5 was relatively stable since 1982. The potential change in capacity could be due to the increase in encrustation observed during the visual inspection of laterals in all three collector wells. Overall, the three collectors are still within the optimal design parameters (screen entrance velocity $< 0.305 \text{ m min}^{-1}$ and axial flow velocity of lateral screens $< 1.524 \text{ m s}^{-1}$).

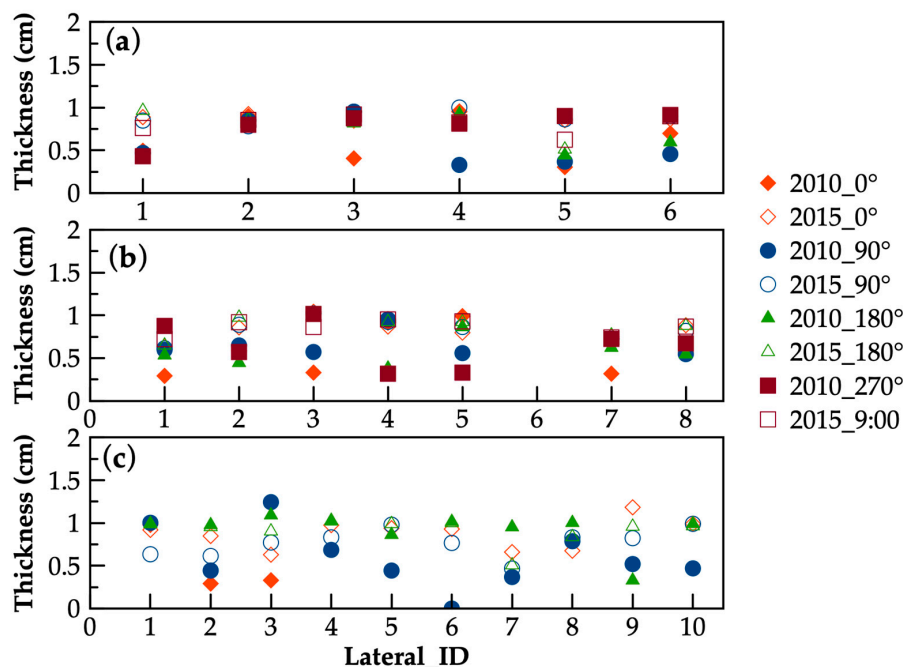
During both inspections, the caissons of the three collectors as well as all underwater structures appeared to be in good structural condition. No evidence of fracturing or spalling in the caissons was observed [1,3]. However, surface corrosion was observed on several valve stem risers and brackets and on the ladder [1,3]. The pumps and pump columns were in good conditions even if they contain surface corrosion. The laterals from the three caissons appeared to be in good condition with varying amounts of surface corrosion (Figure S2). Compared to the 2010 inspection, the 2015 inspection highlighted the presence of more corrosion along the internal steel pipe surfaces and screen slots [3]. The video inspection of the laterals showed signs of progressive encrustation along the lateral pipe interior and within the slot openings (Figure S2). Gravel piles were detected at the end of many laterals and were probably related to the high screen entrance velocity. In addition, the average thickness of the screen metal in the laterals slightly increased during the two inspections (Figure 3). In the laterals

from Caisson 3, it ranged between 0.46 and 0.84 cm during the 2010 inspection and between 0.71 and 0.91 cm during the 2015 inspection (Figure 3). In the laterals from Caisson 4, it ranged between 0.56 and 0.73 cm during the 2010 inspection and between 0.66 and 0.98 cm during the 2015 inspection. Similarly, in the laterals from Caisson 5, it ranged between 0.44 and 1.03 cm during the 2010 inspection and between 0.66 and 0.98 cm during the 2015 inspection (Figure 3).

Figure 3. Lateral structural integrity in (a) Collector 3, (b) Collector 4, and (c) Collector 5 during the two inspections. The gauge was inserted into the section of the lateral nearest the caisson and obtained thickness measurements at 0°, 90°, 180°, and 270° from the vertical position for the three collector wells.

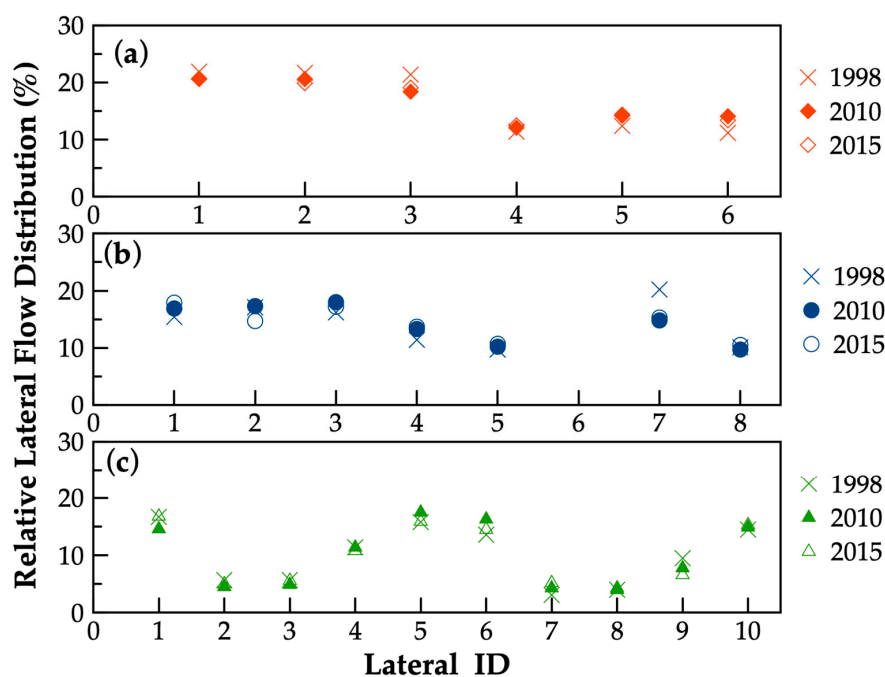
Throughout the three investigations (1998, 2010, and 2015), minimal changes in relative percentage flow were observed (Figure 4). In Collector 3, the laterals (1, 2, and 3) closest to the river had the largest percentages of flow (Figure 4). The collective gain in flow in these three riverward laterals balances the collective loss of flow in the three landward laterals. During the 2015 evaluation, the relative distribution of flow among Collector 3 laterals ranged between 12.5 (Lateral 4) and 20.7% (Lateral 1). Lateral 6 had the largest decline in flow (-2.7%) compared to the 2010 results [1,3]. The limited changes observed may be related due to varying influence of recharge from the Russian River, as well as Infiltration Ponds 2 and 3 northeast and east of Collector 3 (Figure 2), respectively.

Figure 4. Relative lateral flow distribution (%) in (a) Collector 3, (b) Collector 4, and (c) Collector 5.

In Collector 4, during the three investigations, the productions of most of the laterals slightly improved over time. Laterals 1 and 2 (oriented toward the river) and Laterals 7 and 3 (parallel to the river) showed the highest percentages of flow. On the other hand, the lateral with the lowest percentage of flow (Lateral 8) is oriented on about a 45-degree angle towards the river, similar to Lateral 2, but it is also the shortest lateral (29.41 m) (Figure 2). The two landward laterals projected towards the infiltration ponds collectively provided 24.4% of the well's total production. During the 2015 evaluation the relative flow percentages ranged between 10.5% (Lateral 8) to 17.9% (Lateral 1). Lateral 2 showed a decline (−2.5%) in production between 2010 and 2015 (Figure 2) [1,3]. Based on the video obtained, this decline was probably due to the presence of sand and gravel within the lateral.

In contrast with the trend observed in Collectors 3 and 4, in Collector 5, the laterals showed contrasting results. The production slightly increased in Laterals 1 and 7, slightly decreased in Laterals 4, 5, and 9, and remained constant in the remaining laterals. In addition, the impact of the 10 laterals is different. Four laterals individually produced 14.5% or more of the total capacity, while five laterals individually produced less than 6.6% (Figure 4). The orientation of the laterals had no impact on the percentage of flow distributions. On the other hand, the length of the laterals impacted the flow distribution. The four longest laterals (>51.20 m) were also four of the five highest producing laterals, while the three shortest laterals (<26.52 m) were also the three lowest producing laterals. The three remaining laterals were of intermediate lengths (37.49 to 40.54 m), as well as in producing capability [1,3].

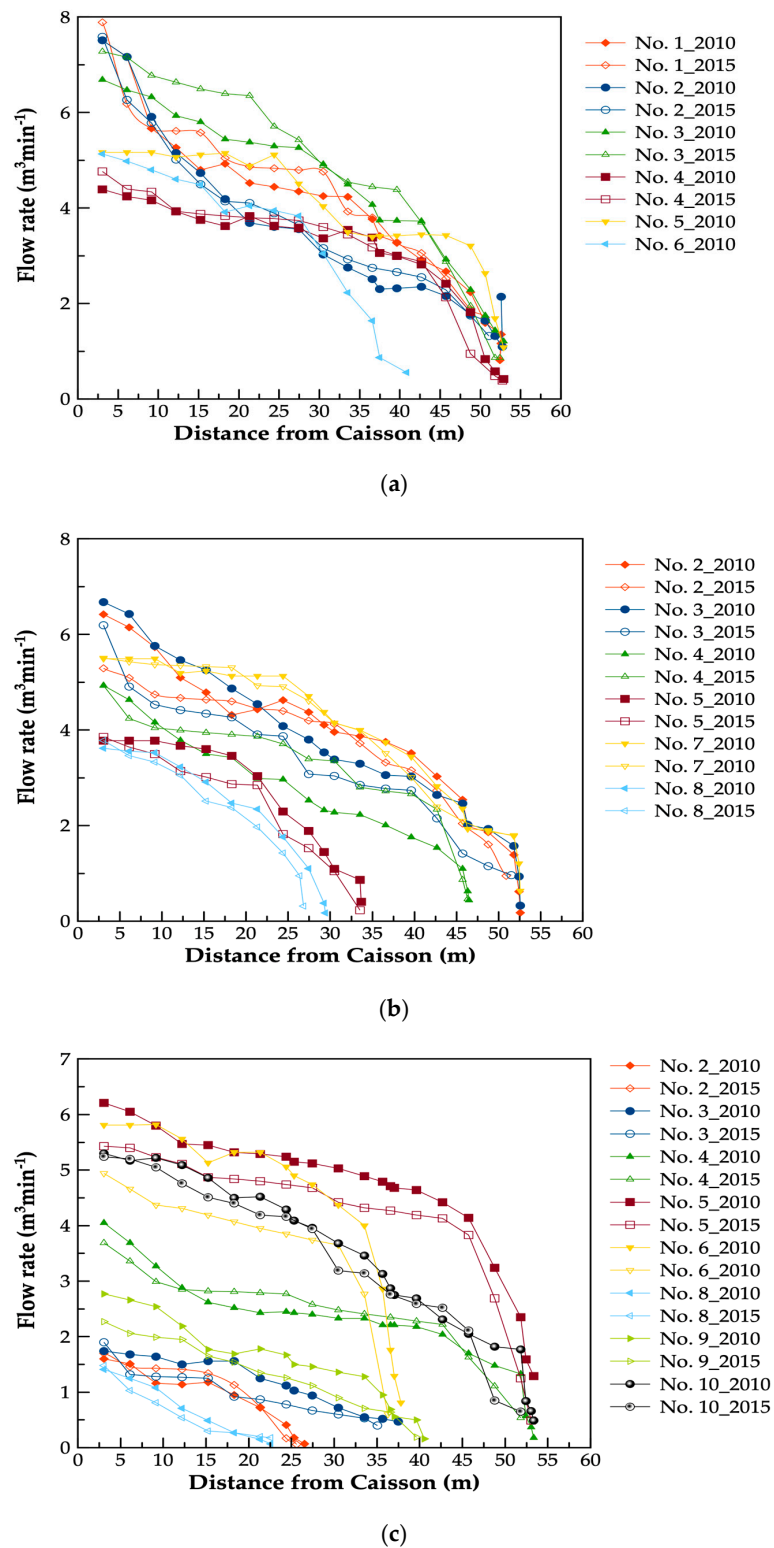
Non-uniform flow occurred along the laterals from the three collectors (Figure 5). In fact, for uniform flow along the lateral, the trend for each lateral would be a straight line beginning with zero m min^{-1} at the outer end of the lateral and concluding with the total flow for the lateral where it enters the caisson. However, none of the laterals follow this straight-line trend of uniform distribution. Each lateral displays steeper gaining trends in production in the outermost segments of their length where they are obtaining most of their flow. After these steep gains in flow in the outer segments, the remaining trends of flow while moving progressively closer to the caisson were more gradual because of the generally slower production in those segments. Similar overall trends were

observed during the 2010 and 2015 monitoring events. However, for Collector 3, regardless of the lateral, higher flow was observed during the 2015 campaign. On the other hand, for Collectors 4 and 5, a slightly higher flow was observed during the 2010 campaign [1,3].

Figure 5. Flow versus distance at (a) Collector 3, (b) Collector 4, and (c) Collector 5.

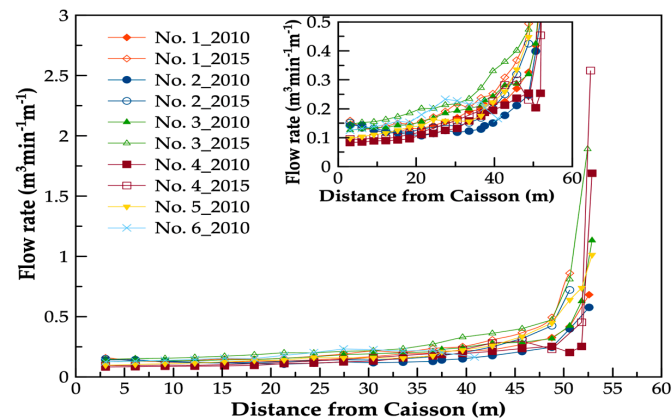
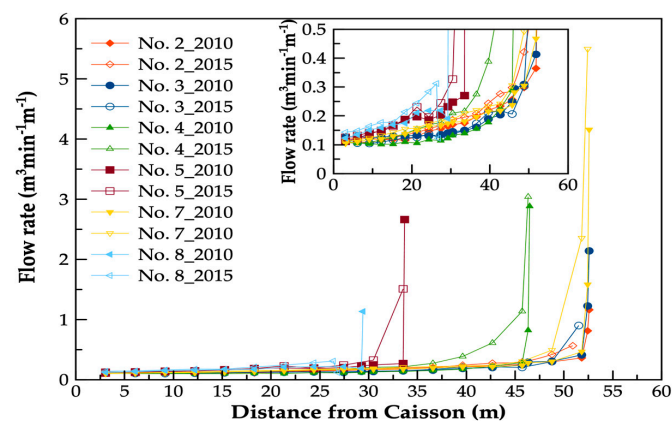
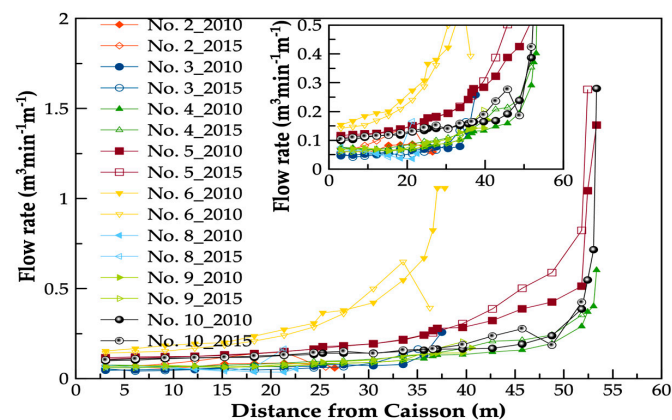
Average unit flow capacity of each lateral, which is also greater at the end of lateral flow, effects large gains in production within only a few meters. This is particularly noticeable in Laterals 3 and 4 from Collector 3. In these outermost few feet, unit flow capacities can approach or even exceed $2 \text{ m}^3 \text{ min}^{-1} \text{ per m}$. On the other hand, while moving along the lateral toward the caisson, the gains in flow progressively decrease and the average unit flow capacity begins to assume a more consistent trend (Figure 6).

Figure 6. Flow along different laterals at increasing distances between the screen length and the caisson for (a) Collector 3, (b) Collector 4, and (c) Collector 5.

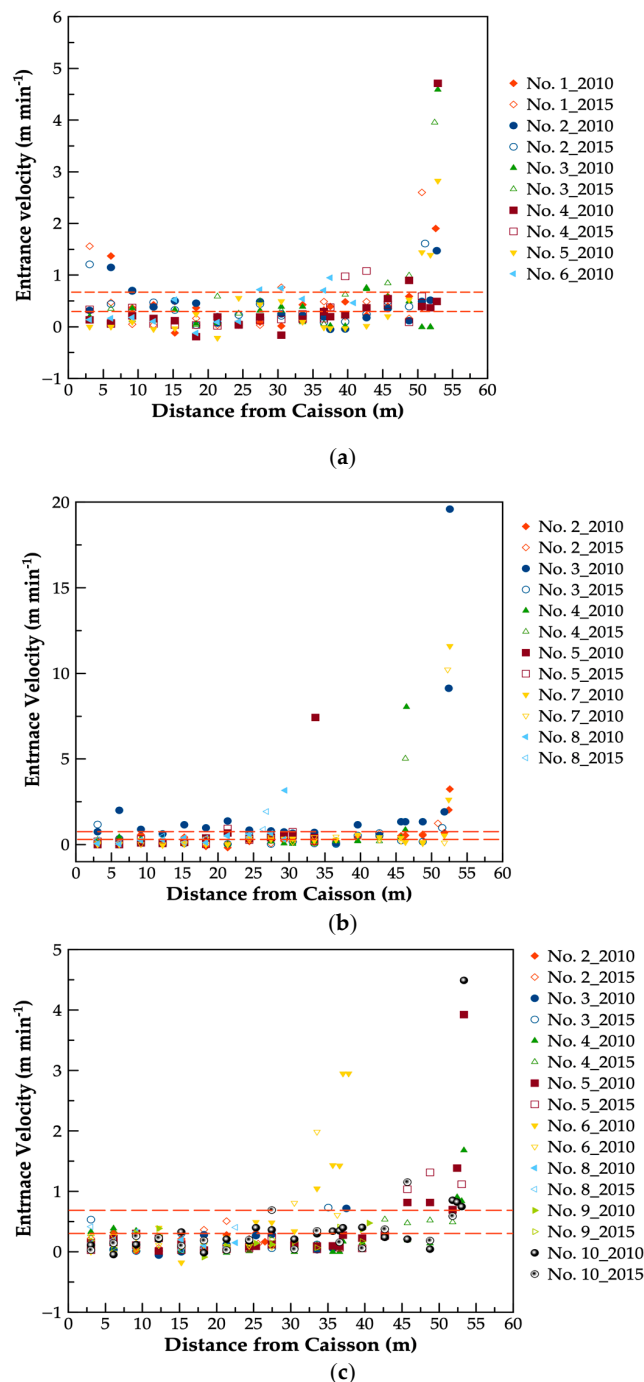
Overall, the three collectors are still within the optimal design parameters (entrance velocity $< 0.305 \text{ m min}^{-1}$ and axial velocity $< 1.524 \text{ m s}^{-1}$ [8,9]) (Figure 7 and Figure S3). Collector 6, constructed in 2002, consisted of a larger steel reinforced concrete caisson (5.49 m vs. 3.96 m inside diameter) with larger laterals (30.48 cm vs. 24. cm) than the Collectors discussed in this investigation, showed a lower entrance velocity (consistently $< 0.610 \text{ m min}^{-1}$) and axial velocity ($< 1.524 \text{ m s}^{-1}$) during the 2010 monitoring campaign. This can also be related to lower presence of deposited materials and rust in Collector 6 (Figure S6) compared to the older collectors (Figure S2).

Figure 7. Entrance velocity through different laterals with increasing distances for their ends for (a) Collector 3, (b) Collector 4, and (c) Collector 5. Ideal and optimal design < 0.305 and $< 0.610 \text{ m min}^{-1}$ (bottom and top red line).
