Article

Development of a Safety-Inspection Method for River Bridges in Turkey

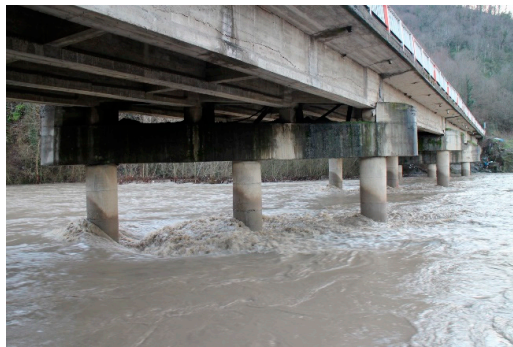
Figure 1. Bridges selected for full inspection: (a) Filyos V Bridge (April 2016); (b) Gokcebey Bridge (August 2017); (c) Bartın I Bridge (April 2017); (d) Bartın III Bridge (December 2014); (e) Catalzeytin Bridge (February 2016).

Considering the current situation of Filyos V Bridge, some amendments could be suggested with simple or comprehensive measures that can be made on the auxiliary elements of the bridge, which was classified as the poorest bridge among four other bridges. Generally speaking, scour holes observed at the piers were assumed to be partly induced by debris accumulation, such as tree branches and trunks. A simple scaled rod can be installed at scour critical piers of the bridges, thus scour depth around piers can be observed. It should be noted that important bridges crossing large rivers may be supplemented by a sonar instrument for continuous monitoring of scour patterns. Sufficient quantities of riprap can also be dumped into scour holes to mitigate further scouring around piers of the bridge. Damages to the guiding wall of abutments and approach fill should be repaired. That way, a reduction in the RP of the bridge by 11 points can be achieved. Thus, instead of a costly solution, such as reconstruction of a new bridge, the risk factors can be reduced by repairing the problematic parts. Moreover, construction of a new bridge without considering the stream stability and other local hydraulic indicators may result in the same problems in time. Therefore, inventory of those bridges and lessons learned can be used during design stage of new bridges nearby. Furthermore, HYRISK [51], a risk-based software can be applied to determine the annual risk of scour to a bridge, as done by Yanmaz and Apaydin [52] for several bridges in Turkey.

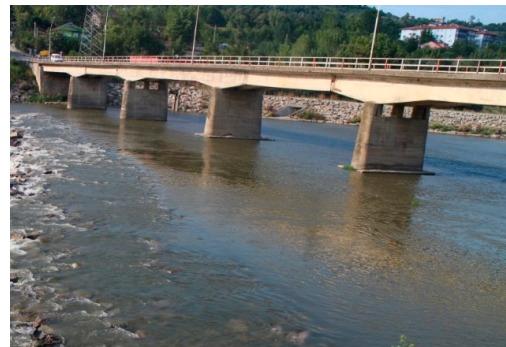
(b)

Another example for effective hydraulic factors was Gokcebey Bridge, which had a crack at its abutment and experienced serious maintenance in 1968. Then, again in 1999, it was reconditioned after a progressive settlement at one of its abutments. Repeating similar problems at those bridges show the importance of detecting problems caused by hydraulic factors, since the condition is persistent and only defining the source of the problem can enable an appropriate solution. When the results of the application of the method were analyzed, it was found that the bridges having problems due to hydraulic factors were successfully identified. Moreover, further assessment for Filyos V Bridge was strongly recommended according to the rapid scour assessment, while scouring around piers of other bridges was considered negligible, as presented in Table 17. It was also seen that there was a good agreement between the results of the proposed method and the rapid scour assessment, showing that indicators of hydraulic factors affecting scouring around piers were successfully identified and ranked.

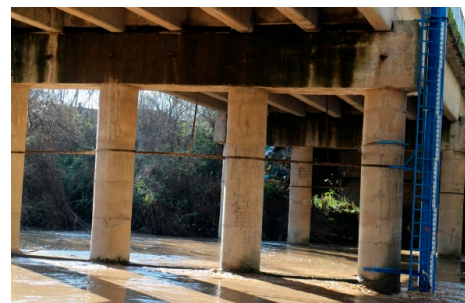
(d)

According to the structural assessment, the most critical bridge was found to be Bartın III Bridge (Tables 15 and 16). During visual inspections, serious structural problems, such as segregation, deterioration of concrete cover leading to corrosion of reinforcements, and cavities on the concrete surface at the bridge were observed. Bartın III Bridge got the highest SG value from the inspection. Therefore, the safety-inspection method classified the bridge as structurally poor. Hence, it was recommended that Bartın III Bridge should urgently be inspected with equipment and necessary maintenance should be carried out.

Bartın III Bridge was found to be subject to structural deficiencies of main body components. Therefore, retrofitting of the bridge should be performed.
