# Combination of Ecological Engineering Procedures Applied to Morphological Stabilization of Estuarine Banks after Dredging

**Abstract:** Gravel extraction and upstream damming caused profound effects on the estuary of the Lima river (NW Portugal) which was reflected by the collapse of banks, leading further to the destruction of riparian vegetation. This led to consequences such as a progressive negative impact on the preservation of salt marshes over several decades of this protected area, which continued even after the cessation of extraction activities. In this work, we present a restoration project combining civil engineering with soft soil engineering procedures and revegetation, along with two distinct segments, and follow the recovery process. The main intention of the study is to promote hydraulic roughness in order to dissipate energy from peak flows and tides, increasing accretion and indirectly the stimulation of plant succession and salt marsh recovery. We are able to observe that the built structures (an interconnected system of groynes, deflectors and rip-rap/gabion mattress) allowed the erosion process to be detained. However, they did not allow as much sediment as

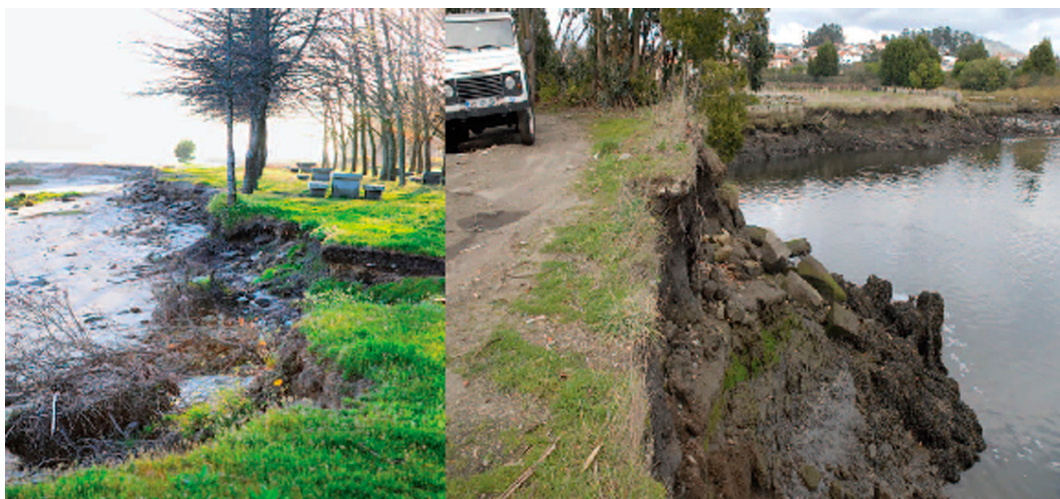
The survey carried out in situ and by aerial photography led us to consider that interventions with long-term purposes could not be limited to the consolidation of banks, but that they also should modify hydrodynamics because of the continued process of excavation of the lower layers of the bank. These display a complex structure, with a less cohesive layer at the base, affecting the stability of the entire bank. These aspects are similar, both in Cardielos (Figure 2, left) and Portuzelo (Figure 2, right), where the progressive erosion has led further to the collapse of the riparian layer.

This part of the estuary, downstream of the previous section, displays a higher vulnerable condition, which is due to the fact that the lowering of the estuarine bed caused by dredging reached a considerably higher depth close to the banks (the channel deepening reached here is 4–6 m).

**Figure 2.** Cardielos (left panel) and Portuzelo (right panel) sections in 2010, previous to the bank reinforcement, where an apparent bank collapse is visible.

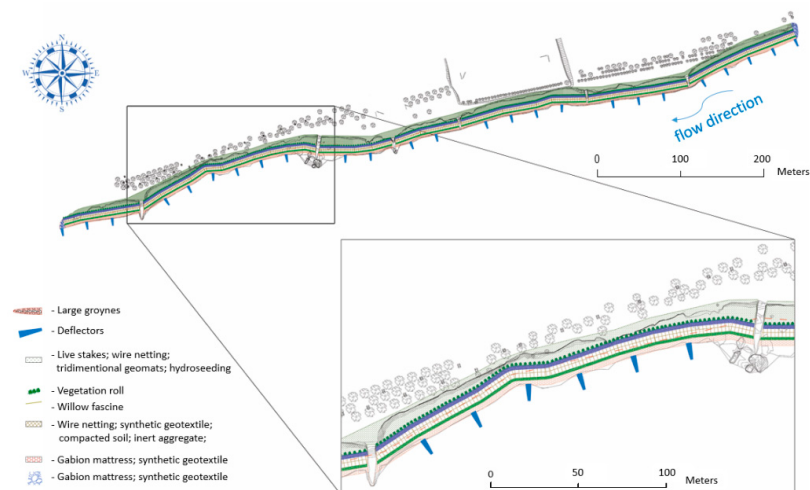
Figure 3. General view of the intervention area at the Cardielos site.

Both sets of layers were built with rip-rap material, whereas the second line removes their visual impact since it is below the waterline at high tide. This group of structures (Figures 3 and 4) include granite rocks of 0.5–0.8 m in diameter packed in a layer thickness between 1.5–1.9 m and creates structures ranging in length from 13–29 m, depending on the topographical conditions where they are implanted. The second set (closer to the water) was composed of material with similar diameters, but packed around an axis of material with a small grain size (20–30 cm) and placed over a synthetic mat.

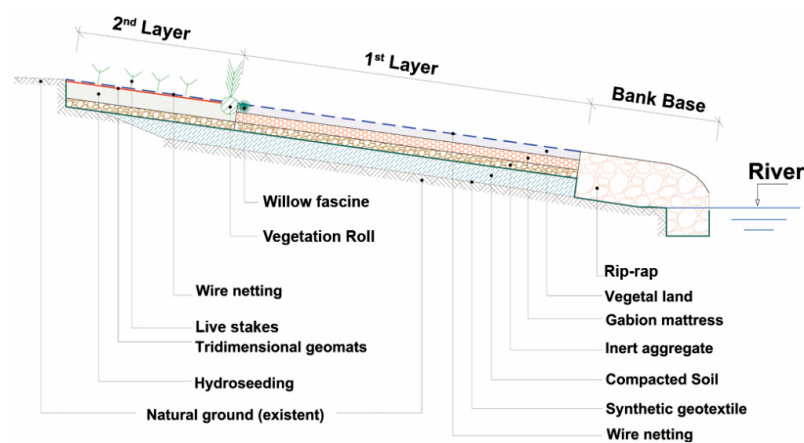
Figure 4. Planned techniques and vegetation species along the bank profile designed for the Cardielos site.

Because this set was placed in a plane which was more exposed to tidal and river flow energy, it was planned that the foundation of the structure should be placed at a level close to the depth of the expected scour; this level was indicated by a careful observation along this section of the river. The defined layout (straight in plan and perpendicular orientations) allows the set of groynes to trap a moderate amount of sediment upstream and downstream, keeping the current more or less parallel to the bank and offering a medium potential for scour at the head. Both sets of groynes were rooted successively in a set of structures, which are listed in order from water level as follows: a) rip-rap between 3–5 m long; b) gabion mattress (placed on a gravel layer after shaping the bank), which is characterized by a wire basket filled with rock (covered with 20 cm of soil for planting and a wire mesh to decrease tidal washing); c) vegetation roll and willow fascine; and d) a gravel layer with soil (40 cm) covered by tridimensional geomats after bank reprofiling (Figure 4).

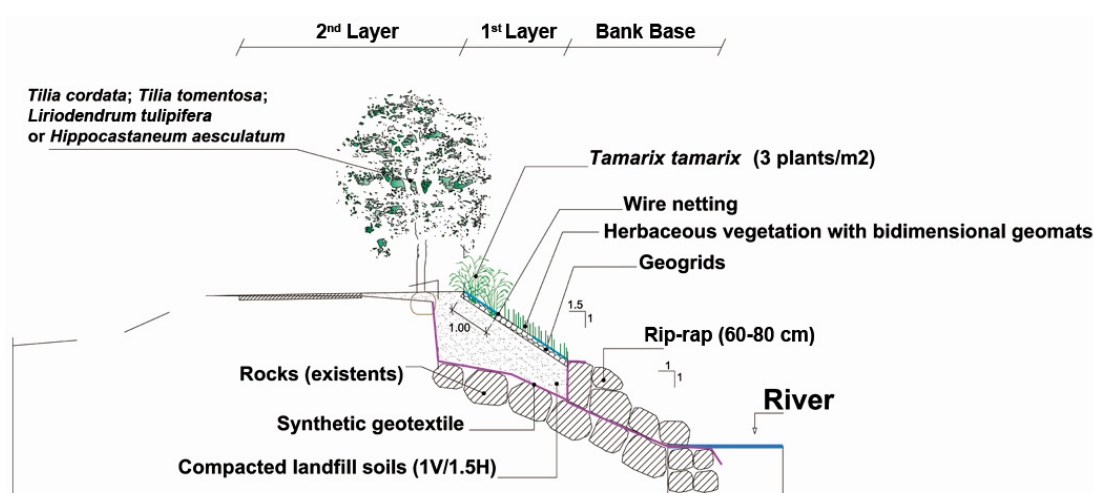
**Figure 5.** Planned techniques and vegetation species along the bank profile designed for the Portuzelo site.

The techniques designed and implemented for this area, with lengths of approximately 150 m, are schematized in the profile shown in Figure 5 and Table 2. Again, the objectives, besides bank stabilization, allowed for the settlement of vegetation and increased the roughness on the submerged bank in order to trap sediments and to dissipate the energy from river flow and tidal dynamics, contributing to long-term sustainability. Besides, this bank constitutes a barrier that protects a large salt marsh. Therefore, it is a crucial aspect of this defense system for the preservation of this sensitive environment. As Figure 5 shows, from the base to the top of the bank different layers, we successively used a) rip-rap with large boulders (0.6–0.8 m) in a foundation frame of wood piles, with stakes driven into the riverbed (since the river depth was higher when compared to the previous section) in order to promote roughness (groynes were not considered because of the water depth); b) bank reprofiling to smooth the slope, which was covered with a layer of geogrids, filled in the lower part with gravel (for adequate infiltration) followed by soil and further vegetated, where reeds were placed near the base and woody vegetation (mainly *Tamarix* sp.) was planted in the upper layer, and finally a wire mesh was used to decrease the potential tidal washing; and c) top lining and plantation with willow species as well as a row with broadleaf trees to improve the landscape attractively for visitors and to increase the overall bank consolidation. Besides this, we installed drains to allow the water to flow between the estuary and marshland.

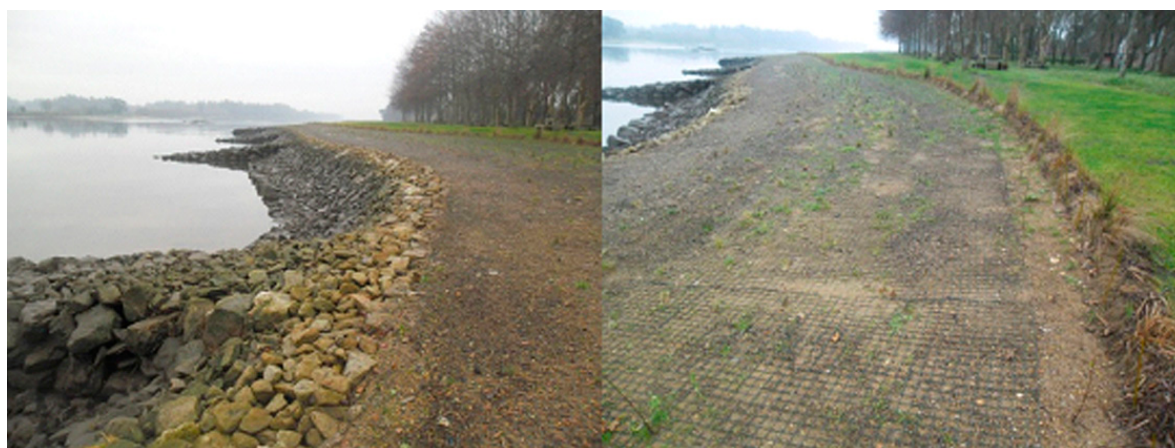
**Figure 6.** Rip-rap (left) and first row of small groynes (right) in Cardielos, after the implementation of the project in Cardielos in 2014.

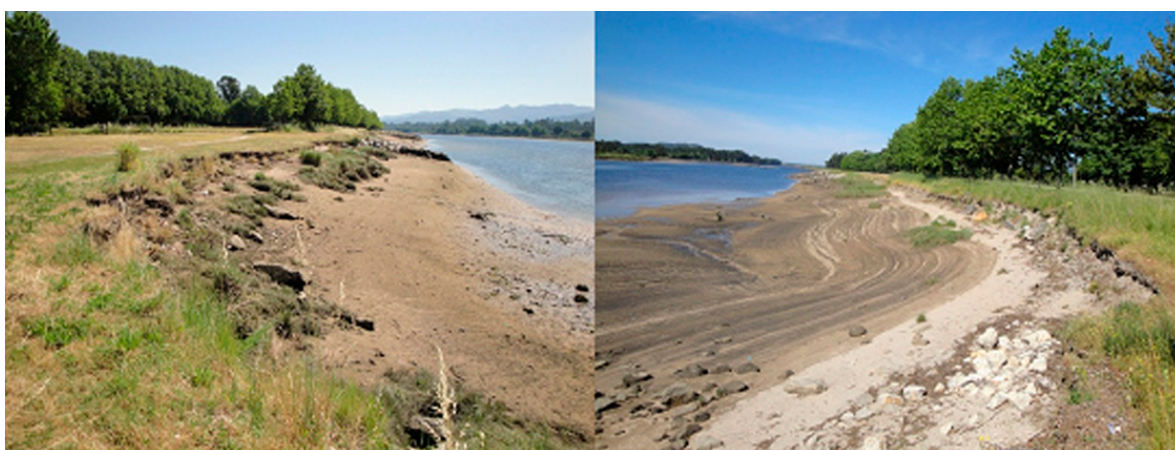
Of course, this action was focused in a specific part of an overall degraded estuarine environment. Immediately upstream and downstream of the rehabilitated sections, there is still a constant progression of the pressure on the banks and the consequent set-back of the bank line, which is reflected in Figure 8.

**Figure 8.** Two segments of the estuary banks, adjacent to the rehabilitation project in Cardielos (2014), showing that the severe erosion still progresses along the un-revetted banks, either in the upper section (left) or in the lower section (right), which requires an extension of the techniques already implemented.
