# Water Inrush Hazards in the Chaoyang Tunnel, Guizhou, China: A Preliminary Investigation

**Abstract:** This paper reports on a water inrush hazard, which occurred during the construction of the Chaoyang tunnel in Libo County, Guizhou Province, China. On 10 June 2018, a continuous water inflow of about 57 thousand m<sup>3</sup> of water within 40 min took place at the tunnel excavation face, resulting in three casualties. The objectives of this study are to investigate and discuss the water inrush process of this atypical case. Further, an inclusive description of the implemented emergency responses will be provided. The principal causes of this tunneling incident include the karst geological condition at the construction field, hydraulic conductivity induced by the connection between karst water system and surface water body, and effects of excavation and precipitation. Moreover, based on a preliminary investigation and analysis, three main control measures to overcome similar incidents in the future are proposed: (1) Performing “water inrush risk grading” in areas prone to water inrush; (2) undertaking comprehensive geological forecast for a synthetic analysis; and (3) employin

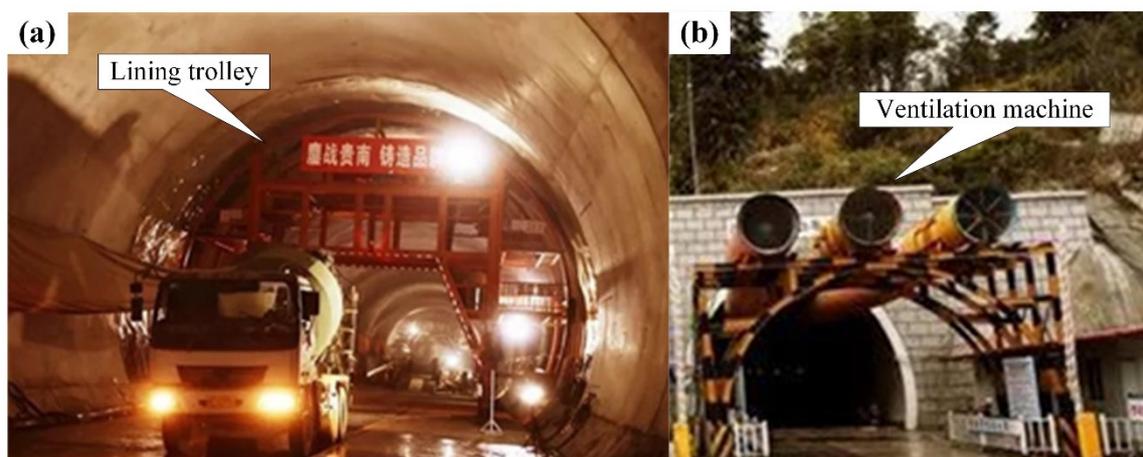
The Chaoyang railway tunnel project exhibits approximately 12,734 m in length with a maximal buried depth of 386 m. The tunnel line passes through a complex geological profile characterized by the transition zone between limestone mountain (Qiangui plateau) and peak forest-plain area (western Guangxi). Indeed, dense vegetation is observable at the surface of the tunnel in this area. More importantly, the geological investigations revealed the presence of karst geology, which typically hampers tunnel construction processes. Given this challenge and in order to reduce the construction time, a short excavation method was employed in the tunneling process; in particular, four service galleries including two parallel holes, two transverse holes, and an inclined shaft were equipped for drainage during the construction and operation period. Nevertheless, the water inrush incident occurred at the tunnel face located 1893 m away from the structural opening (see Figure 2).

**Figure 2.** Construction situation (a) inside and (b) outside the tunnel before the incident.

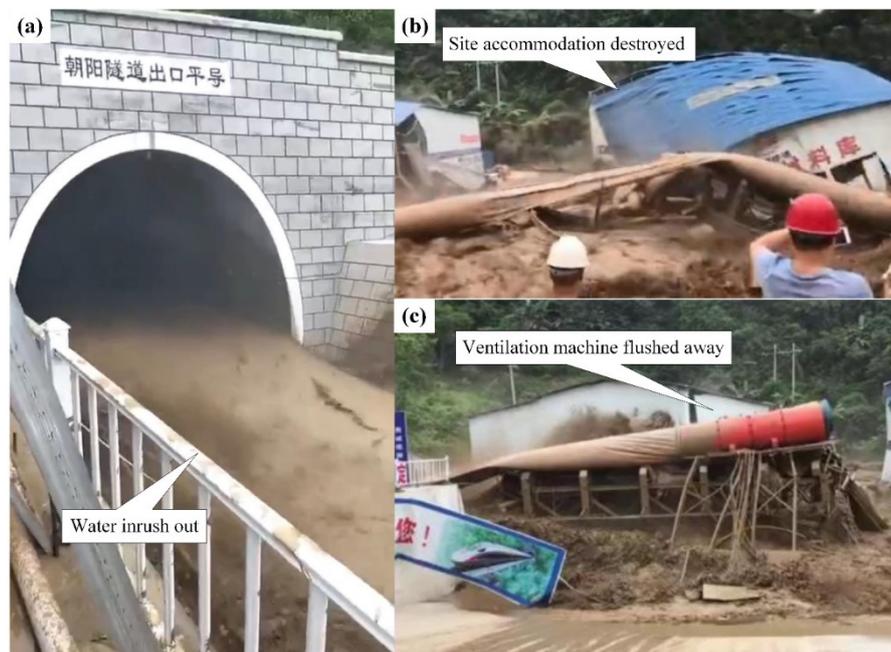
At 4:40 a.m. on 30 May 2018, a muddy water ejection from the bottom plate with increasing pressure occurred during the drilling operations on the tunnel face. As a result, the excavation was temporarily stopped, and exploratory drilling was conducted to decipher the geologic conditions and trend of the water-eroded groove in front of the tunnel face. The surrounding rocks of the tunnel face were observed daily to ensure the stability of future excavation operations. Nevertheless, at 8:30 a.m. on 10 June 2018, a non-pressure water leakage was found at the early inrush points in the tunnel face. At 9:56 a.m., a heavy flood of water and mud suddenly ejected out (as shown in Figure 3), and the water level reached a maximal height of 2.5 m above the bottom plate. An excavation bench (1800 m away from the structural opening in the tunnel) and a lining trolley (716 m away from the structural opening in the tunnel) were flushed out of the hole owing to the huge water pressure. Regrettably, a local villager doing cleaning work approximately 100 m away from the structural opening died after an unsuccessful emergency rescue attempt. Further, two workers died on the scene. The water inrush lasted approximately 40 min until the situation smoothed favorably for ample rescue operations.

**Figure 3.** Accident scenes: (a) Water rushing out of structural opening; (b) portable dwellings destroyed by inrushing water; and (c) ventilation machine flushed away by inrush water.

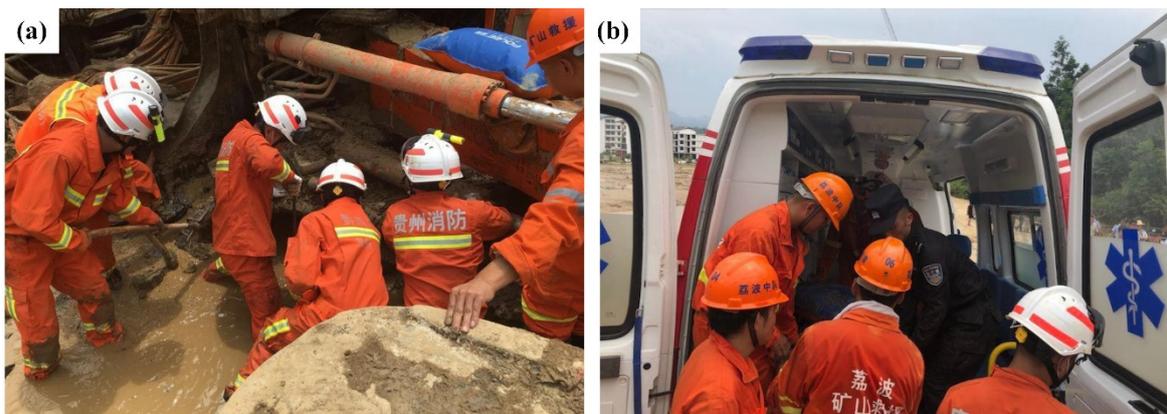
Rescue operations were undertaken immediately by an investigation agency working collaboratively with the government of Guizhou province, construction and supervision units, firefighters, and medical staff, as shown in Figure 4. Twenty-four-hour on-duty monitoring was implemented, and the structural opening of the tunnel was closed. In addition, protective facilities and warning signs were installed to avoid secondary disasters.

**Figure 4.** Joint rescue activity: (a) Firefighters searching for victims; (b) emergency treatment (Picture source: <http://m.news.cctv.com/2018/06/11/ARTI6F58tT5PonH5KXoex9X5180611.shtml>).

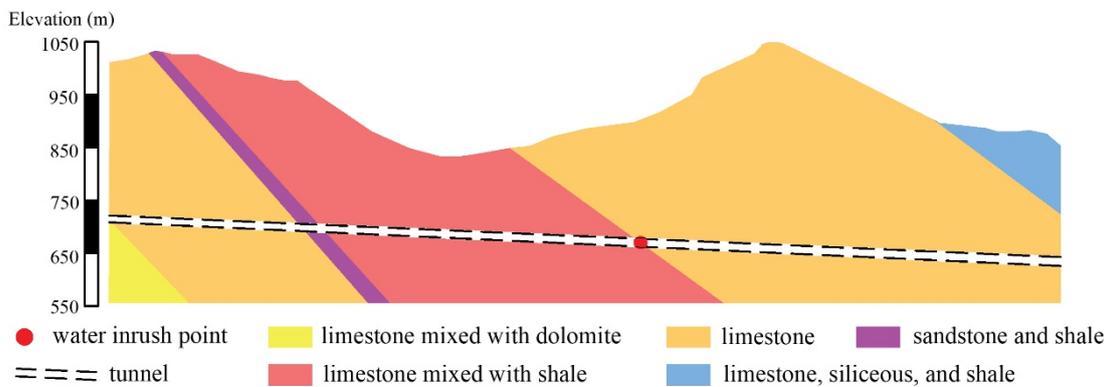
Figure 6. Sectional view of geological profiles for incident point.

which often induce several hazards and a variety of engineering construction accidents. In terms of the effect of fissures on the corrosion of karst caves, it is found that the faults and fractures play an important role in karst corrosion [40,41]. The analyses indicated that the karst fractures increase the area of contact between water and carbonate rock, which helps to increase the limestone erosion, and has a clear effect on the stabilization of tunnel rock. The adverse geological formation of the site is believed to be the origin of the water inrush incident in Libo County.

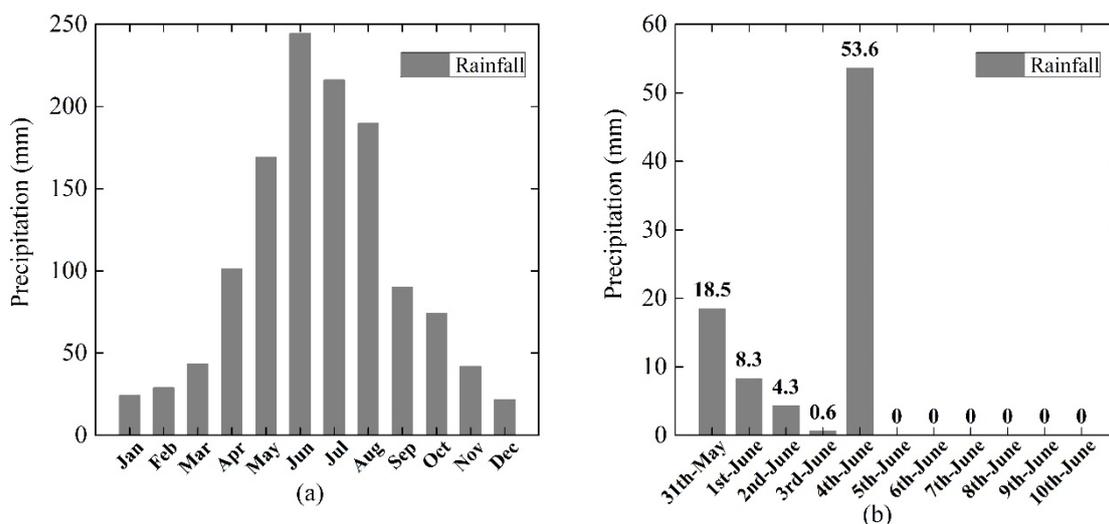
The rainfall water was considered as another significant cause of the water inrush incident. The monthly average rainfall in Libo County reached its peak (244.45 mm) in June, as shown in Figure 7a. The precipitations in May 2016 and 2017 measured 222.3 mm and 184.8 mm, respectively, according to the information provided by the local weather bureau. However, statistical records for the same period

but 2018 reveal that the precipitation reached 250.4 mm, which is more than twice as the monthly average rainfall of 103.7 mm. Moreover, Libo County was stricken by a heavy rainfall on 4 June. The precipitation reached the astonishing value of 53.6 mm, as shown in Figure 7b. The intense rainfall is one of the critical triggering factors since it resulted in the increase of surface water which became the main recharge source of underground karst water system. Consequently, the unfavorable situation was further aggravated because of the triggering factor of heavy rainfall and tunnel excavation. Figure 8 shows a schematic cause-and-effect diagram of the water inrush incident.

Figure 7. (a) Average monthly rainfall in Libo County. (b) Rainfall in Libo prior to the incident.
