# Assessment of Restorative Maintenance Practices on the Infiltration Capacity of Permeable Pavement

Mari E. Danz <sup>\*</sup>

U.S. Geological Survey—Upper Midwest Water Science Center, 8505 Research Way, Middleton, WI 53562, USA; wrselbig@usgs.gov (W.R.S.); nbuer@usgs.gov (N.H.B.)

Received: 15 April 2020; Accepted: 27 May 2020; Published: 30 May 2020

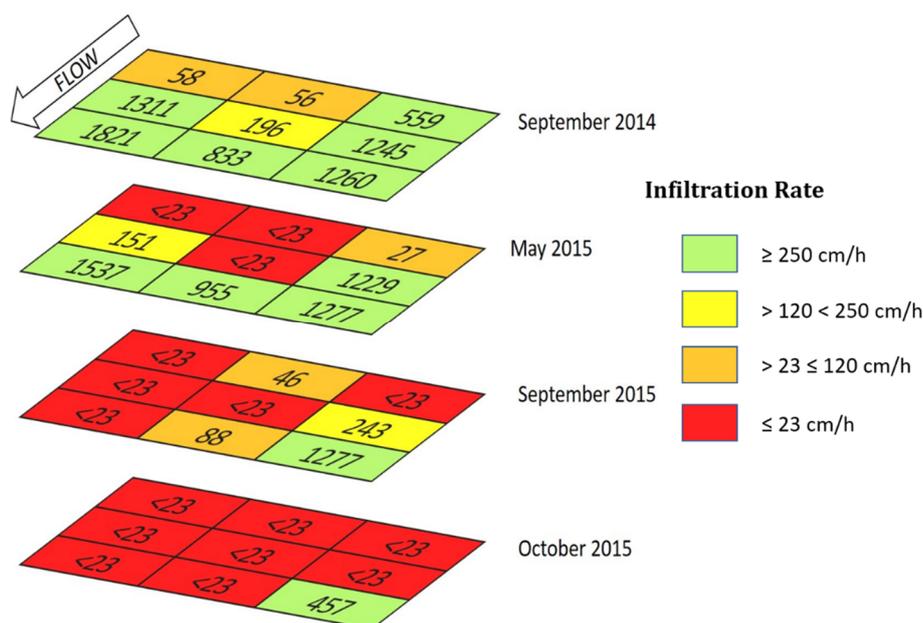
**Figure 4.** Heat map illustrating the progression of clogging across the permeable interlocking pavers surface over the first 14 months of the study when no restorative maintenance occurred. Adapted from Selbig and Buer [1] (cm/h, centimeters per hour).

Within 14 months of installation, prior to any maintenance activity, both PICP and PC had reached clogged status (six or more of the nine discrete infiltration test locations showed a rate of less than 23 cm/h). The PICP and PC average infiltration rates dropped to 71 and 84 cm/h, respectively (Figure 8). PA did not reach clogged status until one year later in October 2016, at which time its surface infiltration rate was 218 cm/h.

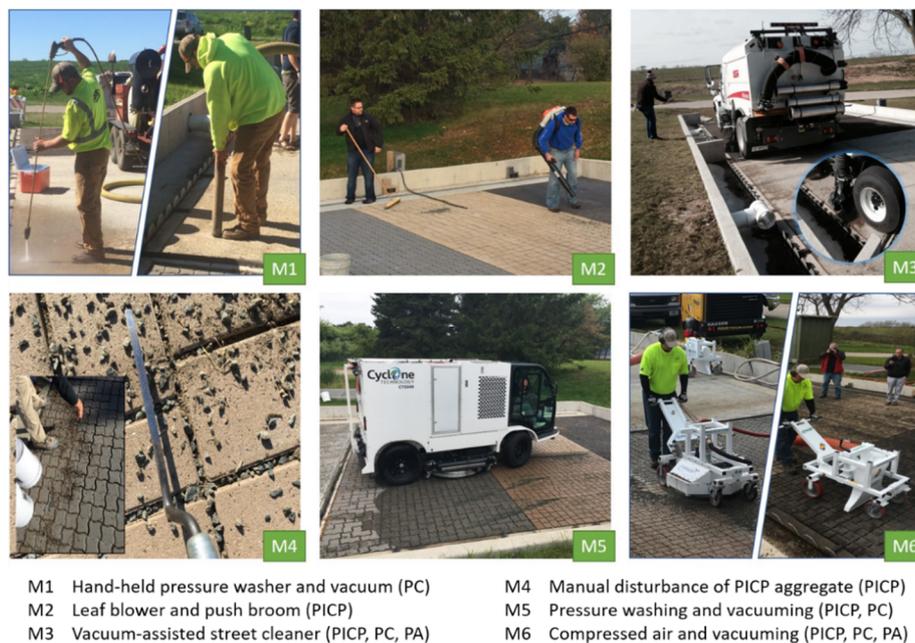
**Figure 5.** Images of the six different maintenance practices that were evaluated for use on permeable interlocking pavers (PICP), pervious concrete (PC), and porous asphalt (PA) test plots.

In May 2015, the high-powered pressure washer followed by high-powered vacuum suction features of a Ditch Witch FX30<sup>®</sup> (Charles Machine Works, Perry, OK, USA) vacuum excavator were applied to a portion of the PC surface to remove any dislodged material (Figure 5, M1). The angle of the washer spray was applied at approximately 90° to the PC surface with a pressure of 207 bar (3000 psi). The suction velocity of the vacuum was 15.3 m<sup>3</sup>/min. The machinery used for this exercise is typically meant for removal of accumulated sediment from catch basins and sumps and not restoration of permeable pavement; however, this cleaning targeted a 1.8 m swath on the north edge of the plot that clogged rapidly due to an installation defect, creating preferential flow across a narrow band of the PC test plot. The maintenance area included the discrete test locations 1, 4, and 7, as illustrated in Figure 3.

In November 2015, a manual cleaning was done on the PICP surface only. This process involved the clearing of surface debris using a high-powered leaf blower (Figure 5, M2). Any dislodged aggregate was removed using a bristled push broom and dustpan and replaced with new aggregate. The intent was to replicate what a typical homeowner may do to maintain their own PICP.

In June 2017, all the joints between pavers in the PICP were scraped by use of a 0.6 cm masonry trowel (Figure 5, M4). Any aggregate loosened by the scraping action of the trowel was removed by use of a push broom and dustpan and replaced with new aggregate. This method was very labor-intensive but was done to further confirm clogging of PICP due to shallow penetration of the sediment into joint aggregate, as described by Selbig and Buer [1]. It was also done to test if a non-mechanical means of PICP maintenance could result in similar improvements to infiltration rates as demonstrated by more sophisticated technologies.

was applied to the permeable surface in a circular motion within a surrounding chamber at 29,647 kilopascals. The Cyclone<sup>®</sup> passed over PICP and PC surfaces each three times. Any dislodged aggregate in the PICP test plot was removed with the wastewater and stored within the Cyclone<sup>®</sup>.

In October 2018, all three surfaces were treated with the TYPHOON<sup>®</sup> and PAVEVAC<sup>®</sup> by PaveTech<sup>®</sup> (PaveTech Inc., Prior Lake, MN, USA) (Figure 5, M6). The TYPHOON<sup>®</sup> is primarily intended to be used as an excavator of PICP joint aggregate by use of compressed air. Once the aggregate was dislodged, it was removed by the PAVEVAC<sup>®</sup>, which uses a high-lift vacuum to remove the excavated material in preparation to refill the joints [22]. Although designed for restoration of PICP, both the TYPHOON<sup>®</sup> and PAVEVAC<sup>®</sup> were applied to PC and PA to determine the restoration potential for other permeable pavements. A portion of the PC surface received two passes of the PaveTech machinery (discrete location numbers 1, 2, 4, and 5 in Figure 3) to determine if the number of passes provided additional improvement over a single pass.

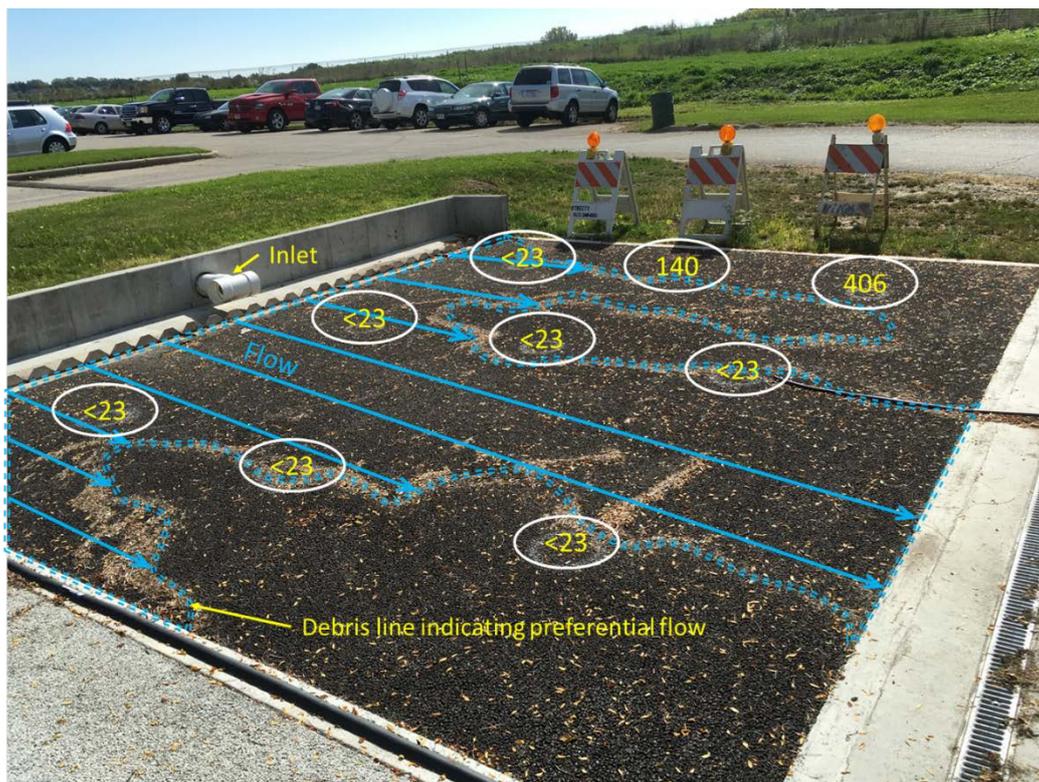
Discrete measurement results showed that infiltration was not uniform across the surface of each plot. This variability is typical of permeable pavement surfaces [11,15,24]. In the current study, variability was largely due to irregular flow patterns across the permeable surface. Measurement locations closest to the influent typically clogged earlier than those farther away (Figure 4). In addition, despite attempts to evenly distribute runoff across the entire permeable surface, preferential flowpaths emerged depending on rainfall intensity. Flowpaths were more pronounced during low-intensity rainfall events where influent runoff was slowly applied to the permeable surface. Discrete test locations within these paths tend to show clogging earlier than those that remained outside the flowpaths. For example, on 21 June 2017, PA had an average surface infiltration rate of 79 cm/h; however, seven of the nine values used to determine the average were assigned as 23 cm/h, the remaining two being 140 and 406 cm/h (Figure 6). The discrete test location that resulted in 406 cm/h was in the corner furthest from the inflow. Evidence of flowpaths on the surface indicated that runoff most likely did not reach that section except during larger events. Without knowing when all or part of the permeable surface received runoff, the average value of the nine discrete test results was decided as the best representation of surface infiltration rates.

**Figure 6.** Infiltration values (cm/h) for nine discrete test locations on 21 June 2017. Average surface infiltration rate was 79 cm/h.

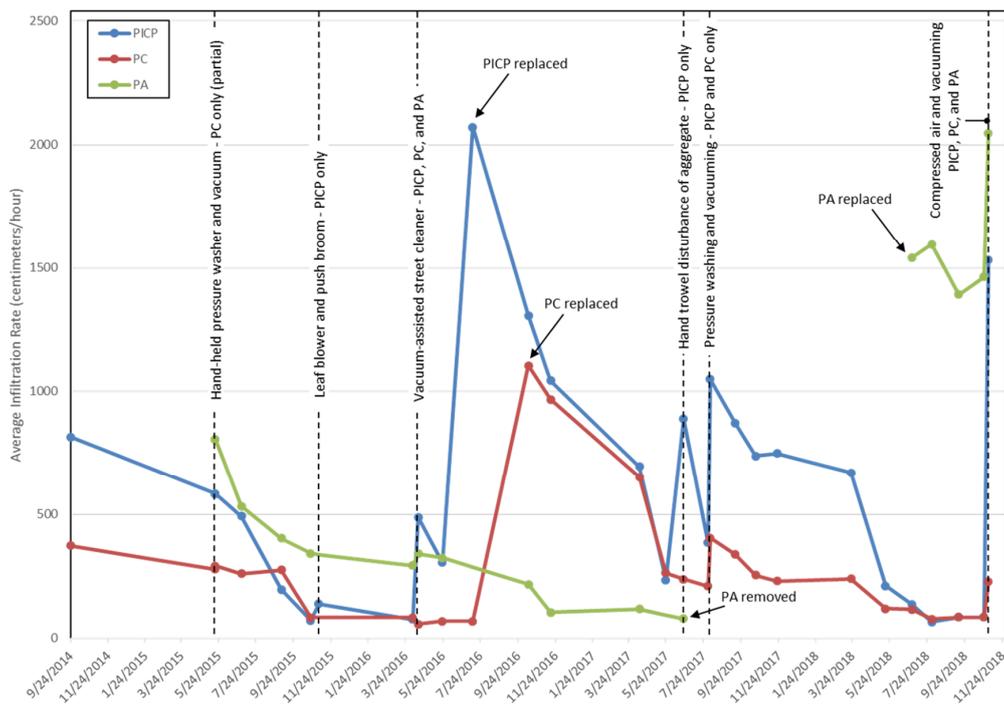
The first infiltration measurements were performed on 24 September 2014, approximately 1 month after installation. At that time, the surface infiltration rates for PICP and PC were 815 and 374 cm/h, respectively (Figure 7); PA results are not reported, due to measurement error. The first PA infiltration test recorded was 807 cm/h on 18 May 2015. These initial infiltration rates are above the rate of 254 cm/h (100 in/h) required by the WDNR conservation technical standard [20], but lower than findings reported from other studies, which, in many cases, exceeded 2500 cm/h [25,26]. This discrepancy may, in part, be due to clogging that occurred between installation and measurement; during this 1 month period for PC and PA, the site received 5 cm of rainfall distributed over seven events, two of which were greater than 1.27 cm.

**Figure 7.** Response of average infiltration rates to restorative maintenance practices and surface replacement at the permeable interlocking pavers (PICP), previous concrete (PC), and porous asphalt (PA) test plots (the dashed line intersects the date and identifies the type of maintenance practice tested).

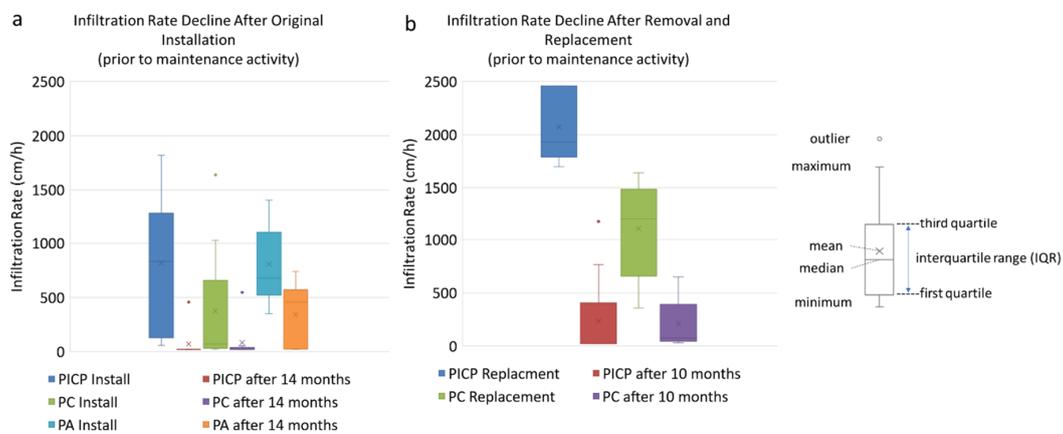
**Figure 8.** Decline in infiltration rates during the period without maintenance activity following (a) initial surface installation and (b) surface replacement of the permeable interlocking pavers (PICP), previous concrete (PC), and porous asphalt (PA) test plots (cm/h, centimeters per hour).

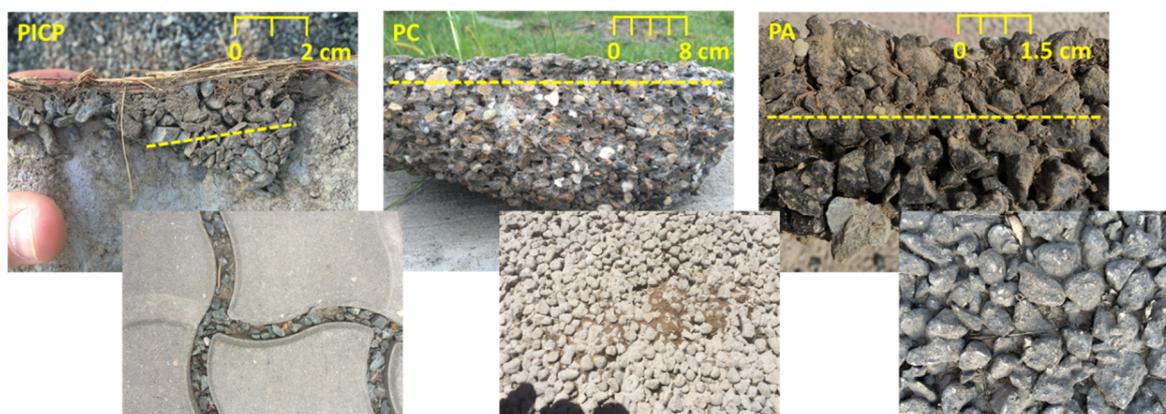
The surface structure of individual pavement types can influence the advancement of clogging, as well as the response to maintenance. Despite varying thickness during the construction process, the majority of clogging for permeable pavements has been shown to occur within the top 1.5 to 2.5 cm [1,17]. This was verified at each plot by visual examination of pavement surfaces and profiles upon removal (Figure 9). These findings were further confirmed by Kayhanian et al. [27] who scanned cores from 20 PC parking lots and found that clogging generally appeared to be limited to the upper 2.5 cm. Winston et al. [17] reported that milling of a 21 year old porous asphalt surface to a depth of 2.5 cm nearly restored the infiltrative capacity to like-new conditions. Results from this study and others [1,17,27] indicate that maintenance practices that penetrate deeper into a permeable surface will have a greater likelihood of restoring the infiltrative capacity.

**Figure 9.** Photographs of the sediment captured in the profiles and on the surfaces of the permeable interlocking pavers (PICP), pervious concrete (PC), and porous asphalt (PA) (the dashed line indicates sediment penetration depth; lower images not to scale).
