CT Scans of Asbestos Cement Pipes as a Reference for Condition Assessment of Water Mains

Karel van Laarhoven ^{1,*}

Abstract: The water distribution network of The Netherlands contains around 30,000 km of asbestos cement (AC) pipes, which constitutes around 25% of the total network. As a pipe material, AC has a relatively poor performance, and therefore is a high priority for renewal. To help decide an effective order of replacement, the water utilities need condition assessment techniques that help them determine which pipes have the highest risk of failure. In the presented work, X-ray computed tomography (CT) was used to measure the degradation of AC pipes taken out of the field. These scans provide a description of the pipe degradation with unmatched detail. The results are compared with strength tests performed on the same pipes, revealing that detailed knowledge of the complete pipe degradation is more important than previously assumed. Moreover, comparison of the CT results to those of a commercial, non-destructive inspection technique was used as a new avenue for validation of this technique, demonstrating its future usefulness for attaining the detailed measurement of pi

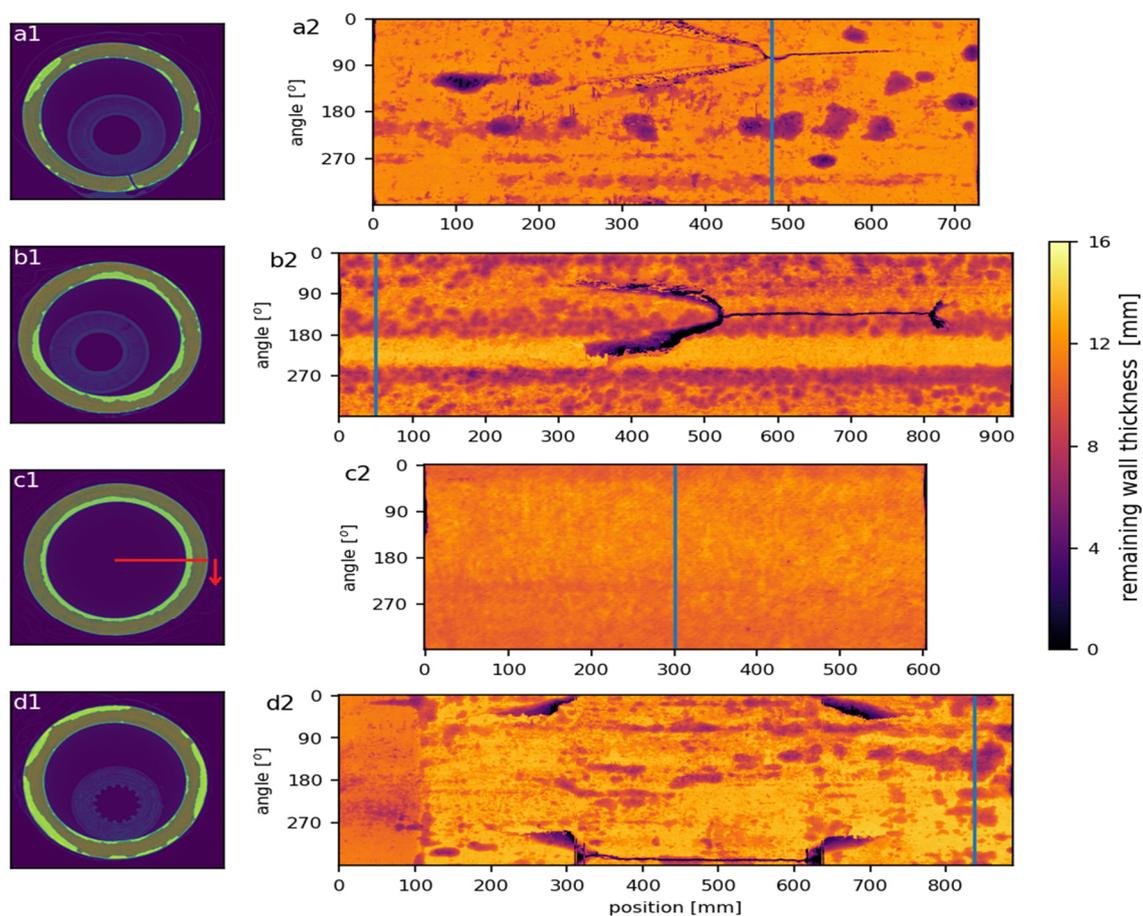
Figure 2. Four examples of degradation patterns of AC pipes as measured with CT. The ID's of the pipes in Table 1 are 103679 (a), 168218 (b), Blerick4 (c), and D161290 (d). The cross-sections (a1–d1) are the CT slices at the locations marked with the blue lines in the corresponding height maps of the pipes (a2–d2). The height maps indicate the remaining wall thickness of a pipe as a function of the angle around and position along the longitudinal pipe axis. The horizontal red line and the red arrow in (c1) demonstrate the origin and direction of the vertical angle axes in (a2–d2).

The remaining wall thickness of the pipe in Figure 2a displays a spotty pattern across the pipe surface that corresponds to many localized areas of external degradation. In Figure 2b, internal and external degradation are drawn out in thin bands across the surface. The pipe in Figure 2c displays a far more even landscape, which corresponds to the homogeneous, internal degradation across the pipe wall that is considered to be typical for leaching AC pipes [10]. Figure 2d again shows a somewhat spotty, inhomogeneous pattern, with degradation clearly being more pronounced at certain angles around the pipe's longitudinal axis.

Presumably, the localized external degradation in Figure 2a–d stems from contact with un-homogeneously distributed aggressive soil components around the pipes while they were in use. The inhomogeneous nature of the internal degradation in Figure 2a,b is more remarkable, however, since the leaching of calcium hydroxide from AC pipes into

the drinking water is usually understood to be a diffusion controlled process that occurs homogeneously across the pipe surface [10], as was the case for the pipes like the one in Figure 2c. Research on the chemical (and possibly the microbiological) microclimate of the inner pipe wall in relation to local deterioration is needed to further explain this discrepancy. This would also require research on possible factors that lead to such local differences, such as fault production or installation, damage due to pressure surges, or water compositions that lead to inhomogeneous precipitation across the pipe wall or that support colonial microbial growth. Obtaining the historical operational data of water utilities required to study this may prove a challenge in itself.

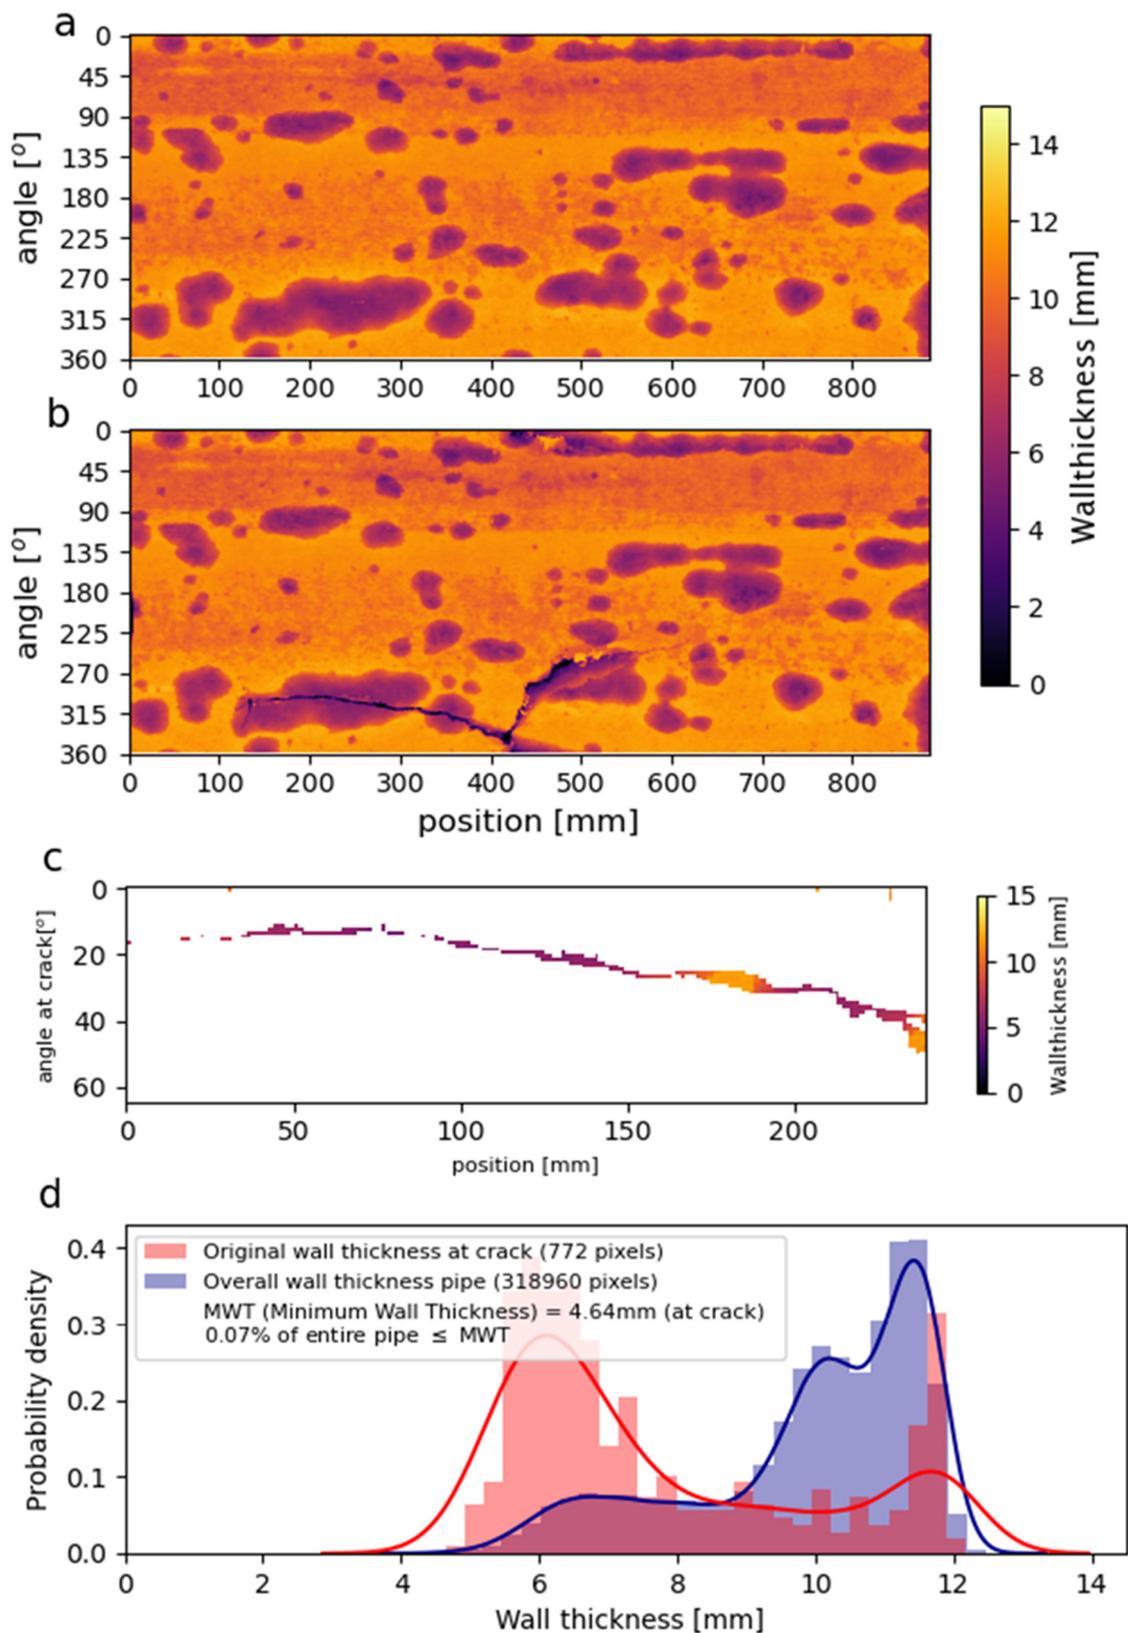
Figure 3 shows an example of how this was approached for pipe 177598: the location of the crack that resulted from the strength tests was obtained from the scans that were taken after the tests (Figure 3b). Subsequently, that information was combined with the scans that were taken prior to the strength tests (Figure 3a) to determine the original remaining wall thickness along the trajectory of the crack (Figure 3c). Since the crack's exact point of initiation could not be obtained from the CT scans, the part of the crack between forks was taken to be the first part of the crack, which formed directly after initiation. The distribution of remaining wall thicknesses along this part was compared to the distribution of the remaining wall thicknesses across the complete pipe wall (Figure 3d). In this particular case, indeed, one of the lowest values for the remaining wall thicknesses was found on the crack, and the wall thicknesses along the crack were clearly lower than those that were present elsewhere on the pipe, although there was a clear overlap in distributions as well. The minimum wall thickness on the crack belonged to the 0.07% lowest anywhere on the pipe.

This exercise was carried out for 10 pipes (see Table 2, the IDs marked with an asterisk) that failed during the strength tests. In 8 out of 10 cases, the minimum wall thickness on the crack belonged to the 1% smallest wall thicknesses anywhere on the pipe, like the example of Figure 3. In 2 out of 10 cases, at least 8% of the pipe wall had lower remaining wall thicknesses than anywhere on the crack, so that a clear connection between the location of the crack and the points of lowest wall thickness was not obvious. The fact that, in 80% of the studied cases, the crack included the 1% most degraded spots indicated that local spots of inhomogeneous degradation indeed influenced failure behavior, although the 10 cases studied here cannot provide a statistically representative basis for that conclusion.

Figure 3. Approach for investigating an influence of local degradation on cracking. (a) The CT scan of pipe 177598 prior to the strength test; (b) The CT scan of the cracked pipe after the strength tests; (c) The remaining wall thicknesses in the first scan on the location of the crack in the second scan; (d) Normalized histograms of the distribution of wall thicknesses along the crack (red) and across the whole pipe (blue).

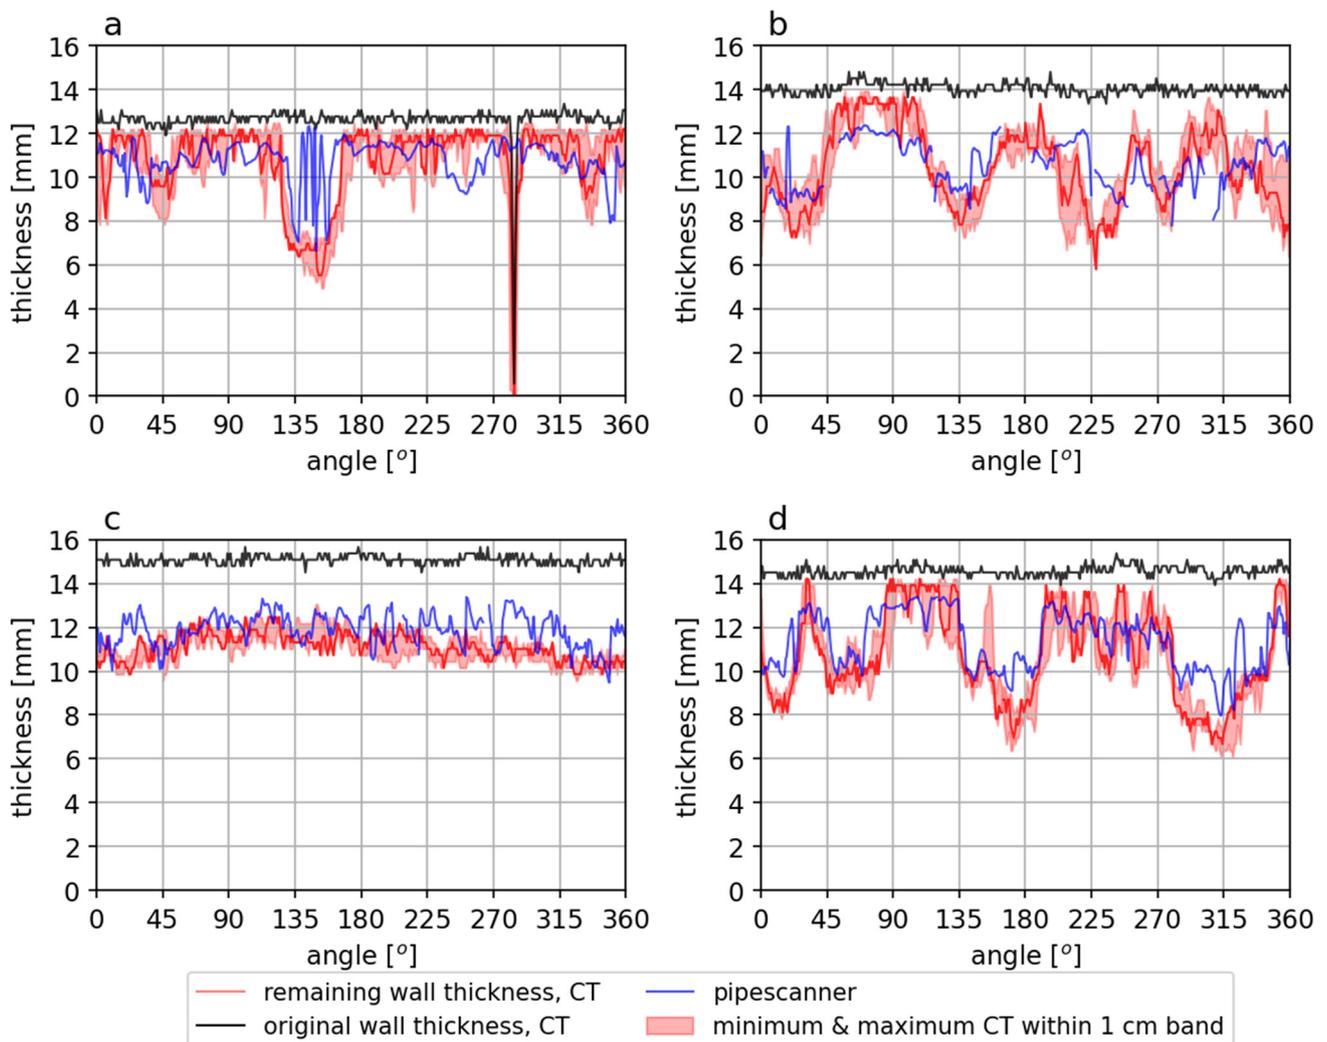
Figure 4. Comparison of CT (red) and ultrasound (blue) measurements of the remaining wall thicknesses of the four cross-sections of degraded pipes shown in Figure 2 (the lettering (a–d) corresponds to pipes with the same letters in Figure 2). The black lines represent the original wall thickness (comprising degraded and undegraded material) as determined from the CT scans.

Overall, the ultrasound profiles matched the CT profiles quite well in terms of shape and order of magnitude. There were offsets in the order of a few mm at some locations, such as Figure 4a around 135°, Figure 4b around 90°, and Figure 4d around 90°.
