Technical Note

Damage Characteristics and Mechanism of the 2017 Groundwater Inrush Accident That Occurred at Dongyu Coalmine in Taiyuan, Shanxi, China

Abstract: On 22 May 2017, a groundwater inrush accident occurred in the gob area of coal floor at Dongyu Coal Mine in Qingxu County, Shanxi Province, China. The water inrush accident caused great damage, among which six people died and the direct economic loss was about CNY 5.05 million. An elliptical permeable passage appeared at the floor of the water inrush point, and the lithology of the outburst is mainly fragmented sandy mudstone and siltstone of coal roof No.2 in the lower layer of coal seam No.3, which is currently being mined, with a peak inflow of 500 m³/h. The water inrush happened due to following reasons: There is an abandoned stagnant water-closed roadway in coal seam No.2, which is the lower mine group of coal seam No.3. The abandoned roadway of coal seam No.2 is an inclined roadway. The water level of the roadway far away from the accident point is higher than the floor elevation of coal seam No.3. Under the joint action of water pressure, mining disturbance, and weakening of goaf water immersion, the original equil

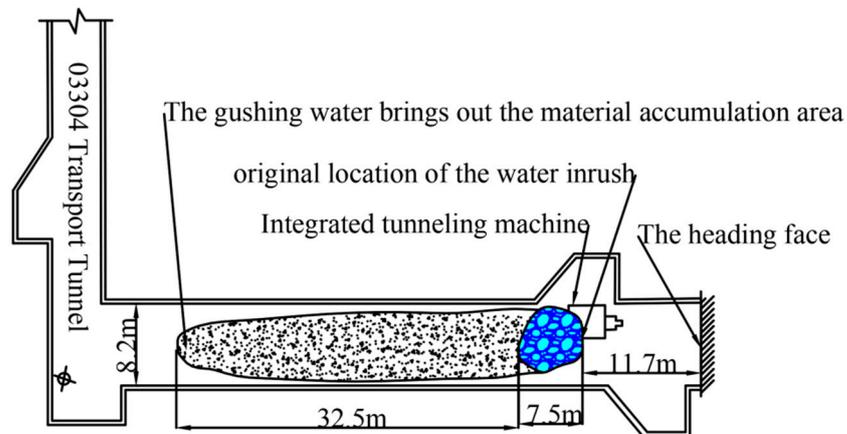
According to the on-site investigation by the accident investigation team, the floor damage occurred at 11.4 m behind the heading face of the setup entry of the 0344 panel working face in coal seam No.3, resulting in groundwater inrush, as shown in Figure 4.

Figure 4. Schematic diagram of plane analysis of the water inrush point.

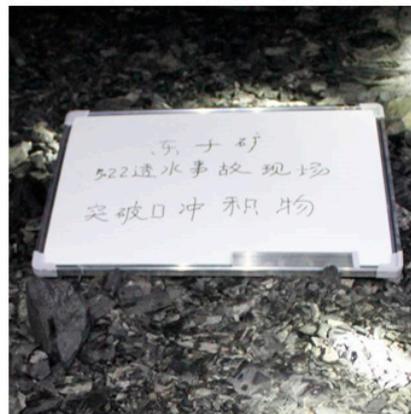
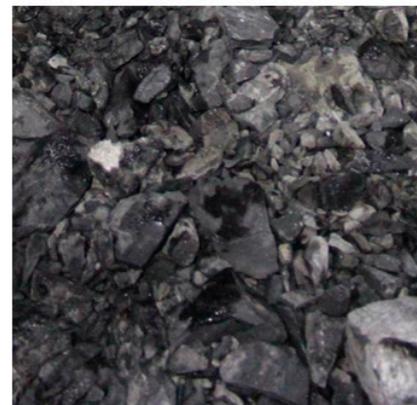
The water inrush mainly came from the accumulated water in the goaf of coal seam No.2 after mining. The reasons are as follows: First, according to the results of hydrochemical tests, the groundwater characteristics of water inrush have obvious goaf water characteristics, as shown in Table 1. Secondly, at 23:38 hours on May 22nd, the water inflow suddenly increased to about 500 m³/h, and two days later, the water inflow rapidly decreased to 5 m³/h, which conforms to the change characteristics of goaf water permeability. This conclusion is supported by the following facts: the field investigation of the investigation team found that a gravel accumulation area within a range of 32.5 m appeared behind the water inrush point (Figure 4), and the lithology of the outburst was mainly fragmentary fine sandstone and siltstone, which was basically similar to the roof of coal seam No.2 (Figure 5). The integrated tunneling machine fell into the collapse pit, a small

Figure 5. Sandy mudstone, siltstone, and other broken rock deposits in the water inrush site. (a) Board marked by the investigation team at the scene of the accident; (b) gravel with different particle sizes.

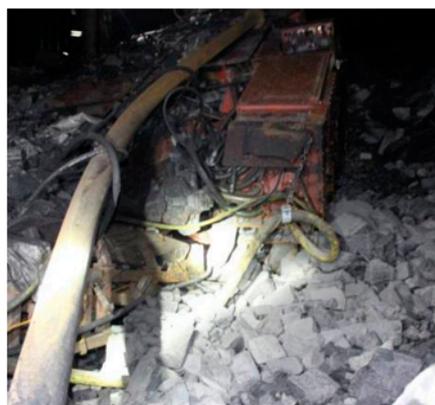
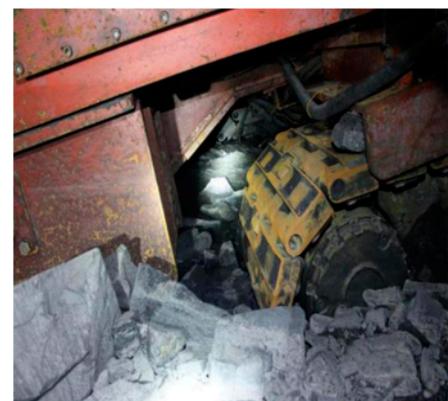
amount of water flowed out of the roadway floor, and a small amount of bubbles came out, as shown in Figure 6.

Figure 6. A collapse pit formed at the outlet point. (a) Power switches and cables that fell into the collapse pits; (b) integrated tunneling machine that fell into the collapse crater.

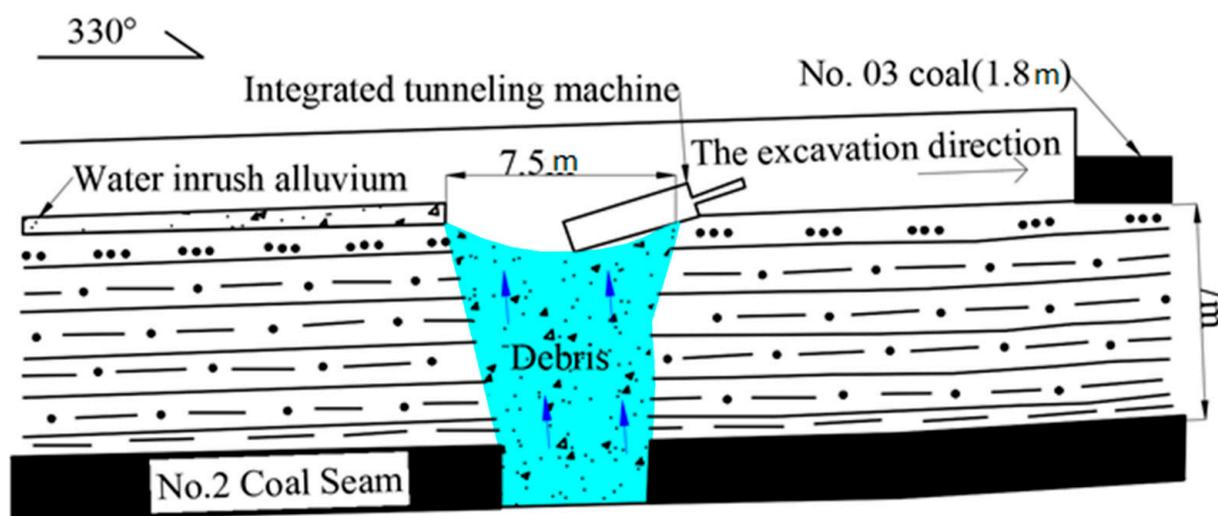
As shown in Figures 7 and 8, the fracture zone of the goaf roof of coal seam No.2 in the lower group is the water-conducting channel. The mining disturbance of coal seam No.3 and the high-pressure water in the goaf of coal seam No.2 in the lower group jointly induce the formation of the water-conducting channel.

Figure 7. Profile diagram of the water inrush location in the heading direction.

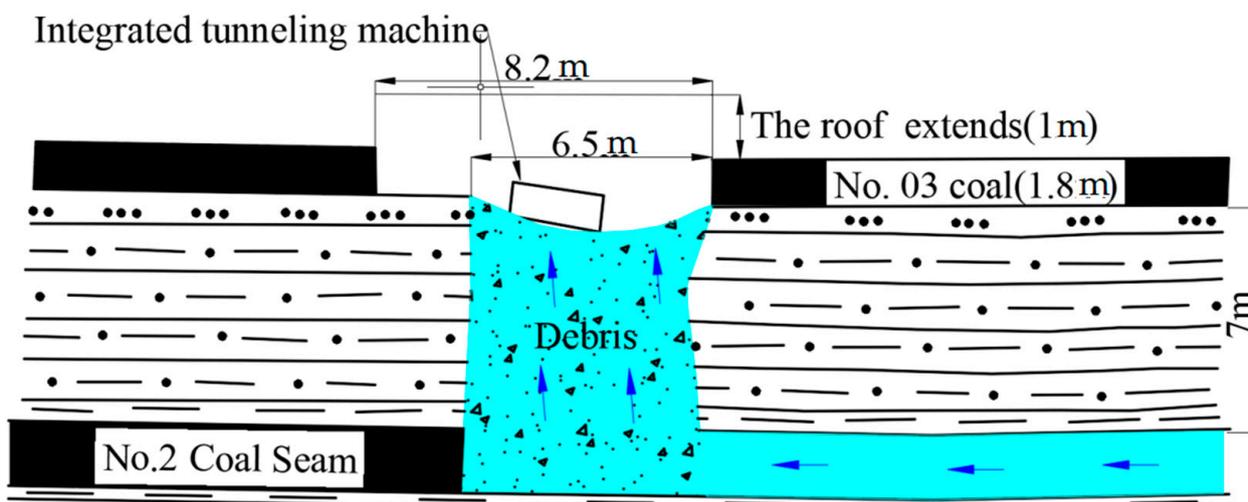
Figure 8. Section diagram of the water inrush position perpendicular to the excavation direction.

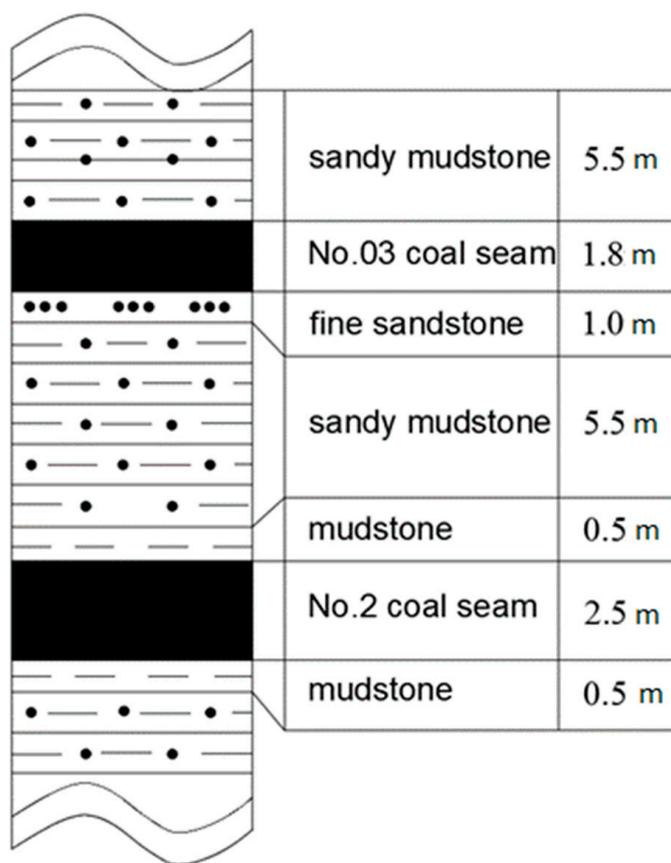
According to the geological data and borehole data, five boreholes were drilled at the cut opening and 60 m away from the cut opening, respectively, two of which were boreholes in the direction of the floor. The stratum structure and thickness of coal seams No.3 and No.2 were obtained (Figure 9).

Figure 9. Horizon structure of coal seams No.3 and No.2.

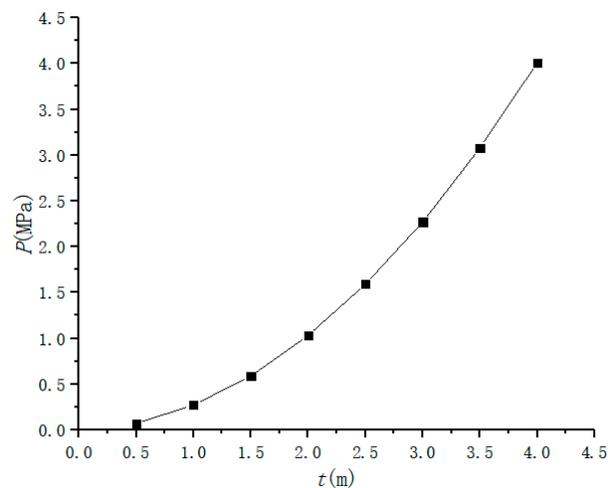
The average tensile strength K_P of the waterproof layer of the bottom plate is far less than 2 MPa due to the influence of the nearby collapsed column structure. The effective thickness of the aquifuge between them was reduced to 1–4 m, because the influence of the goaf of coal seam No.2 and the tunneling of coal seam No.3 disturbed the aquifuge of 7 m. The width of the roadway is 8.2 m. The unit weight of the waterproof layer in floor is $0.026 \text{ MN}/\text{m}^3$. The relationship curve between water pressure and the thickness of the effective insulating layer was obtained as shown in Figure 10.

Figure 10. Relationship curve between water pressure and thickness of the floor safety barrier.

The actual water pressure is less than or equal to 0.25 MPa, as calculated from the amount of water inrush and the water storage space of the roadway; thus, the thickness of the actual effective waterproof layer is less than 1 m under the influence of mining and other factors. Therefore, the groundwater stored in the goaf of coal seam No.2 poured into the gallery on a large scale, and the disastrous accidents occurred rapidly.
