# Assessment of the Breaching Event, Breach Parameters and Failure Mechanisms of the Spillway Collapse in the Swa Dam, Myanmar

**Abstract:** The spillway of the Swa earthen dam, constructed in Yedashe Township, Bago Region, Myanmar, collapsed suddenly on 29 August 2018 and resulted in a huge flood to downstream areas causing fatalities and the displacement of thousands of localities. This study aimed to assess the spillway breaching process in terms of the breaching parameters such as the average breach width, failure time and peak outflow, and failure mechanisms. We analyzed the event from the changes in the study site before and after the event and used water discharge conditions from satellite data and water level records during the event. We compared the breaching parameters using empirical equations from past failed events with tested scenarios for failure mechanisms, such as overtopping and piping. According to satellite data, 97% of the storage from the reservoir was discharged, and the peak breach outflow rate was 7643 m<sup>3</sup>/s calculated from the water level records. The selected empirical formulas were applied, and the estimated average breach widths, failure time

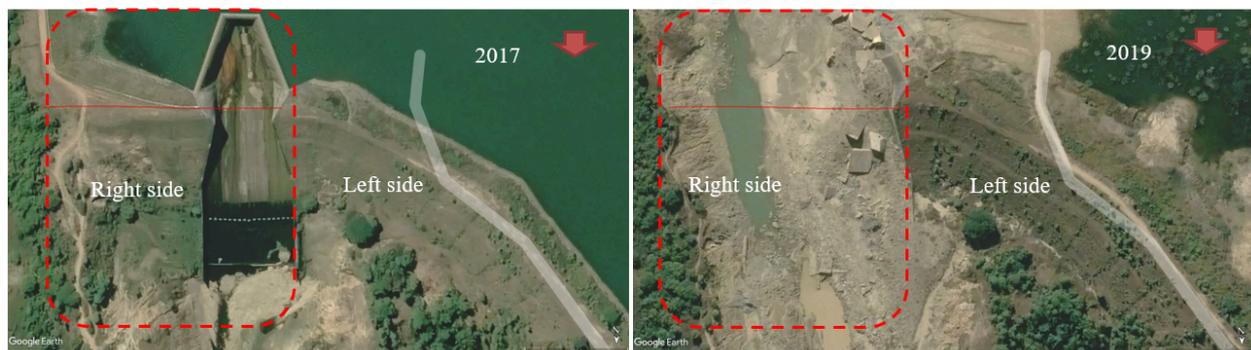
Before the event, the spillway overflowed at about 0.5 m water depth above the spillway weir crest, and the water level was about 103.2 m which was about 4.1 m from the crest of the dam embankment. The water level in the reservoir remained at that level until the early morning of 29 August. According to the witnesses of the breach event, Swa’s spillway seemed to have collapsed before 5 a.m. LT on the morning of 29 August 2018; however, the water levels could be recorded at 5:00 a.m. The gauge watcher of the Swa Dam noticed that the water level at the gauge of the Swa Dam suddenly went down at about 4:00 a.m. LT and the villagers in the nearest village to the dam also reported that they found water under their residences. When the watcher reached the event site at 6:00 A.M, the spillway had already broken and the breach opening at the spillway had already extended to the right-side embankment of the Swa Dam. The left side of the duckbill part remained undestroyed during the event. The water from the reservoir flowed out from the opening continuously from 29 August to the next day, 30 August. The conditions of the study site before and after the spillway broke can be visualized using Google Earth images from December 2017 and 2019 as shown in Figure 4. The breach opening expanded to the right embankment was clearly identified by comparing the images in Figure 4.

**Figure 4.** Collapsed spillway before and after the breach event (Google Earth images).

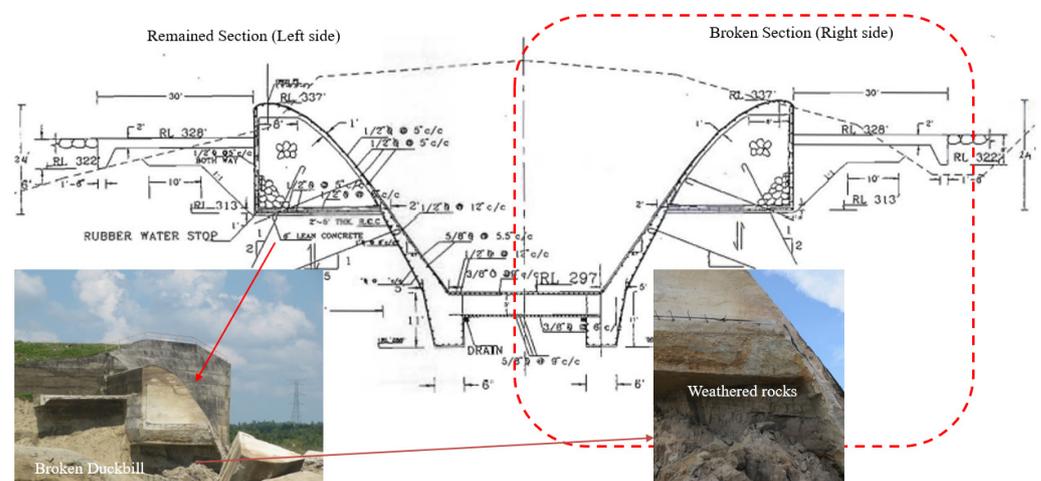
The investigation team from the IWUMD visited the spillway collapse site in November 2018 to find the causes of the spillway collapse. With limited information because of the condition of the study site, the team figured that the failure causes might be related to the foundation and climate-change-related issues. The spillway foundation was found to be composed of sand, rocks and mudstones, and weathering was observed in the foundation as shown in Figure 5. Duckbill-type ogee structures might suffer uplift of the water head during high water periods; although reinforcement bars were provided in the concrete structure of the ogee spillway to resist the uplift of the water head and other tension stresses. On the other hand, foundation rocks become weak against tension stress caused by uplift of the water head and the slaking would have probably occurred to those stones according to the technical report of the investigation team. The weathering including slaking of the foundation and uplift of the water head may have acted against ogee spillway, and many specialists in Myanmar fault the main reason of failure on the foundation of the spillway.

**Figure 5.** The typical cross-section of the collapsed spillway (design by the IWUMD).

Actually, after the impoundment of the Swa Dam in 2005, water has overflowed from the spillway every year according to the records of the IWUMD. On the other hand, the water level of the reservoir comes down lower than the bottom of ogee elevation starting in the dry season of 2009 according to the records of the IWUMD. Thus, the repetition of wet and dry conditions would lead the foundation toward slaking which would be one of the causes of weathering in the foundation. Therefore, the changing of the climate pattern of the study site might also be one of the factors of the failure. The team also recognized that seepage happened at the construction joint of the spillway, and each block of the spillway weir had a smooth surface, as shown in Figure 5. The team described that the seepage that

happened at the construction joint might be one of the factors that affected the stability of the structure.

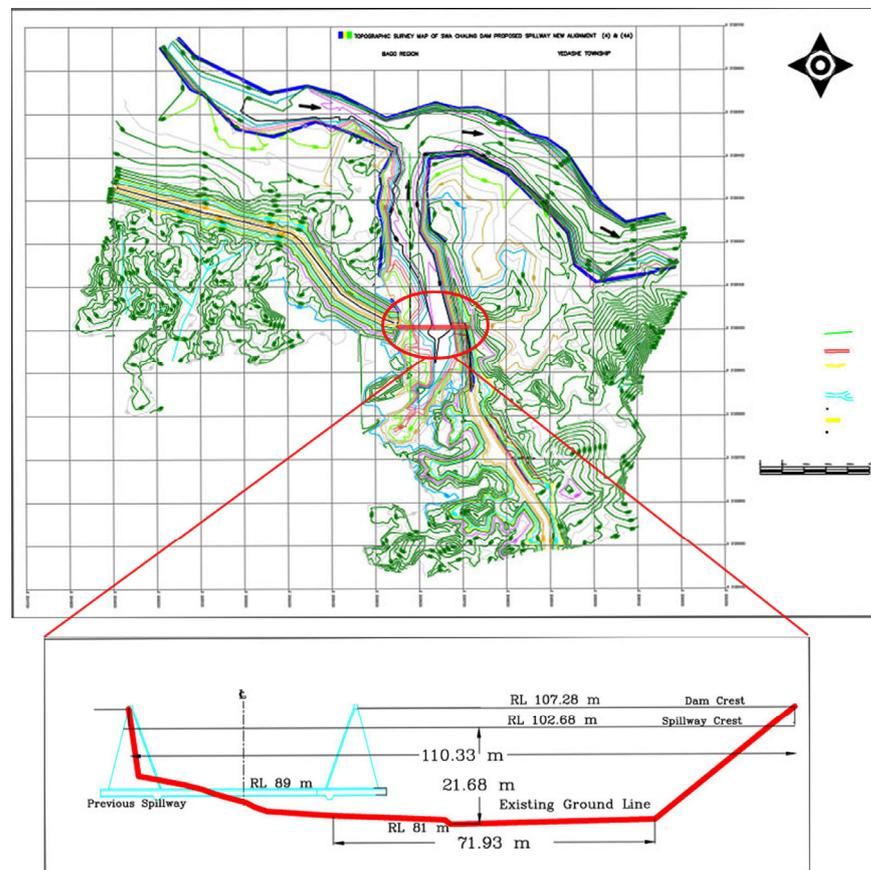
average breach width was 110.33 m taken from the topographic survey data of the IWUMD (Figure 7). This average width measured from the survey data was applied as the observed average breach width in the comparison of the resulting average breach widths ( $B_{avg}$ ) by empirical equations.

**Figure 7.** Breach dimensions from the topographic survey data (after the event) (IWUMD).

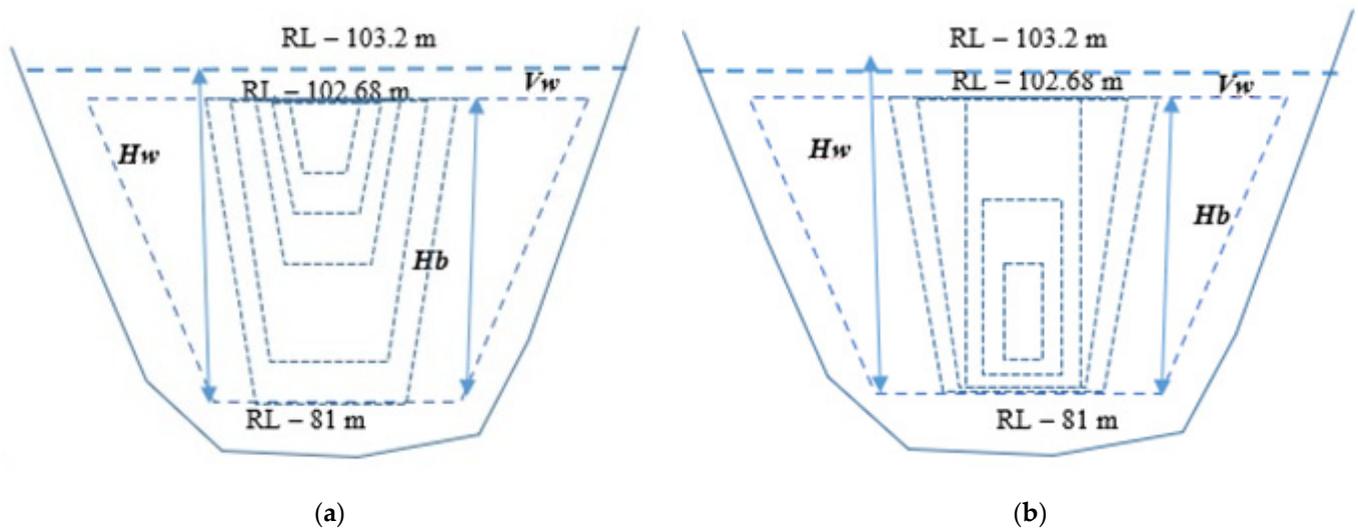
Most previous studies on dam failure have focused on two main mechanisms: overtopping erosion and piping failure of the dam body. Meanwhile, an ogee-type spillway failure happened in the Swa Dam case, indicating that the dam failure mechanism was not the same as those of previous events. However, two probable processes, overtopping erosion and piping erosion, were also considered in the spillway failure in the Swa Dam. Because the water level data indicated that the overflow occurred at the start of the breach, we cannot eliminate the possibility of overtopping erosion. Thus, we set two scenarios, Scenario 1 (overtopping erosion) and Scenario 2 (piping erosion) as described in Figure 8, to apply the selected empirical equations from previous studies.

Figure 8. Spillway breach by (a) Scenario 1: overtopping and (b) Scenario 2: piping.

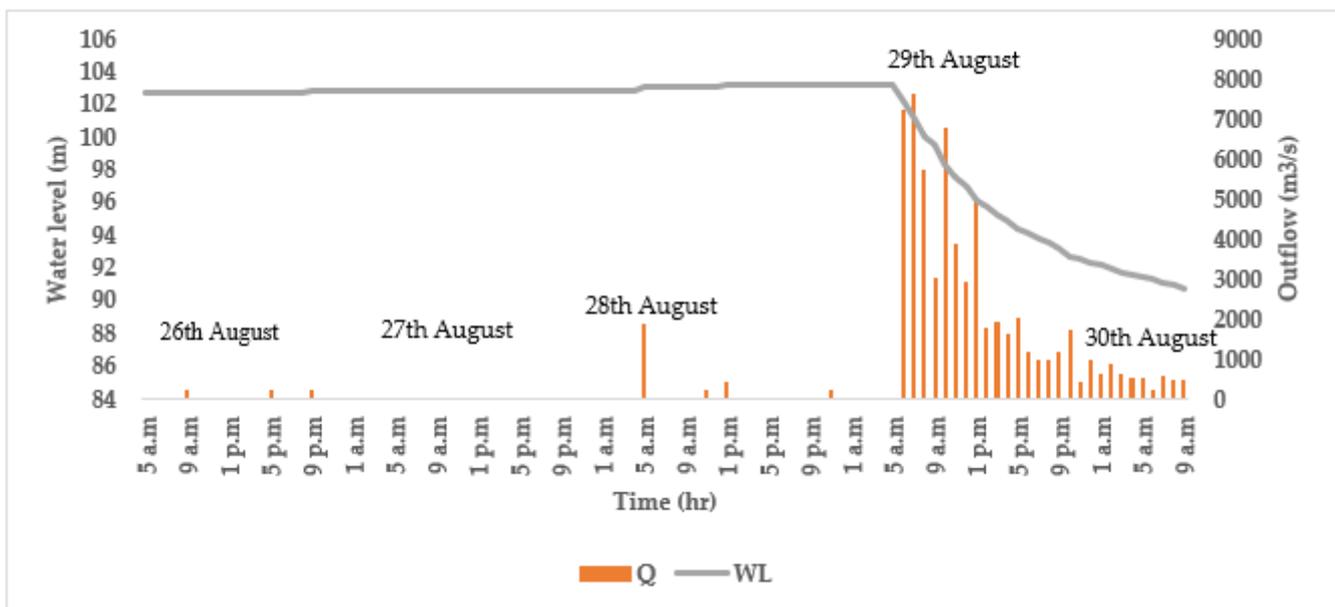
On the day of the collapse (29 August 2018), no rainfall was recorded, the overflow depth of the spillway was about 0.5 m (water level 103.2 m) and the water discharge rate drastically increased from 0 to 7217.9 m<sup>3</sup>/s within 1 h (Figure 10). The maximum breach discharge was about 7642.8 m<sup>3</sup>/s at a 101.1 m water level and happened at 7:00 a.m. LT on 29 August 2018, as shown in Figure 10. This peak discharge is around five times larger than the discharge rate for the spillway design discharge (1486 m<sup>3</sup>/s). Moreover, the estimated peak discharge was around two times larger than the designed peak flow (3491 m<sup>3</sup>/s) because of rainfall that occurs once in 1000 years. The peak discharge continued for 1 h until 7:00 a.m. LT, although the water level in the reservoir dropped from 102.2 to 101.1 m. After that, the water discharge rate dramatically decreased to 3000 m<sup>3</sup>/s in 1 h with a decrease in the water level from 100.1 to 99.5 m. After the drastic decrease, the water discharge decreased gradually with the decrease in the water level, but the discharge rate was still larger than 1500 m<sup>3</sup>/s until 14:00 LT, suggesting that the water discharge exceeded the spillway design discharge rate for around 9 h. The discharge rate became 500 m<sup>3</sup>/s 24 h after the peak discharge. The recorded hourly water level and corresponding water volume in the reservoir are described in Table A3 (Appendix B). The total discharged volume until 24 h from the beginning of the breach (29 August 2018, 5:00 a.m. to 30 August 2018, 5:00 a.m.) was around 215.5 million cubic meters, as shown in Table A3.

**Figure 10.** Observed dam water level and calculated outflow rate from 26 to 30 August 2018.

According to the observed water level and corresponding calculated outflow rate, the water level decreased with time; however, the discharge rate remained nearly constant in the peak 2 h (from 5 a.m. to 7 a.m.), as in Figure 10. This suggests that the cross-sectional area of outflow gradually enlarged with time for the first 2 h. Two possibilities for this process are (1) the gradual erosion of the spillway intake, and (2) the gradual erosion of the right bank and bed of the spillway. At peak flow periods, the flow rate was very large, suggesting that the shear stress of flow to the bed and side bank of the spillway was much larger than designed, and the drastic erosion and collapse might have occurred because of the large shear stress. Moreover, the water flow might have been subjected to the right bank side because only the right side of the spillway was eroded in the event. This agreed well with the foundation test of the spillway, which found that the bearing capacity of the left side was larger than that of the right side of the spillway (Section 2.4).

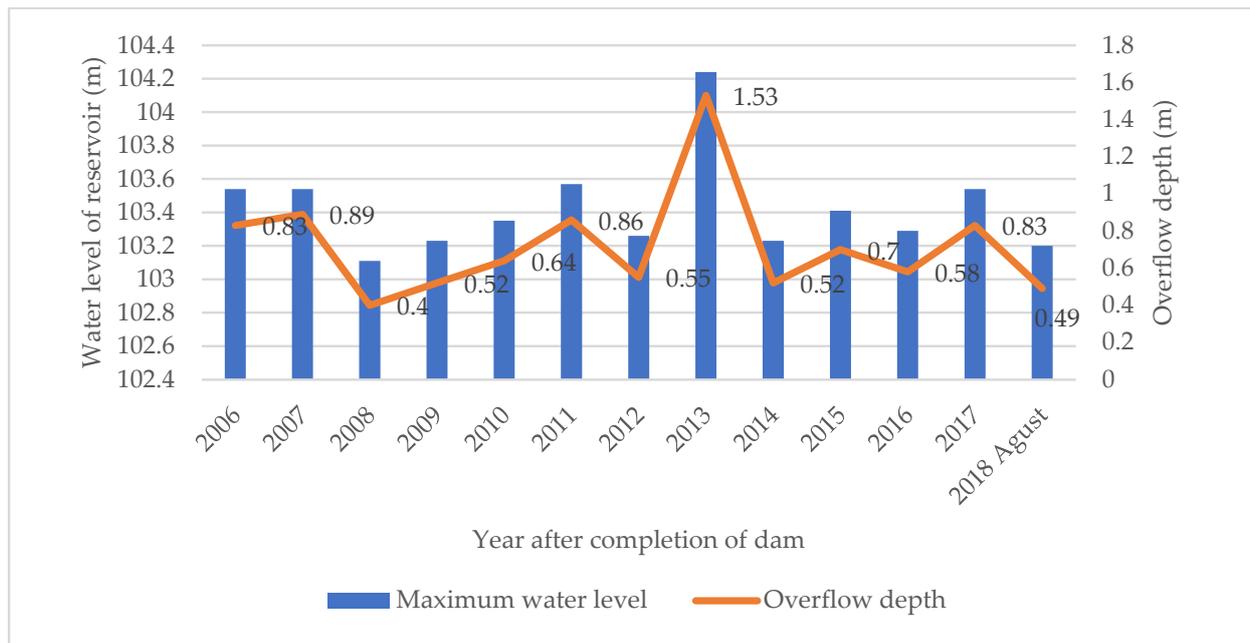
By compiling 13 years of water level records from the IWUMD, the spillway overflowed 38 times; 8 times in 2017 and 6 times in 2011. Generally, the maximum overflow occurred in August and October of each year, according to the records. We compared the overflow depth of the spillway in August 2018 with the highest overflow depth in each year, and the overflow depth of the breach day was about 0.5 m, which was not high enough compared with those in previous events, as shown in Figure 14. The largest overflow depth happened in 2013, which was 1.53 m and around three times larger than the highest overflow depth on the breach day. This suggests that the overflow depth cannot fully explain the occurrence of the spillway breach. The surface or interior of the spillway might have weakened over time because of other reasons.

**Figure 14.** Highest overflow depths of the Swa Dam after completion (IWUMD).

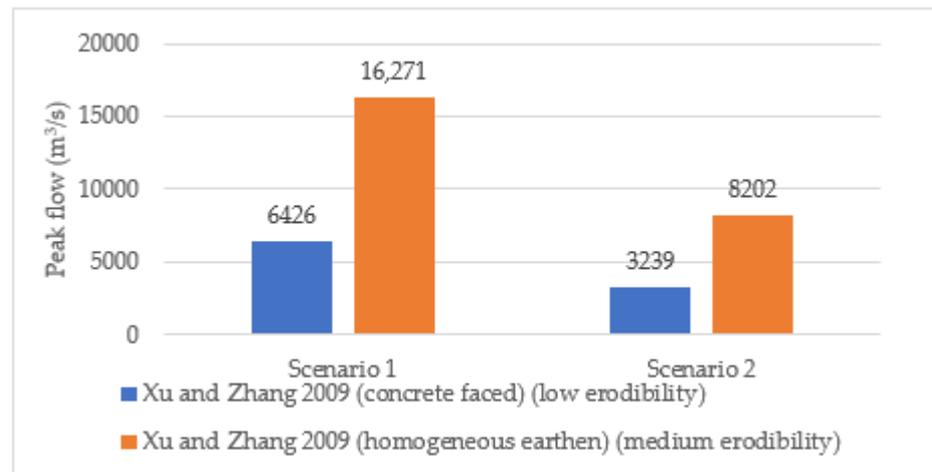
The effects of the concrete spillway in the event were analyzed on the basis of the erodibility and dam type, referring to the calculated results from Xu and Zhang's (2009) equations. Once we assumed the erodibility level to be the medium erodibility and homogeneous earthen dam, the calculated peak flow,  $Q_p$ , was about 1.1 to 2.1 times larger than the observed peak discharge. Meanwhile, in the case of the low-erodibility and concrete-faced dam, the calculated peak flow was 0.4 to 0.8 times lower than the observed peak discharge, as shown in Figure 15. This indicates that the case of the Swa

Dam was intermediate between low and medium erodibility and was relatively close to low erodibility, rather than medium erodibility. This suggests that the spillway in the Swa Dam might have had a reduced erodibility compared with that of a homogeneous earthen dam. This agrees well with the condition of the Swa Dam, where the floor of the spillway was covered by 15 cm-thick lean concrete over 0.3 m-thick reinforced cement concrete at the duckbill part. Moreover, the side bank of the spillway might be considered as contributing to reducing the breach width because the left bank of the spillway was not eroded. The collapse event that happened in the spillway of the Montedoglio earth-fill dam in Italy also concluded that the presence of the spillway channel walls reduced the breach outflow [27].

**Figure 15.** Comparison of peak discharges from Xu and Zhang’s 2009 [26] empirical equation for different dam types and erodibilities.
